INCIDENT INVESTIGATION REPORT

INCIDENT NAME: Alpine CD1 Gas Release

May 3, 2022

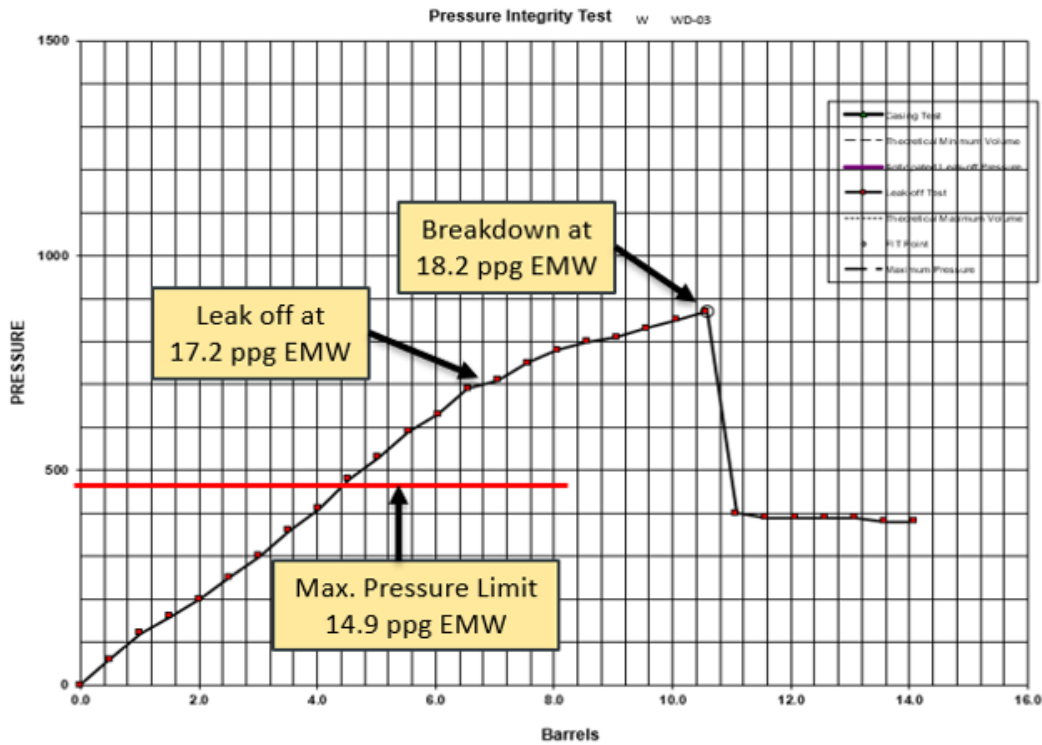
Figure 1.

The Section Plan 03 Annular LOT and Freeze Protect procedure stated on Page 10, section 1.b. "Max. test pressure of 14.9 ppg EMW which was LOT at surface casing shoe." The actual WD-03 Annular LOT results were 17.2 ppg, with the pressure breaking over at 18.2 ppg as injectivity was established. See Figure 1 below.

Exceeding the surface casing shoe LOT of 14.9 ppg EMW by up to 3.3 ppg during the Annular Leak-Off Test and Freeze Protect operations on February 27 most likely broke down the casing shoe and provided an initial pathway for gas migration around the outside of the WD-03 surface casing. Subsequent injection of approximately 300 bbls of water to displace the mud in the OA as part of the freeze protection procedure likely expanded this pathway.

WD-03 Annular LOT Injection #1 – 2/27/2022

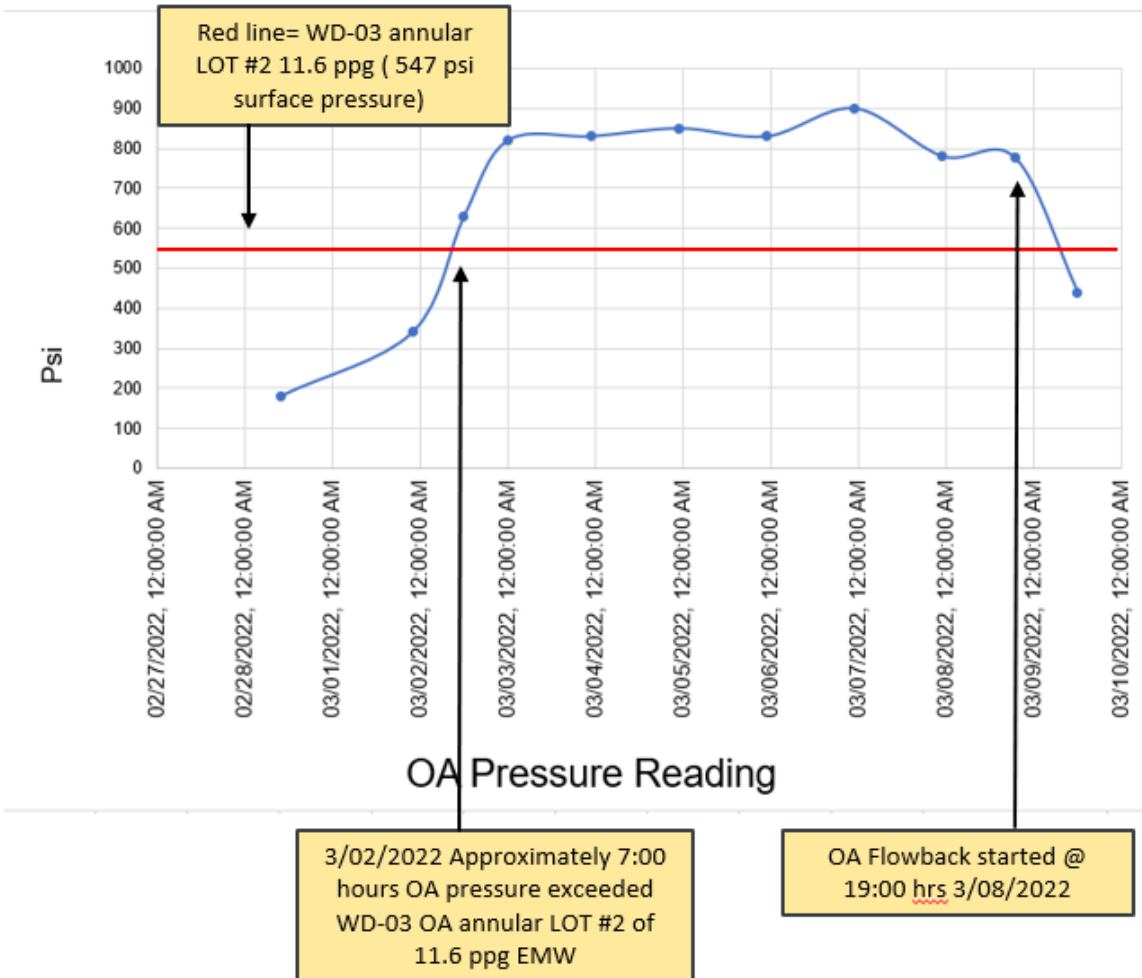
Figure 2.

The pressure increases in WD-03’s OA from March 1 to March 3 were not recognized and/or addressed and, accordingly, did not lead to investigation or remedial action during that period. The volume of gas released from the C10/Halo in WD-03 could have been reduced if actions to address the elevated OA pressures had been taken earlier. See Figure 2 below.

WD-03 OA Pressure Trend

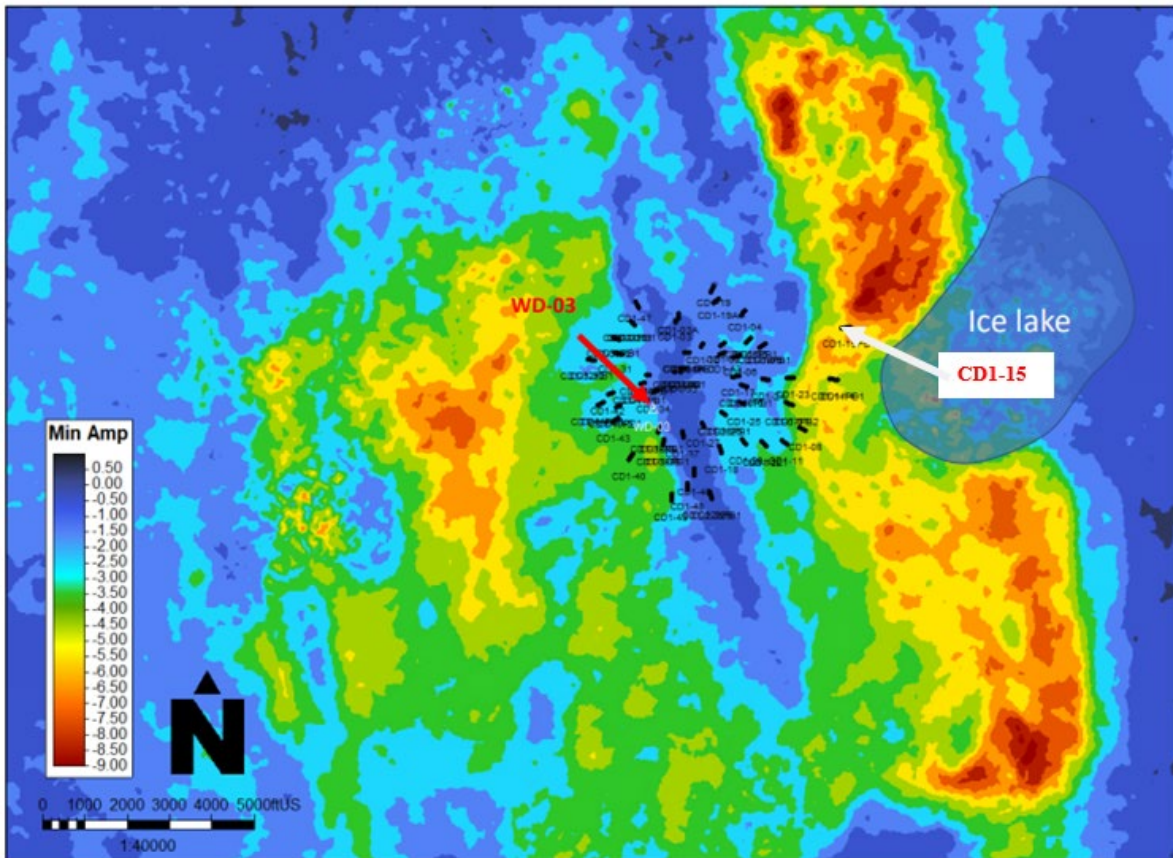
Note #1: The CD1-15 well produces gas intermittently from the C10/Halo as necessary to restart the Alpine facility following shutdowns. Thus, in contrast to the C10/Halo formation interval at the WD-03 well path, the C10/Halo formation interval at the CD1-15 well path was determined to be a “significant hydrocarbon zone” and was accordingly isolated with cement as per AOGCC regulations. The CD1-15 C10/Halo interval is located in a seismic bright spot/amplitude approximately 4922 ft NE of the WD-03 C10/Halo location. See Figures 3 and 4 below.

Halo LR Amplitude Extraction

Figure 3. WD-03, CD1-15, and offset CD1 well locations at the C10/Halo interval

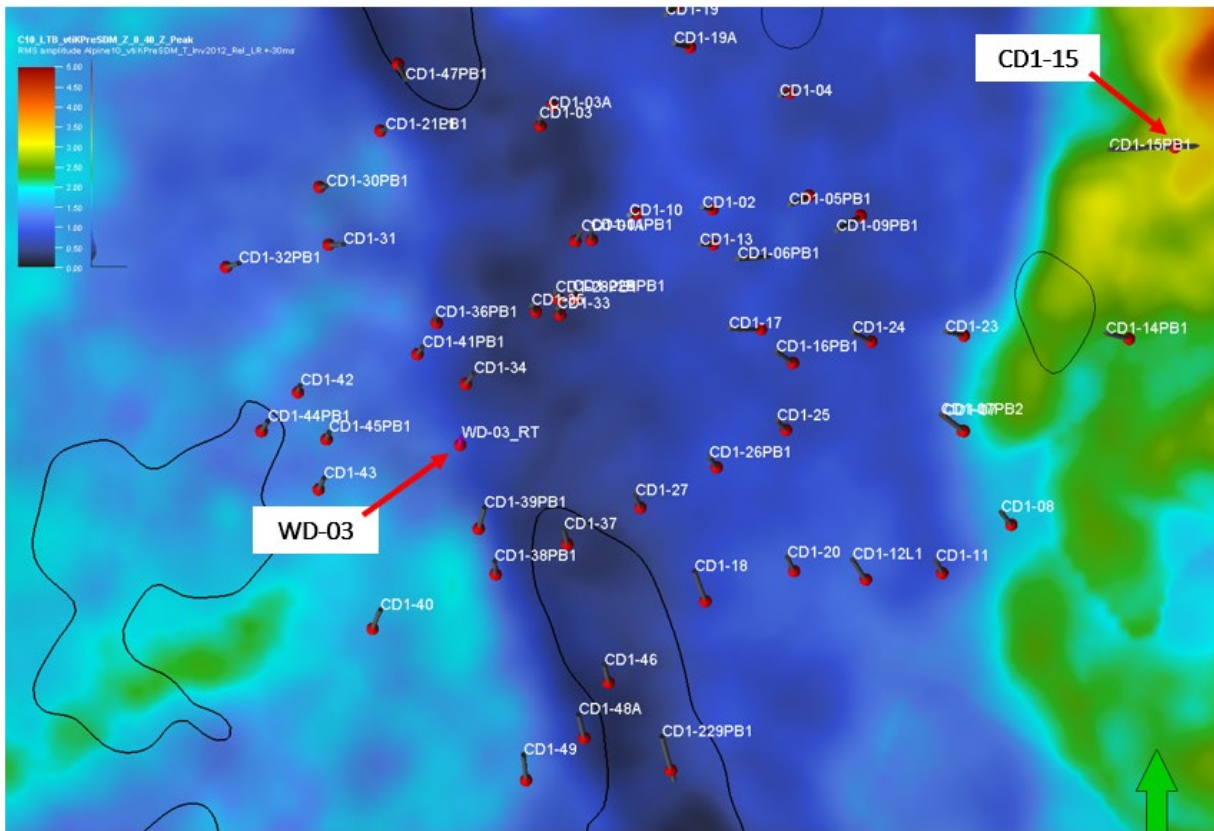
Figure 4. Zoomed in view showing WD-03, CD1-15, and offset CD1 well locations at the C10/Halo interval

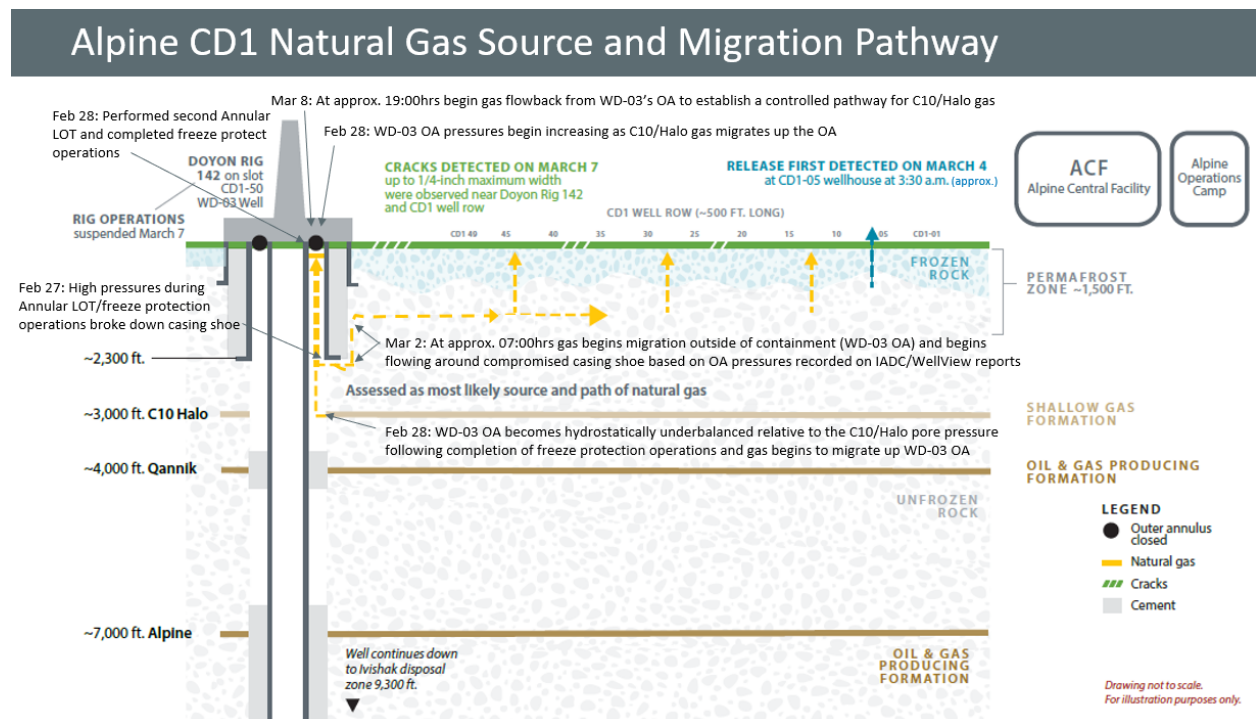
Figure 5.

Displacing water with diesel in WD-03’s OA for freeze protection purposes was necessary to prevent casing damage from the forces that would be exerted by the expansion of fluids (e.g., water or water-based fluids) that would freeze across the permafrost interval. Displacing the water with diesel for freeze protection purposes also reduced the hydrostatic pressure in the WD-03 OA. This put the WD-03 OA into a hydrostatically underbalanced pressure condition relative to the C10/Halo pore pressure, thereby allowing gas to flow out of the C10/Halo and into the WD-03 OA. See Figure 5 below.
