# Atmautluak Hazard Impact Assessment

June 2010

Prepared for  
The Atmautluak Traditional Council

Prepared by  
WHPacific  
with  
Shannon & Wilson

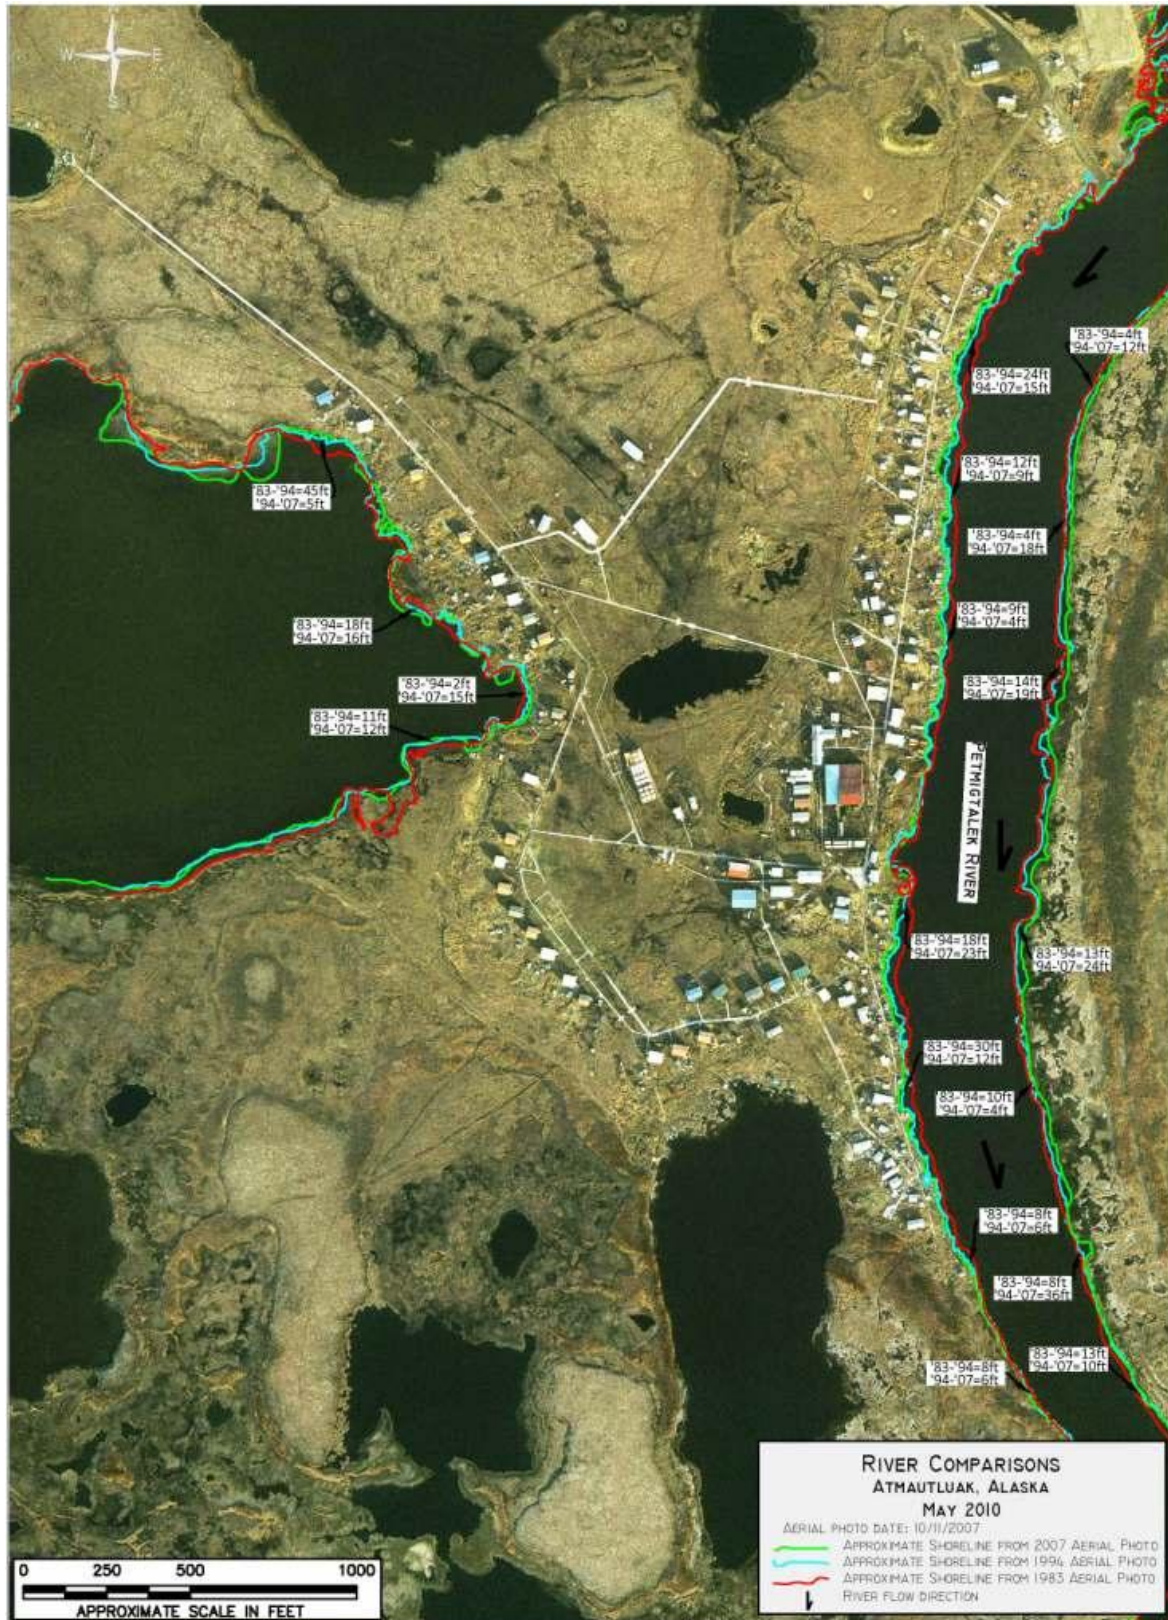
Figure 6 River Comparisons

As Based on the result of the analysis, the team observed that erosion was occurring along the Pitmiktakik River. Between the years of 1983 to 1994, the cut or concave bank (village side of the river) generally was observed to migrate toward the community on the order of 8 to 30 feet, or approximately 0.7 to 2.7 feet per year. Between the years of 1994 and 2007, the cut bank migrated on the order of 4 to 23 feet, or approximately 0.3 to 1.8 feet per year. These numbers are generally similar to what was reported as part of the Corps Baseline erosion project.

was identified in the Corps Erosion Information Paper (2007), there are several potential causes to the erosion, such as natural river erosion along the cutbank of a bend, ice impacts associated with spring breakup, boat wakes, degradation of permafrost, and ice jams. To help assess the impact of the erosion due to the bend in the river, the opposite river bank (convex or accreting) was also examined. Measurements indicated the opposite bank migrated 4 to 13 feet from 1983 to 1994 (0.3 to 1.2 feet per year) and 10 to 36 feet between 1994 and 2007 (0.8 to 2.8 feet per year). The total erosion is similar over the study period (1983 to 2007) for both sides of the river, which may be an indication that the impact of the bend may not be a major contributing factor to the overall erosion rate.

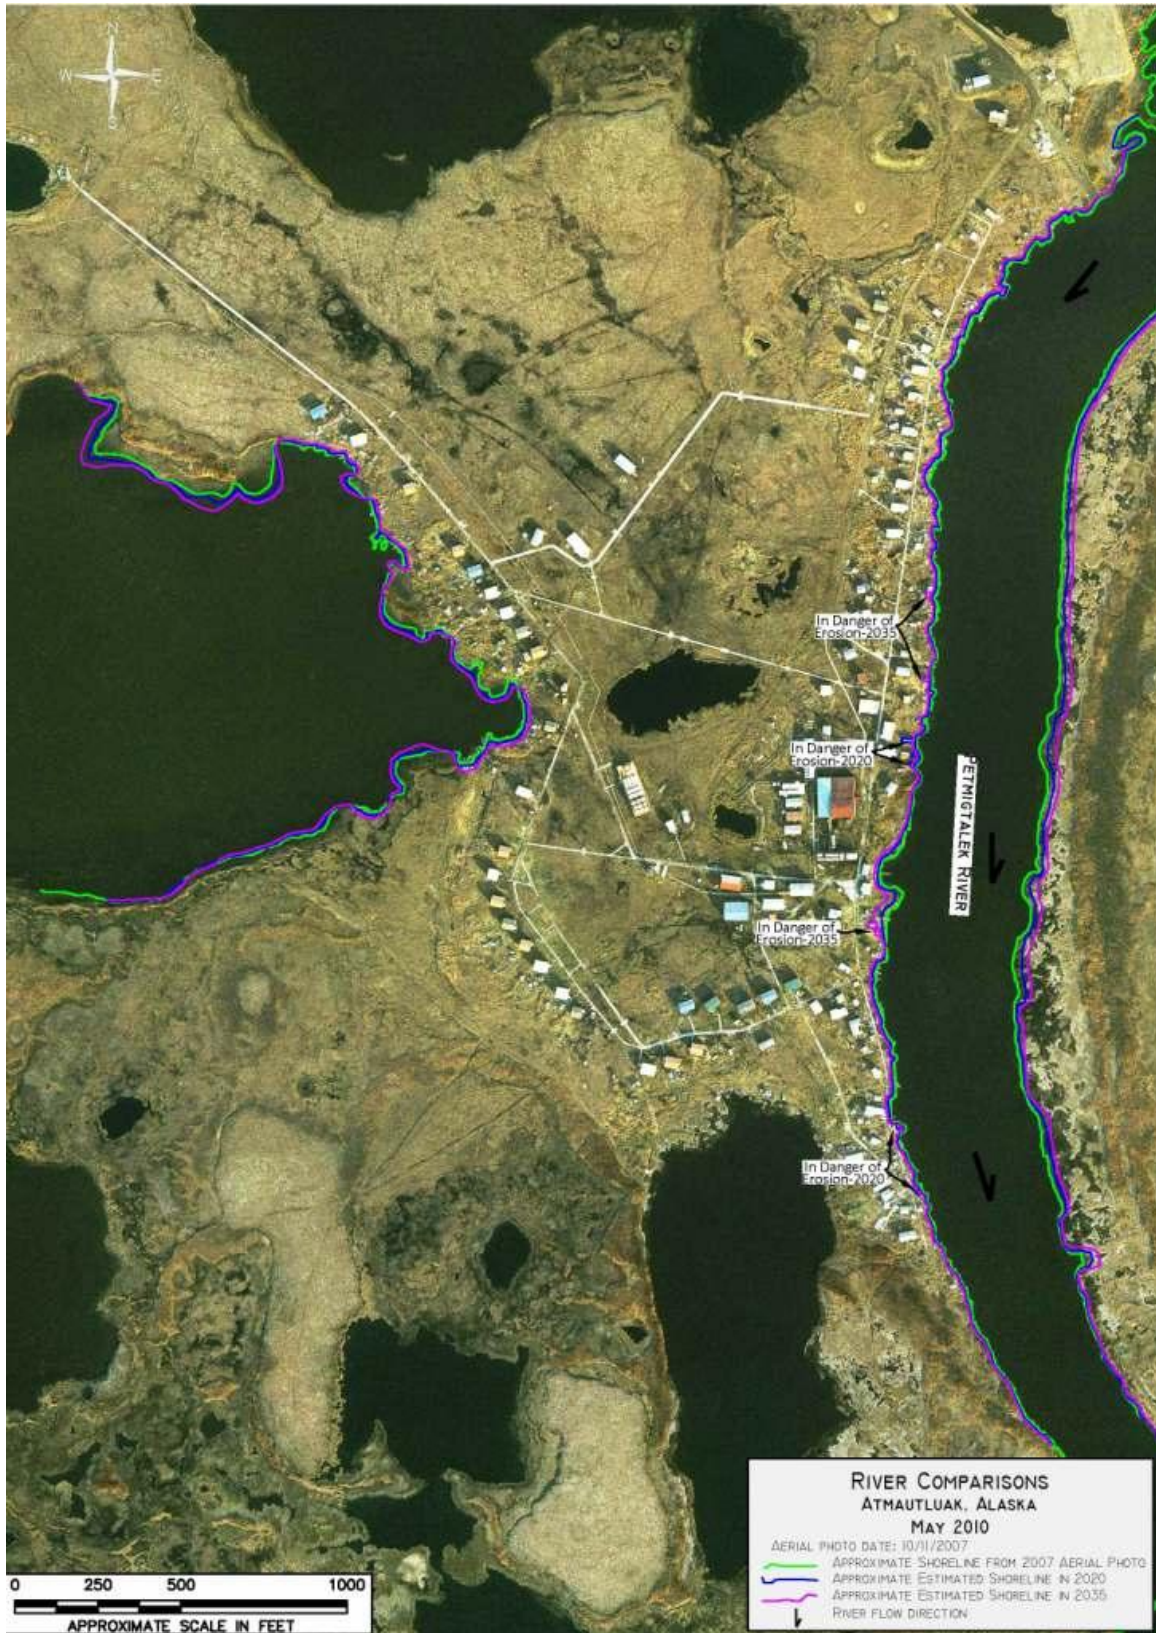
Figure 8 Future River Impact

The team's best estimate of structures vulnerable to erosion is depicted on Figure 8. Structures likely in danger within 10 years are labeled 2020, and those likely subject to erosion in the 25-year planning horizon are labeled 2035. These structures should be assessed for their long-term viability, whether they are structurally able to be moved or whether they should be replaced in a more secure location.

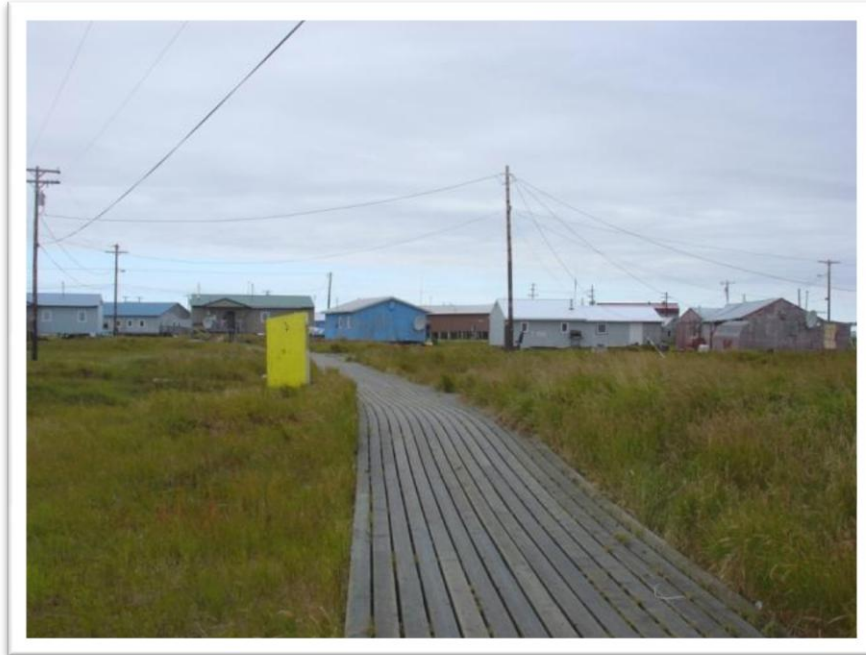
Boardwalks are used to protect the tundra and provide a walking and driving surface between most of the structures in the village (Photo 1). These boardwalks appear to be founded on shallow piles located along the length of the paths. The boardwalks were observed to undulate up to approximately six inches (primarily settlement) in isolated areas, but were generally usable without difficulty. Evidence of damage due to localized frost jacking was not observed.

Photo 1: Village of Atmautluak illustrating typical boardwalk and grass

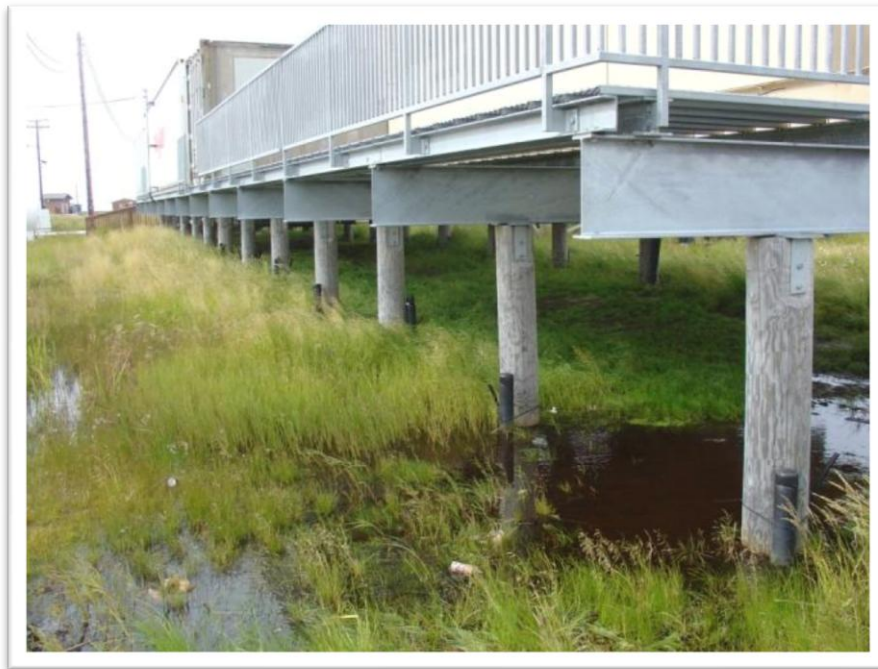
Photo 2: Timber piles supporting generator and electrical support pad. Note ponded water near piles. We attempted to measure temperature in black PVC pipe, but the water in the casing was frozen at a depth of approximately 2 feet.

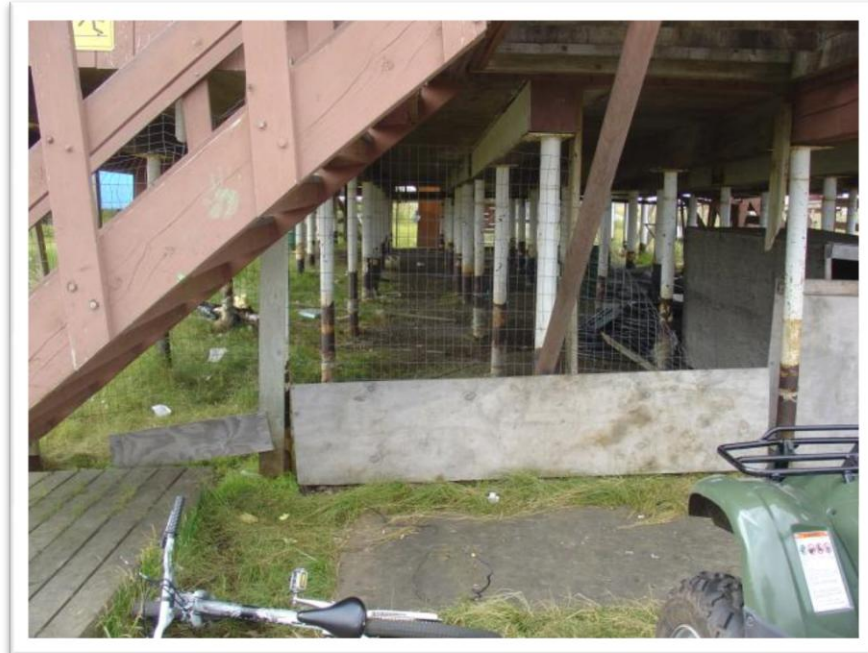
Photo 3: Steel pipe piles under washeteria/water supply building. Piles are wrapped with plastic sheeting near the ground surface, which may be to reduce potential frost jacking. This may indicate relatively shallow piles.

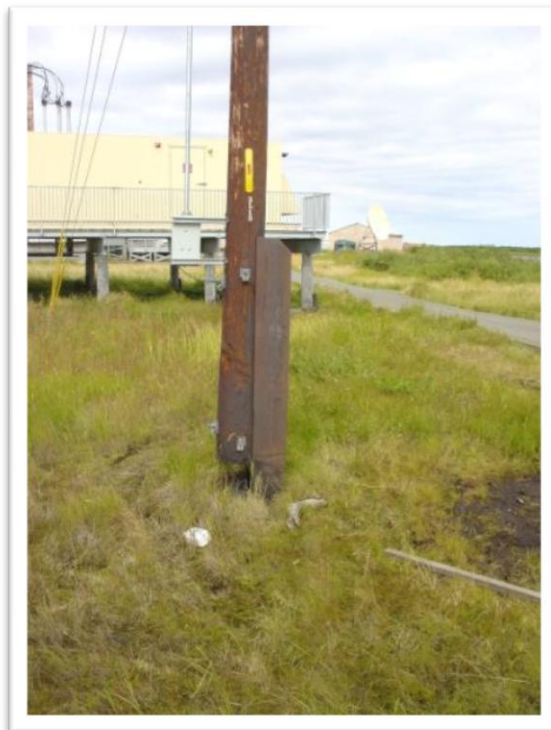
The buildings in the community are served by power and telephone lines located atop wooden poles. Most, if not all, of these poles have been cut off at the base and attached to steel H-piles (Photo 4). The Village reports that this was done approximately two years ago to provide additional stability to the poles, which were beginning to show signs of frost jacking and tipping.

Photo 4: Timber utility posts have been cut off near the ground surface and attached to H-piles. We understand this work was completed within the last few years.

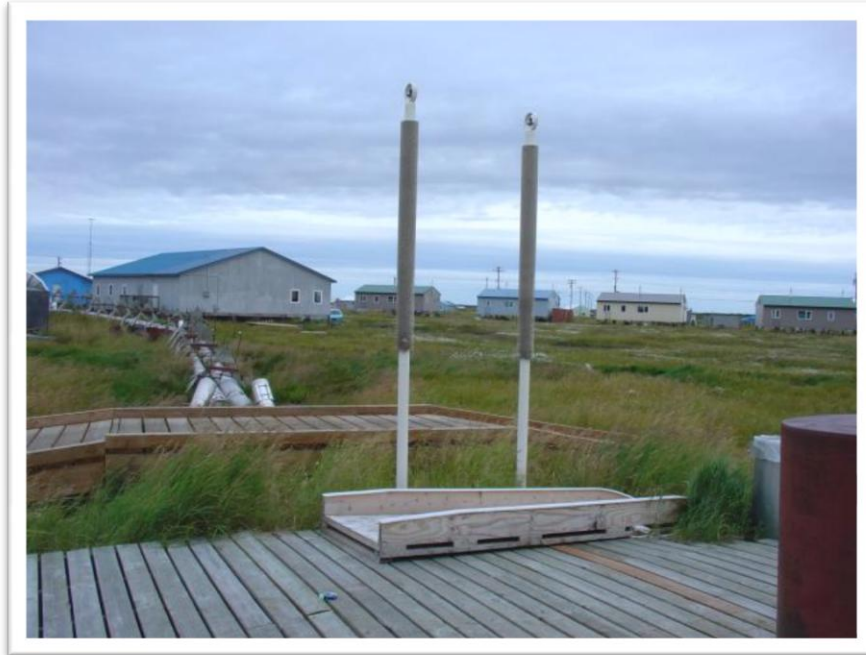
The piles are generally not passively refrigerated. The only passively refrigerated piles observed were two passively refrigerated thermosphyons observed near the wastewater lift station (Photo 5).

Photo 5: Passively refrigerated thermosyphons near the sewage lift station, sewer line in background.

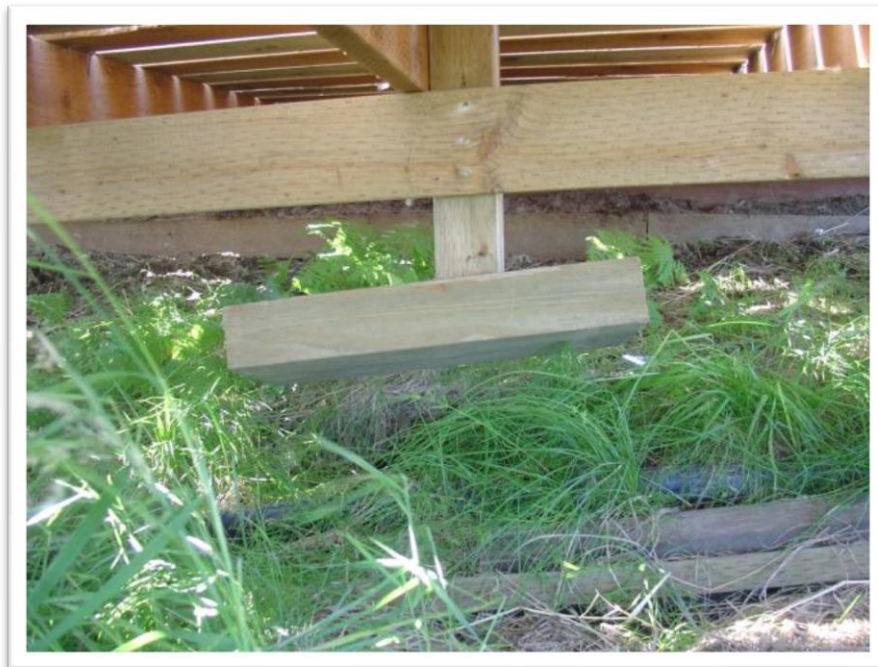
Photo 8 shows a small wood pad under the lift station. The pad is “floating” approximately 12 inches in the air. It is unclear whether this pad was originally at the ground surface or whether there was additional cribbing that was previously removed. No discoloration was observed on the wood, giving some indication that the wood was not in contact with the ground. Photo 30 shows the entrance stairs to the National Guard Armory located near the airport. As seen in the photo, the stairs no longer touch the approaching boardwalk, but are suspended several inches above it.

Photo 8: Floating footing under lift station. Given the lack of discoloration that would be an indicator of embedment, the pad may have been supported on blocks in the past, rather than being an indication of settlement.

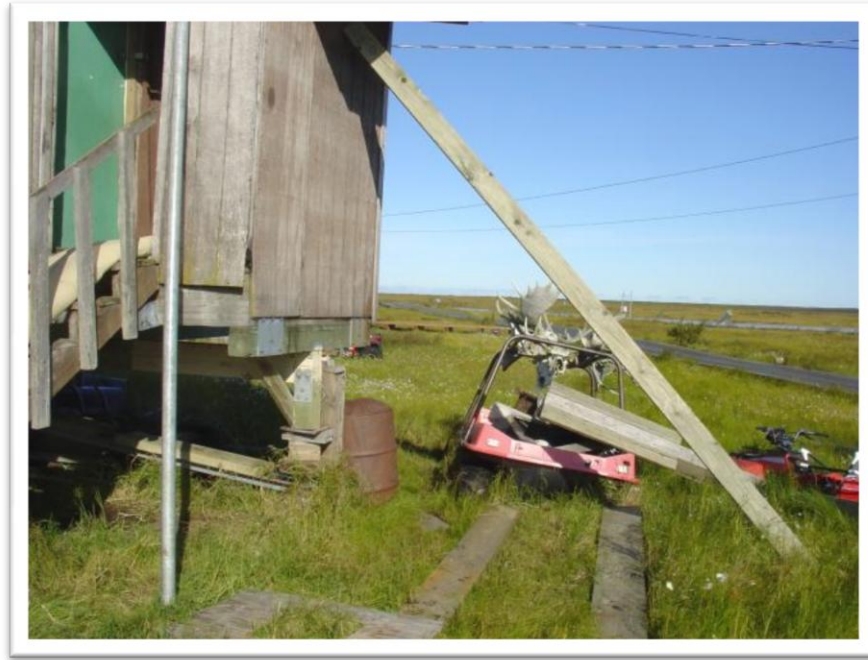
Photo 9: Repair of distressed residence near north end of village. Note blocking between pile top and support. The diagonal member appears to provide lateral support to the entryway.

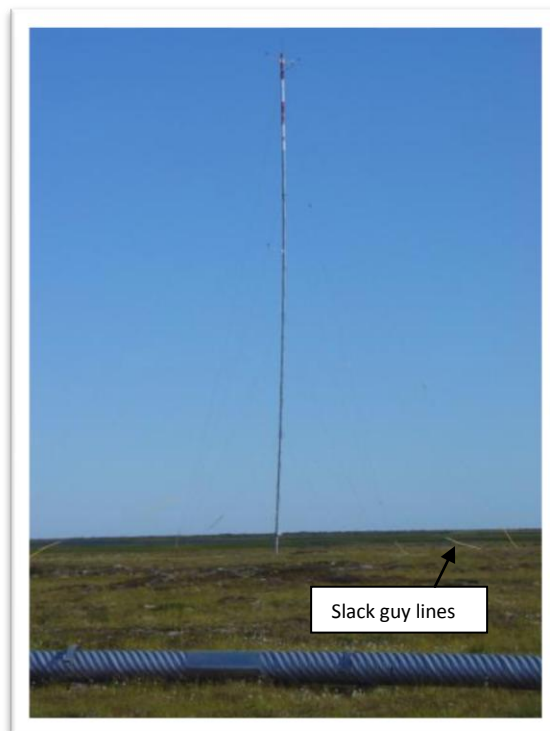
Two towers were observed to the west of the runway (Photo 10). Several of the guy lines appeared to be slack, which may reduce the stability of the towers particularly in high wind events.

Photo 10: Tower located between sewage lagoon boardwalk and runway. Note the slack in the guy lines.

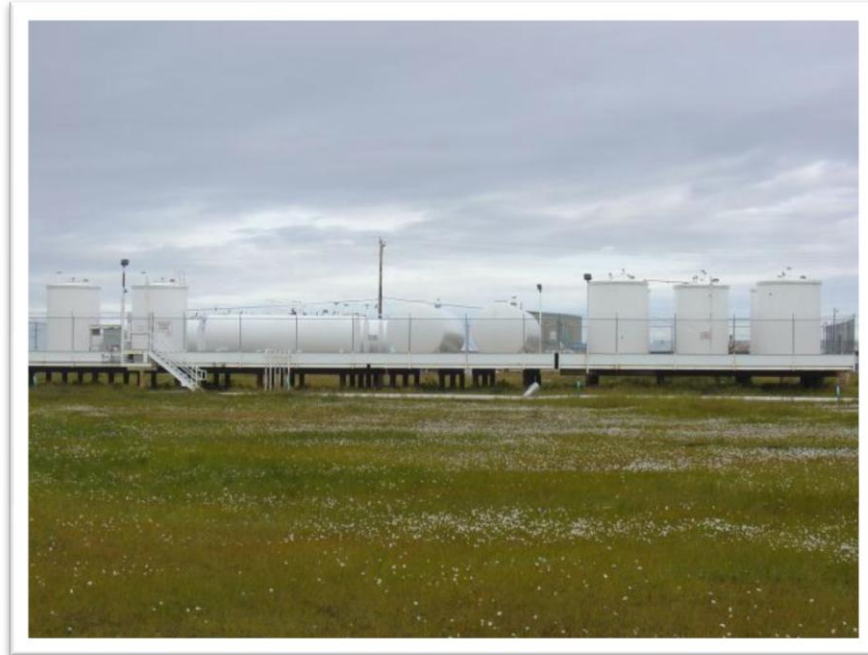
Diesel for power and heat, as well as gasoline, is stored on an elevated fuel storage platform in the central part of the community (Photo 11). This structure is founded on steel piles and appears to be in good condition. Fuel lines leaving the structure generally consist of steel pipe that is placed on the ground surface with occasional wooden blocks placed underneath to provide some support. The pipes are physically unprotected from traffic and are often located within standing water (Photos 23 and 24).

Photo 11: Pile support fuel storage facility.

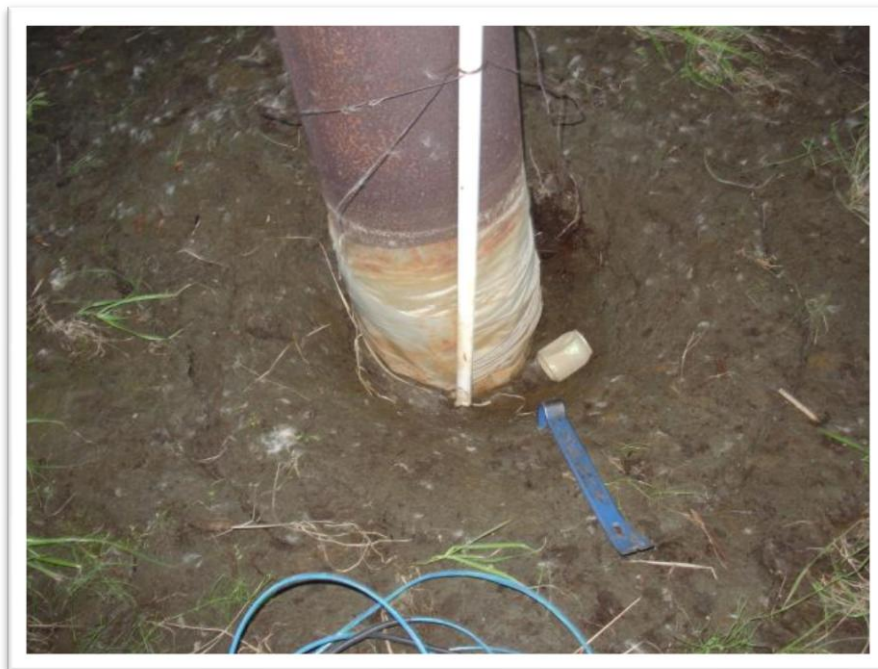
Photo 12: Settlement around wrapped steel pile under the fuel storage area.

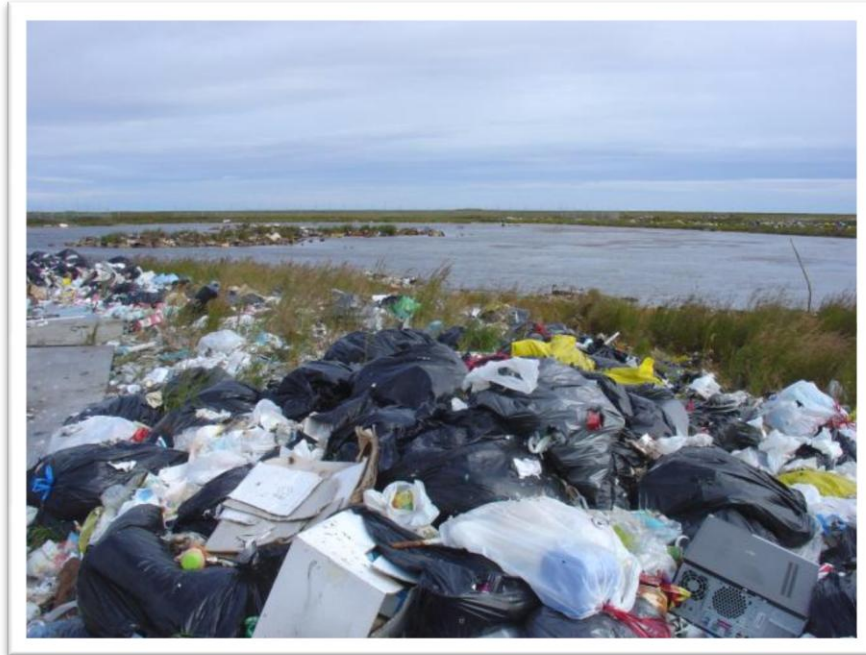
Photo 13: Ponding water in solid waste disposal area.

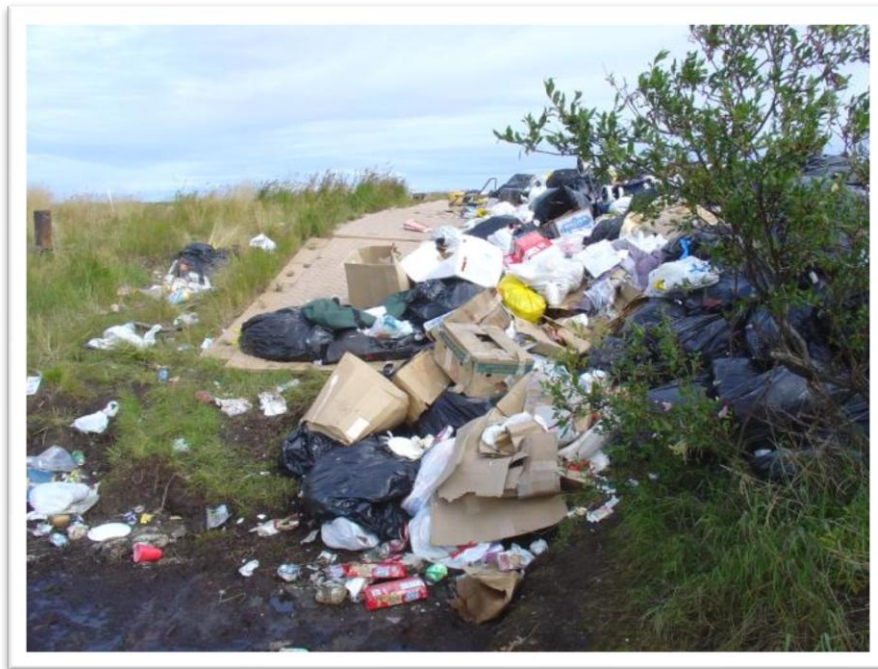
Photo 14: Temporary disposed refuse on riverbank near solid waste facility.

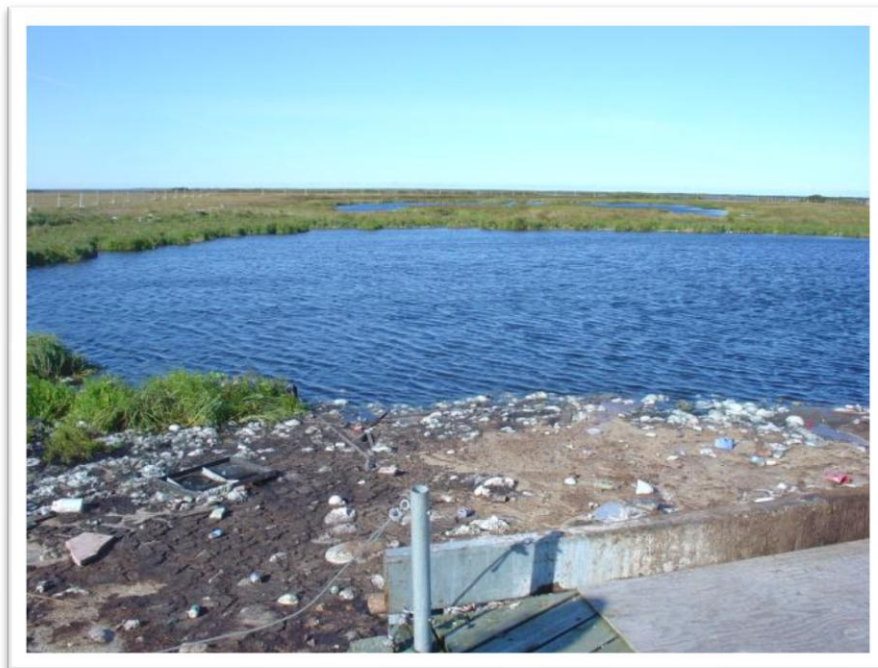
approximately 600 feet north of the edge of the lake that borders the western part of town. The lagoon is also approximately 400 feet southeast of another large lake. There is currently no wastewater discharge permit for the lagoon on file with the Alaska Department of Environmental Conservation, and it may be assumed that the lagoon does not discharge. An organic mass was observed on the lagoon surface near the point that the honeybuckets are emptied (Photo 16). The water quality of the lagoon is unknown.

Photo 16: Primary wastewater treatment lagoon located approximately one-half mile northwest of the main body of the village.

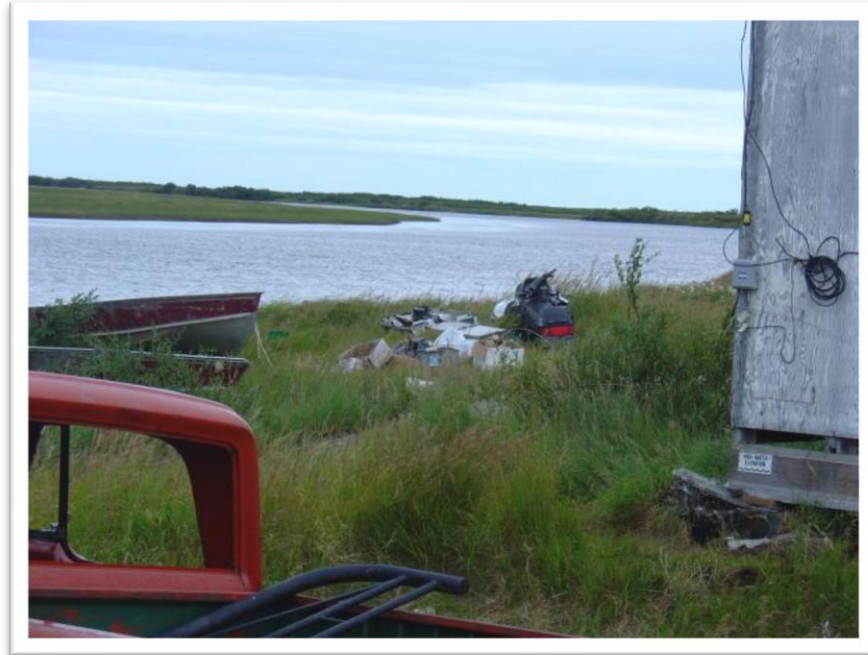
Photo 17: Proximity of house to Pitmiktakik River at south end of Atmautluak. Note high water elevation mark on structure.

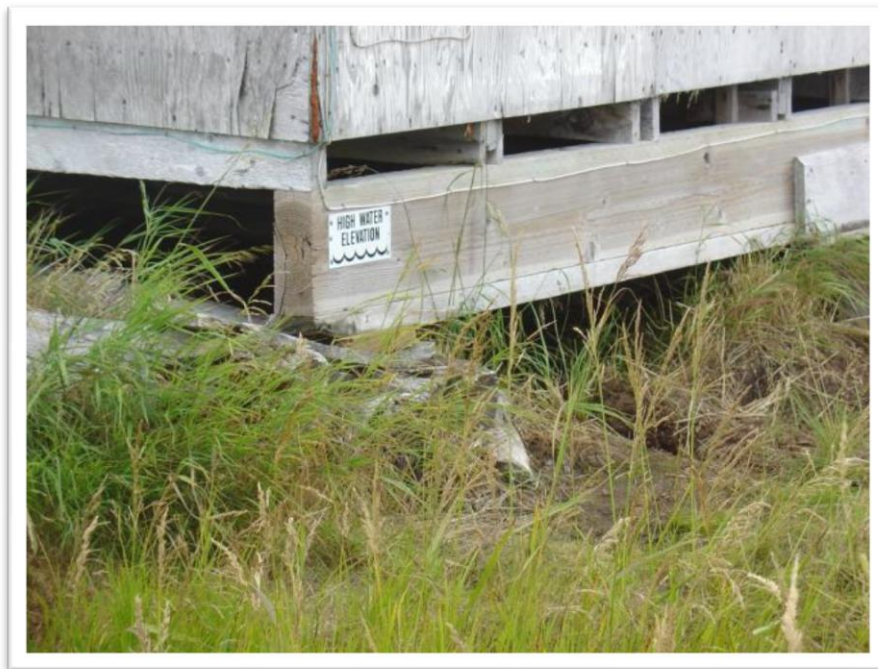
Photo 18: Close up of high water elevation mark on residence. Note apparent timber (non-pile) foundation.

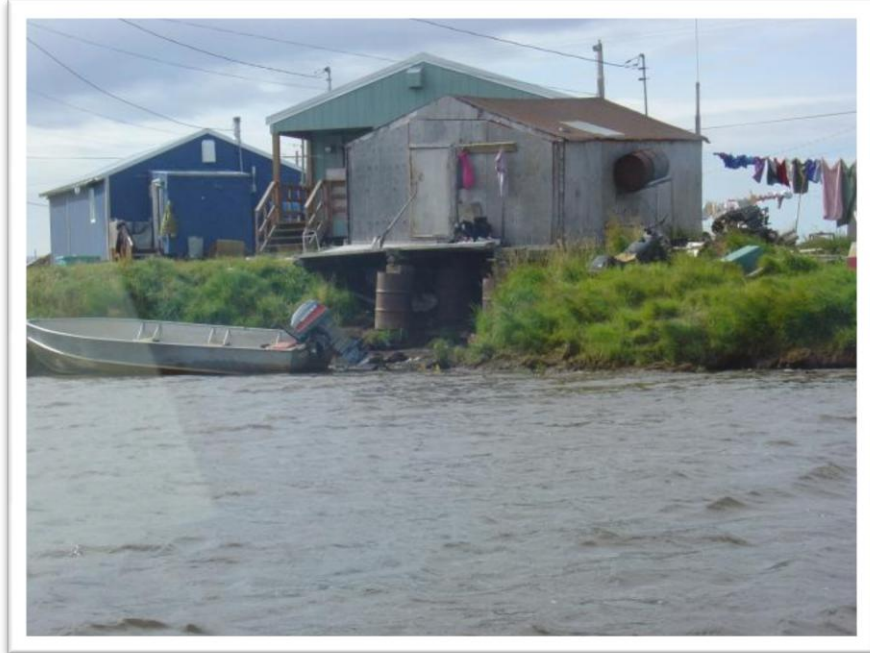
Photo 19: Riverbank erosion under existing structure. Building is being supported, in part, on fifty-five gallon drums.

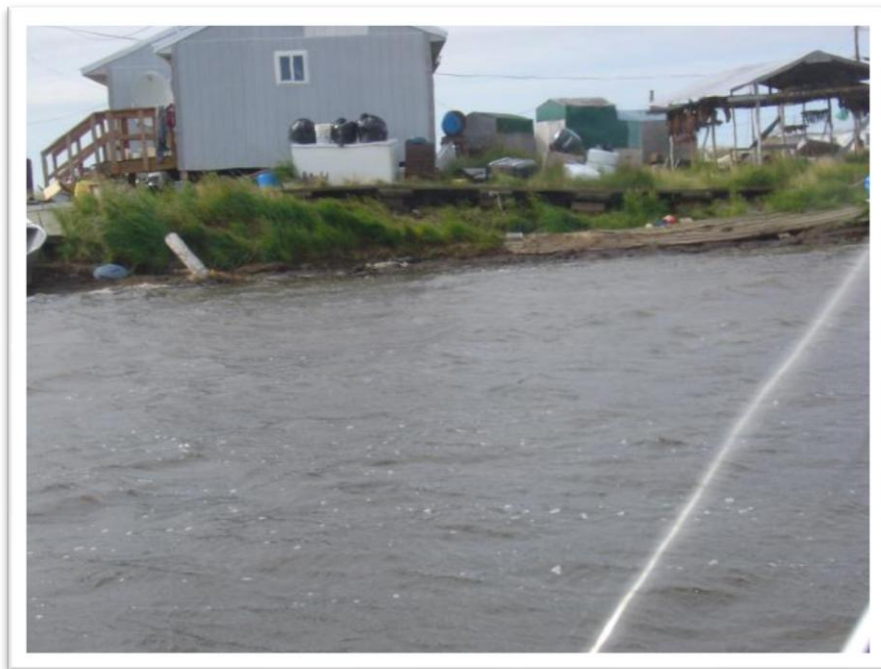
Photo 20: Riverbank erosion near existing structures and undermining boardwalk.

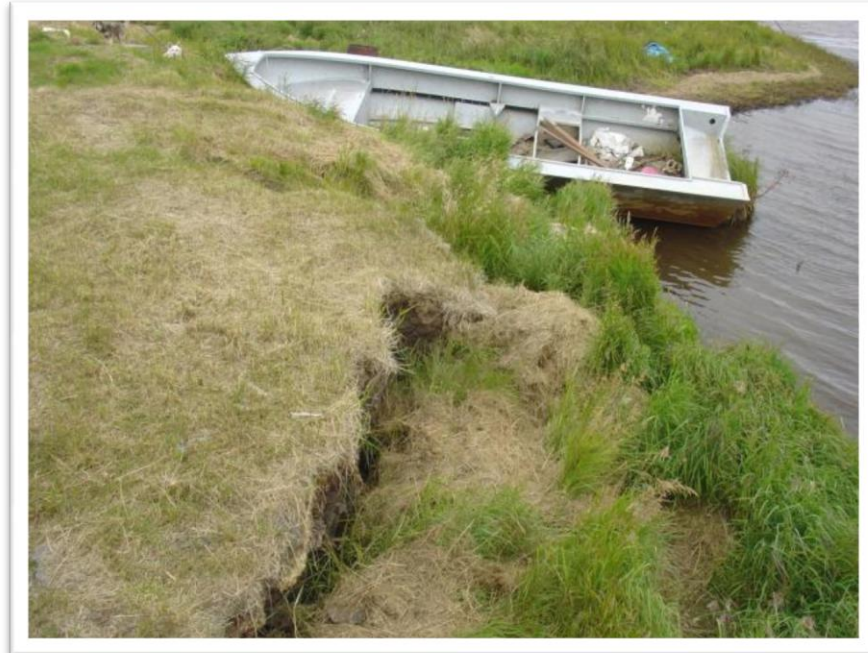
Photo 21: Riverbank erosion. The grass mat likely reduces the rate of erosion, as it provides some insulation against thaw and resistance to water flow and wake erosion.

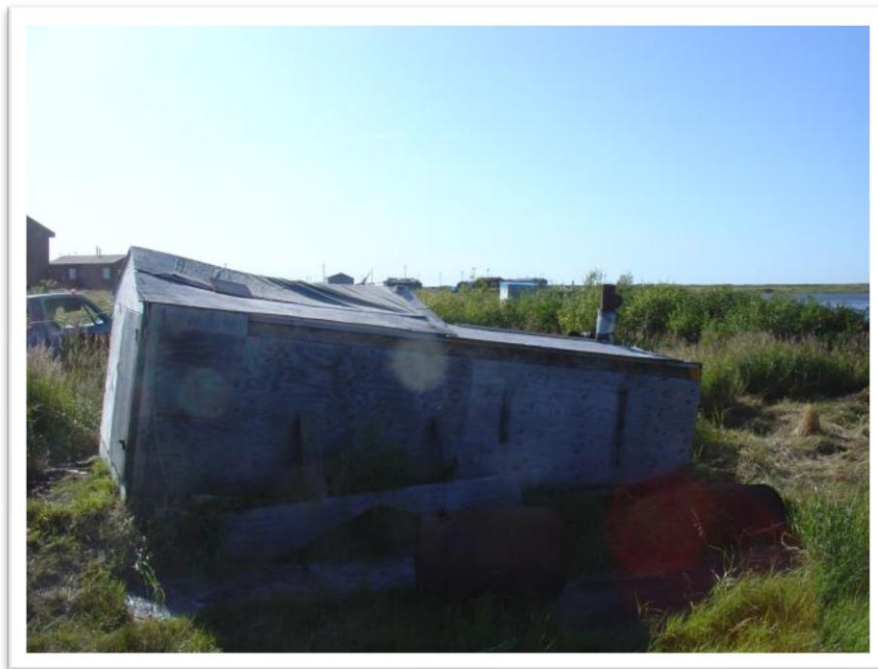
A few residences, as well as most of the smokehouses or smaller structures, are founded on timbers placed on the ground surface. Several of these structures have undergone significant differential settlement (Photo 22).

Photo 22: Smoke shed undergoing settlement near lake on north side of village.

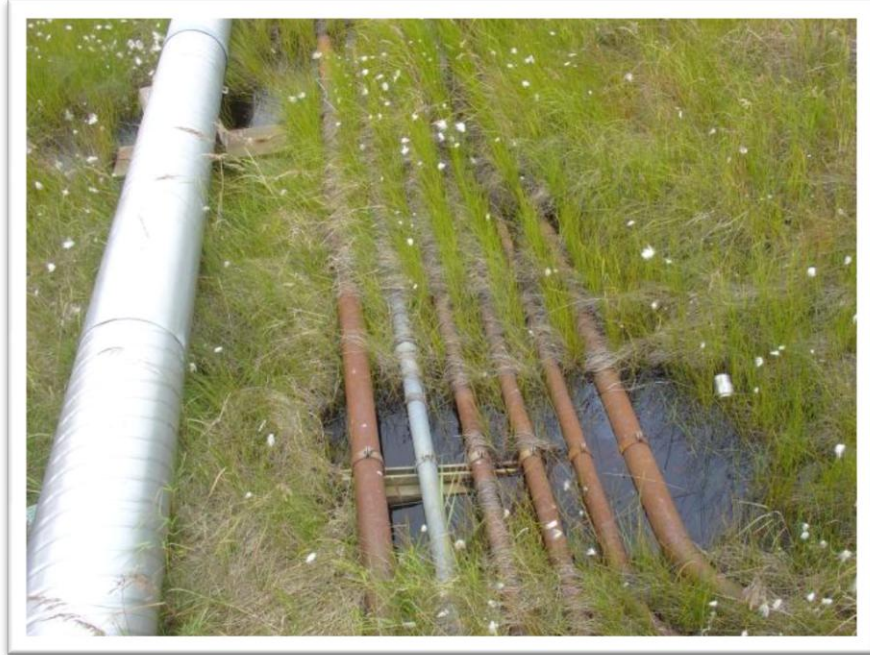
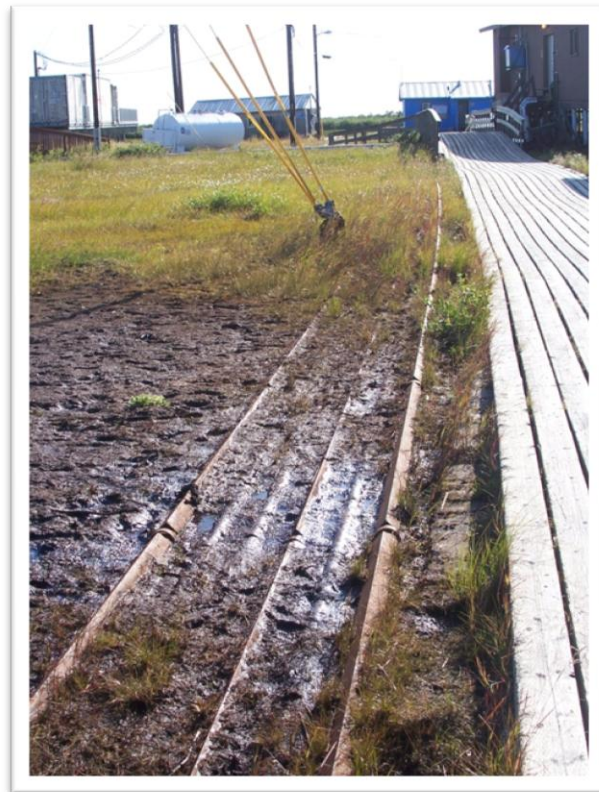
Photo 23: Fuel piping along ground in central part of community

Photo 24: Fuel piping along ground in central Atmautluak

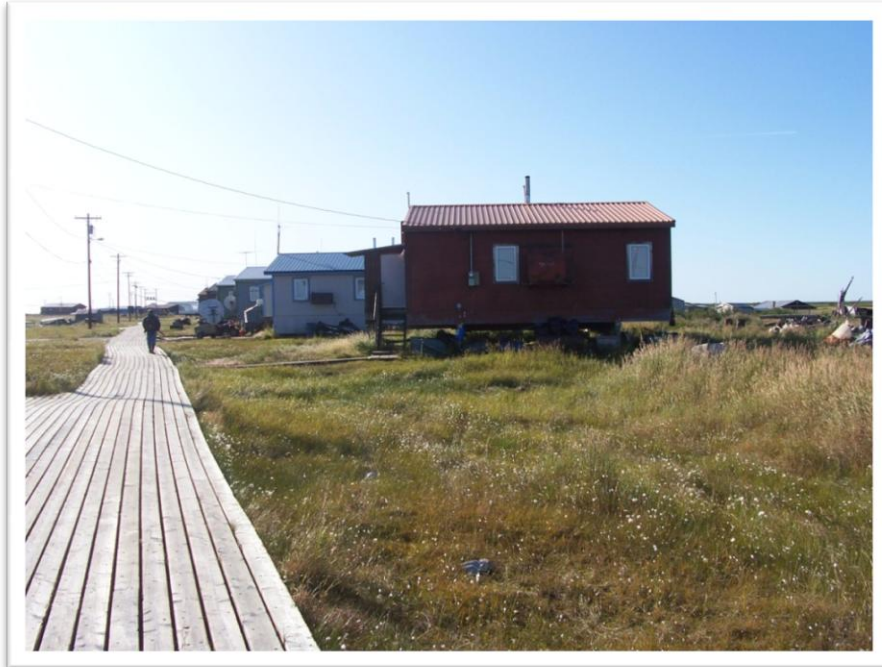
Photo 25: Homes next to big lake on west side of Atmautluak. These homes are reported to slant toward the lake.

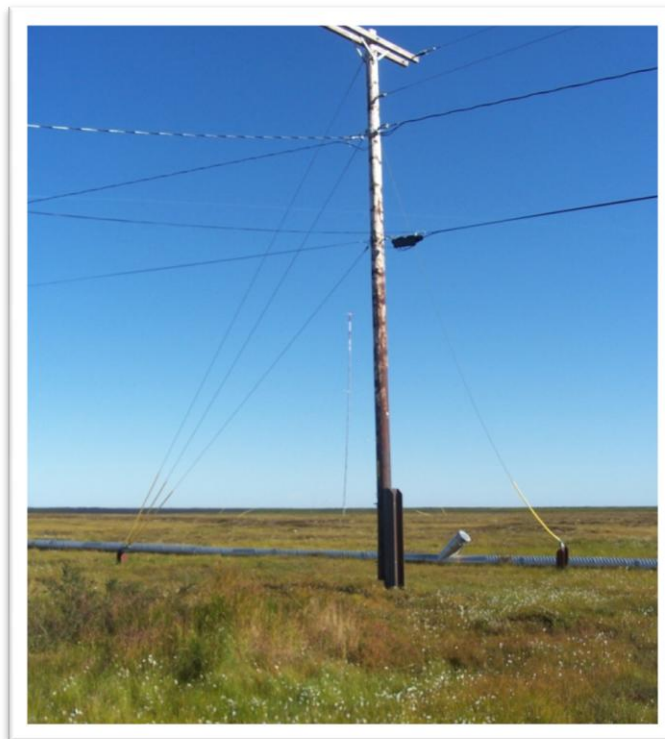
Photo 26: Utility pole on H-piling support with slack guy wires

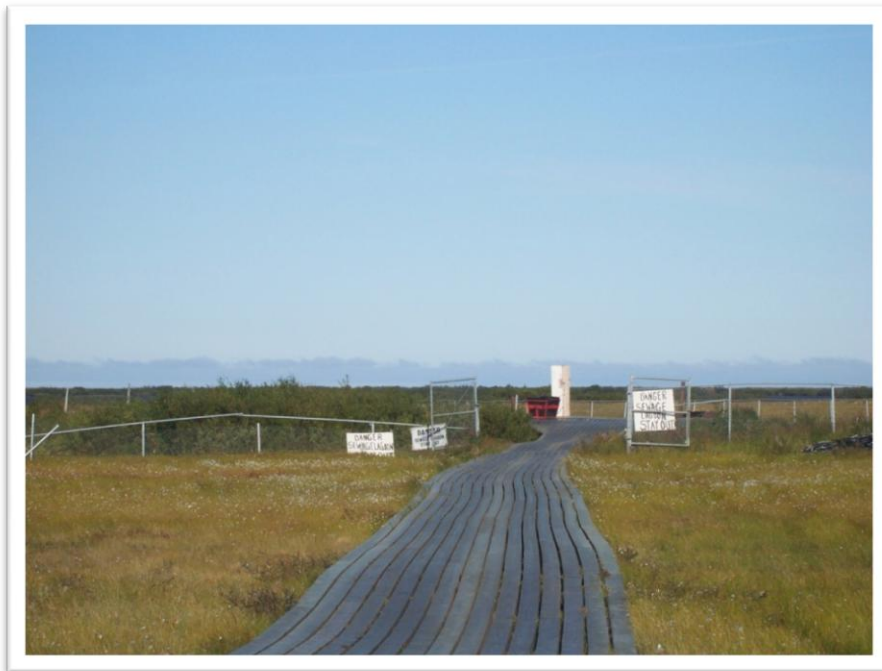
Photo 28: Fencing around sewage lagoon slumps as land subsides.

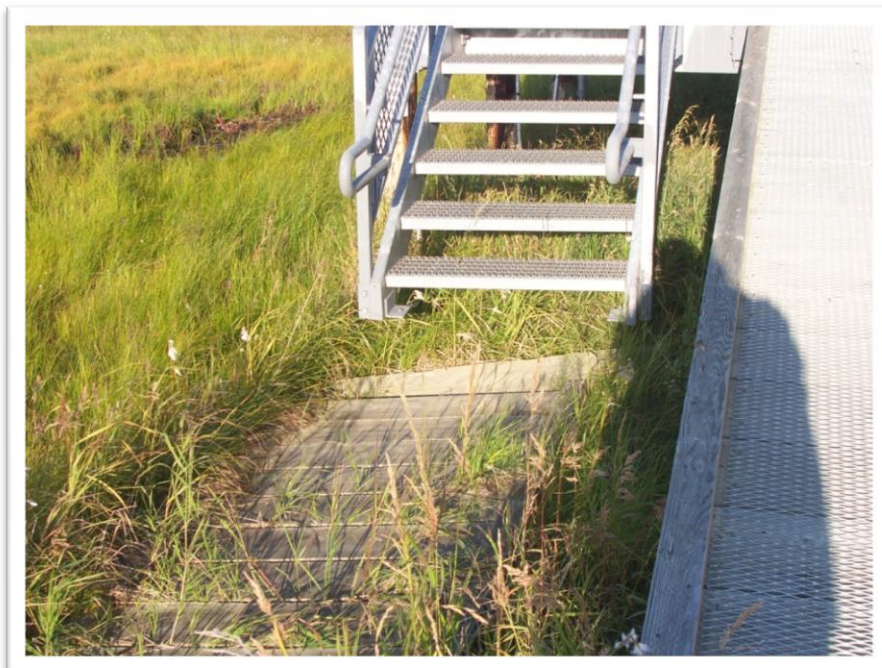
Photo 30: Stairs at National Guard Armory no longer reach ground level.

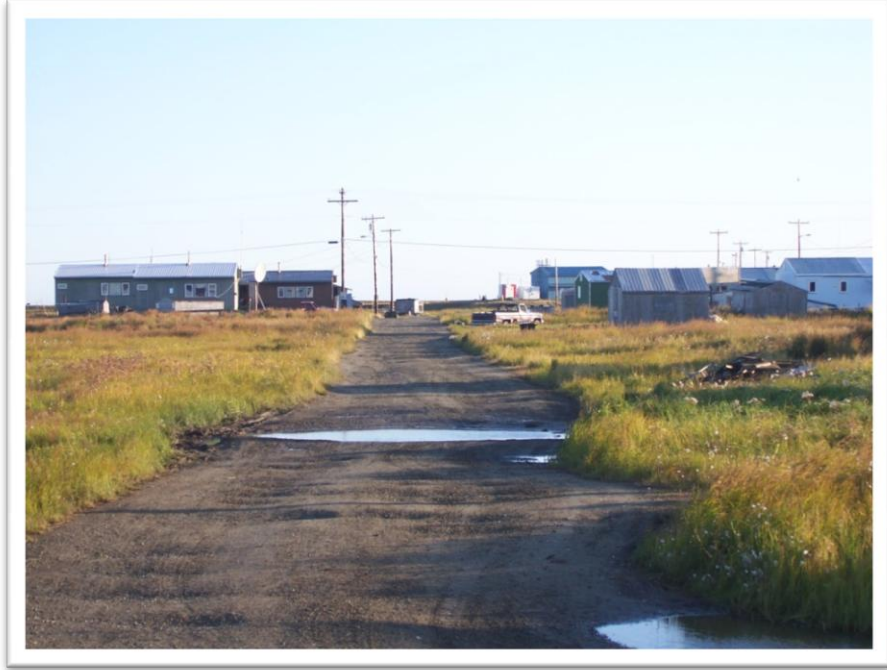
Photo 33: Ponding in gravel road from airport through town.
