Subject: ENG-Trip Report
Akiak EWP Visit
Akiak, Alaska

Date: June 24, 2019

Purpose: The community of Akiak requested NRCS assistance through the Emergency Watershed Protection (EWP) Program, due to erosion related to spring snowmelt runoff threatening homes.

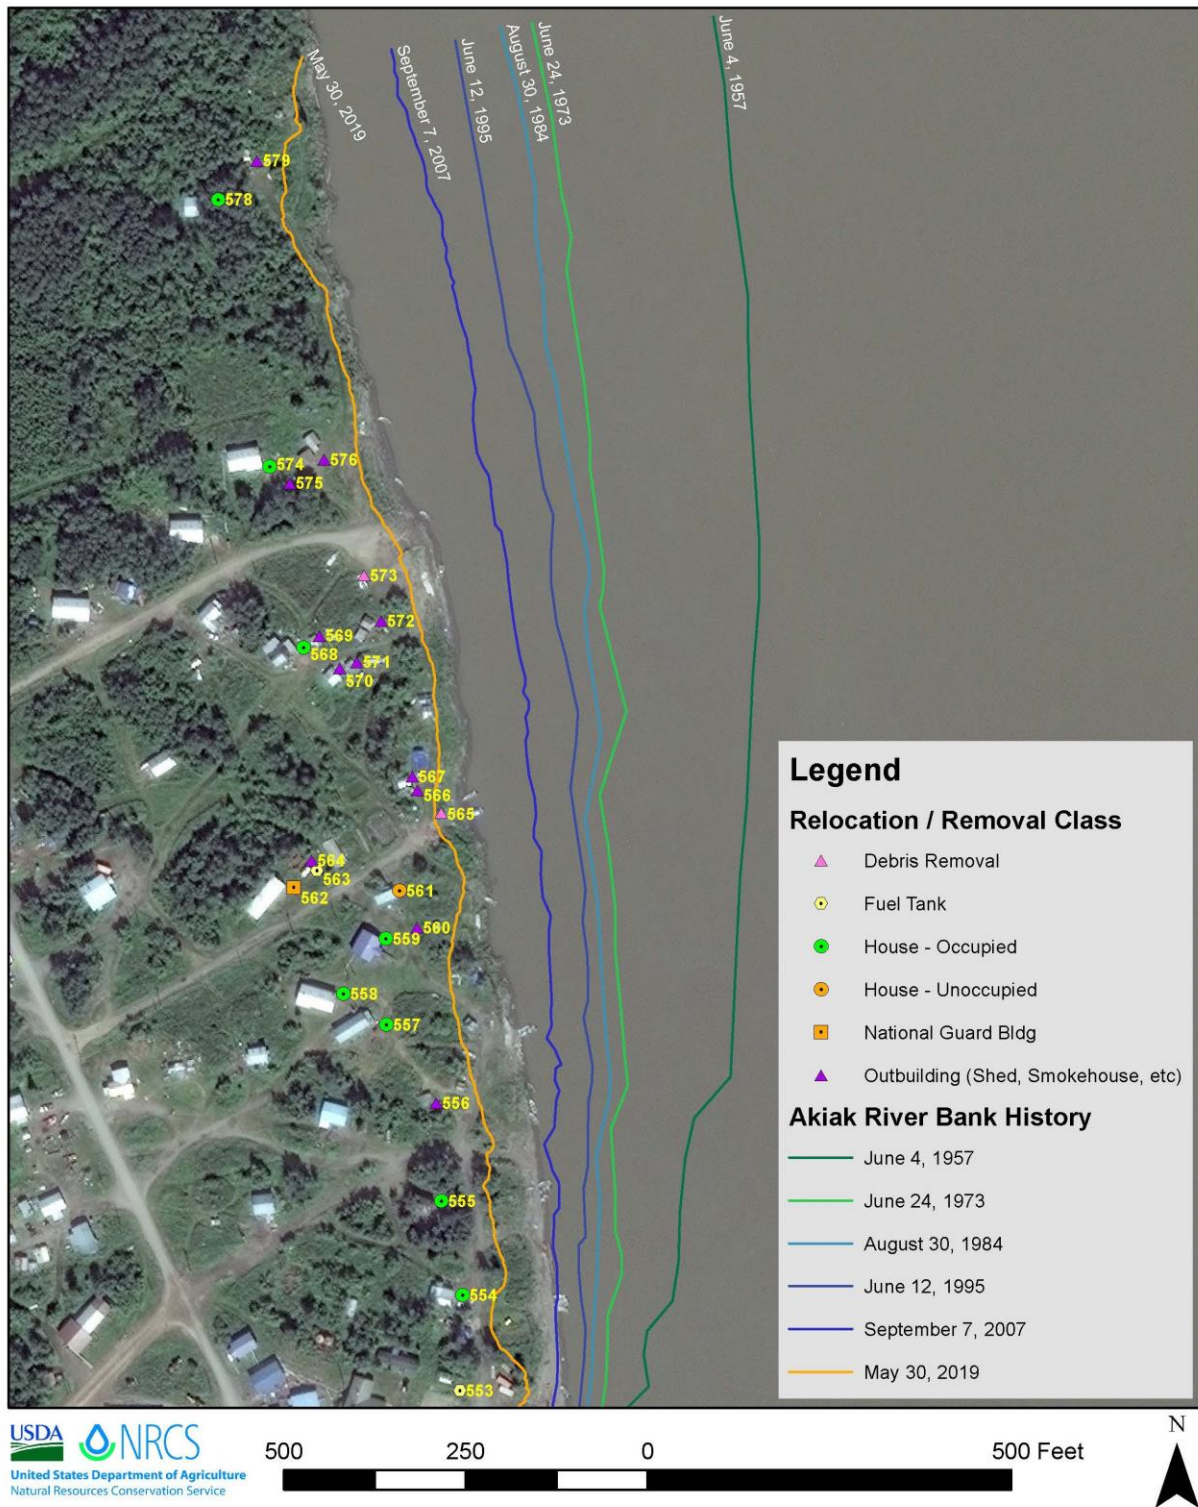
We used a handheld GPS to record the top of bank location. We then measured the distance from the top of the bank to each structure. Figure 1 shows the results of this effort. This figure also illustrates how the bank erosion at Akiak has progressed from 1957 to 2019. Table 1 summarizes the data with the measured distance to the top of the bank.

It appears that the active erosion at the downstream end of the community observed on May 30, 2019 is now worse than it was in 2013. Figure 1 reinforces that impression and shows that most significant erosion between 2017 (the date of the image) and 2019 has occurred in the lower 1/3 of the image. With the largest amount of erosion adjacent to a home (Identified as #554) where almost 100 feet of land has eroded between July 2017 and May 2019.

Recommendations/Follow-Up: Several homes are immediately threatened. The data presented in Figure 1 and Table 1 show that the closest home to the top of the bank is approximately 50 linear feet, and that there are five homes that are within approximately 100 feet of the top of the bank. A high-water event could easily erode 50 feet of land in a single day. The current trend appears to be towards more erosion at this location.

Figure 1. This 2017 image shows the approximate location of the top of the bank in 2019, as well as the top of bank location for 1957, 1973, 1984, 1995, and 2007. Also identified are the homes and other features identified during the May 30th, 2019 site visit.

Ryan and I are continuing to work with the community to define the scope of a potential EWP project. We arranged a meeting with community leaders in Akiak on June 18th and presented copies of the map in Figure 1 and requested guidance on developing a cost estimate. Akiak Native Community indicated they would provide NRCS with a letter identifying the structures the Tribe would like to relocate or demolish should EWP funds become available.
