U.S. Army Corps
of Engineers
Alaska District

ALASKA BASELINE EROSION ASSESSMENT

Erosion Information Paper - Chefnak, Alaska

Current as of January 10, 2008

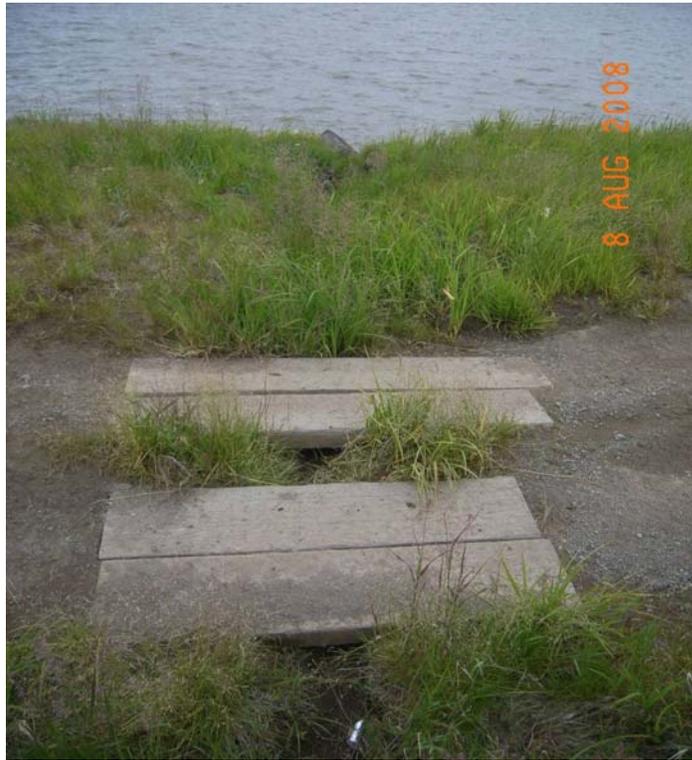
RIMG0119

Photo 1: Erosion through the road to the BIA structures.

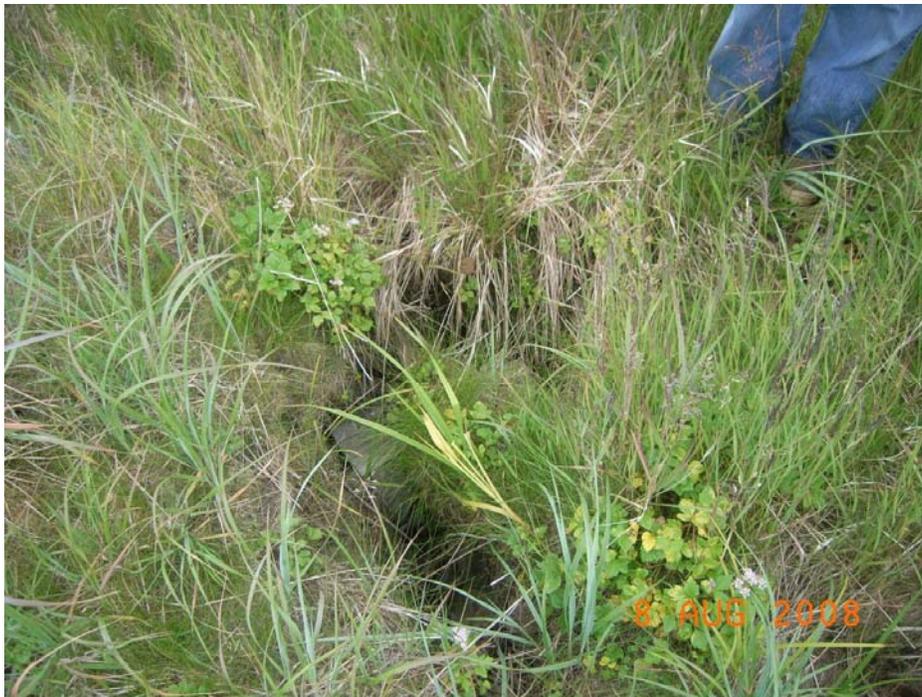
RIMG0134

Piping water through the bank is another major cause of erosion. The water carries away finer materials and leaves mostly large volcanic boulders with a covering of tundra mat, according to a 2003 Corps *Trip Report*. Portions of the bank are lost when the mats break off and are destroyed while the naturally occurring boulders are often transported into deeper water by ice sheets during breakup. Ice jams in the river are rare.

Photo 21: A small sinkhole near the top of the bank.

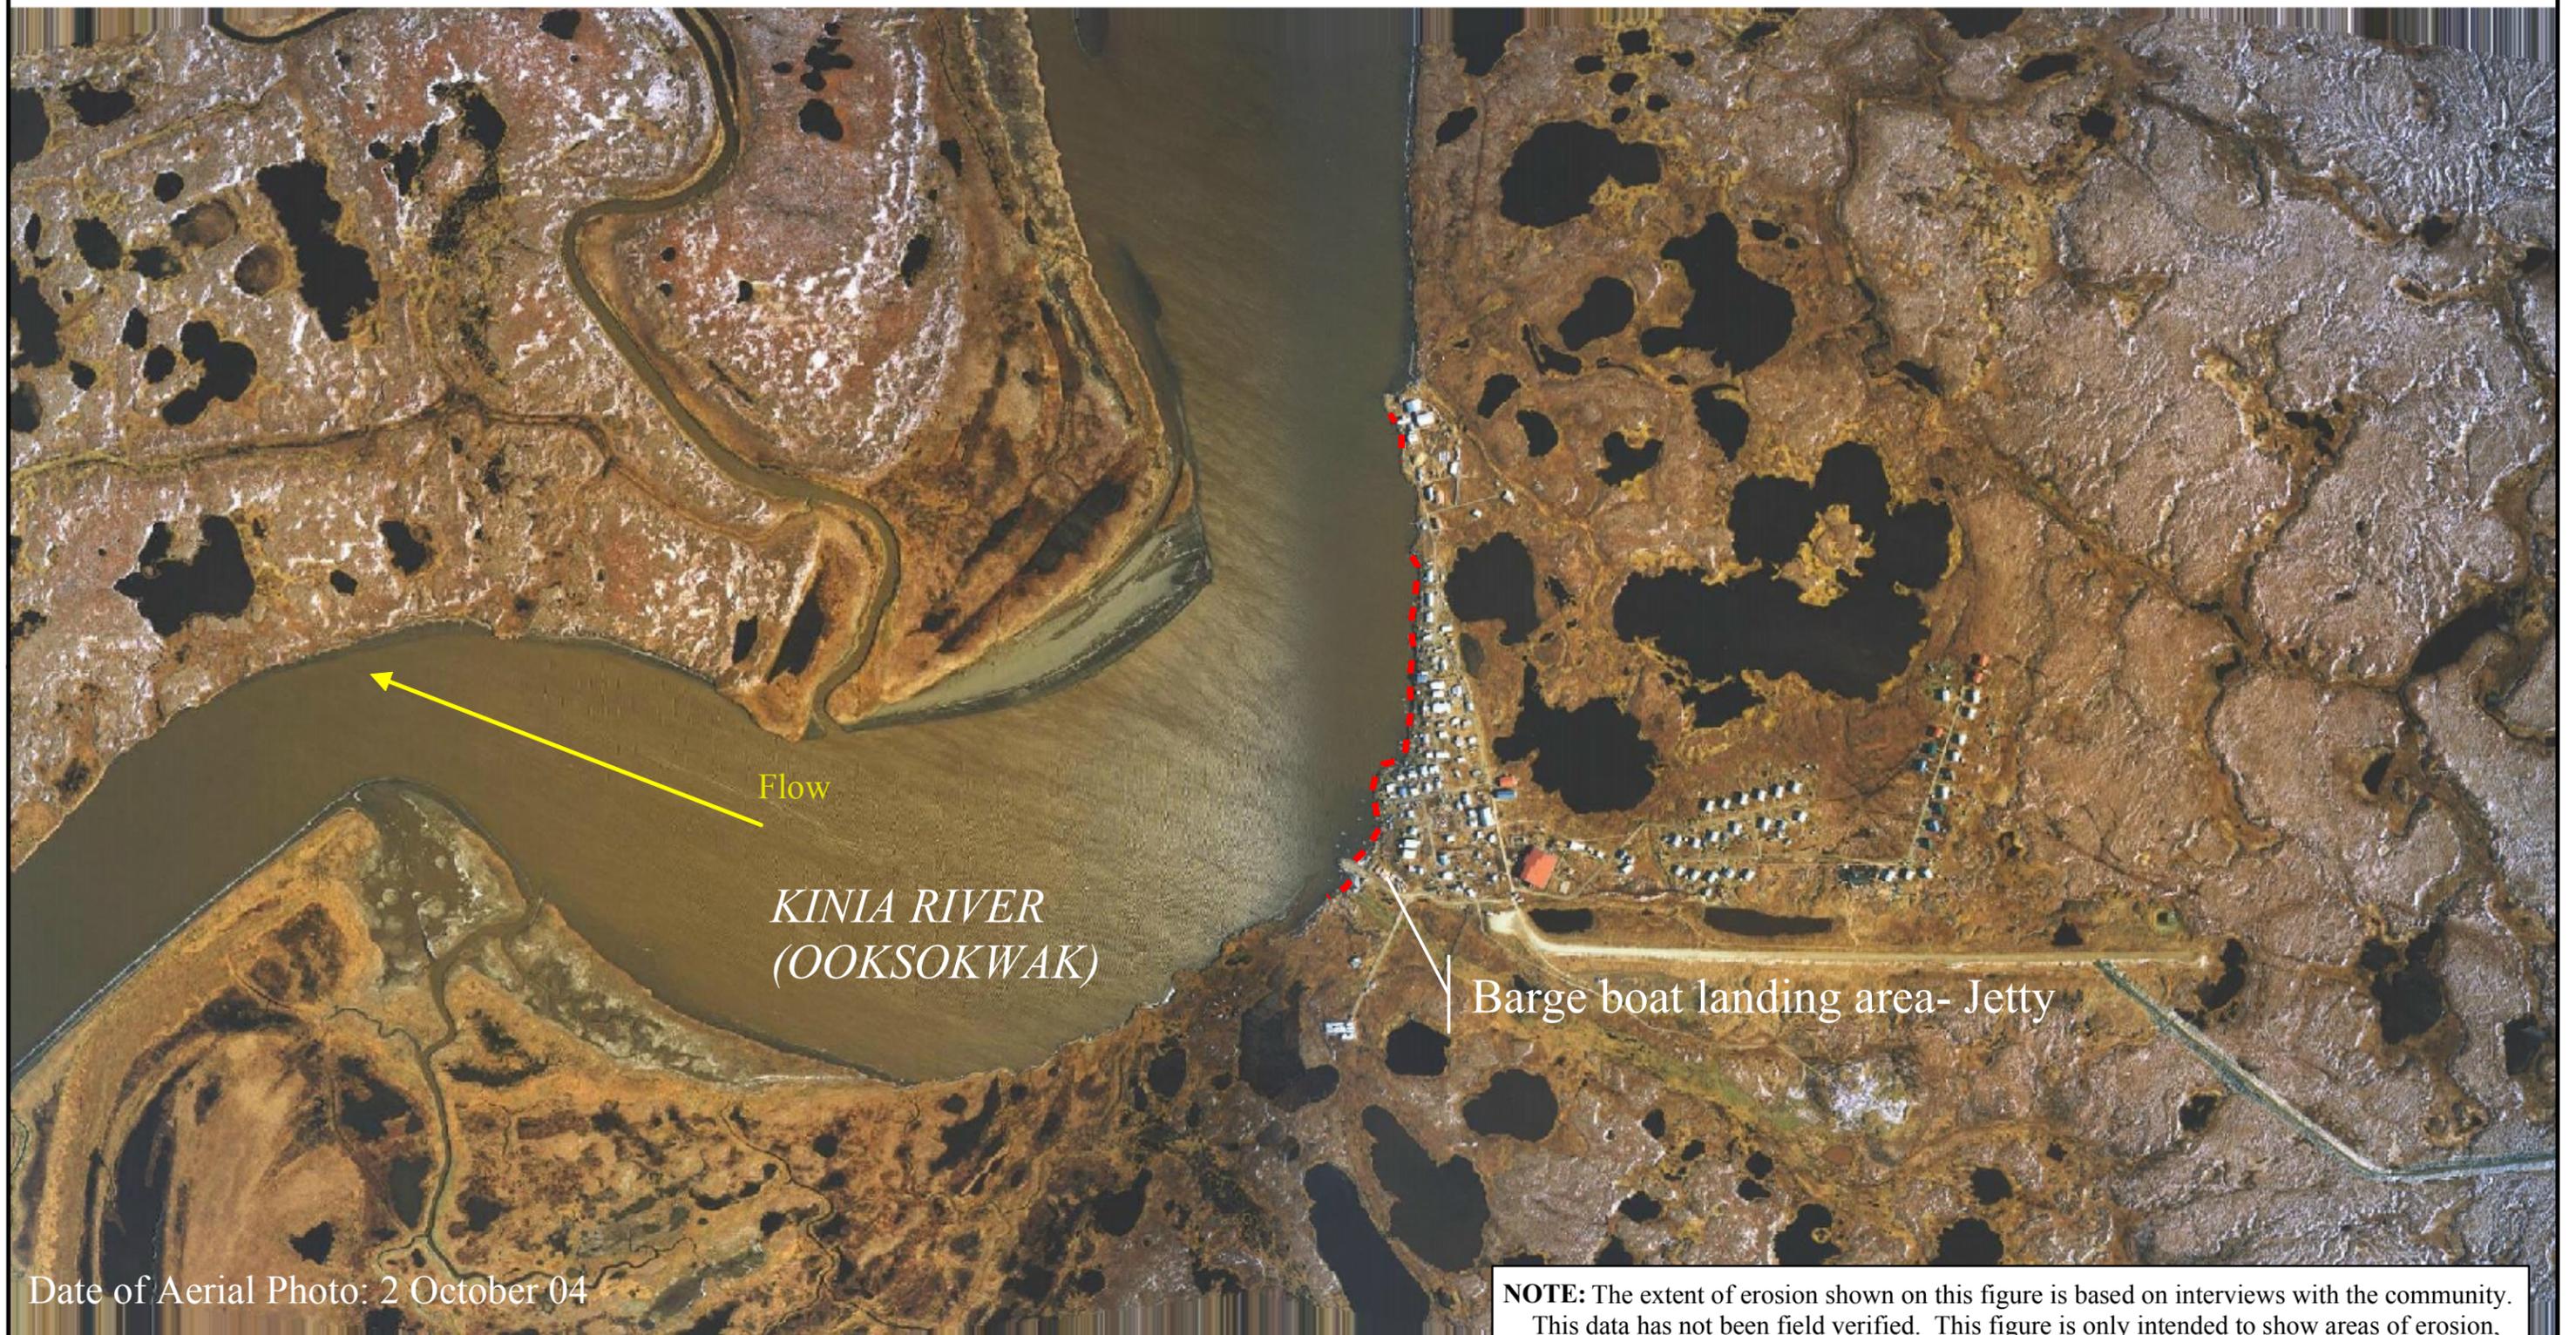
Alaska Baseline Erosion
Chefnak, Alaska

Barge boat landing area- Jetty
