City of Chefornak Head Start Building Replacement

Project No. 181012

PND Engineers, Inc.
1506 West 36th Avenue
Anchorage, AK 99503

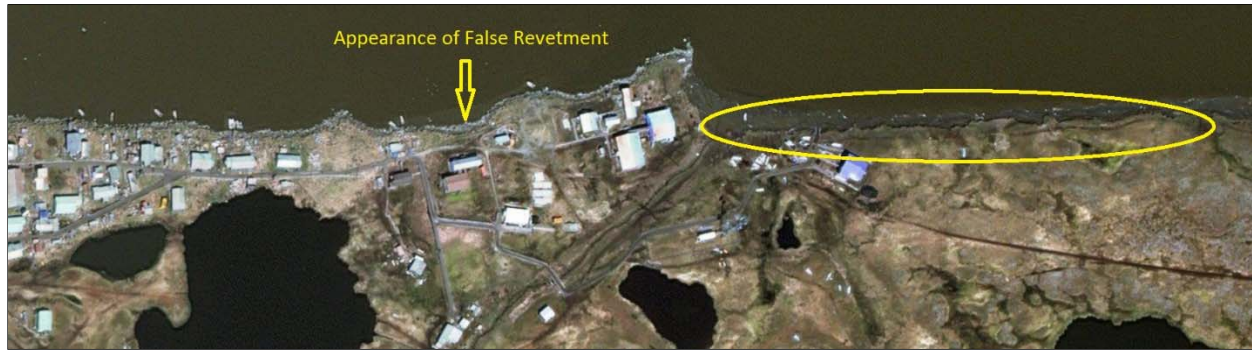
The banks of the river on either side of this Basalt extension, as well as the sands and gravels (Figure 3) within the exposed edge of the formation have been eroding due to spring breakup flooding. In addition to this, due to the low elevation of Chefnak, storm surge and wind driven wave action has exacerbated this problem.

Figure 3. Contact between Basalt Rock and Soil (Image Courtesy of Microsoft Bing Maps)

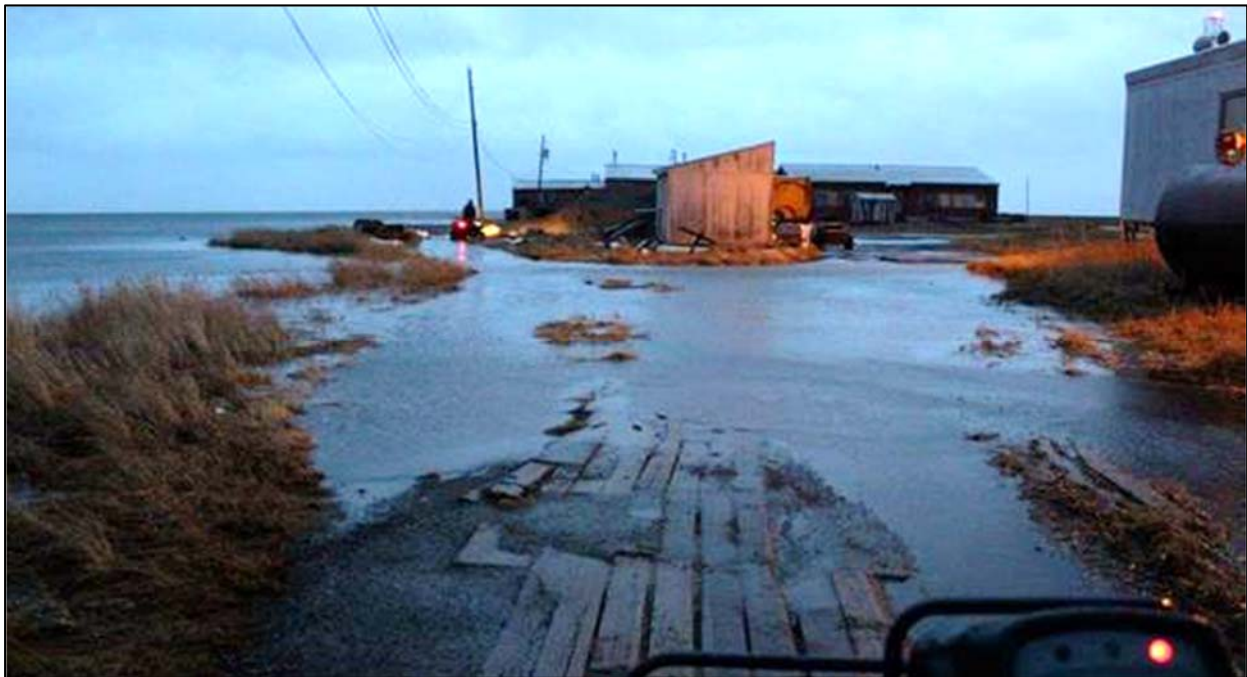
Figure 7. Head Start building access, morning October 5, 2017.

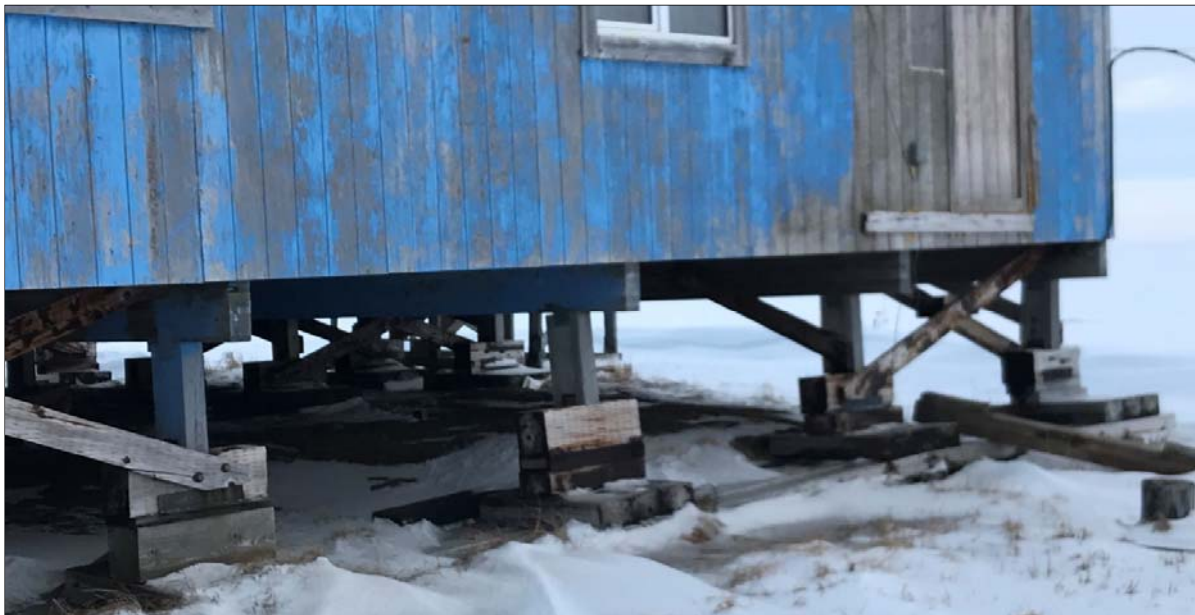
Building Condition- The Head Start Building, located at the east end of Chefnak on the bank of the river, was constructed in the 1960's. It is in poor condition (Figure 8, Figure 9, and Figure 10), showing signs of wood rot, sagging floor support beams and a failing foundation. Adjacent and connected structures are settling differentially with respect to the Head Start Building causing cracking walls and windows, sticking doors, and an uneven floor.

Figure 8. Head Start Building Foundation

The entire building is tilting on its post and pad foundation due to surface thaw settlement. This problem has been exacerbated dramatically by the additional rapid rate of thaw caused by the October 2017 flood event and the introduction of salt water into the thawed active layer as described in section 1.2. Some of

the pad foundations are not in contact with the ground surface and are providing no support to the structure. This causes other members and foundations to support loads for which they were not designed. Additional thaw settlement is expected once the soil begins warming and thawing during spring and summer months. If similar storm surge events occur in the late summer or fall again, further thaw settlement under the structure is to be expected. This may result in its ultimate collapse of the structure given its current condition.

These buildings should be demolished as they are likely be abandoned and eventually collapse into the river. If this were to happen, it would create potential health and safety concerns due to the asbestos, lead paint and other contaminants that would be released into one of the community's food and water sources.

These buildings should be replaced at a location secure from the influence of river bank erosion and storm surge related flooding. They are in imminent threat of collapse due to the combination of thaw settlement and their current structural condition. This buildings are not likely to survive any attempts to move to a new location and shoring in place does not address any of the underlying issues highlighted in this report.

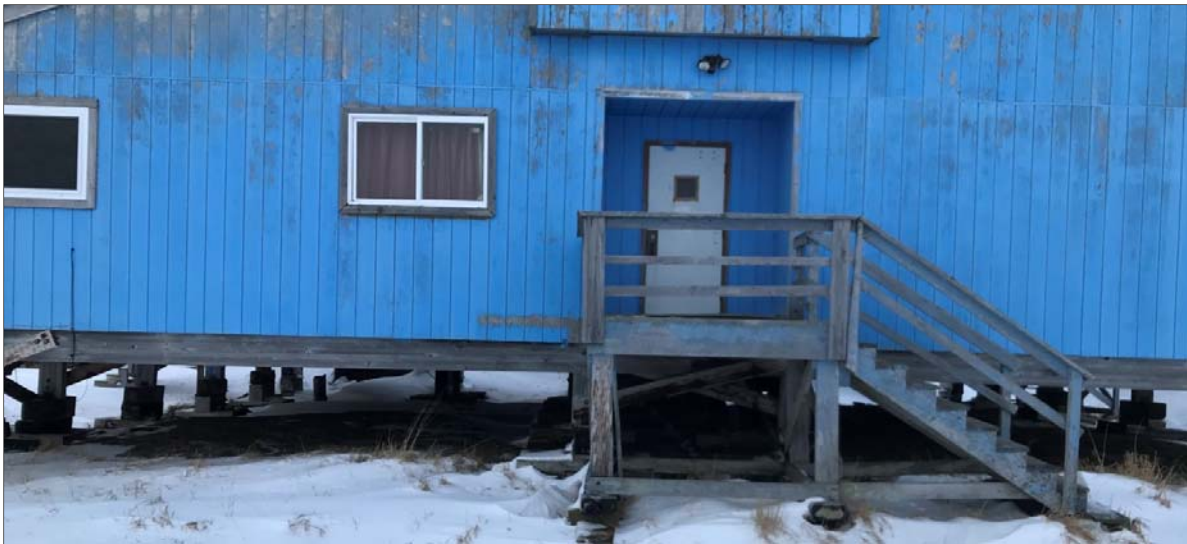
Figure 9. Head Start Building - Shifting Towards River Bank

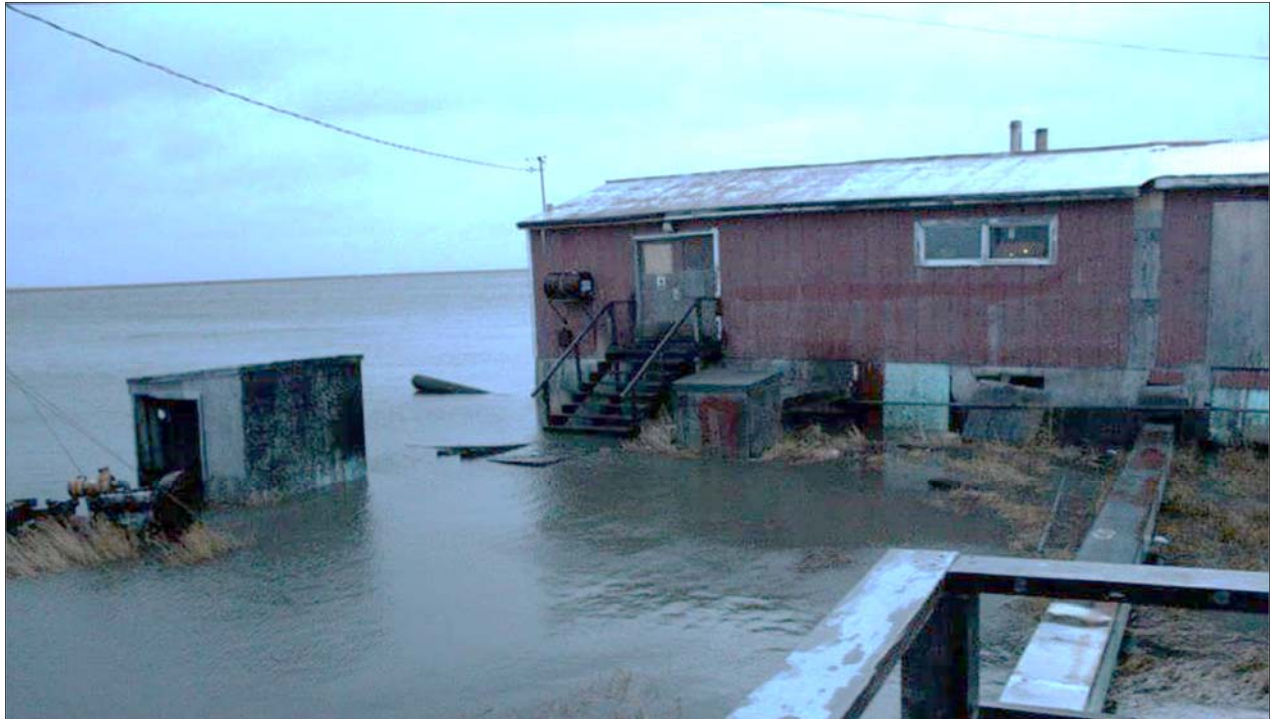
Figure 10. Flooding of Head Start Utility Building, morning of October 5, 2017

The Head Start Building and adjoining Utility Building are two of the lowest elevation structures in the community making them the first structures to experience the effects of increased flood elevations. In years past this has not presented itself as a concern, however recent break up events, summer/fall storms and high-water events have presented unsafe conditions for the children or adults to walk to or from the school during or immediately after major floods. While the river bank at this location appears to be stable, flooding at its present location makes it a problematic site. This problem is especially critical for the Utility Building, shown in Figure 10, which sits at a lower elevation than the Head Start Building itself and is in considerably worse condition.

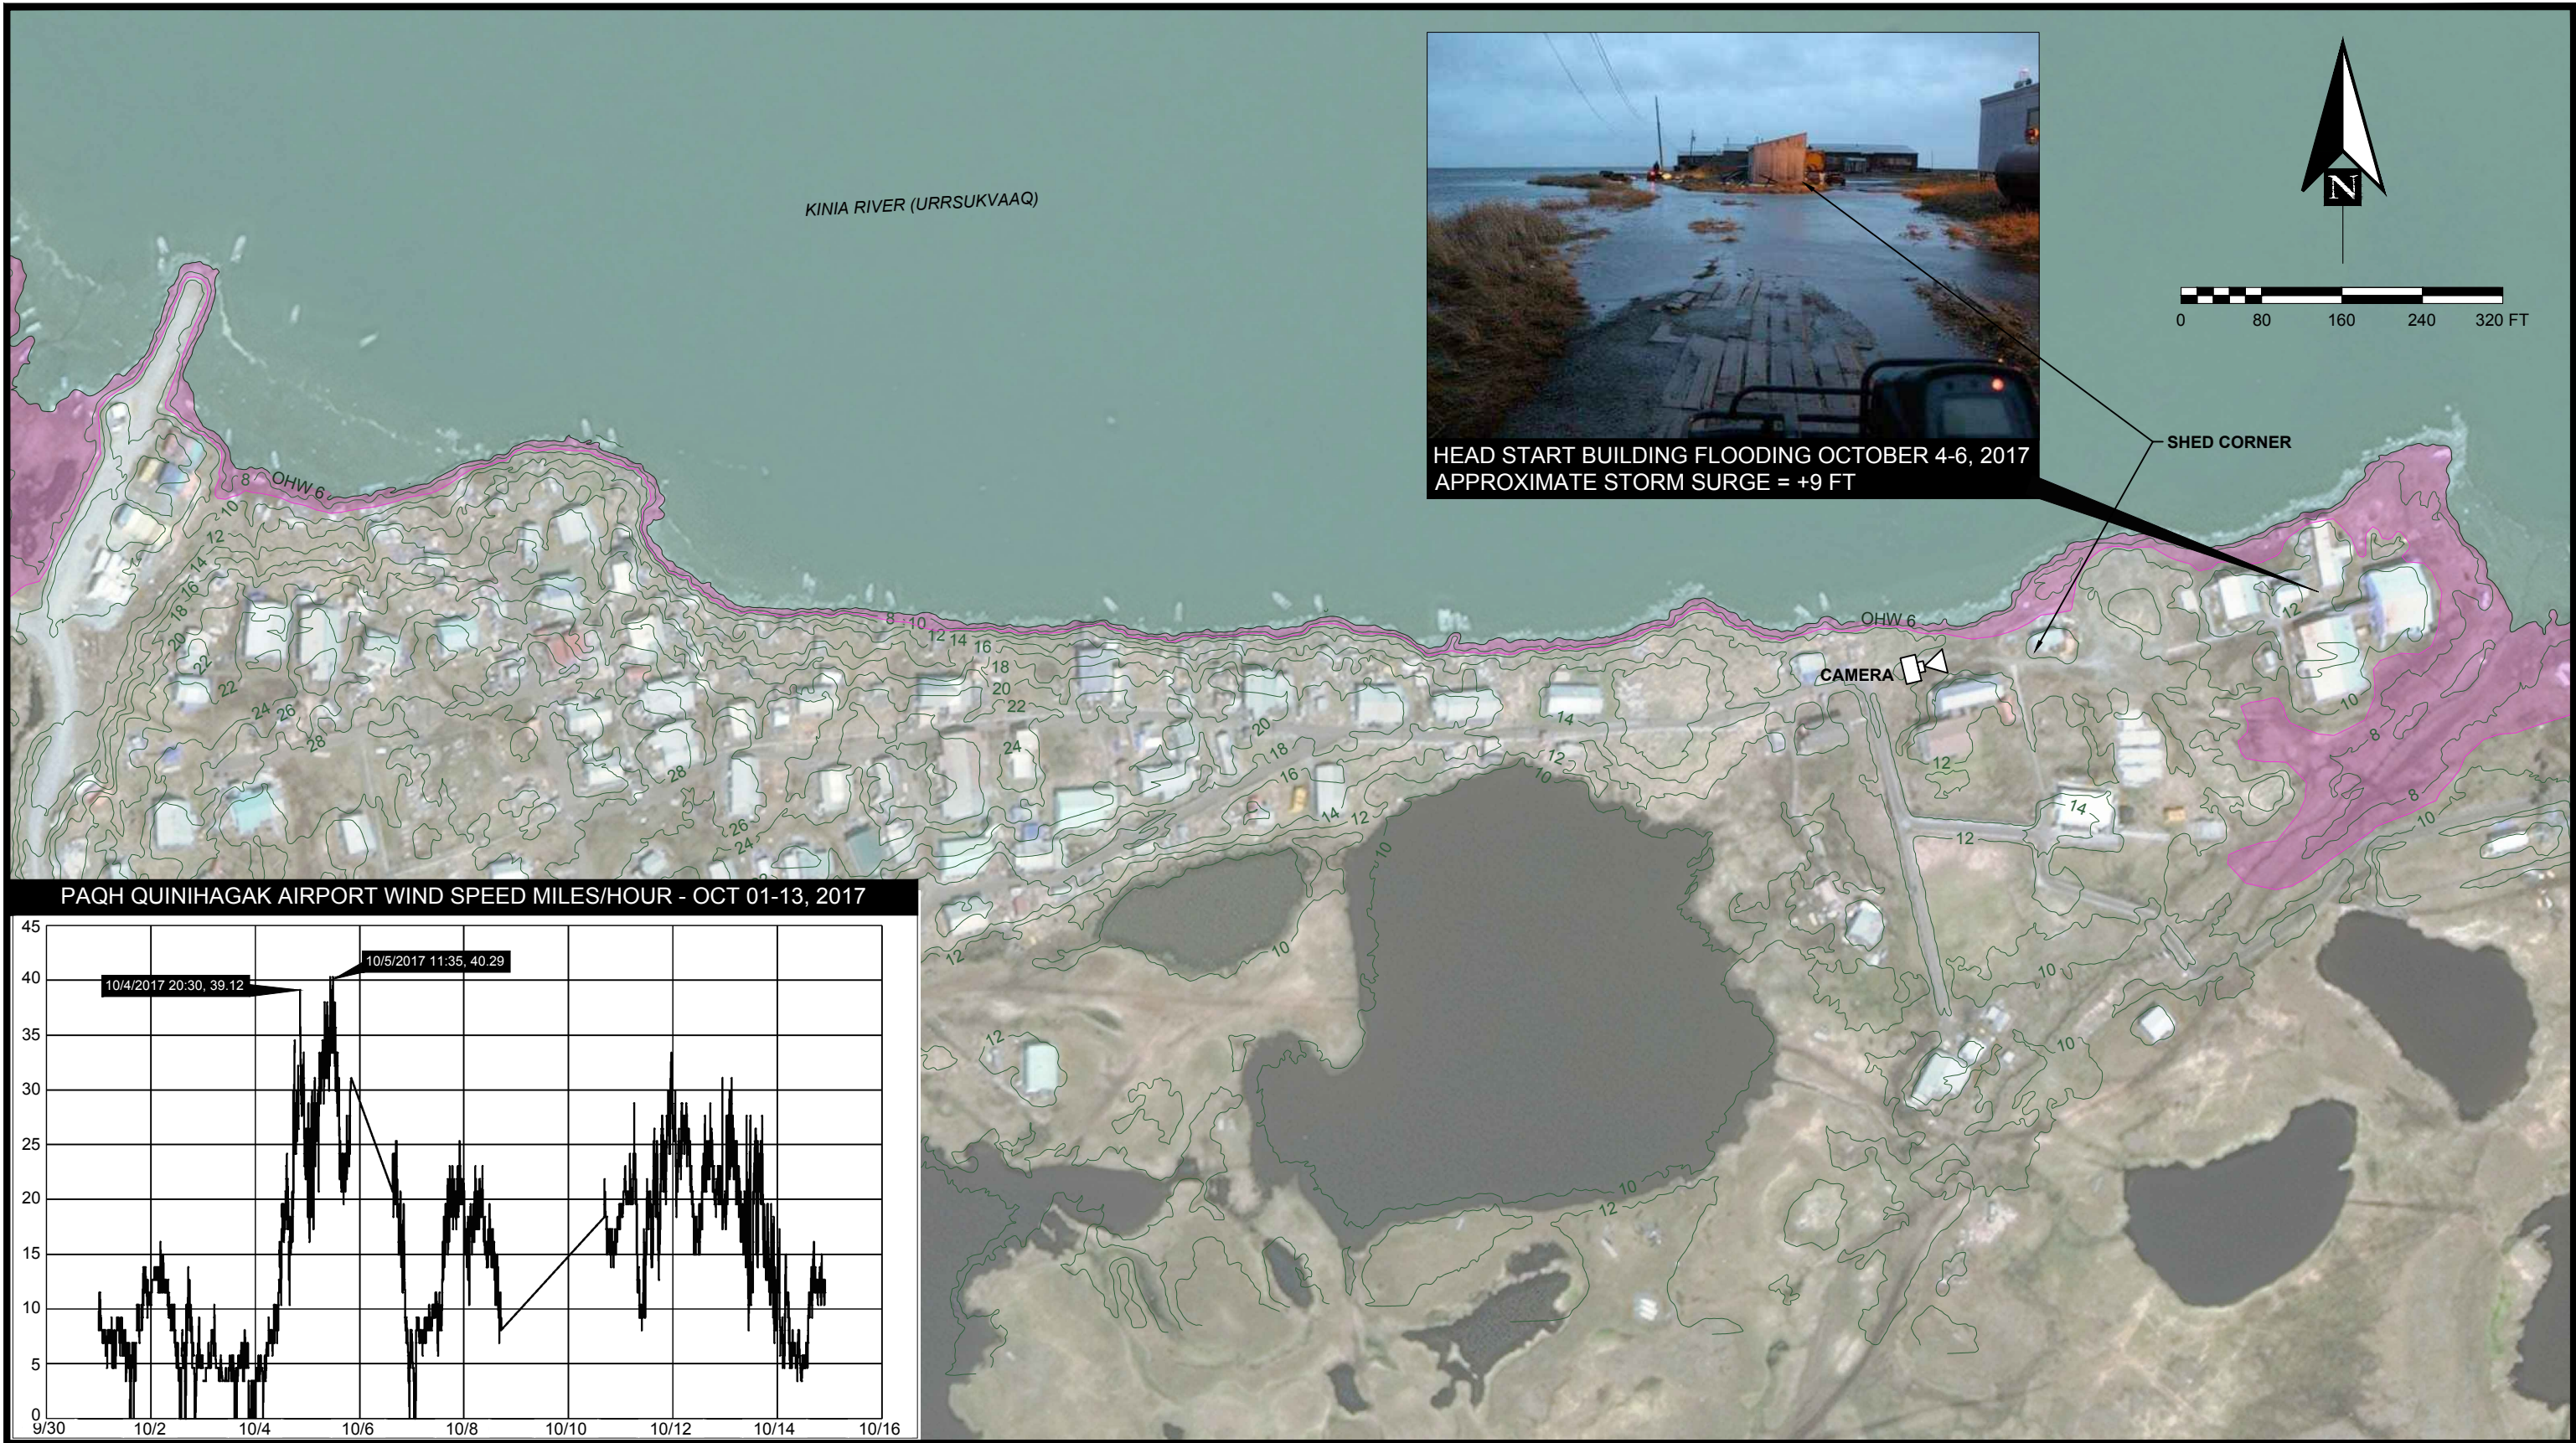
HEAD START BUILDING FLOODING OCTOBER 4-6, 2017
 APPROXIMATE STORM SURGE = +9 FT
