City of Chefornak Site Observation Report

Project No. 181012

PND Engineers, Inc.
1506 West 36th Avenue
Anchorage, AK 99503

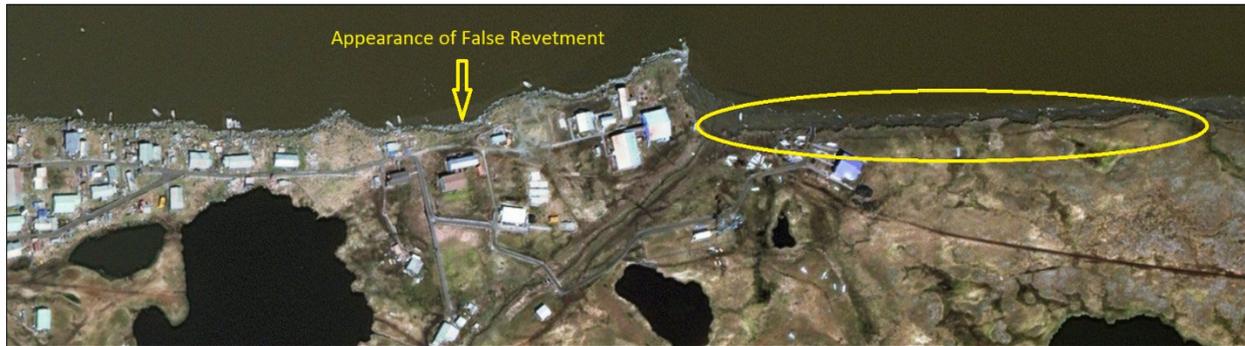
Figure 3. Contact between Basalt Rock and Soil

The eastern and western extremes of the city extend beyond the Basalt rock formation and exposed granular material in these areas exhibit higher rates of erosion (Figure 3).

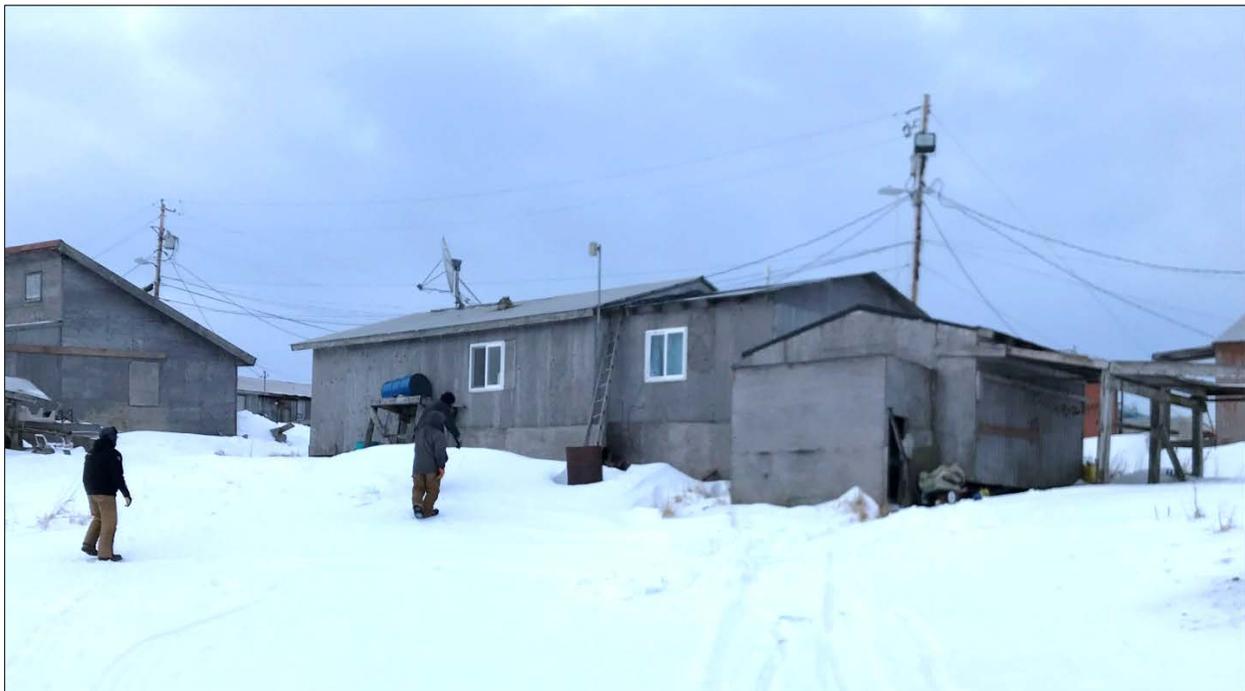
Figure 4. Dolly's House

Dolly's House (Figure 4) is perched approximately 12 feet from the embankment at the apex of what appears to be a backchannel forming behind the rocky outcrop. Her house is in poor structural condition, is not level and is positioned at one of the most active zones of erosion. There is cause for concern that the house may be substantially damaged or lost in the upcoming 2018 summer season.

Due to the combination of erosion and thawing permafrost, Dolly's house is at high risk of failure as early as 2018 if recent trends continue. Because of this increased risk, plans to address erosion and/or move residents to a new location should be explored beginning immediately.

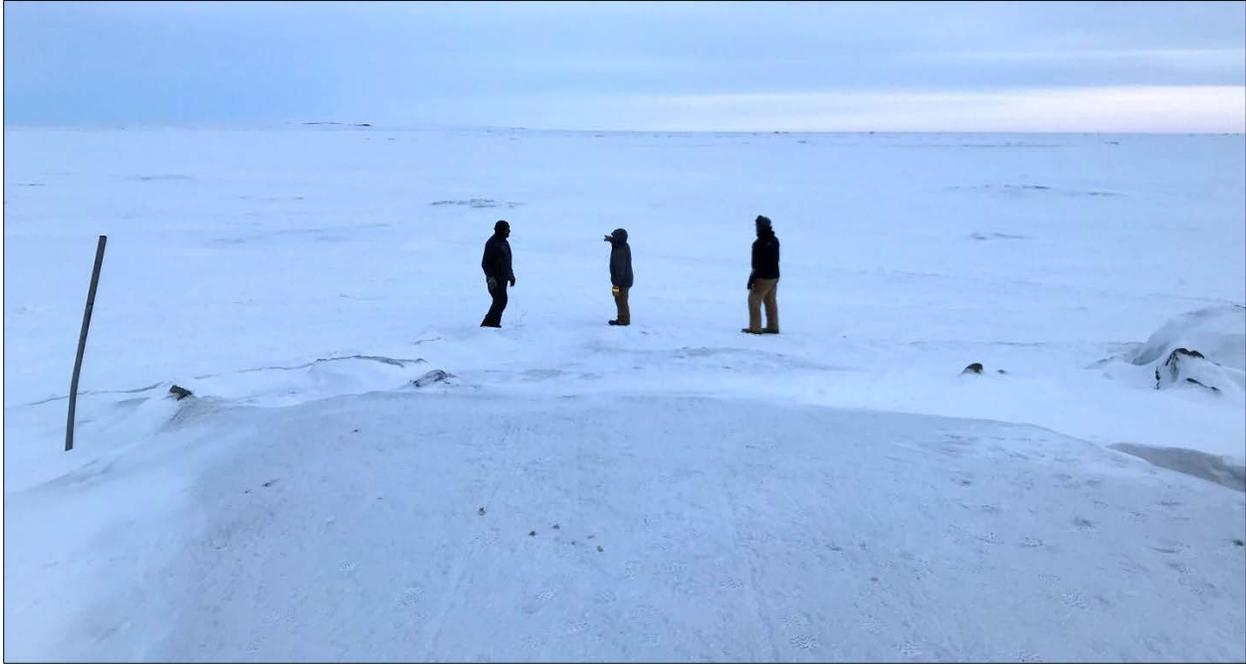
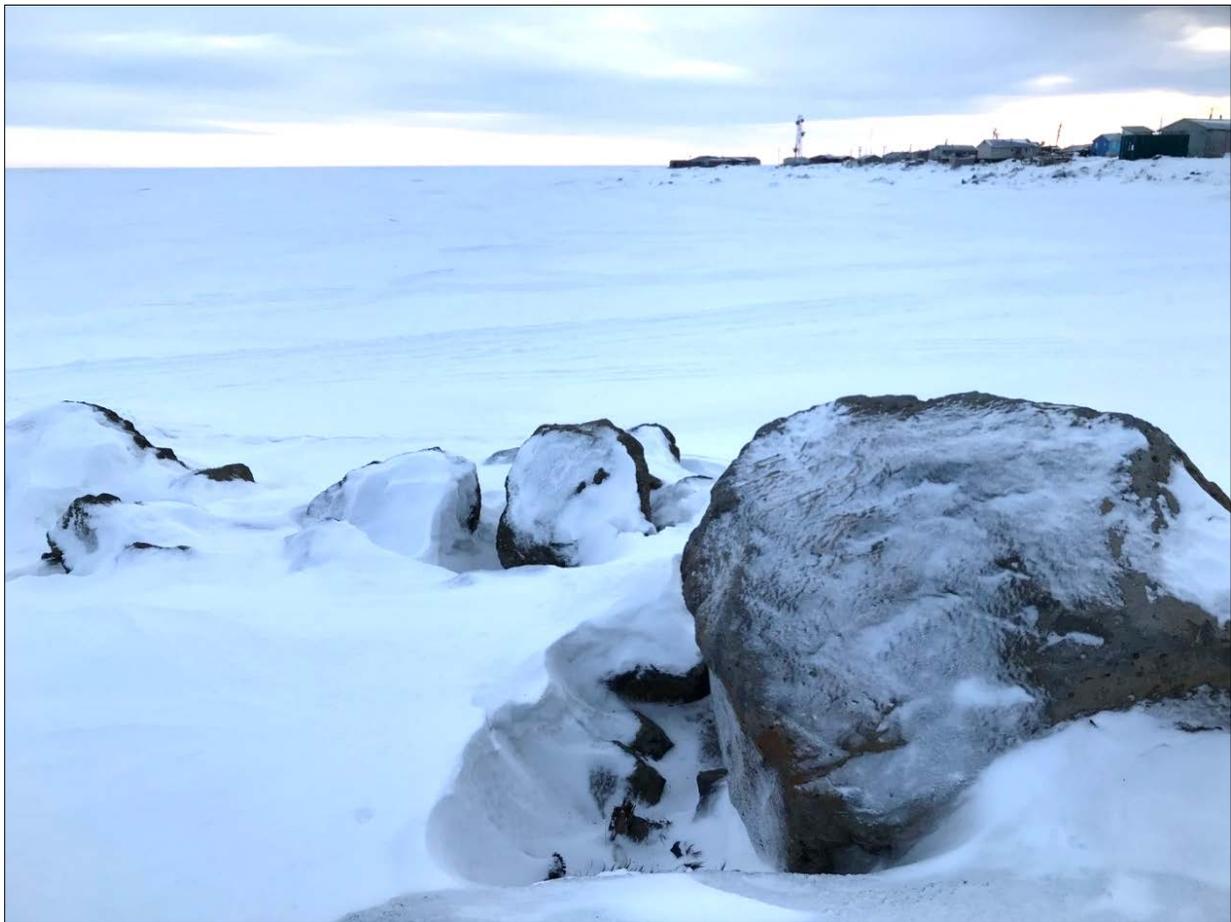
The barge landing (Figure 5 and Figure 6) at Chefnak is crucial to the welfare of this community as it is the primary means of bringing materials, supplies and equipment to the city. During the 2017 spring breakup, a portion of the barge landing approximately 20 feet long was lost off its north end due to erosion. The condition of the remaining landing consists of large, armor size rocks both exposed and submerged in shallow water at the approach, making the landing of barges difficult and unsafe. Without

repair of the barge landing this season, Chefnak will be limited to small aircraft access for transportation of goods and materials which would cause serious delays or cancelation of badly needed health and safety related infrastructure repair projects throughout the community.

Figure 5. Extents of Original Barge Landing

Figure 6. Natural Rock at River Bank Erosion

The landing in its current condition is not suitable for barge access. Removal of the larger rocks at the end of the landing and shaping/screeding of the shallow approach to sufficient depth to allow safe access for barges is a critical first step to ensure the health and safety of the community can be maintained and improved in the near term. It is recommended that additional bank stabilization measures be taken on portions of nearby shoreline that are most susceptible to the accelerated erosion rates witnessed during the last open water season. This will allow time for a more permanent solution to be developed and implemented without additional loss to the community.

Due to a failure caused by erosion during 2017 floods, the barge landing is not currently suitable for barge access without removal of some of the larger rocks at the end of the landing and shaping/screeding of the shallow approach to provide sufficient draft for safe barge access.

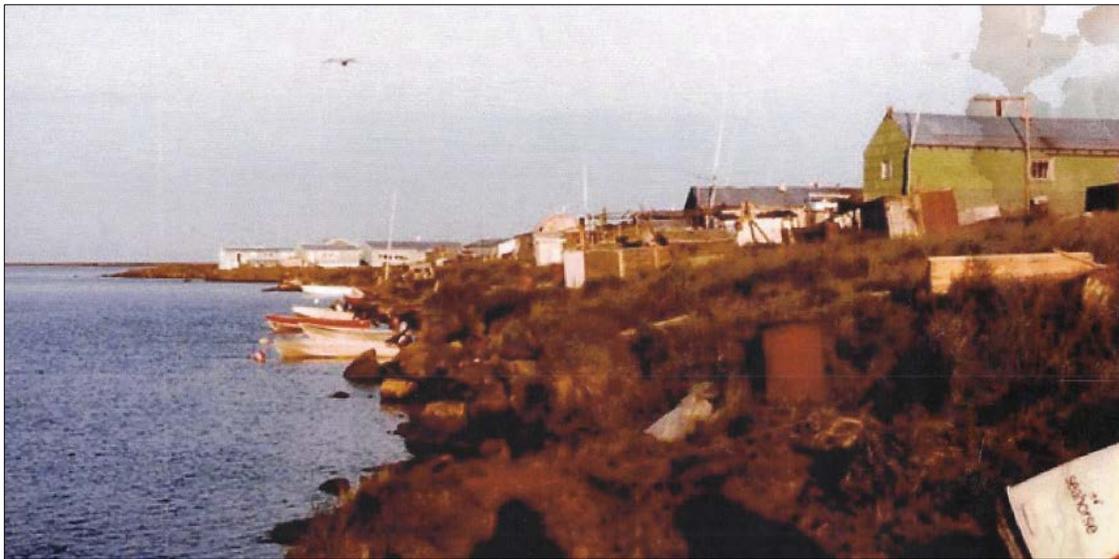
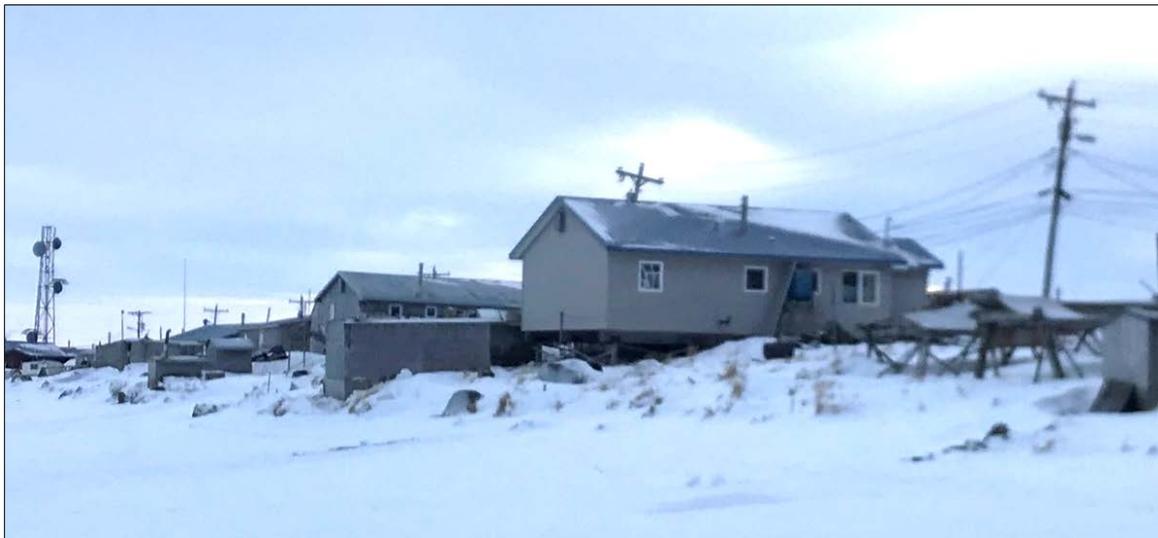
Examination of summer photos of the embankment near Dolly's House (Figure 7 and Figure 8), provided by local representatives, indicates that an accelerated thaw of the permafrost active layer (approximately the surficial 6 feet to 8 feet of soil) is advancing deeper than historically during spring and summer months— leading to accelerated erosion of granular material during summer flooding events and wave action. This leaves behind a large number of natural boulders along the embankment and near the river bank. Spring breakup contributes to erosion as well, redistributing the rock material via ice plucking and erosion of the remaining granular soil matrix. The combination of increased active layer thaw and ensuing ground water runoff through the granular surficial soil, high water and wave action is accelerating the rate of bank migration making prediction of rates based on historical data an unconservative assessment of the situation. Particularly in the last two seasons, erosion rates have increased dramatically necessitating a response, years earlier than expected. It can be seen by comparing photos from Dolly's house in the 1970s and 2018 that the bank has crept to within feet of the structure.

Figure 7. Shoreline looking east of Dolly's House circa 1970's.

Figure 8. Shoreline looking east of Dolly's House

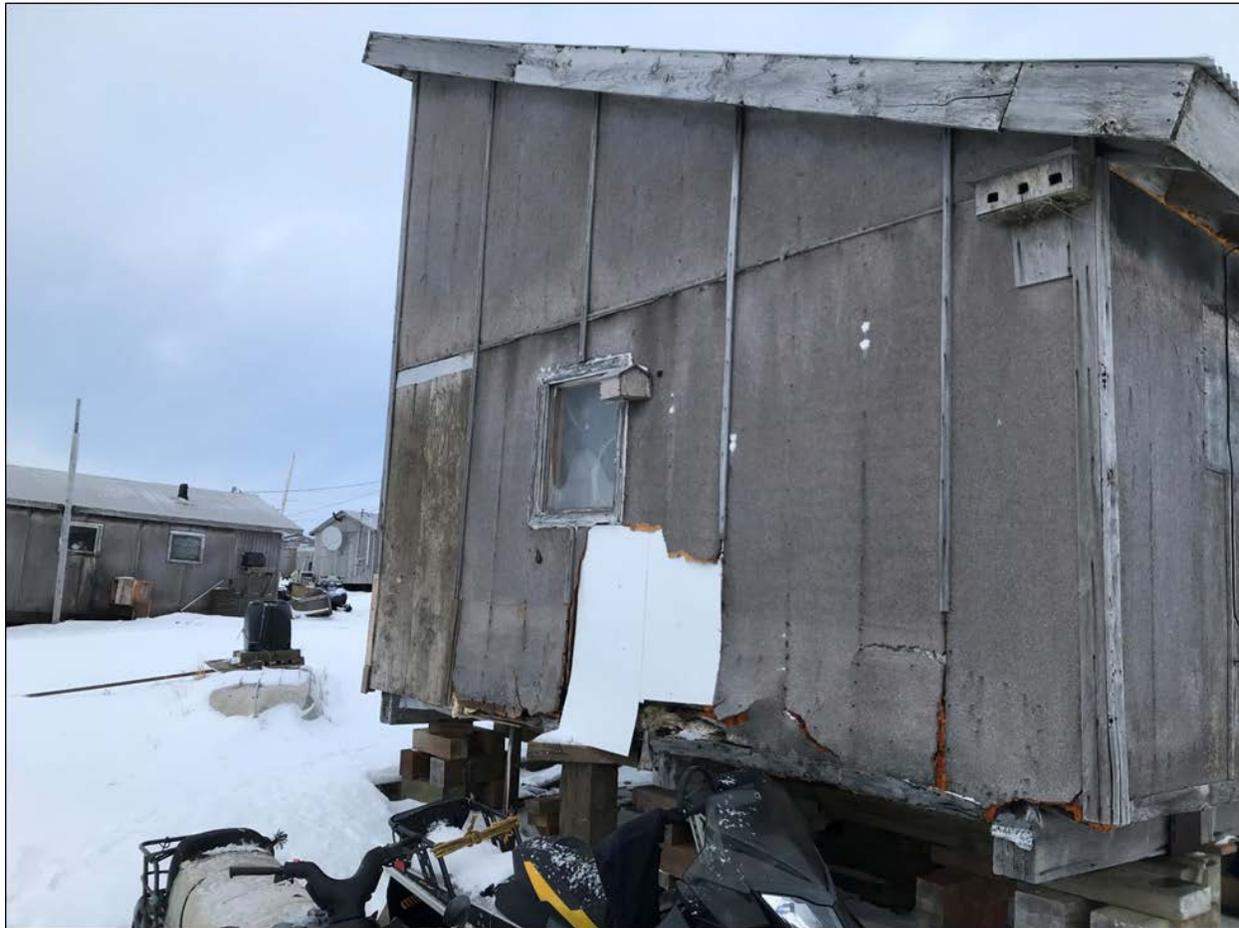
Figure 9. Zone 1 Housing

Zone 1: Northern housing-(approximately 30 to 40 homes) Characterized by structures in poor to very poor condition (Figure 9). Most are unpainted, suffering from varying degrees of wood rot, holes, broken windows, doors that become stuck or cannot be closed due to shifting foundations, many are leaning substantially and foundations that are at or near failure due to thaw settlement. Most of the homes in this zone are not good candidates for moving due to their degraded condition. Additionally, the congestion of the area will make maneuvering of structures to a new location problematic. Many of these homes are perched very near the riverbank and should be replaced further inland in phased approach.

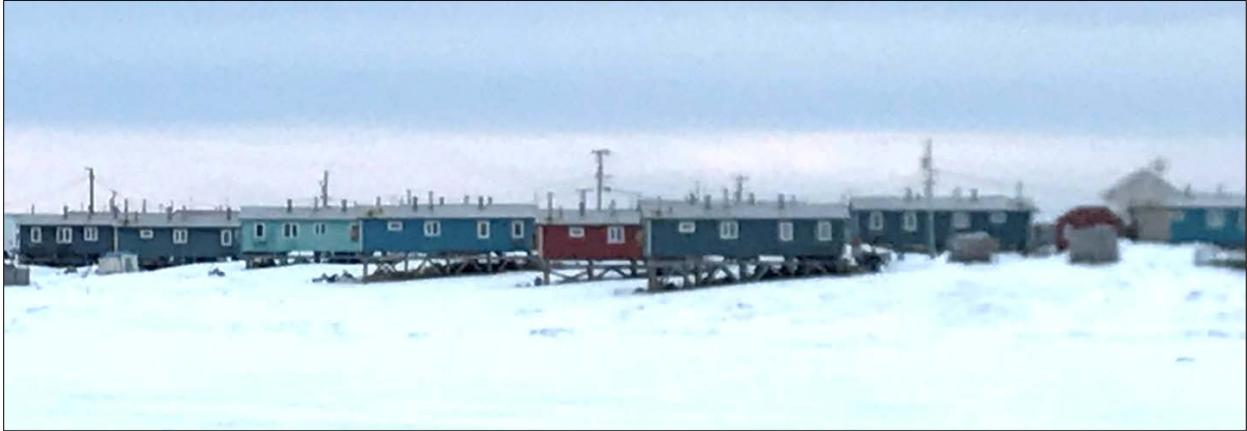
Figure 10. Zone 2 Housing

Zone 2: Midtown housing (approximately 20 homes)-Characterized by structures in fair to poor condition (Figure 10). These homes were built in the 1970's. They are founded on post & pad, surface foundations and are generally level with no obvious holes or broken windows. There are some structures showing signs of early stage wood rot. No immediate action regarding the structures or foundations in Zone 2 is required periodic monitoring of their condition is recommended.

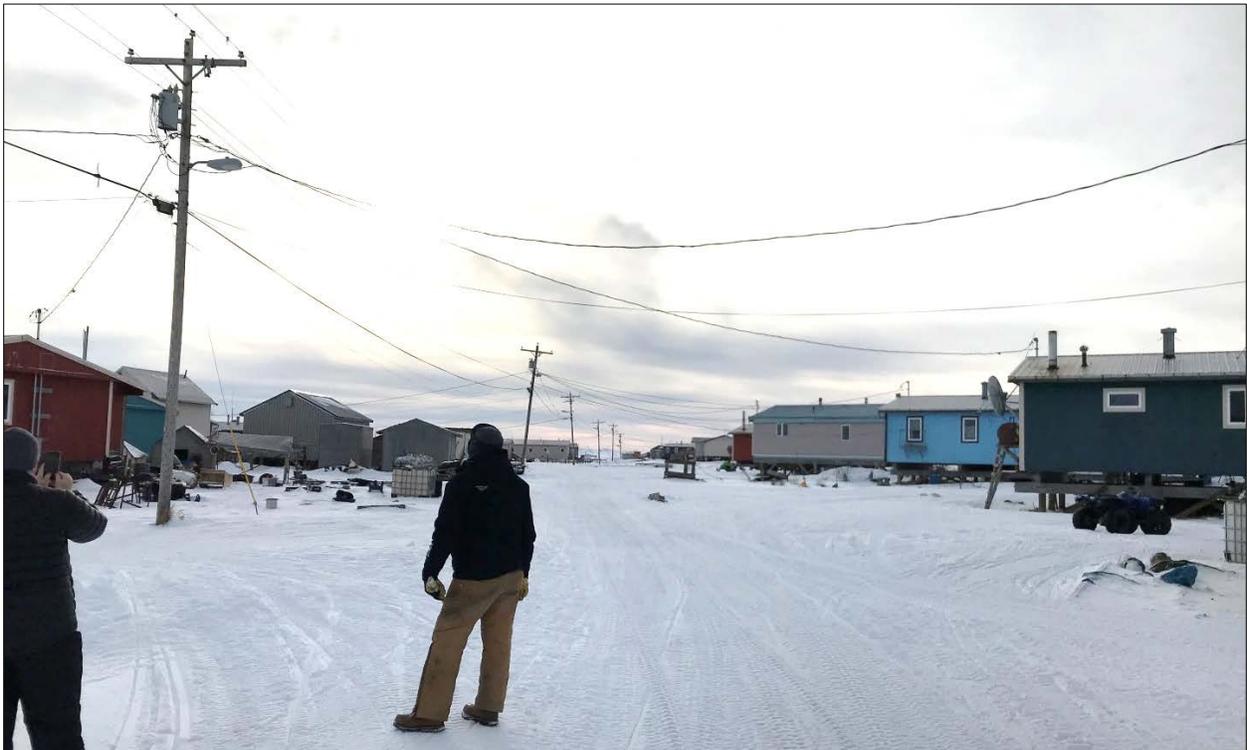
Figure 11. Zone 3 Housing

Zone 3: Southern housing (approximately 20 homes)-Characterized by structures in good to fair condition (Figure 11). These homes were built in the 1990's or early 2000's and are vinyl sided, founded on piles, level with no obvious holes or broken windows. No immediate action regarding structures or foundations in Zone 3 is required at this time.

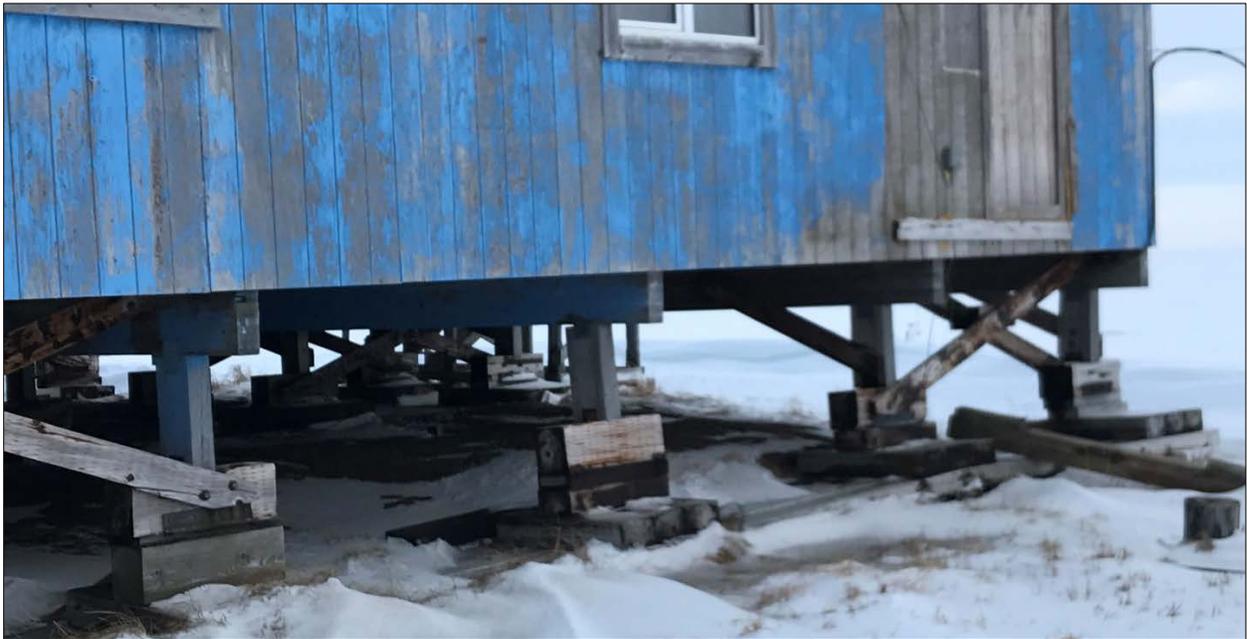
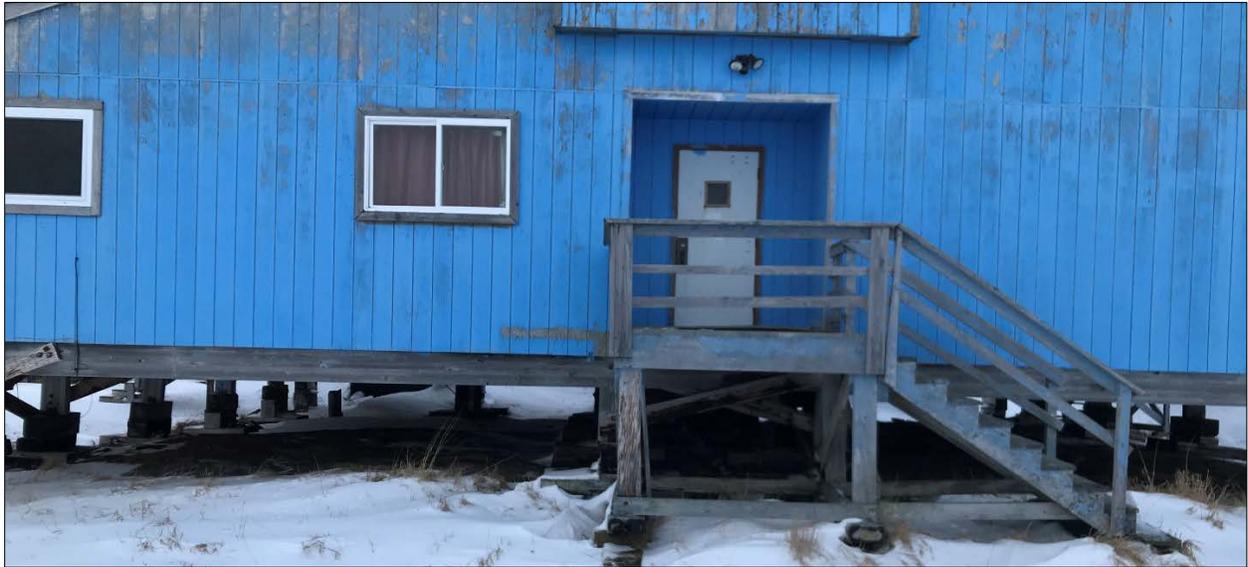
Building Condition- The Head Start Building, constructed in the 1970's is in poor condition (Figure 12, Figure 13, and Figure 14). Some signs of wood rot are apparent. Adjacent and connected structures are settling differentially with respect to the Head Start Building causing cracking walls and windows, sticking doors, and an uneven floor.

The entire building is tilting on its post and pad foundation due to surface thaw settlement. This problem has been exacerbated dramatically by the additional rapid rate of thaw caused by recent significant and prolonged flood events. Some pads are not in contact with the ground surface and are providing no support to the structure. This causes other members and foundations to support loads for which they were not designed. It is anticipated that this flood season will cause further thaw settlement under the structure which may result in its ultimate collapse given its current condition. Non-structural problems identified include: excessive heat loss due to inadequate insulation, and otherwise compromised building envelope. Additionally hazardous insulation (asbestos) has been indicated as a problem by members of the community.

Figure 12. Head Start Building Foundation

Figure 13. Head Start Building - Shifting Towards River Bank

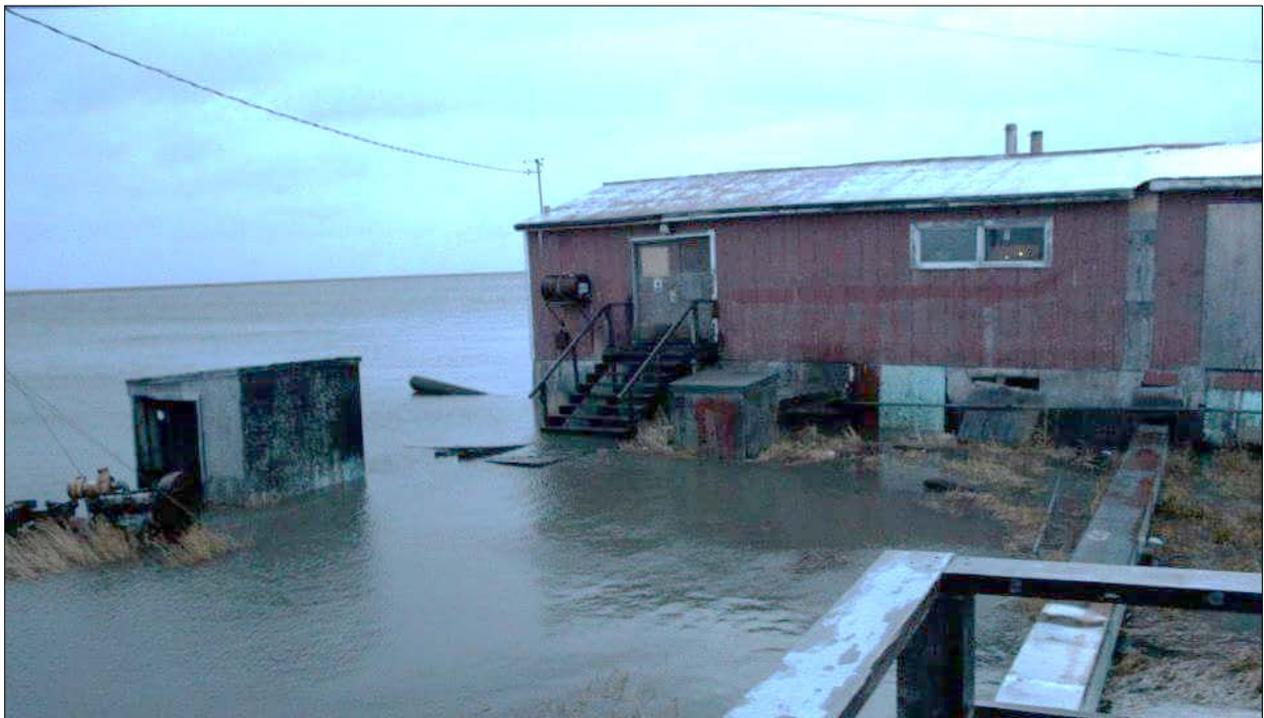
Figure 14. Head Start Utility building as seen from the entrance to the Head Start building.

Head Start Utility Building – as is shown in Figure 14 above, this building is in very poor condition. It provides electric power, heat, and water to the Head Start building and is at a high risk of failure due to flooding and continued permafrost thaw. Estimating the health and safety impacts associated with foundation and equipment failure due to collapse and flooding are beyond the scope of this report.

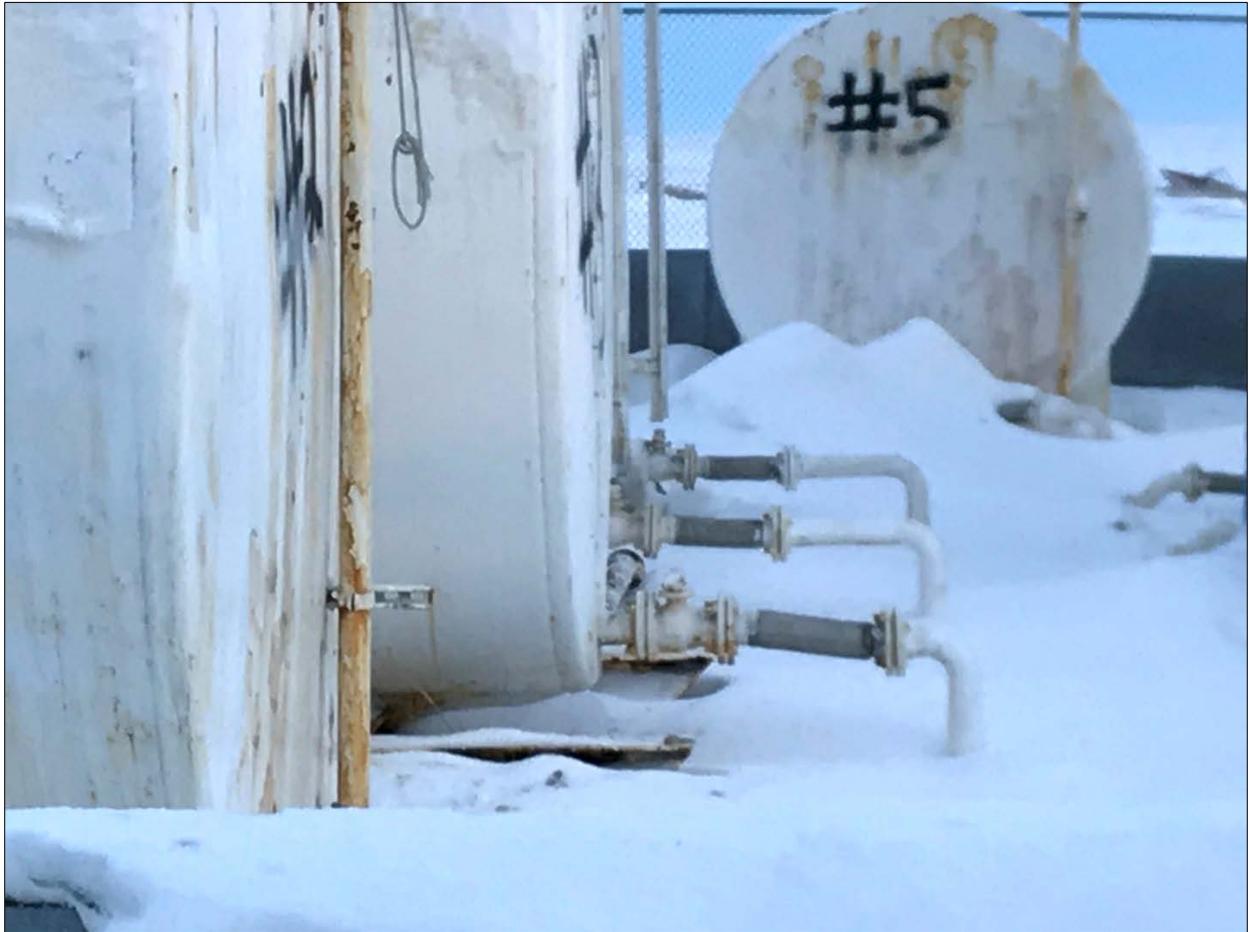
Fuel for Chefnak is stored in a tank farm on the west end of town near the river bank (Figure 18). This location was presumably selected for ease of access for fuel barges. The specific location is in a low-lying area that is regularly flooded during spring breakup and summer floods. It is located beyond the western edge of the Basalt formation where it is subject to increased rates of erosion and bank migration. Regular flooding of the site is causing rapid thawing of the underlying permafrost which manifests itself through thaw settlement and resulting differential settlement and failure of the foundations.

Two new tanks were added during the construction of the school in the mid 2000's. They were founded on piles and the ground was maintained in a frozen state by use of thermosyphons. One of the unintended consequences of this design has been that the underlying soil being maintained in a frozen state has caused it to heave enough to prevent water from draining naturally from the original tank farm site. This further exacerbates the problem of ponding water and subsequent that settlement.

Figure 18. Settlement of Tanks

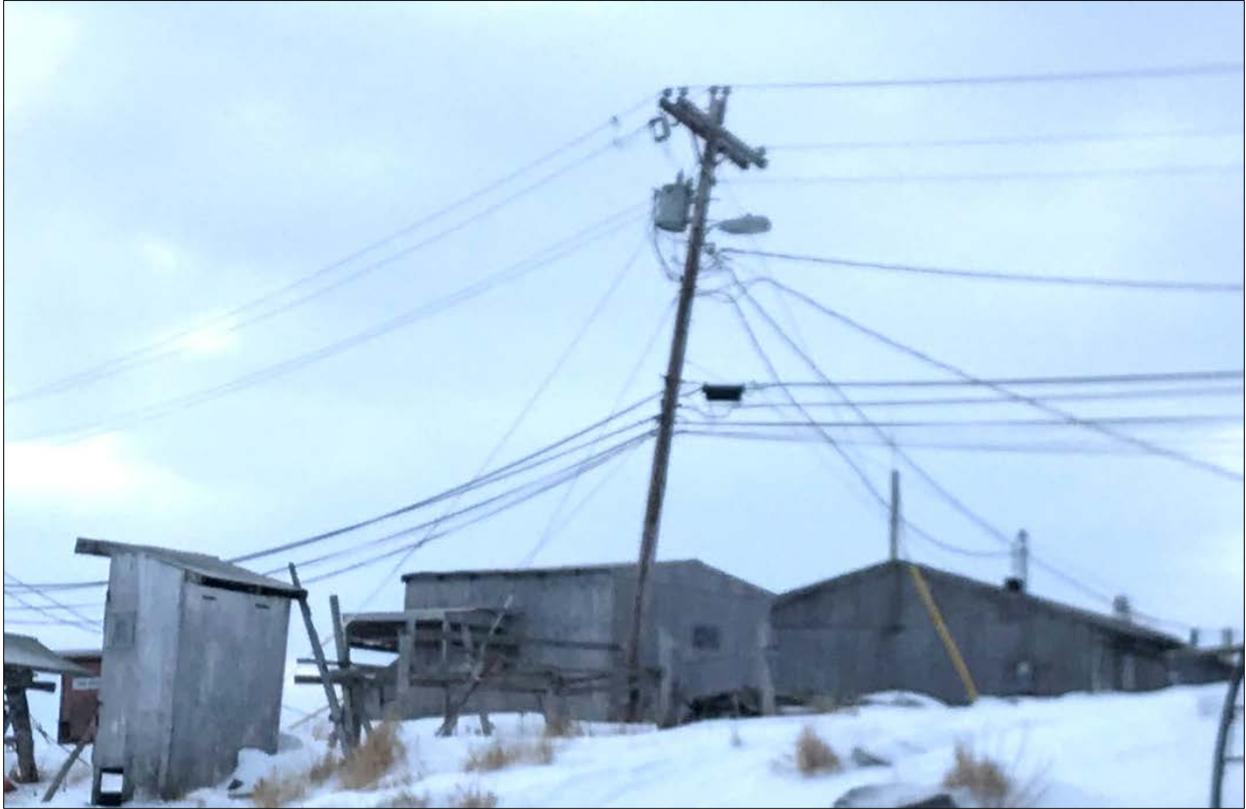
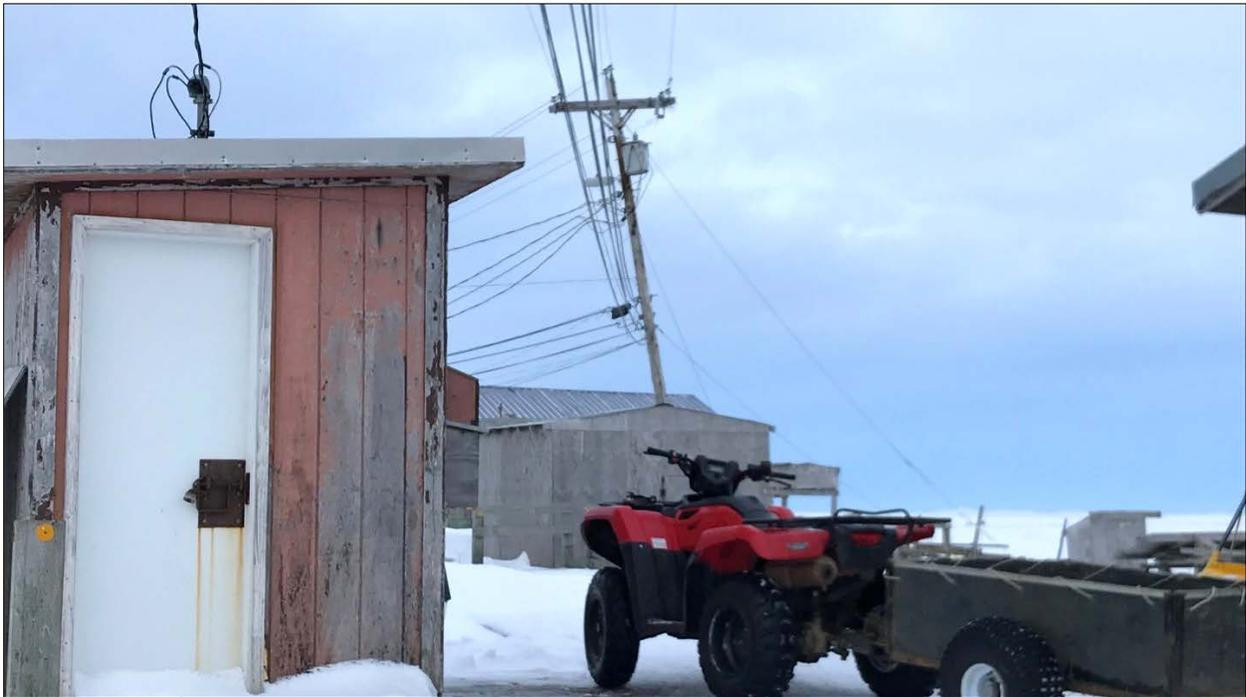
- i. Concerns with condition and proximity of distribution lines to existing metal roofed buildings- fire hazard (Figure 19 and Figure 20)
- ii. Insufficient embedment to prevent jacking
- iii. Poles not as specified?
- iv. Many of the existing poles will not survive a wind storm or ice storm

Figure 19. Heaved and Leaning Power Pole

Figure 20. Heaved and Leaning Power Poles
