# Point Lay Housing Survey 2023

**Cold Climate Housing Research Center & National Renewable Energy  
Laboratory**  
955 Draanjik Drive,  
Fairbanks, AK 99775

# Point Lay Housing Survey

April 2023

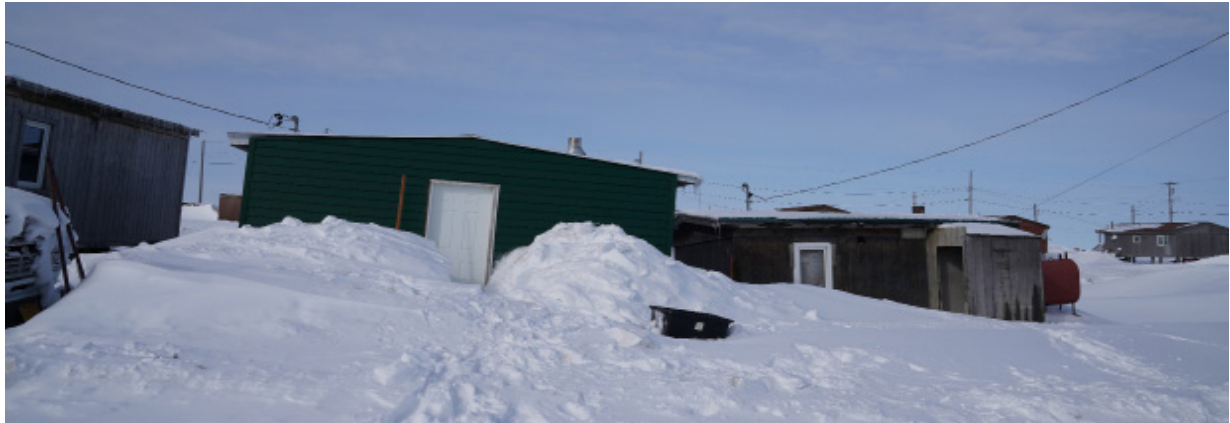
**Figure 3. Point Lay Home Tilting. (NREL, 2022)**

Houses in Point Lay are subject to the ground heaving and subsiding in dramatic ways such as extreme tilting.

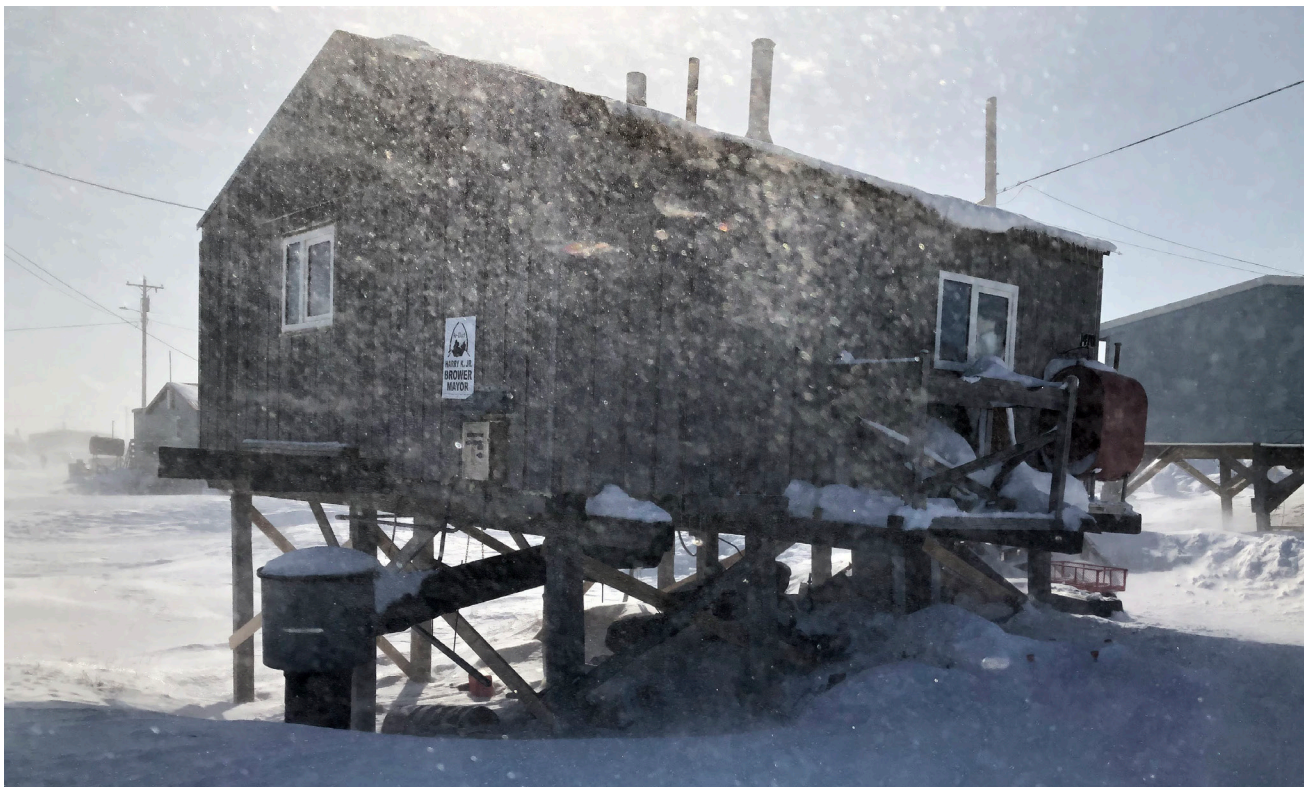
**Figure 5. Point Lay Home Atop Pile Foundation. (NREL, 2022)**

Even atop pile foundations homes are still susceptible to tilting due to subsidence.

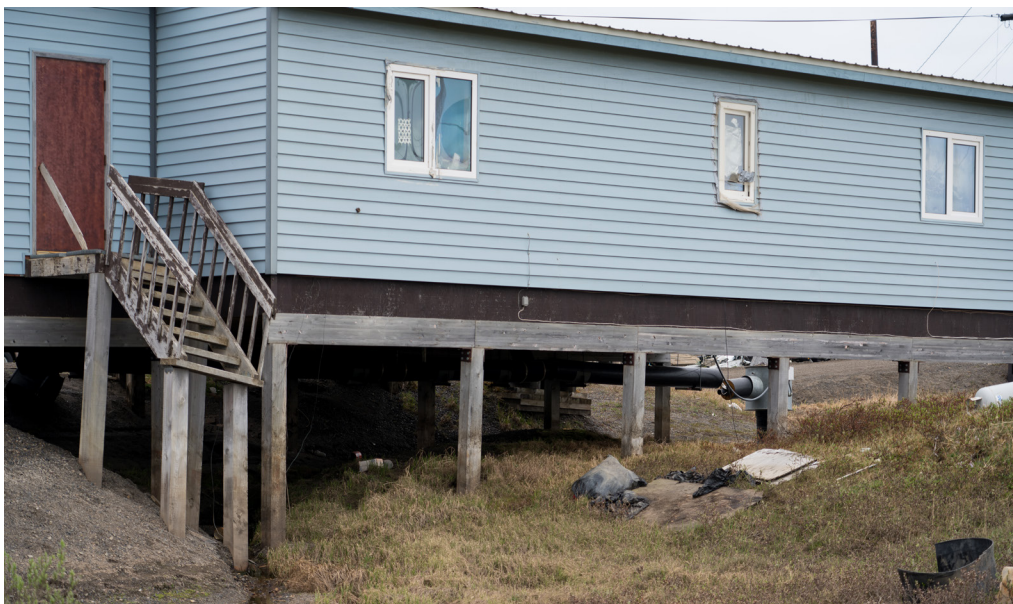
**Figure 23. Example of Stair Conditions and Damage. (Point Lay Resident Bill Tracey, 2022)**

Forty-four out of the 54 residential buildings (81%) reported the conditions of the stairs. Seventeen (39%) reported they were in good shape, 15 (34%) needed minor repairs, and 12 (27%) needed major repairs. These repairs could be varying degrees of damage or non-functioning aspects of the home, such as the stairs not meeting the ground, the materials being in bad shape, or something else that renders parts of the home dysfunctional or unsafe.

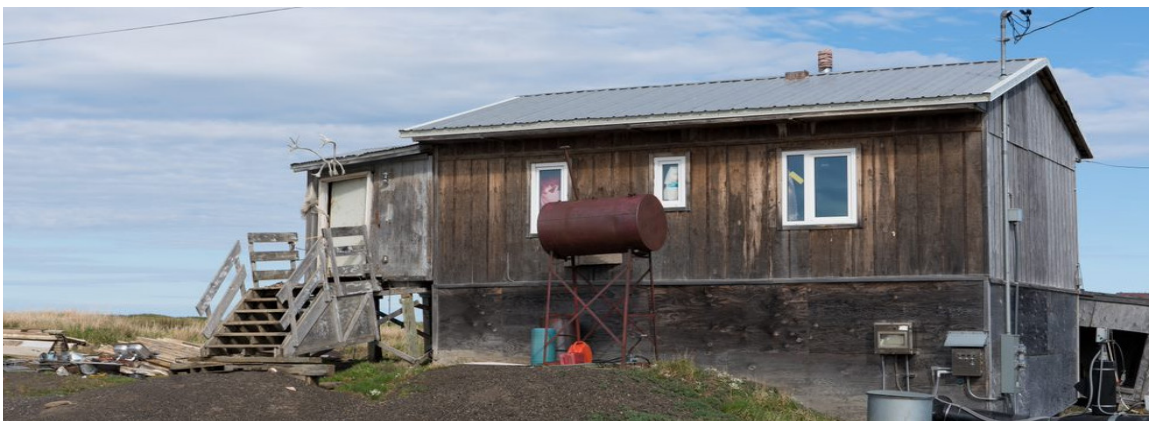
**Figure 24. Example of Porch Conditions. (Point Lay Resident Bill Tracey, 2022)**

Residents in 21 (38%) out of 54 residential buildings answered questions about the condition of the porch: 52% were reported to be in good condition, 19% needed minor repairs, and 29% needed major repairs.

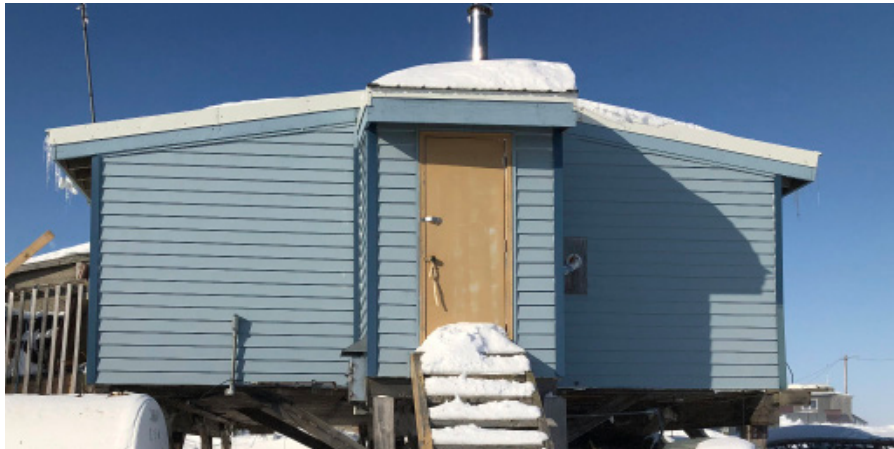
Figure 25. Example of Arctic Entry. (NREL, 2022)

Residents in 44 (81%) out of 54 residential buildings answered questions about the arctic entry, a vestibule or mud room that acts as a buffer between the outside and the living area. Eighteen arctic entries (41%) were reported to be in good condition, 4 (9%) needed minor repairs, and 22 (50%) needed major repairs. Figure 25 shows an example of an arctic entry.
