VILLAGE HOUSING ASSESSMENT FOR THE VILLAGE OF MERTARVIK

FOR DOWL ENGINEERS AND NEWTOK VILLAGE

JUNE 14, 2017

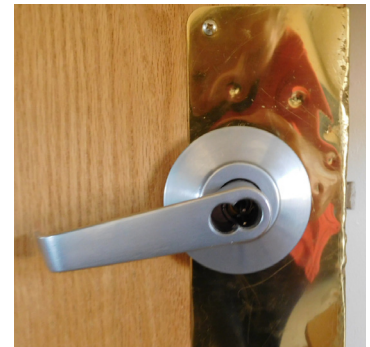
Damaged strike protection plate
(Typical for bedrooms)

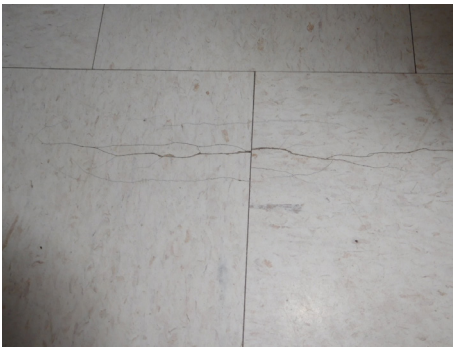
Cracking vinyl tile at module connection

Floors in the units are vinyl tile with some sheet vinyl in the bathrooms. There is some cracking in the vinyl where the modules join at the floor level, but generally the vinyl is in good condition. There are some areas where the vinyl has come loose with chipped corners, but this is very limited. Rubber base is used throughout and is in good condition.

- + Replacement of windows with higher efficiency, egress sized windows with new screens.
- + Enlargement of attic access hatches for fire access.
- + Replacement of flooring in approximately 10% of each unit.

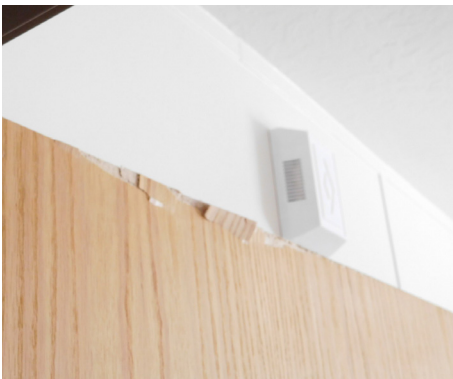
Damaged bedroom door

Interiors: The interior finishes of each unit are in good condition. The walls are finished with vinyl covered gypsum board which has held up very well over time. The face layer gypsum board is backed by quarter inch thick gypsum panels, most likely for durability and to prevent holes caused by abuse. Closet doors in the bedrooms are generally in good condition. Each closet also has a closet organizer for hanging and storing clothing which are in good condition. Doors in the unit are solid core wood face veneer with metal frames. There are several bedroom doors that are damaged, and in one case the frame is broken loose from the jam. The lock set on the bedroom doors have been retrofitted with strike protection plates which have quite a bit of damage. It appears the doors have been exposed to frequent attempts to gain entrance when locked.

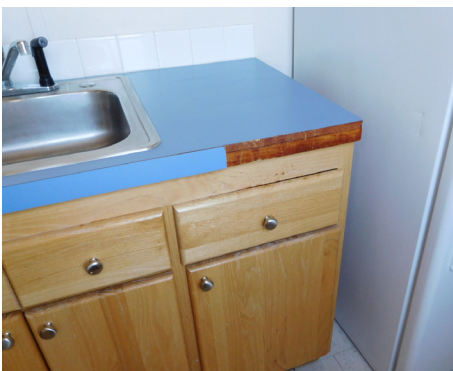
Damaged plastic laminate countertops

Casework in these units is generally of low-quality, with lightweight drawer slides and standard weight hinges. The drawer and door fronts are three-quarter inch thick solid oak. Countertops are plastic laminate with plastic laminate edges, and are damaged in several areas. If these units were converted to support the village-based family, it is likely the entire kitchen would need to be renovated to a more durable solution, with proper storage and amenities.

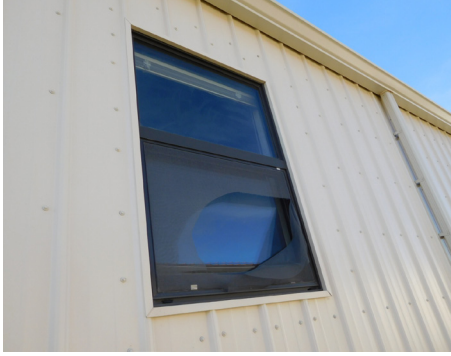
Damaged insect window screen

Exterior windows are fabricated aluminum, in a double hung configuration, with double pane insulating glass. Most of the exterior insect screens have been damaged and would need replacement. The bedroom windows are not fitted with proper emergency egress windows. The current configuration allows a clear opening of 31 inches wide by 15 inches high. Code requires an egress window at each sleeping room with a clear opening of 20 inches wide by 24 inches high (5.0 SF). The IBC Code has an exception to this requirement if the building is sprinkled, however Alaska State amendments do not allow this exception. Because the building was never permitted by the state, the military would have allowed the exception as stated. When these units are moved and then permitted by the State of Alaska, new egress windows would be required on all bedroom openings.

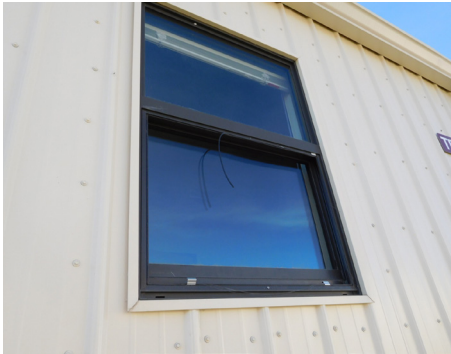
Aluminum exterior window

As stated previously, the double pane aluminum windows are not the proper egress size, and would likely condense excessively in an Arctic environment, leading to moisture problems. A triple pane vinyl casement type window would perform much better thermally in the new location, and would meet the egress code requirements. This type of window would also be fitted with insect screens on the interior, protected against the elements.

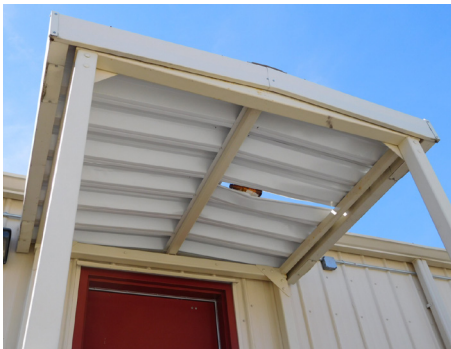
Damaged steel entrance canopy

There is a steel entrance stair and canopy over each unit entrance. The stairs are not constructed to meet current code and are starting to rust. The canopies over these entries have been damaged in many units by snow and ice.

- + Addition of an entry vestibule, with new stairs and entry decks to conform to the new height and foundation type.
- + Improvement to the thermal envelope with new exterior skin of rigid insulation/furring and new siding. Target R-30 minimum walls/floor.

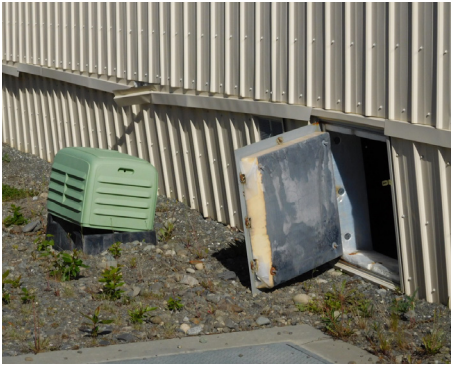
Skirting at access doors

Currently, the modules are set on gravel pads on temporary foundation cribbing with insulated skirting from the bottom of the floor to the top of the gravel surface. The skirting is rigid insulation with a rating of R-19 attached to metal siding. If the modules are moved, a new R-38 soffit would need to be constructed under the units to protect the underfloor utilities from freezing. It is likely that the modules would be placed on an elevated foundation system, so the soffit would need to be protected on the bottom side with a steel liner panel, or painted wood sheathing.

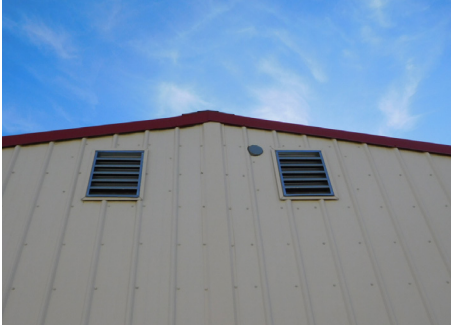
End gable vents

The attics appear to be properly vented as cold roofs, with gable endvents, ridge vents, and eave vents. In Arctic conditions, these types of venting result in snowdrifts in the attic, which leads to water penetration, and eventually mold. If the modules are moved, baffled gable end vents would need to be added at the very least, and the ridge vents possibly removed. It appears additional venting was needed in the attics based on the observation of attic vents poking out of the metal roofing. Any alteration of the venting system could possibly lead to ice damming and other issues. It may be more prudent to apply rigid insulation on the top of the plywood roof deck and then have a new metal roof added, making these a warm roof solution. This would alleviate the need for a vented roof attic, and may give additional space to retrofit water and heating piping overhead if needed.

- + Addition of insulation to the roof by adding rigid insulation and converting to a warm roof system with a heated attic. Target R-40 minimum.
- + Building new, insulated under floor soffits to protect under floor utilities.

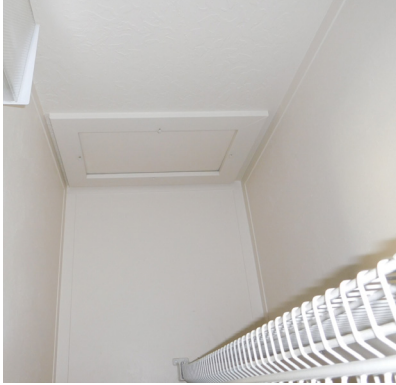
Small attic hatch

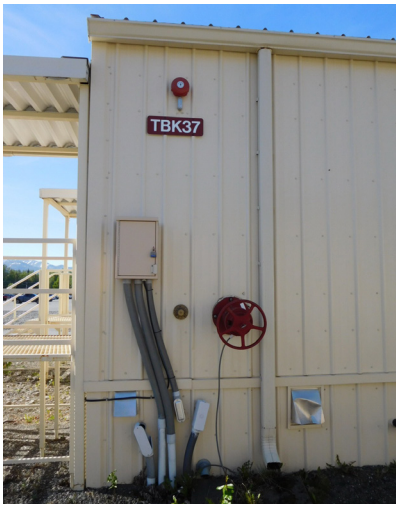
Sprinkler notification equipment

- + The modules are provided with sprinklers throughout, but to satisfy the code for an R-2 apartment style occupancy, sprinklers are not required. The sprinkler system would need to be removed entirely if these units are re-purposed, and cannot be abandoned in place. The sprinkler piping is routed in the crawl space and surface mounted in each unit.
- + The thermal envelope upgrade is not a code requirement, but strongly recommended to keep utility costs within a manageable limit for the tenants.
