## Newtok Environmental Site Inventory and Assessment Project

### Part I: Hazardous Materials Inventory

October 29, 2015

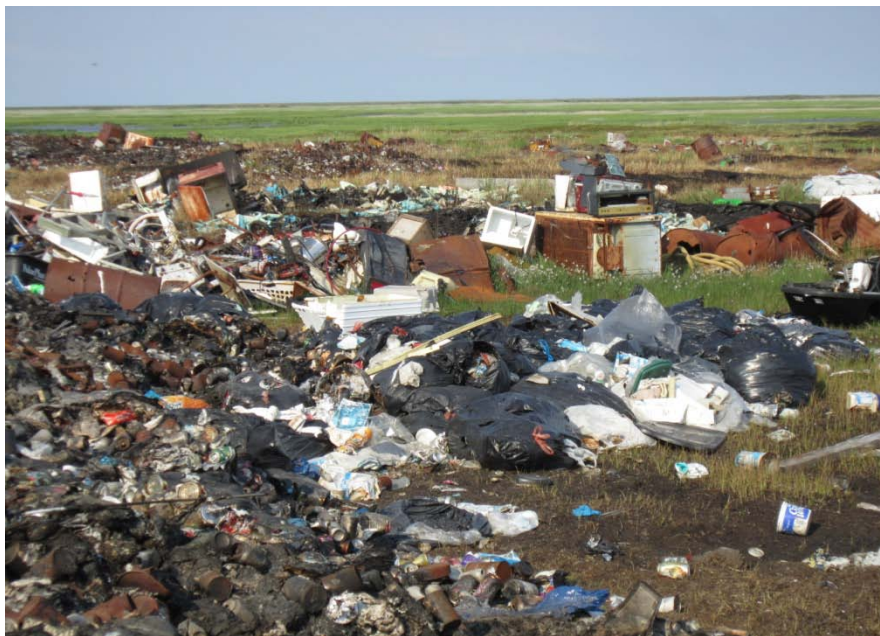
**Photo 2: Contents of Landfill**

The landfill covered an area of approximately 250 ft x 500 ft and on average waste material was about 6 ft deep. The landfill was unregulated and open to anyone; there was no control over dumping. E-waste had been segregated to one side with the plan to eventually haul it to Anchorage for recycling but damage from the fire may have altered that plan. A

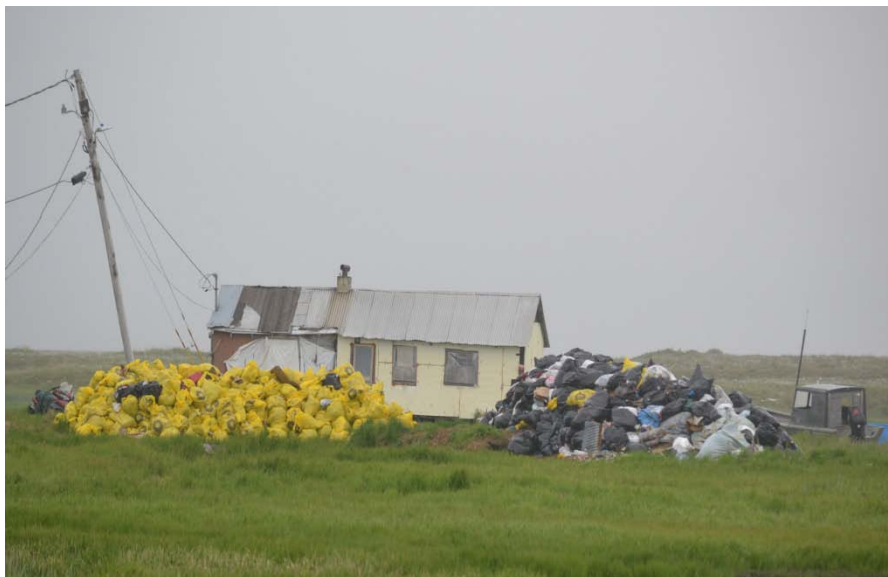
**Photo 3: Bagged Waste Staging Area**

This area was also believed to be a historical burial location for waste incineration ash from the Old BIA School and residential trash between the 1960s and the 1980s. The volume and frequency of waste incineration were not known.

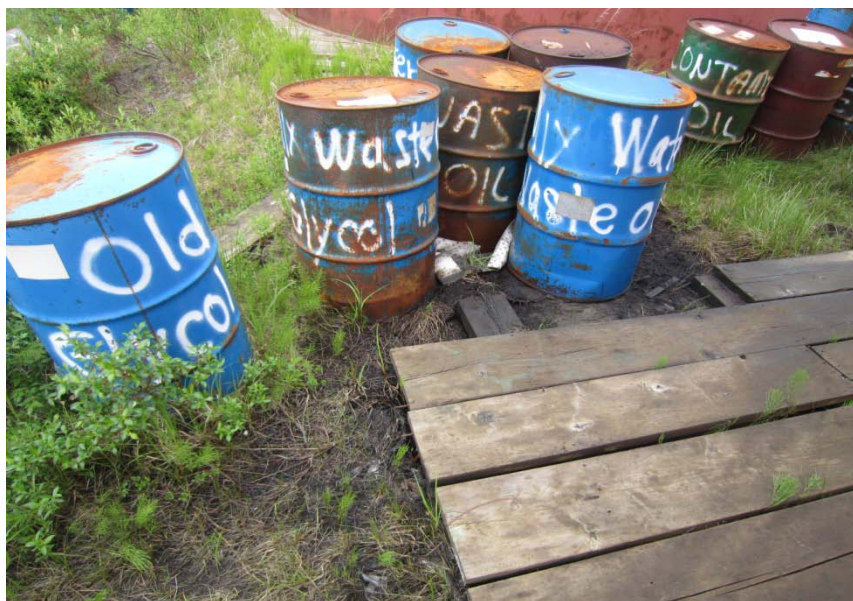
Photo 4: Oil Drums in Newtok School's Tank Farm

Numerous (fifty plus) 50 gallon oil drums were stored within the tank farm secondary containment. Some drums appeared to be empty and others partially filled. Labels were spray painted on the drums and included: paint thinner, mixed waste, waste oil, dirty water waste and used glycol.

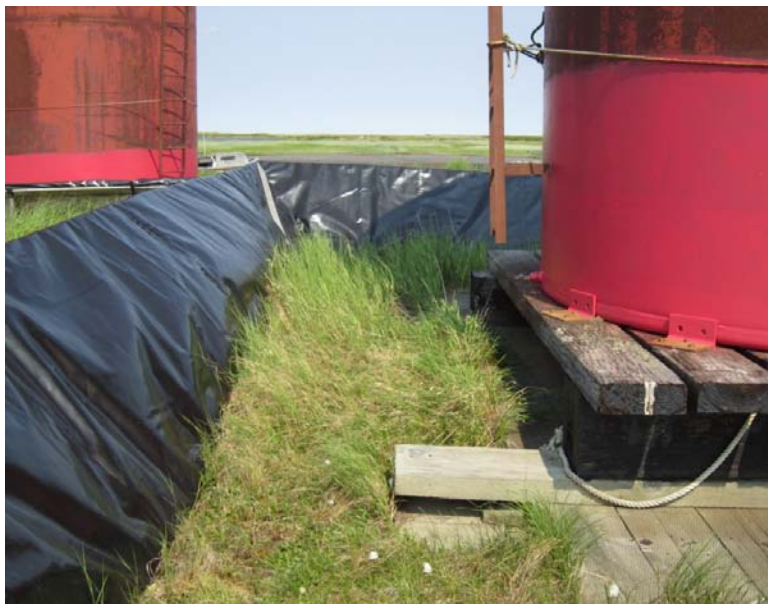
1. Two 9000 gallon vertical above ground tanks were contained in a 26 ft x 45 ft x 3ft enclosure constructed of plywood and covered with a polyethylene liner. The containment was intact and in good condition. The tanks contained heating oil. They rested on creosote treated wooden platforms. Vegetation inside and outside of the containment appeared healthy.

**Photo 5: Secondary Containment around NVC Tank Farm**

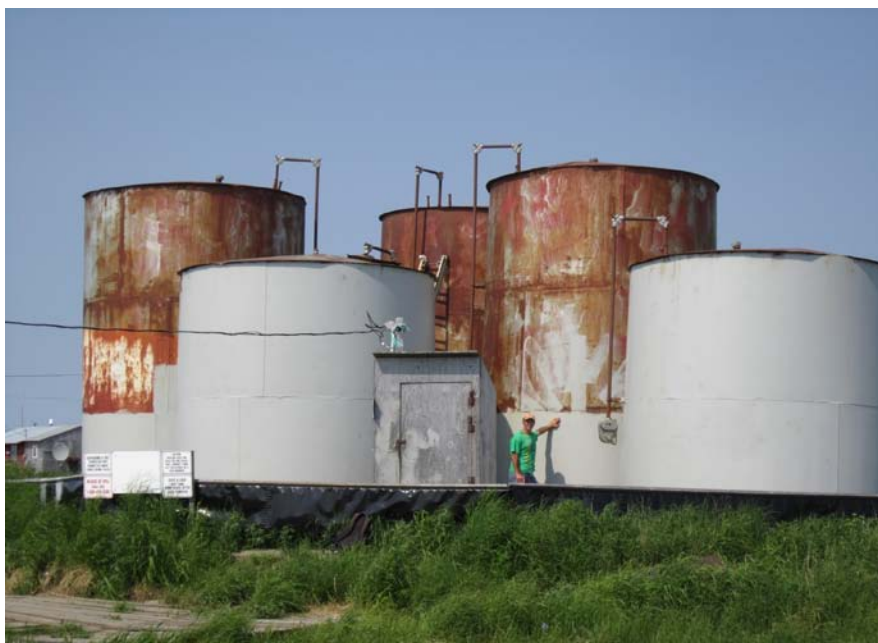
The UPC tank farm consisted of five steel above ground storage tanks; one of the tanks was empty and not in use. Two of the tanks were 10,000 gallons in volume and three of the tanks are 15,000 gallons in volume. The top 2/3 of the 10,000 gallon tanks were rusted. The tanks sat on wooden boards, some of which were broken.

**Photo 6: Jeff Powers Pointing Out the Empty Tank**

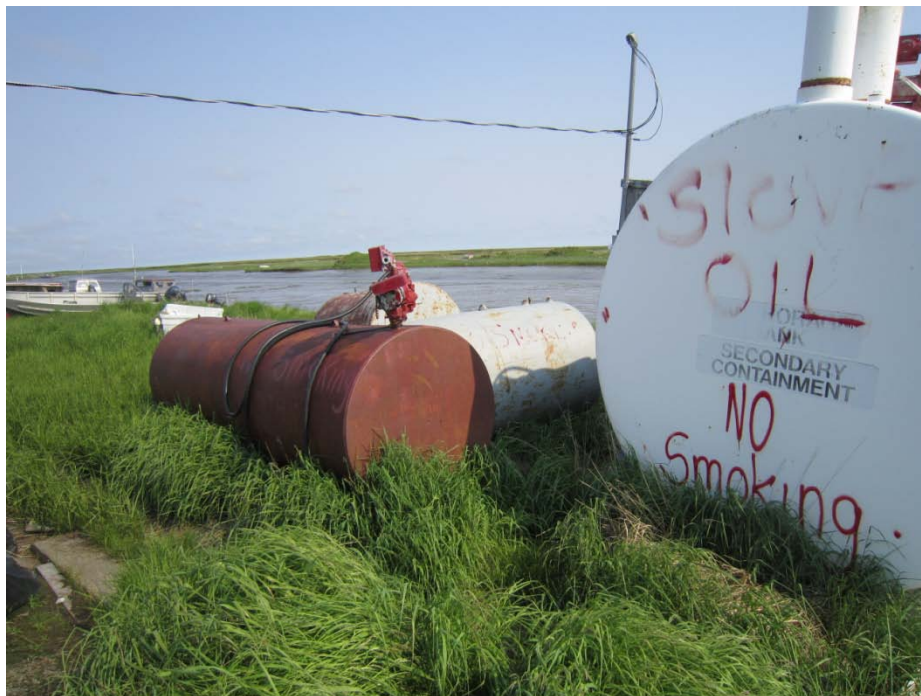
Photo 7: Tom's Store Tanks near the Newtok River

Seven steel above ground storage tanks belonging to Tom's Store were located between the store and the Newtok River. According to Stanley Tom (the owner of Tom's Store) all of the tanks were empty and had been out of service for several years. Two of the tanks were double walled,

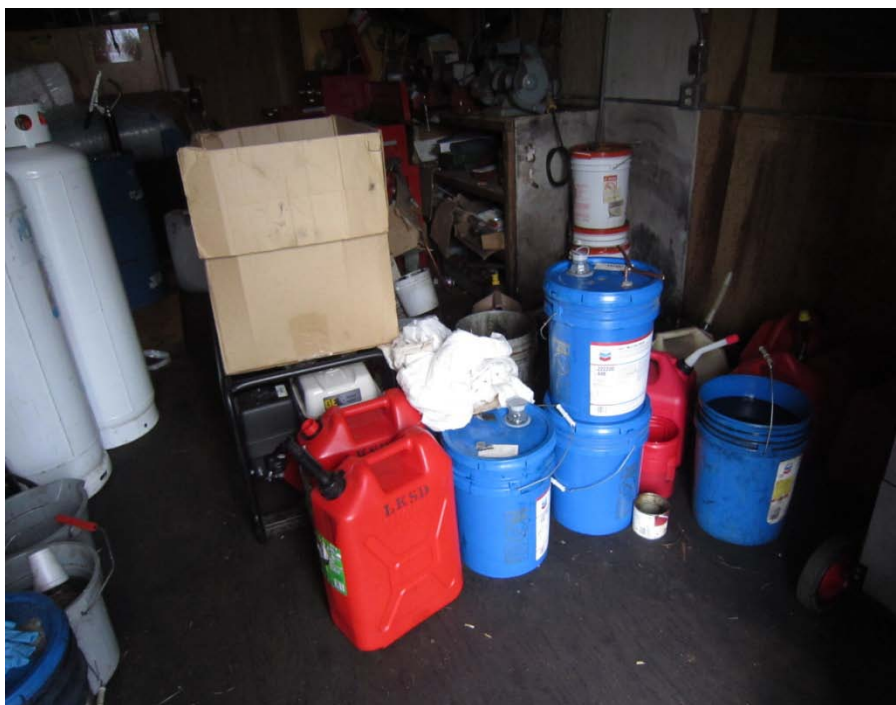
Storage shed WW05 contained tools, plumbing and electrical fixtures and plastic containers with gasoline and oil, propane canisters, insulation, and a waste oil burning unit. Four drums labeled “empty” were outside the shed. The shed served as controlled containment for the materials inside and had a locking door. Some staining from past spillage was noted on the floor of the shed.

Photo 8: Inside the Storage Shed

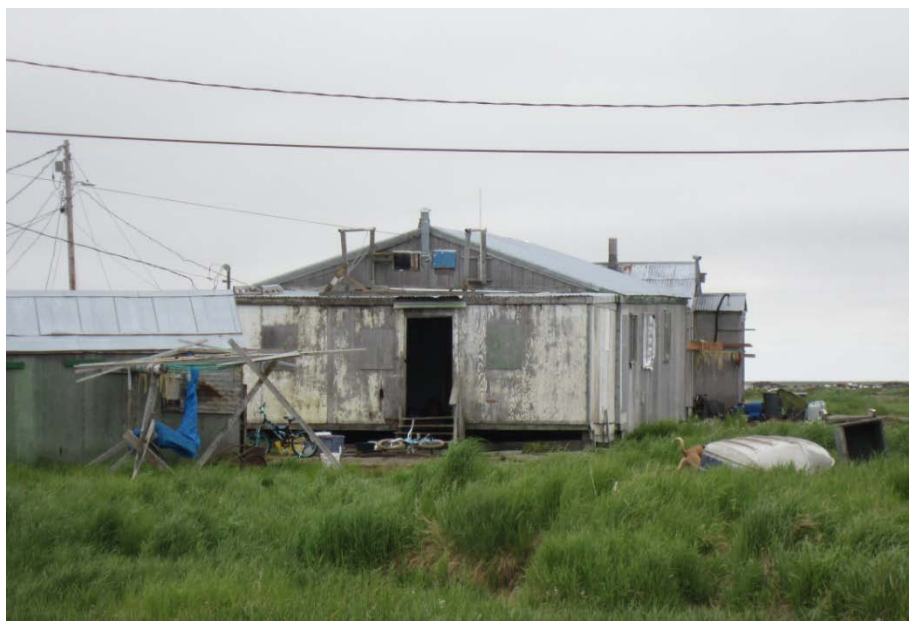
Tom John brought Hobbit to a BIA home to view the inside. The house had been built by the BIA in the 1970s and was the oldest type of housing in Newtok. The flooring was a mixture of old and new tile with the potential for ACM. Given the vintage of the house, paint peeling in the entryway may be lead containing or lead based. Hobbit did not visit other houses so as not to be intrusive to residents.

Photo 10: BIA built home from the 1970s
