U.S. Army Corps
of Engineers
Alaska District

ALASKA BASELINE EROSION ASSESSMENT

Erosion Information Paper - Kotlik, Alaska

Current as of March 7, 2008

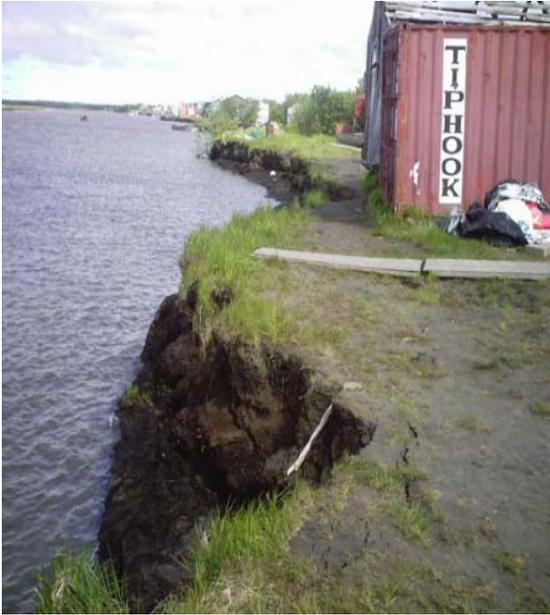
Photo 1: Bank erosion along the Kotlik shoreline, 2007.

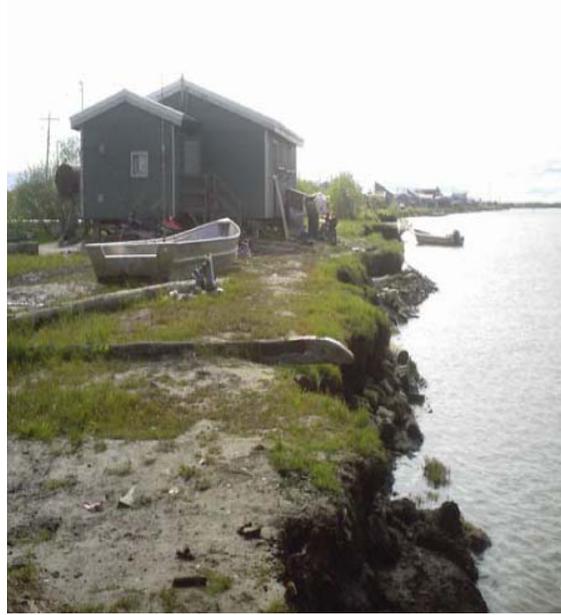
Photo 2: Home close to the eroding shore, 2007.

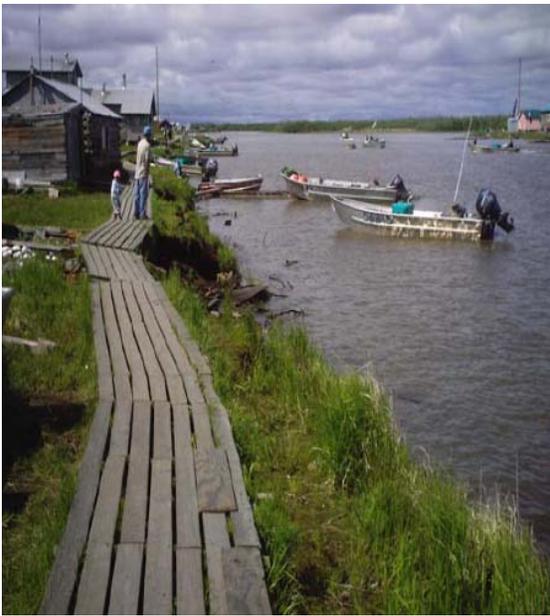
The riverside right-of-way and several structures, including some homes only a few feet from the riverbank are threatened by erosion. The community has moved the riverside boardwalk inland 3 times over the past 6 years. The boardwalk walkway and is heavily used by pedestrians. Outbuildings and sheds, food storage areas, drying racks, smokehouses, the AC retail store, utility poles, and public buildings also are threatened by erosion. The retail store is 4 feet from the riverbank, a church is 5 feet from the riverbank, and utility poles are within a few feet of the riverbank. A Corps letter to the Kotlik mayor cited a 2003 Corps *Trip Report* listing additional buildings and items that “will eventually have to be moved back due to erosion”; including a school building, the city office, the Assembly of God Church, and an old Catholic Church. They were estimated by the Corps in 1986 to be within a 50 year potential erosion area. The *Kotlik Hazard Mitigation Plan*, completed in 2007 by URS, indicated that nearly 60 percent of the community was at risk from erosion, including critical facilities such as those listed above, the Municipal landfill, non-critical facilities, and residential structures. Annual scouring and erosion of the riverbank has created a significant problem, particularly on the east bank of the Kotlik River where the majority of the town is located.

Photo 3: Boardwalks, which are the streets of Kotlik, are threatened and have been repeatedly moved back, 2007.

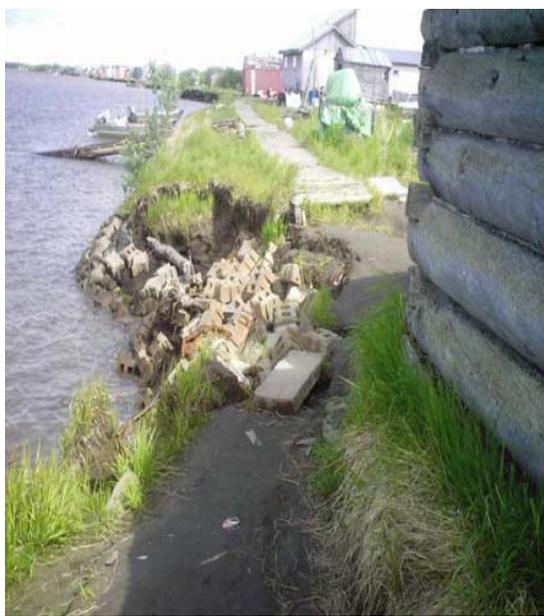
In 1983-84 the city received a State legislative grant to install armorflex concrete matting as an erosion protection measure. Installation was completed in the fall of 1986. The matting has reportedly been less than successful over the years. The city has cut brush and trees, gathered logs, filled sand bags with silt, and restacked concrete blocks in an ongoing attempt to protect the

Photo 4: Concrete blocks, remnants of failed erosion protection litter the shoreline, 2007.
