DETAILED ACTION PLAN KOTLIK LANDFILL

WASTE EROSION ASSESSMENT & REVIEW (WEAR) MAY 2015

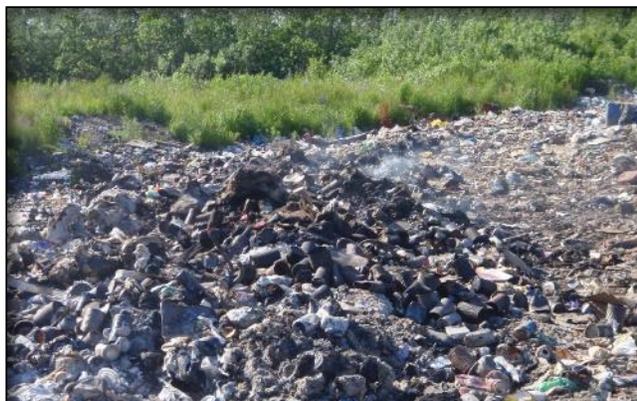
Smoldering Waste (ADEC 2012)

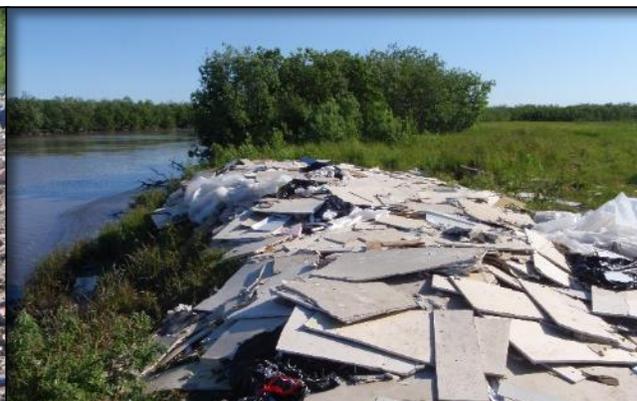
Construction and Demolition Debris (ADEC 2012)

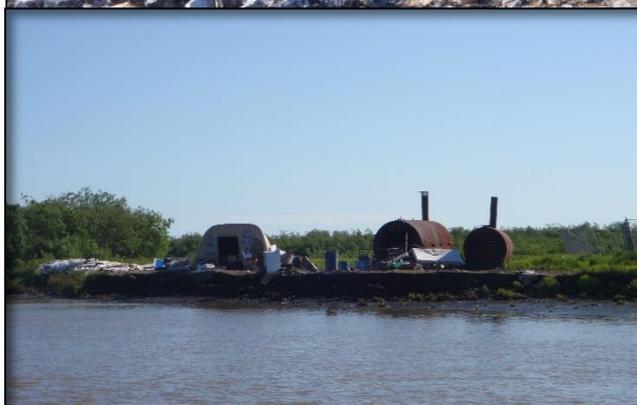
River Access to Landfill (ADEC 2012)

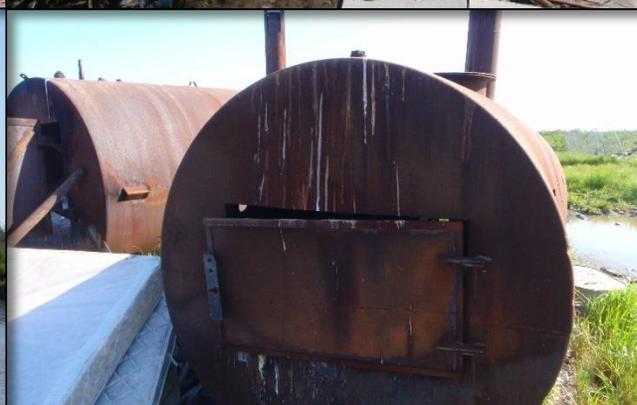
Burn Units (ADEC 2012)

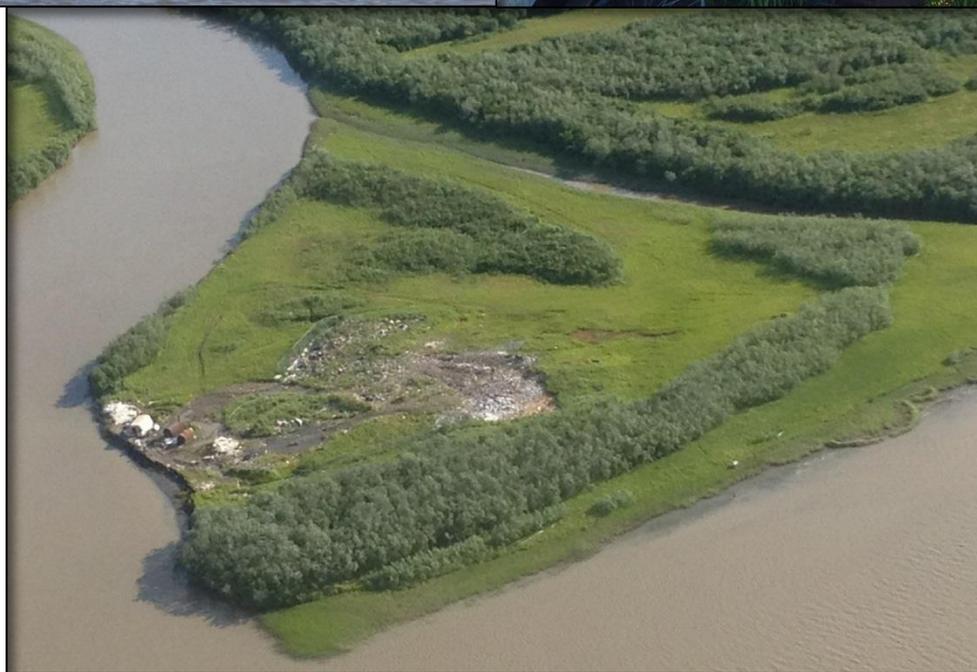
Aerial of Landfill (ADEC 2012)

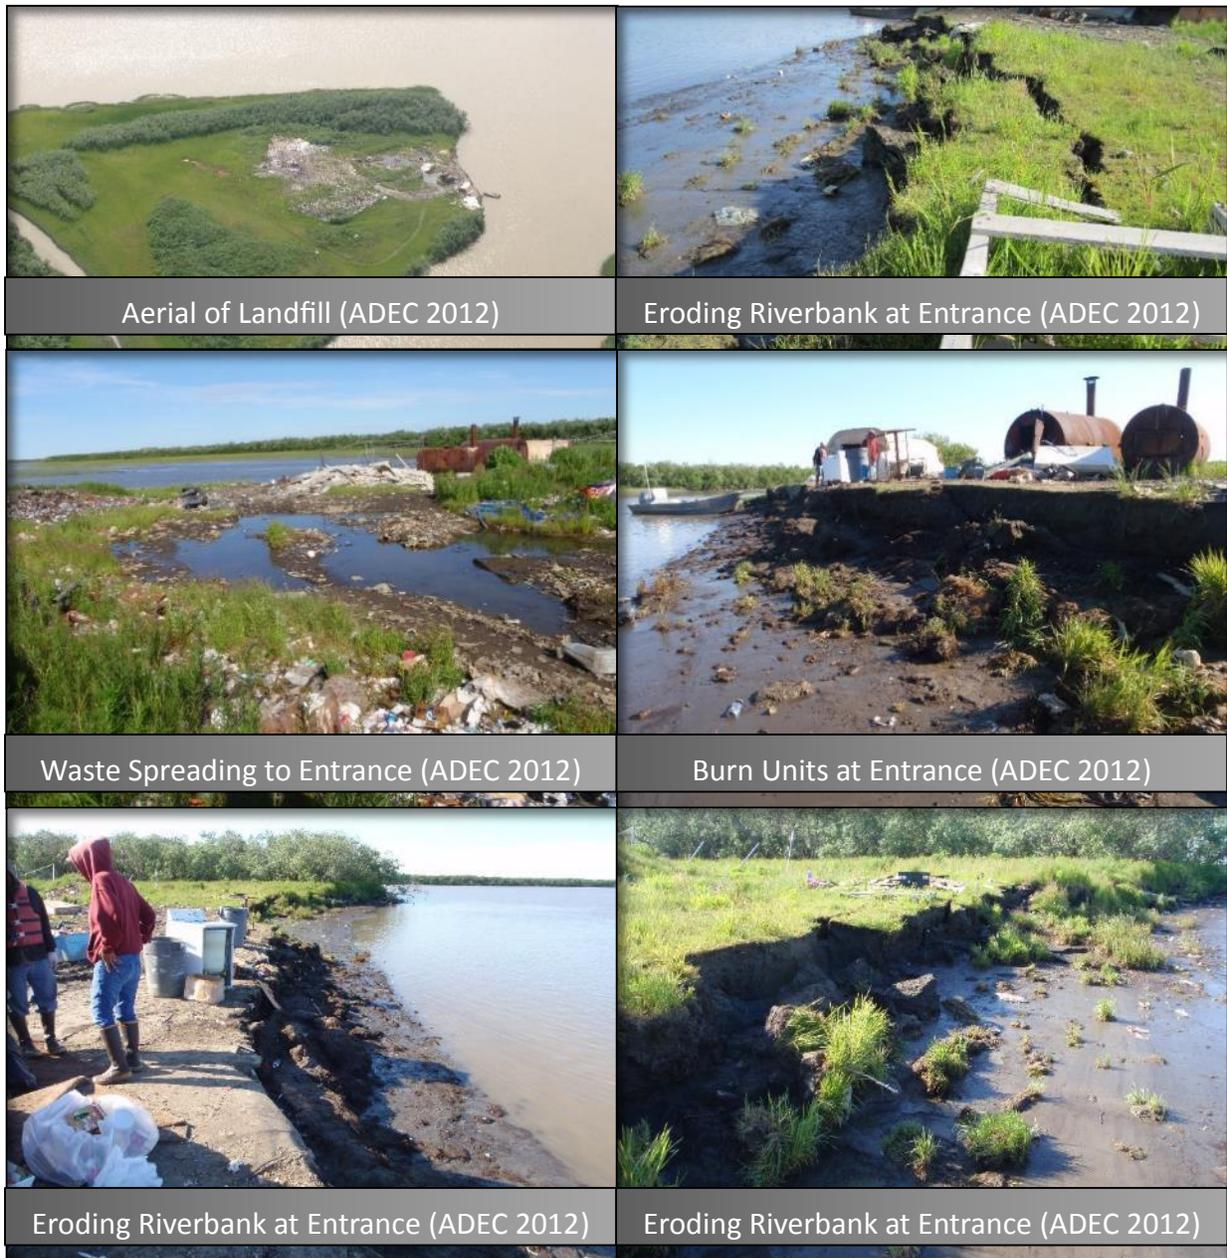
The US Army Corps of Engineers 2009 study, *Alaska Baseline Erosion Assessment (BEA)*, lists an estimated erosion rate of 3 feet per year along the banks of the landfill. During the 2012 WEAR site inspection, the landfill was only 15 feet from the eroding riverbank. According to the BEA, natural fluctuations in flows and water levels, flooding, ice jams, spring break up, and wave action from boat wakes and wind reportedly contribute to bank erosion. The soil structure of silt and clay is more likely to erode than other soil types and is weakened with the semi-annual thaw-freeze cycle.

Erosion is estimated to impact the landfill by 2016.
