MEMORANDUM

RE: Burro Creek Lodge
Outdoor Recreation Lodge License
5432 –1st and 2nd waiver refund
request

RE: BURRO CREEK LANDSLIDE SITE VISIT REPORT AND SLOPE ASSESSMENT,
SKAGWAY, ALASKA

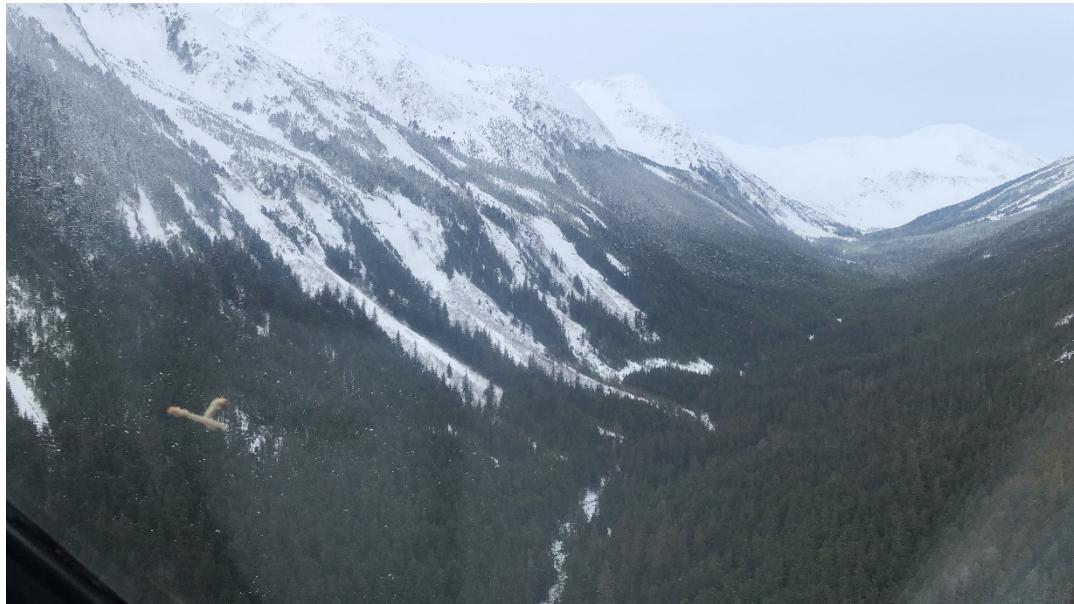
Photo looking up Burro Creek valley to the west, evidence of past landslides and/or avalanches reaching the valley flow are evident on south (left) valley slopes. Photo shows general slope conditions upstream of the landslide addressed in this letter.

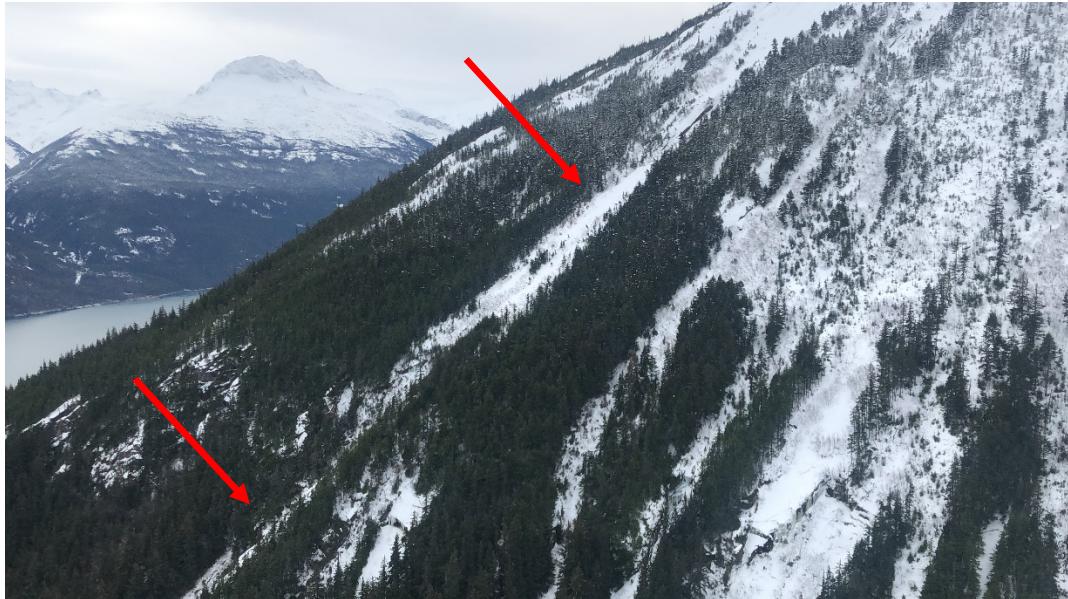
Photo looking southeast at slopes immediately west of the slide, which is not visible in this photo. Red arrows point to a rock structure-controlled linear feature (similar to the features above the landslide discussed in this report) that appears to channelize flow of water and debris to valley bottom. The termination of this feature is approximately 2,500 feet upstream of the property line at Burro Creek and approximately 3,000 feet upstream of the landslide discussed in this letter.

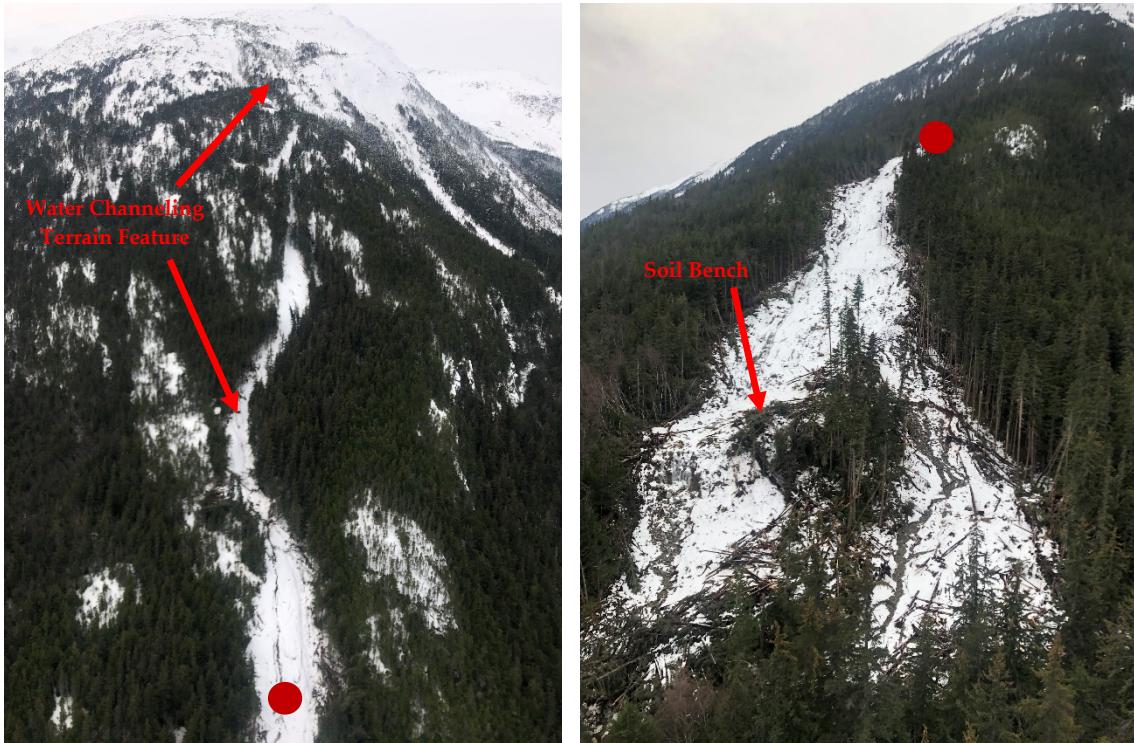
Photo pair capturing the entirety of the debris flow footprint. Left photo is the upper portion of the slide, right photo is the lower portion just above the debris pile. Red dots on either photo are approximately the same location.

Based on our observations, the slope failure is classified as a debris flow, caused by oversaturation of surface soils near the apex of the failure. It is likely that the oversaturation was caused by the record high rainfall event in the days before the slide and mobilized by the flow of surface water focused on this area by naturally occurring topography above the slide. As the debris flowed down the slopes, it stripped the relatively thin organic and mineral soils and tree growth from the slope. The debris flow was split into two lobes just above the creek elevation on an elevated soil bench, with the west lobe partially blocking the

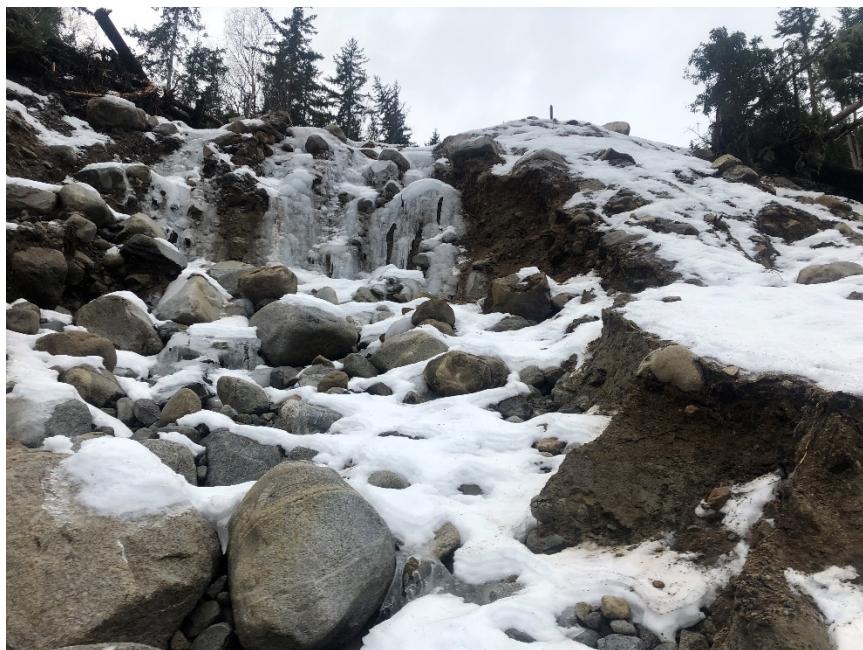
The slide path itself widens as it travels downhill and is bifurcated just above the valley bottom. The areas of the slide path not covered with snow appeared to consist of bare rock with the exception of a zone of exposed soil approximately 100 to 200 feet from the south bank of the creek. Those soils appeared to consist of sand and gravel with cobbles with relatively low fines content. The gravels and cobbles appeared to be rounded to subrounded suggesting an alluvial depositional source. It is our opinion that these soils are likely an old alluvial terrace, but given the terrain, could include intermixed colluvial materials deposited from the slopes above. The soils were exposed in the slopes above both debris lobes and water was flowing on the surface above both soil exposures.

Photo looking south at soil exposed in bench area on east debris flow lobe. Note ice forming on surface where water flows on the surface.

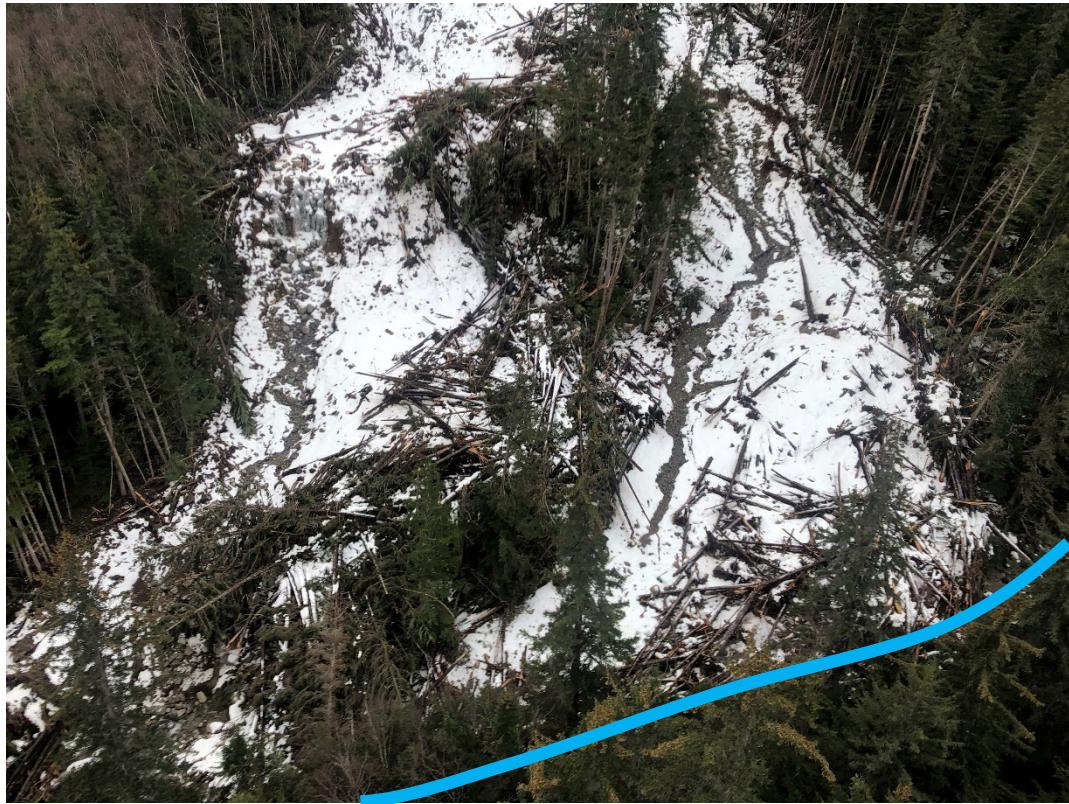
The western debris pile lobe crossed the creek and is responsible for the damage to the existing intake structure. The east lobe of the debris pile appears to have not intersected the creek, terminating just south of the creek bank. The total width of the debris pile near the creek (inclusive of both lobes) is approximately 380 feet, with approximately half of that actually encroaching/crossing the creek. At the time of our visit, the debris pile consisted of mostly tree and organic material carried down the slope. Soil or rock debris intermixed with the organic matter was present, but it appeared make up a relatively minor fraction of the debris.

Photo looking down on bifurcated debris pile lobes (west lobe on the right, east lobe on the left). Blue line indicates approximately location of Burro Creek. Note channels in snow on both lobes where flowing water has thawed recently fallen snow.

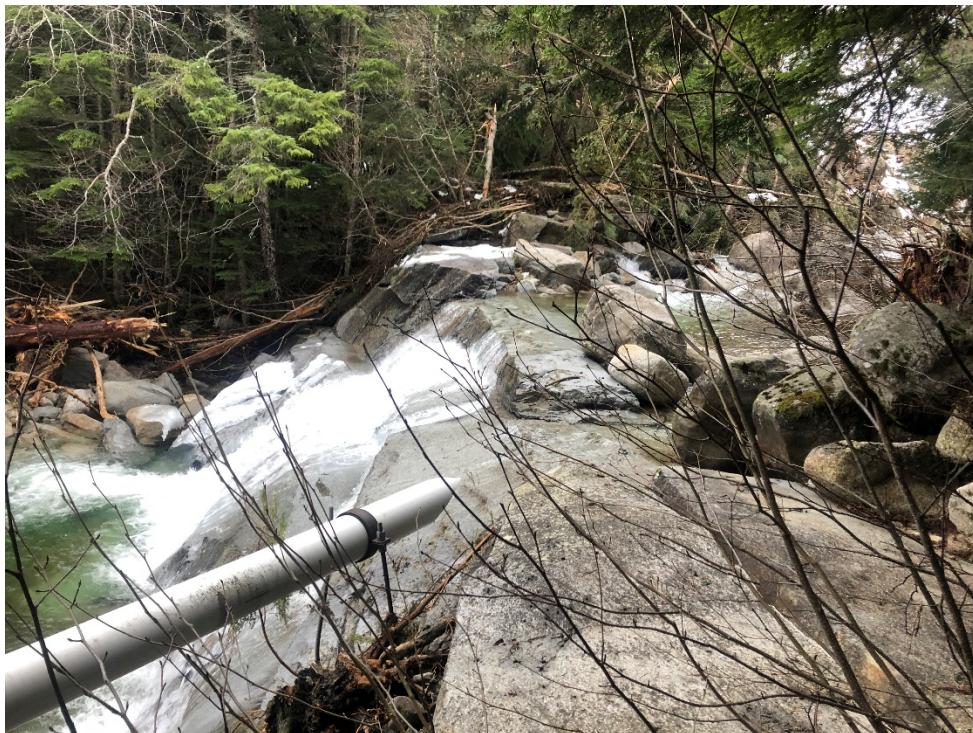
flow of Burro Creek. The subsequent release of water and entrained soil and organic debris from the partial damming is the likely cause of damage to the intake structure, which is located just downstream of the eastern extents of the west debris lobe.

Photo looking at prior intake location. Note that intake is downstream of debris lobes suggesting that release flooding likely washed away in-stream structures.

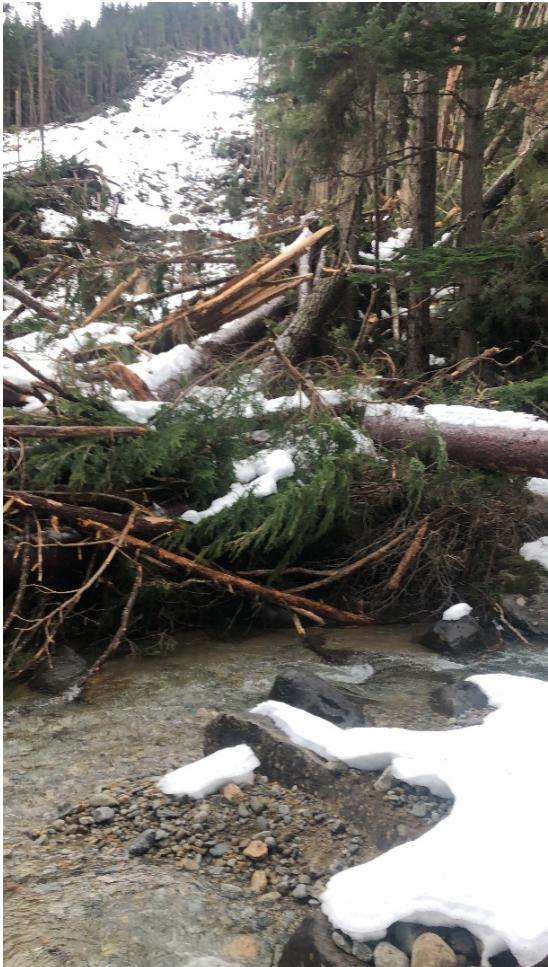
Photo looking south at upstream extent of west debris lobe. Note most of the debris present is fallen timber carried downslope.
