Report of Investigation Findings in Response to Allegations Raised by Mr. Charles Hamel in June 2006

- Investigation Report -

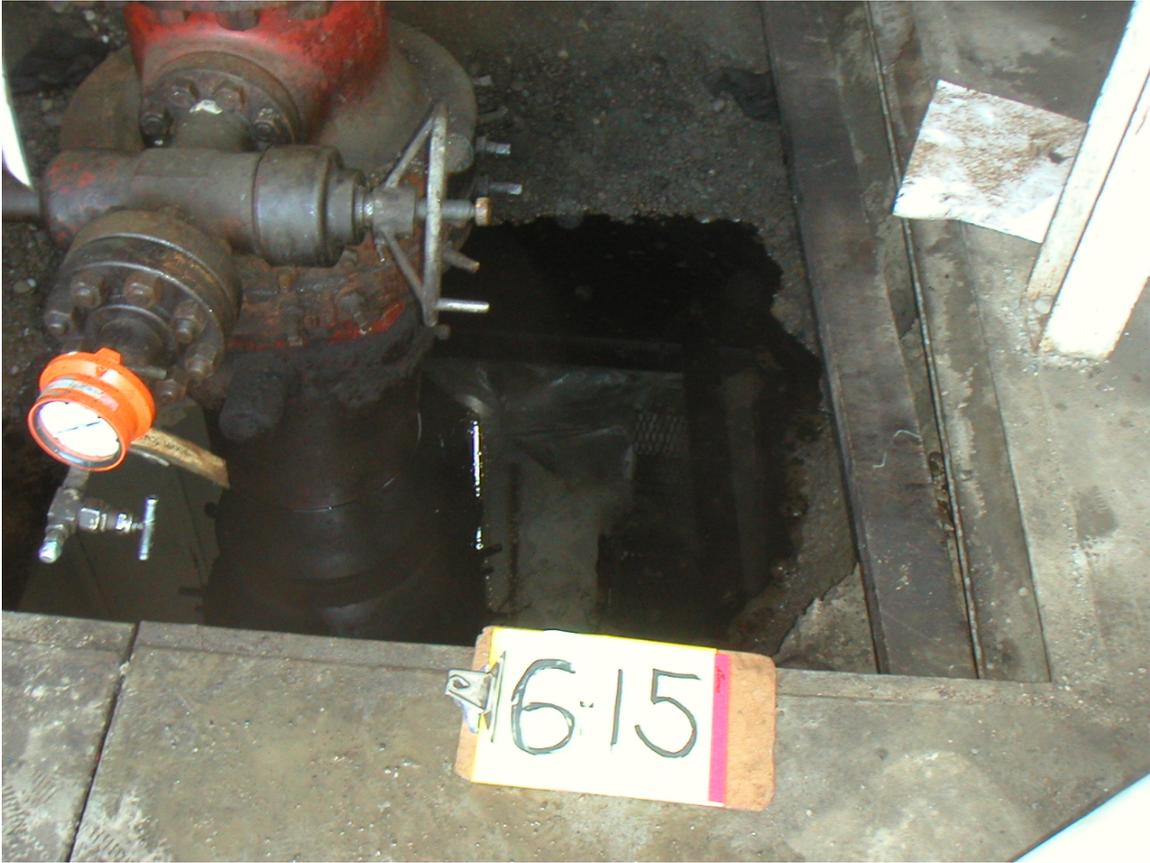
(Hydrocarbon fluid note in PBU 6-15)

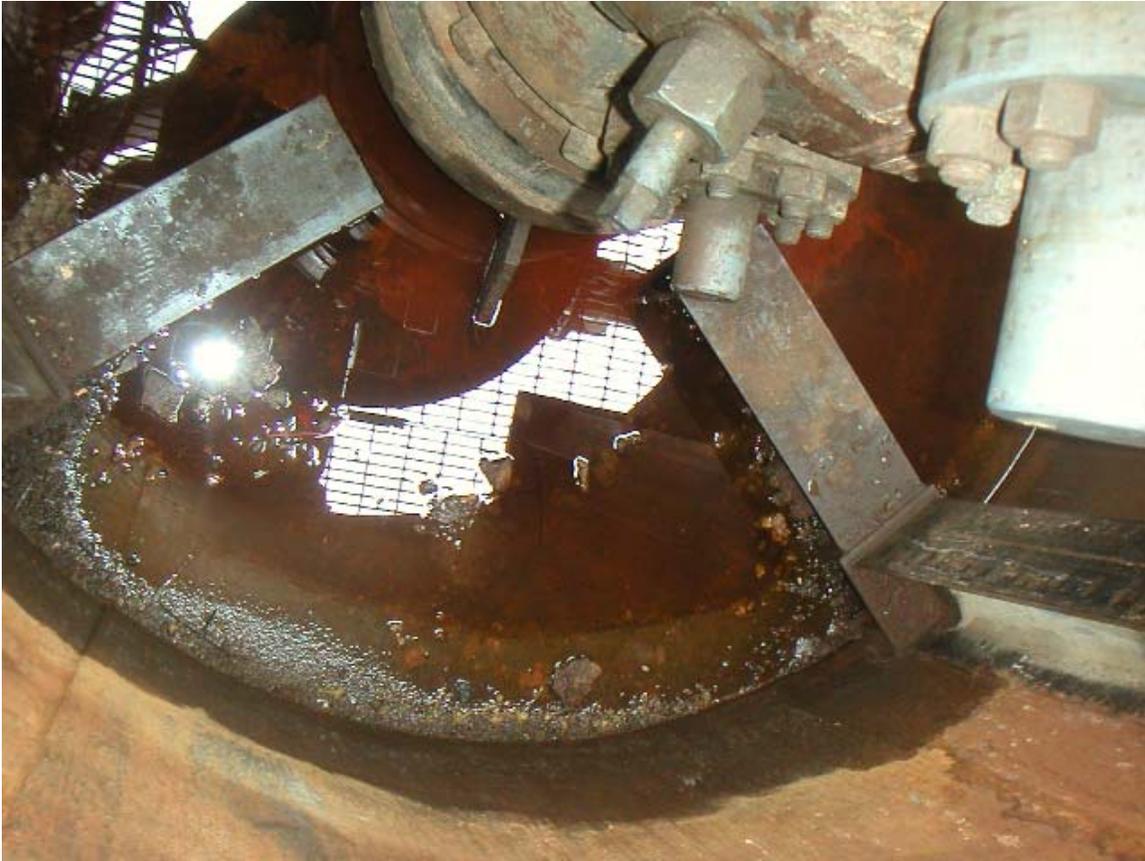
(Diesel like fluid on top of water in the cellar of NS-29)

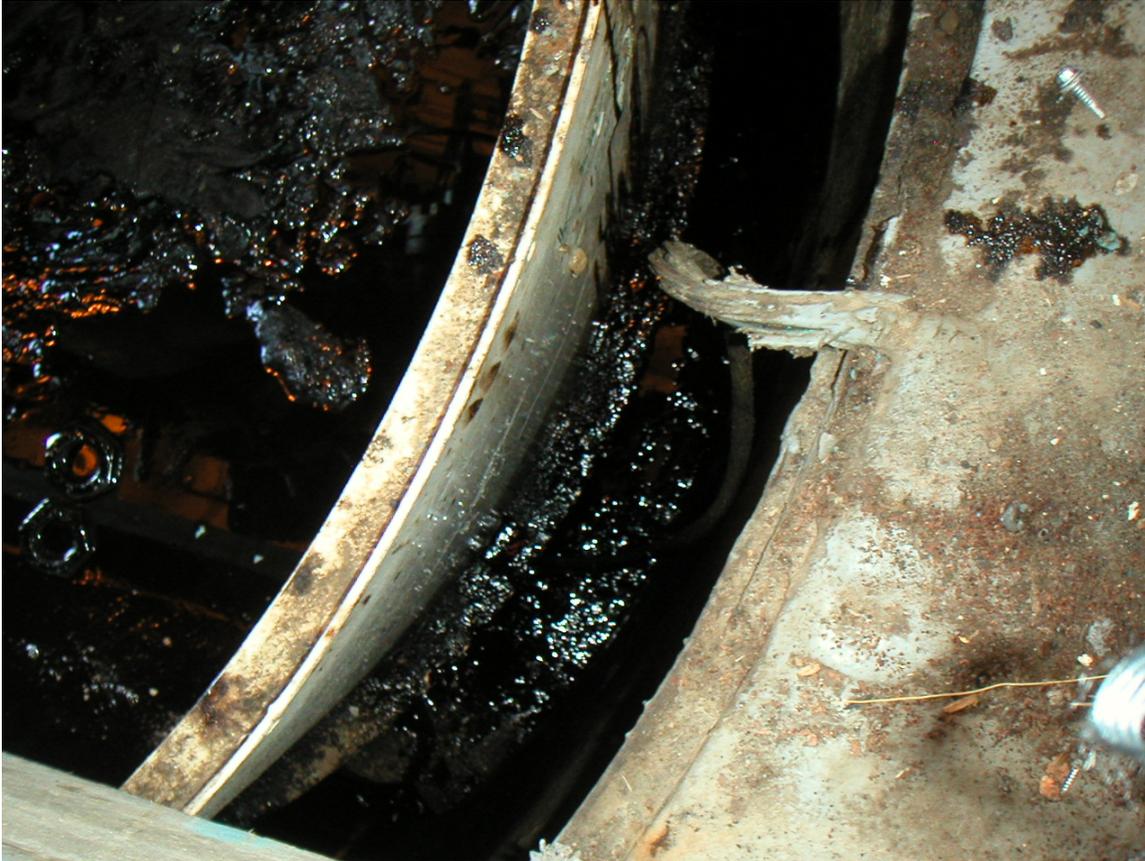
(Hydrocarbon fluid both within and outside secondary containment on DIU 3-11)

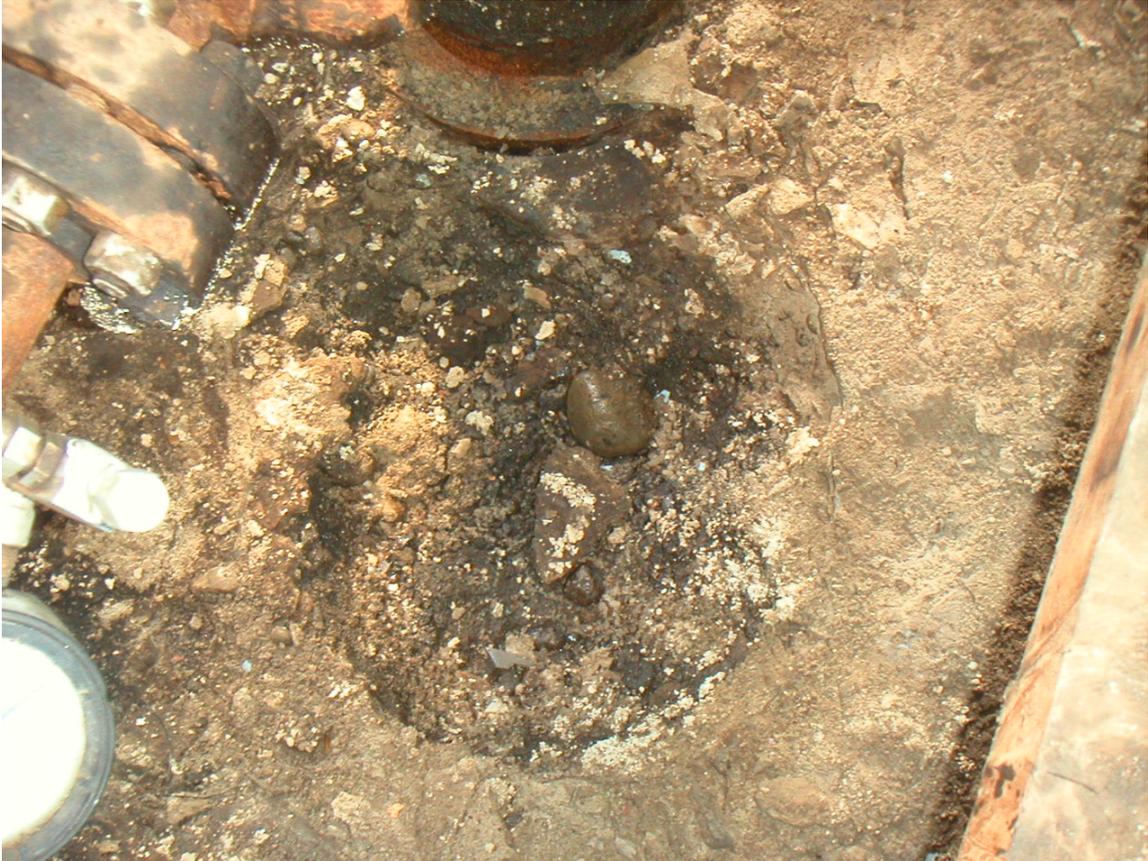
(Hydrocarbon stains on cellar gravel at PBU K-13)

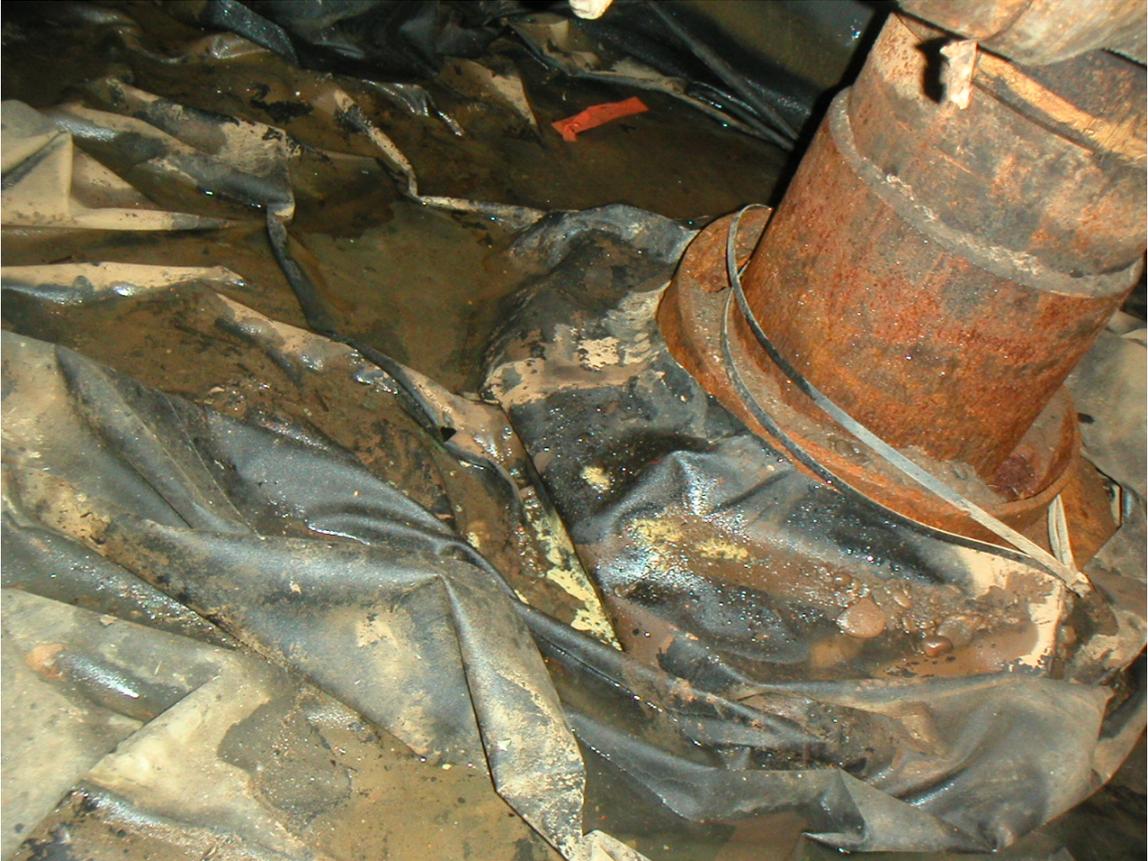
The investigation team noted several instances in which liners, particularly those constructed from herculite, were not secured adequately to the well and/or well cellar to prevent fluid contact with the gravel pad. In addition, some liners were torn and others were not adequately sealed to prevent leakage. It was obvious that hydrocarbons had been and were leaking from the liners into the gravel within the well cellars.

(Secondary containment herculite liner detached from the well casing on PBU S-16)

BP should consider installation of replacements for the existing herculite liners. There are Alaska based manufacturers of products that can be installed in a way that allows for leak free containment, gas venting, and easy access to inspect for fluid accumulation.

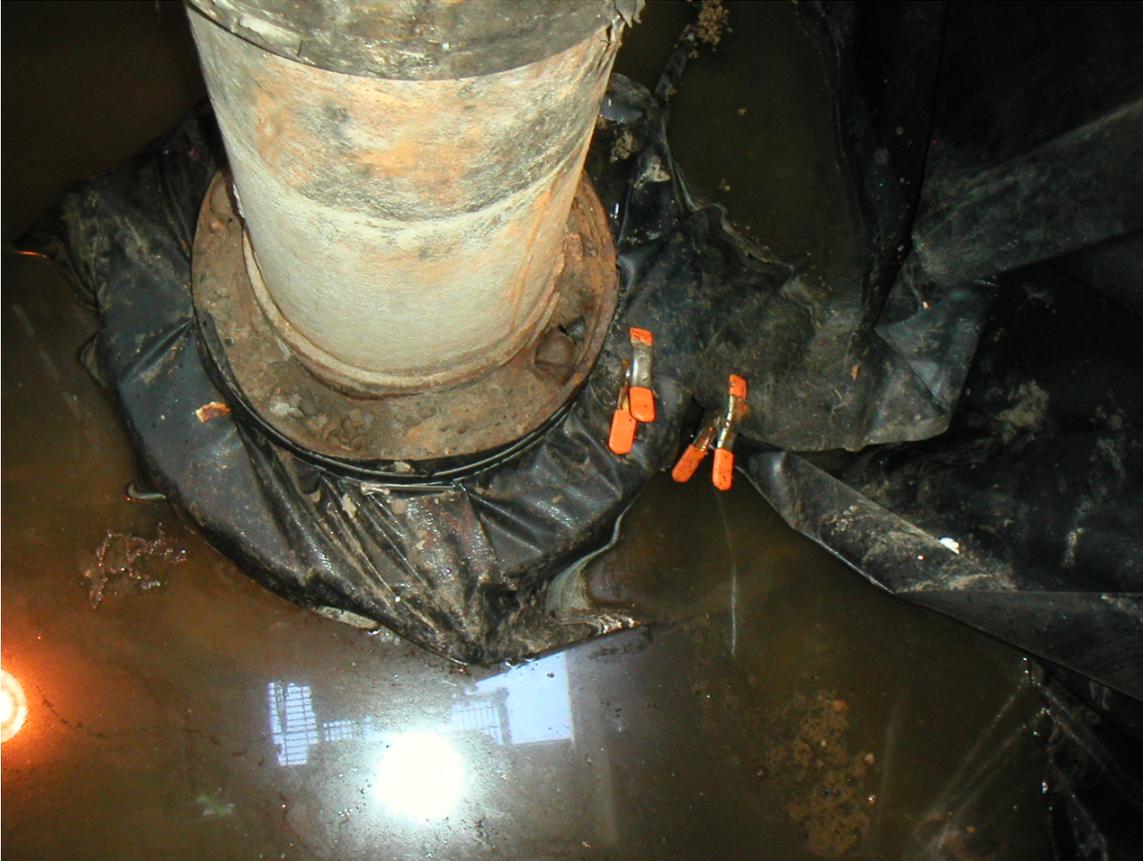
(Secondary containment seam held together by clamps at PBU R-20A)

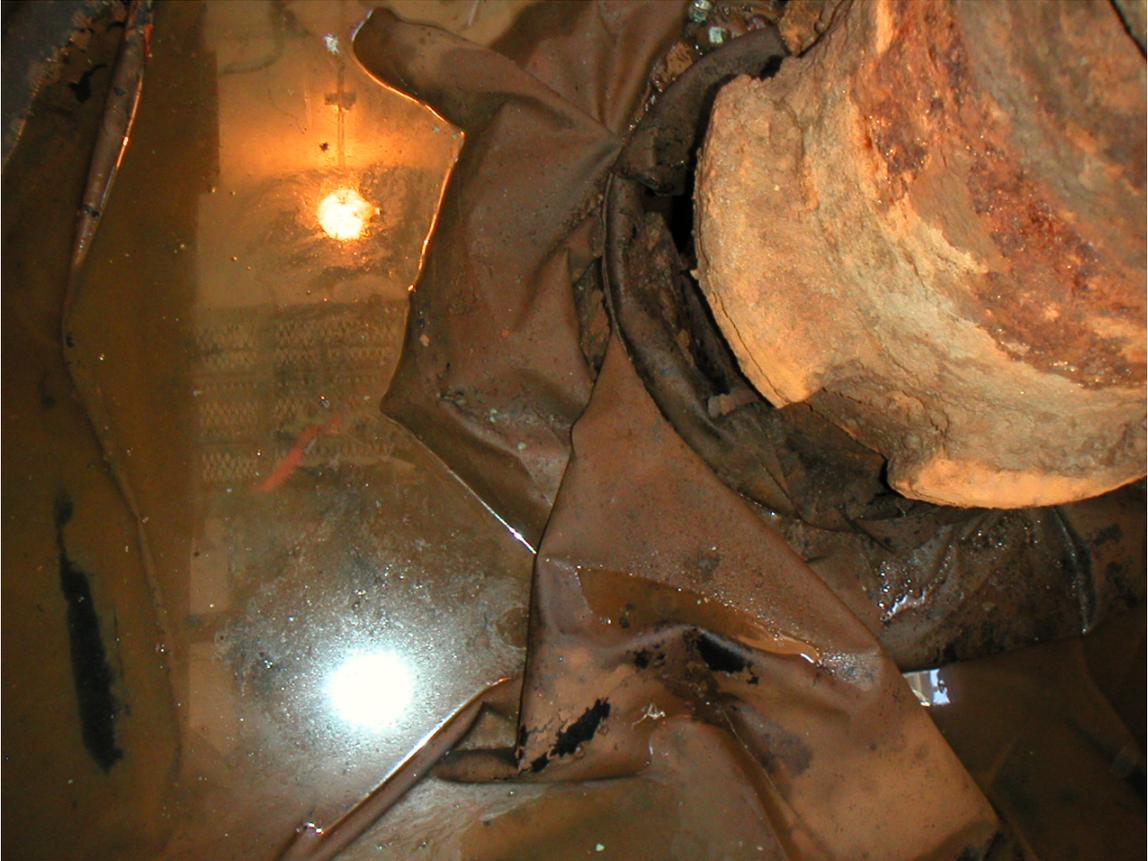
(Torn herculite secondary containment at PBU R-11A)

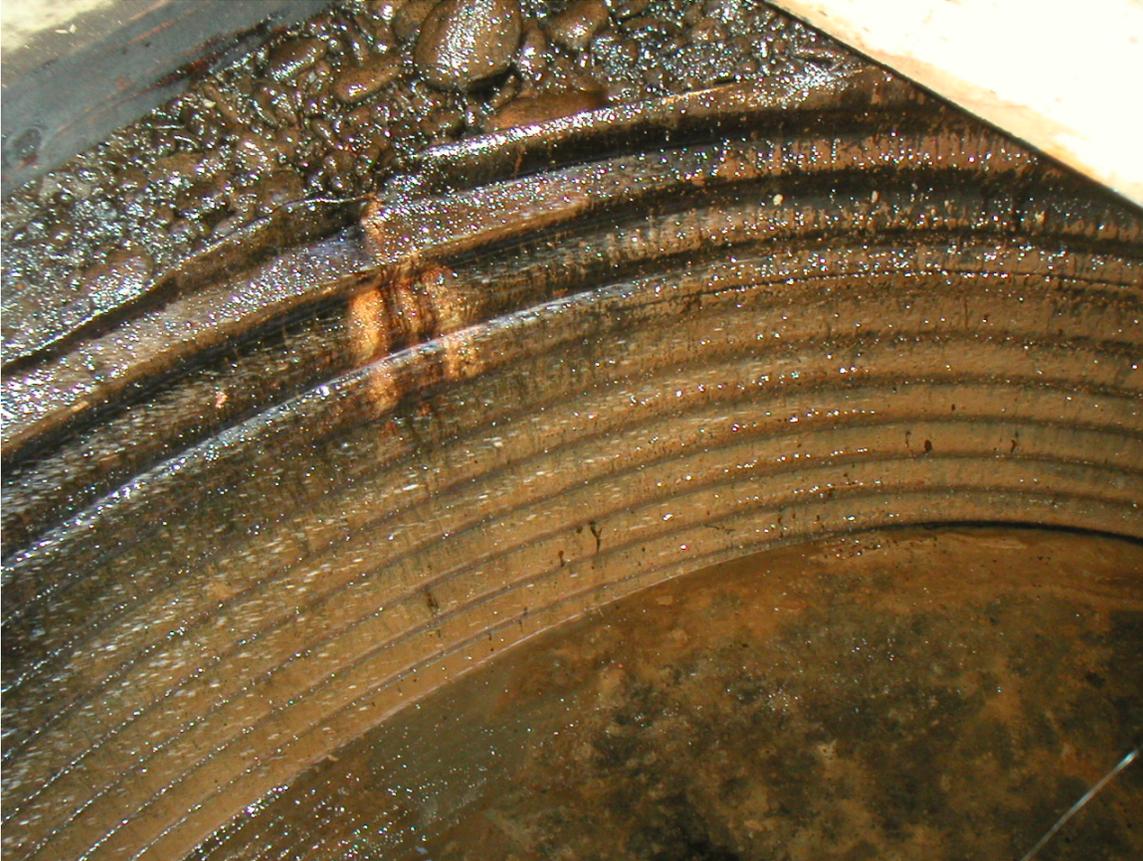
The investigation team noted where cellar flooding had caused hydrocarbons in the cellar to overflow the cellar and contaminate some surrounding gravel within the well house. Site management was notified of the condition by the Pad Operator accompanying the investigation team when the condition was pointed out and the contaminated gravel was removed the next day.

The below photograph is of well PBU R-28 cellar and is an example of a well cellar that has accumulated hydrocarbons, filled with water, and overflowed to contaminate the well house gravel pad.

(Photograph of PBU R-28 showing that hydrocarbons have contaminated well house gravel due to cellar flooding.)
