# HAZARD IMPACT ASSESSMENT

Kipnuk, Alaska

Submitted By: Golder Associates Inc. 2121 Abbott Road, Suite 100 Anchorage, AK 99507 USA

October 31, 2011

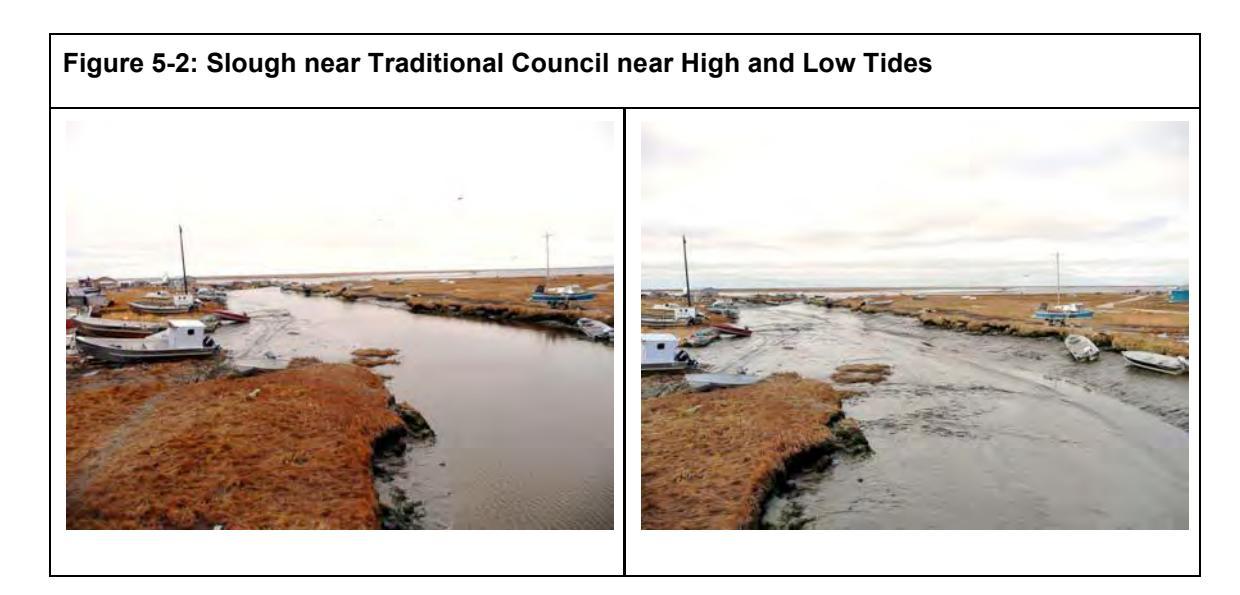
According to the Aerometric topographic contours (local datum), if the river level rises approximately 4 vertical feet over normal high tide (estimated -10 feet), some areas of the community will experience flooding (see yellow line). If the river level rises approximately 6 vertical feet above normal high tide, nearly the entire community could be subject to flooding (see green line).

As residents described the 2007 flood event, they were asked to identify areas that did and did not flood during this event. Based on a visual comparison of anecdotal data and the Aerometric topographic contours, it appears the 2007 flood level may correspond fall between the -6 and -4 foot contours.

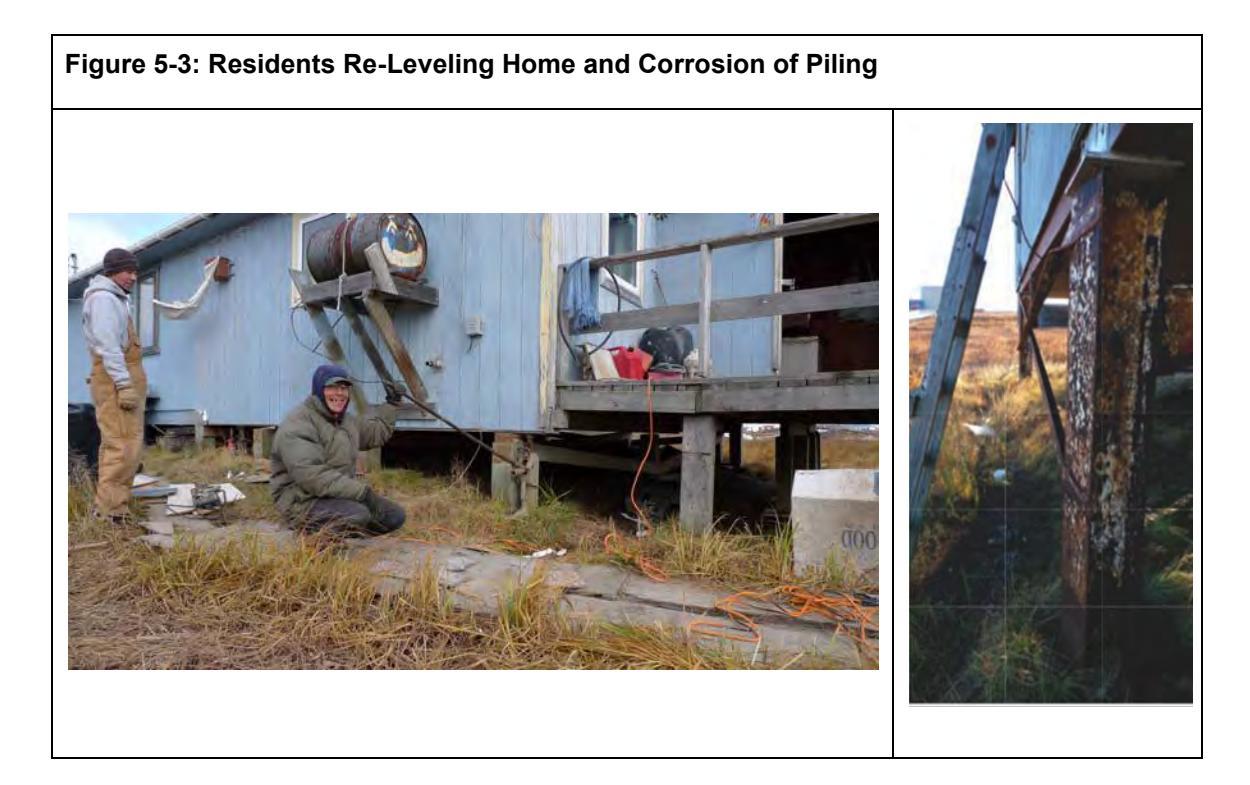
The older houses in Kipnuk are primarily supported on post and pad foundations and are re-leveled periodically with use of timber shims. Various types of blocking indicate that houses have been releveled numerous times. Some housing in Kipnuk was constructed on pile foundations. The houses are raised above ground to provide a blow-through space typical of pile foundations in permafrost soils. The AVCP Housing, on the western side of Kipnuk, was constructed on steel pile foundations. These foundations have performed well, with little to no visually observed movement; however, corrosion of the piles is occurring, most likely from the highly saline conditions. Many of the public buildings are pile supported.

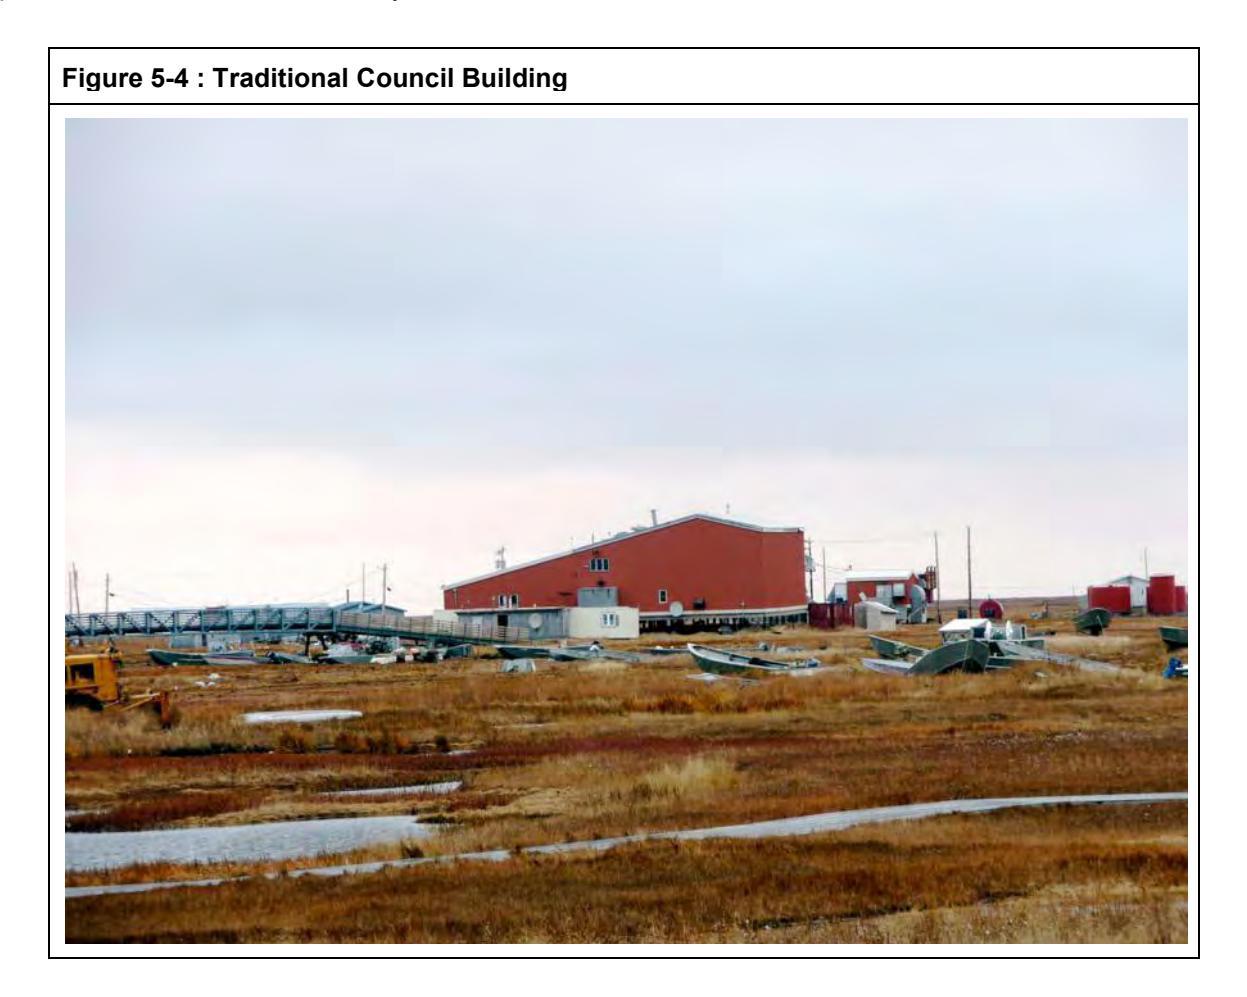
The Traditional Council Office was originally constructed in the late 1970's as a school. Soon after construction, movement of the foundation was reported. An investigation, completed in 1974 by Harding Lawson Associates, revealed soils consisting of organic silt and silt with some unfrozen brine. The building is founded on timber adfreeze piles with a passive refrigeration system installed in the sand-water slurry annulus. Subsequent differential movement of the foundation resulted in an additional investigation by A.W. Murfitt, PE, in 1983. Discontinuous permafrost was found in the area, with frozen ground temperatures between 30°F and 32°F. Some visible ice was evident in the permafrost and measured pore water salinity ranged from 2 to 7 parts per thousand (ppt). Pore water salinity of 8 ppt depresses the

freezing point nearly 1°F. At the time of DMA's 2009 site visit, the condenser portion of the thermal probes was corroded considerably.

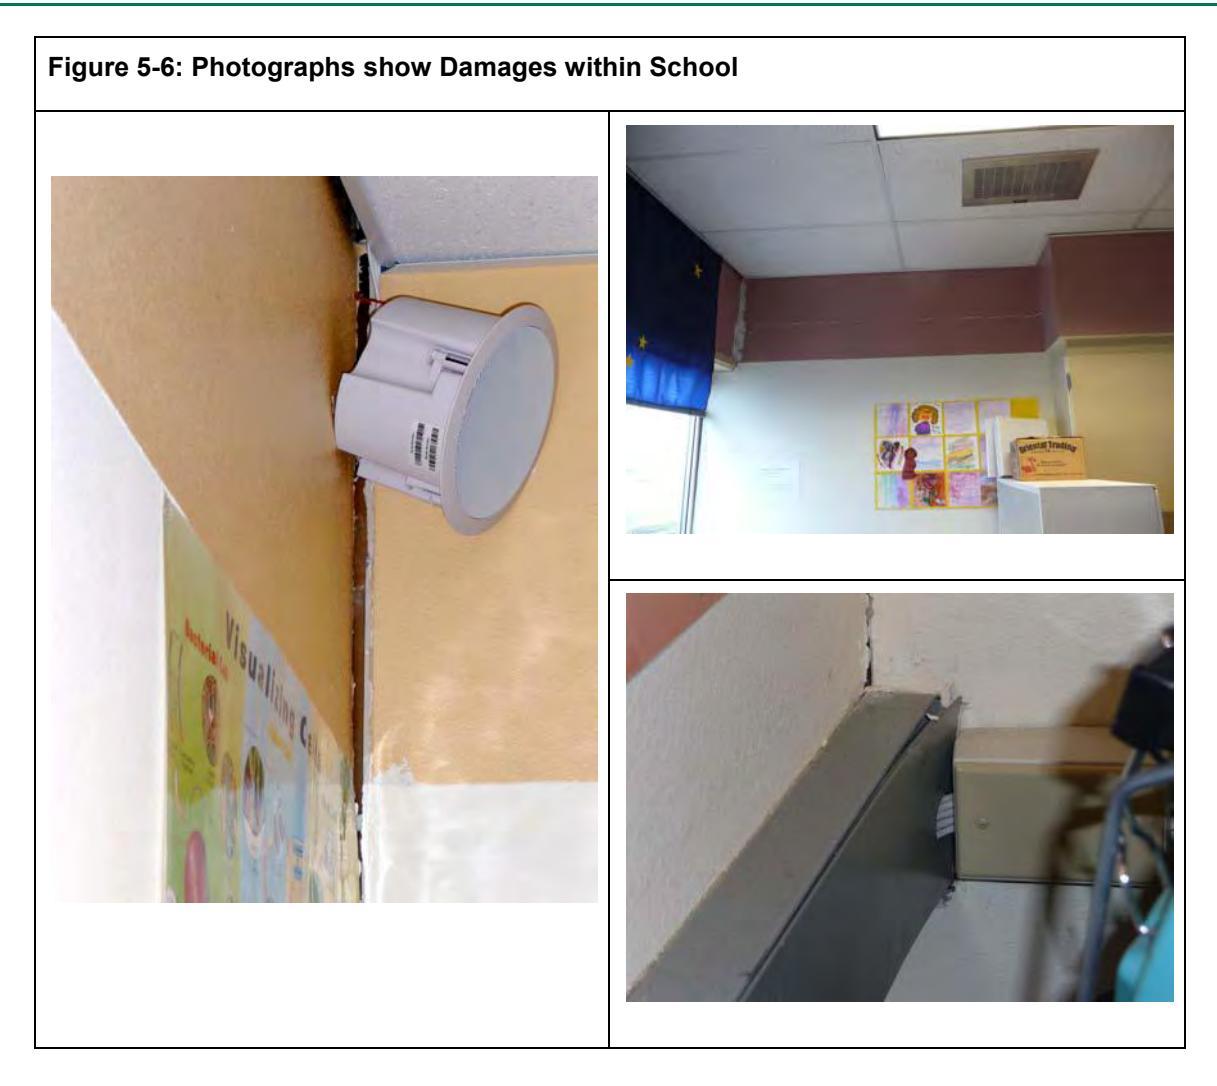
In the mid 1990's, movement of the school was reported. Pile cap surveys and analysis of ground temperatures were completed by Arctic Foundations Inc. Arctic Foundations Inc. determined that the movement was likely pile tip heave caused from over cooling the soils below the thermal pile foundation. Arctic Foundations Inc. determined that previously unfrozen, saline-rich pore water within the soils was most likely frozen due to cooling created by the thermal piles. To address the situation, some of the thermal piles were decommissioned to prevent further cooling and better control the heave. Recent movement of the school has been reported. Damage was visually observed to include cracks in walls and doorways and un-level floors, Figure 5-6.

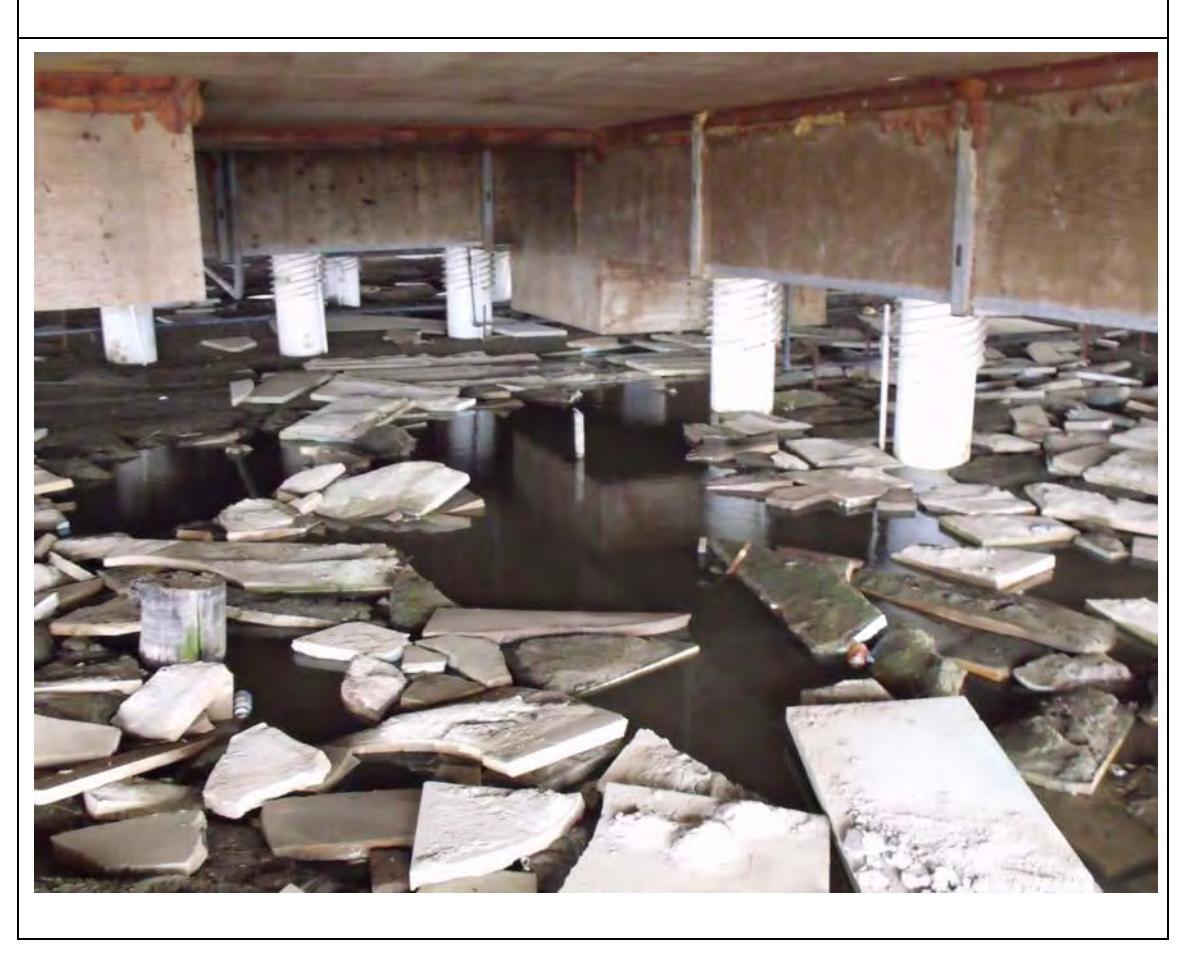
Figure 5-7: K-12 School Foundation showing Insulation Damage and up to 1.5 feet of Standing Water

During the site visit, a pile cap survey was completed in order to compare the current measurements with the survey completed in 1996 by Arctic Foundations Inc. The pile cap survey comparison shows that relative differential pile movement since 1996 has ranged from less than a 1/4-inch to about 4.5 inches. Arctic Foundations 1996 survey showed that pile cap movement, since school construction, ranged from less than a 1/4-inch to about 4.5 inches. It appears the school pile foundation is moving. However, it is unclear from the foundation survey comparison if the heave trend is continuing or if pile movement is related to pile settlement (creep). Ground temperatures measured adjacent to thermal piles during the site visit ranged from 23.1 to 28.7°F indicating the passive refrigeration is working.

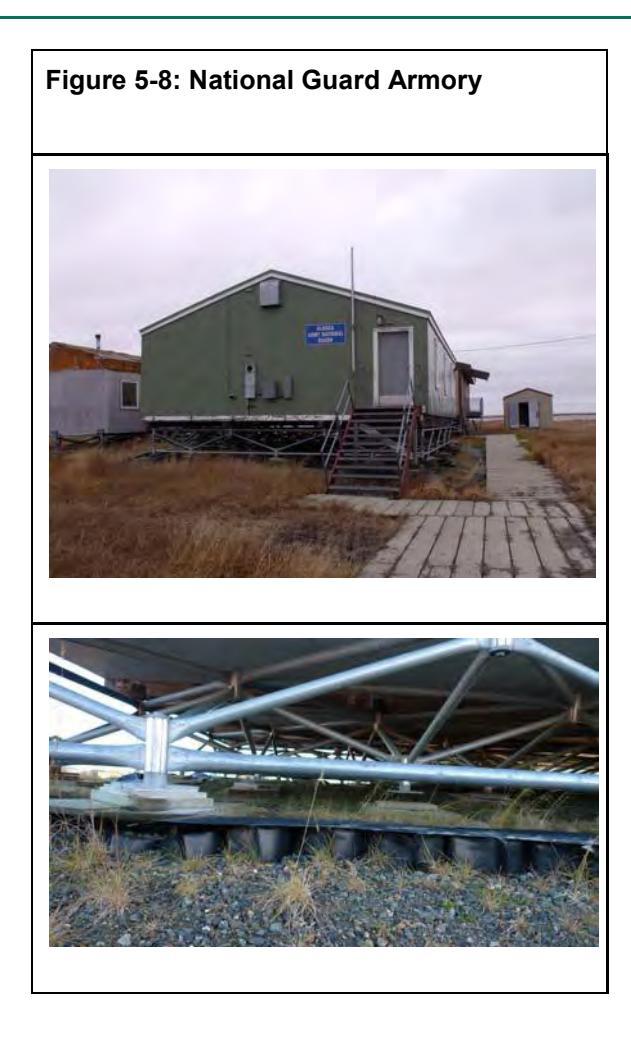
The National Guard Armory is supported on a Triodetic frame. It appears the Triodetic frame is in need of re-leveling so that each Triodetic support point is bearing on the foundation pad. It is not known if the building is experiencing any distress due to Triodetic movement.

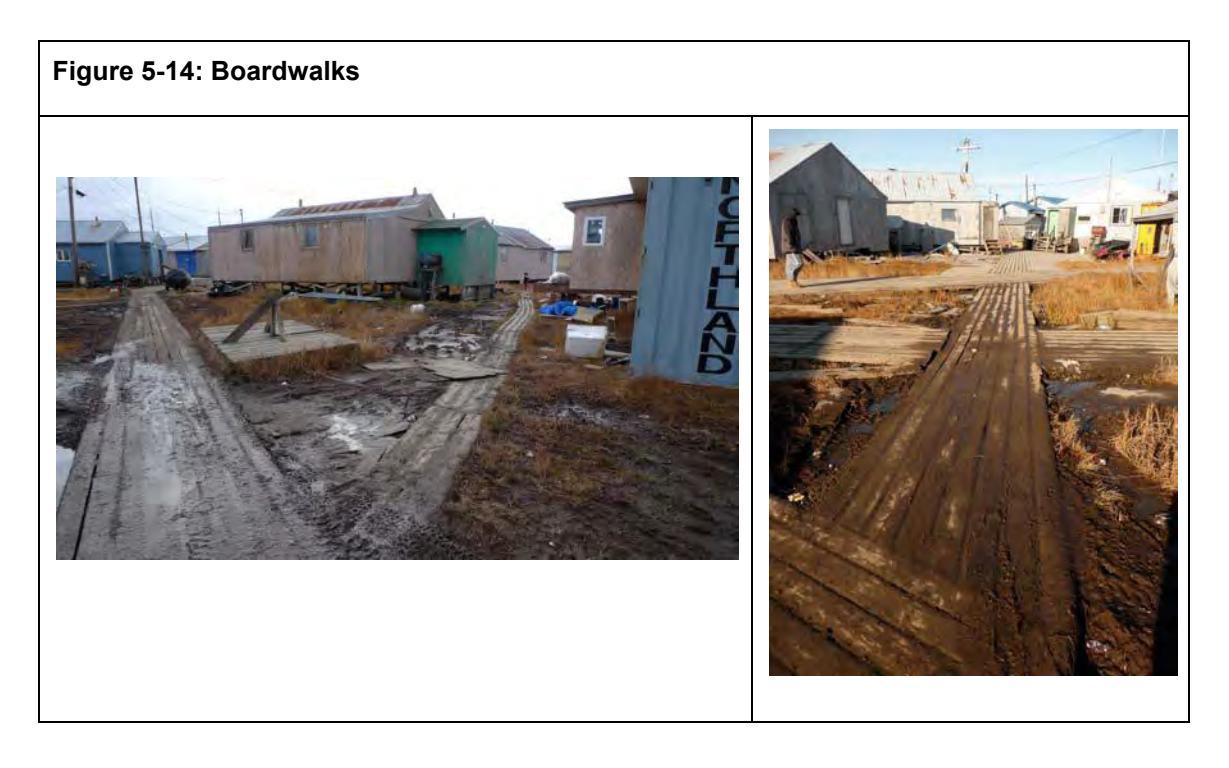
The recently constructed boardwalks are supported by anchored sleepers or helical piers. Residents reported that the new boardwalks were not affected by flooding whereas some of the older boardwalks moved with floodwaters. However, observations conducted during previous DMA Kipnuk site visits showed that at times, some of the newer boardwalks (mid-2000's) were floating during high water events.

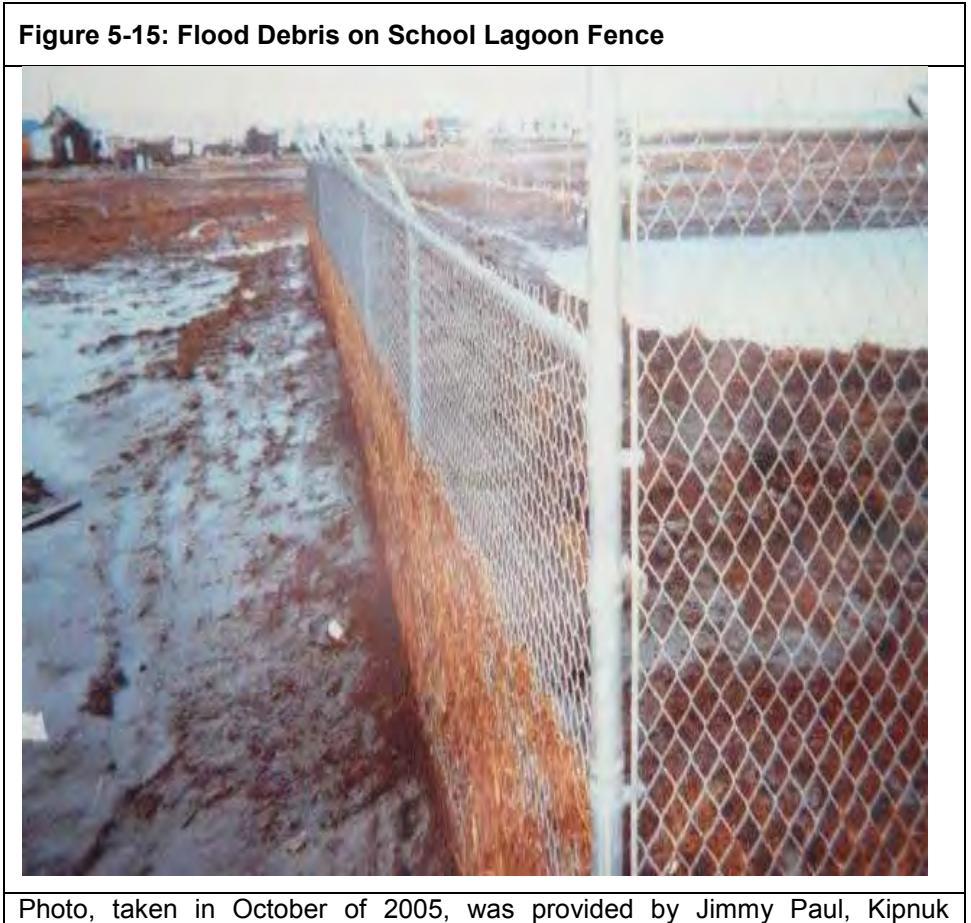
Photo, taken in October of 2005, was provided by Jimmy Paul, Kipnuk Traditional Council.

Residents report that during flooding the contents of the sewage lagoons and landfill are dispersed over the adjacent ground. The community sewage lagoon contents are reported to enter the river system. The school sewage lagoon contents are reported to disperse within the adjacent community areas. This dispersal was noted mostly by teachers residing in housing located near the sewage lagoon and the school. They reported solid contents from the lagoon floating by their residences during flooding events.
