February 2012

# Elim Hazard Impact Assessment

Produced By:  
HDR Alaska, Inc.  
2525 C Street, Suite 305  
Anchorage, Alaska 99503

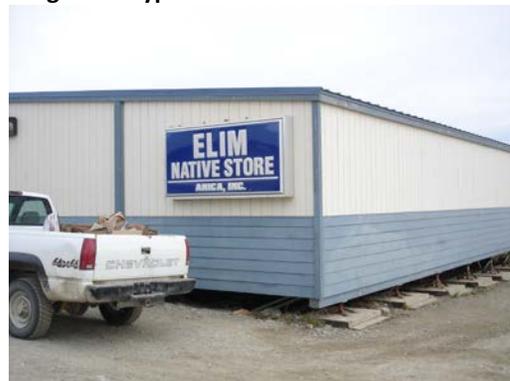
**Figure 2. Typical Post-and-Pad Foundation**

Most of the buildings observed in the community appear to be constructed using post-and-pad techniques. A typical post-and-pad foundation is shown on Figure 2. Many of the homes have wooden skirts around the bottom that prevent air flow under the structure, similar to the school and the Elim Native Store, which is also shown in Figure 2.

Based on our analysis, we anticipate that the houses are founded on relatively shallow soils overlying bedrock. The presence of shallow bedrock in the eastern part of the community is confirmed in

borings drilled by S&W and the Alaska Department of Transportation and Public Facilities (DOT&PF). Although permafrost is likely in the area, no permafrost stabilization techniques (such as insulated or passively refrigerated foundations) were observed in the community. This is likely as a result of being founded on thaw-stable bedrock.

During the first public meeting, several of the residents identified a “permafrost problem” associated with some of the housing. They indicated that this problem is generally an up-and-down movement, rather than a long-term settlement. As such, it appears likely that this movement is related to seasonal freezing and thawing of soils.

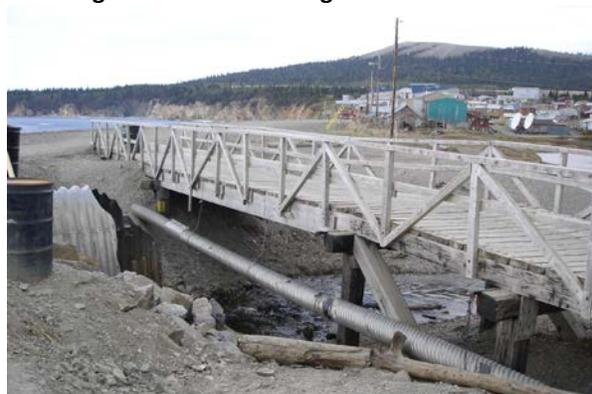
Figure 3. Wooden Bridge over Elim Creek

There is a wooden bridge over Elim Creek approximately 200 feet from the edge of the water (see Figure 3). Suspended under the bridge are water and sewer lines. In addition to the bridge, the community has constructed a gravel road over Elim Creek approximately 30 feet down hill of the bridge. A large, oval, corrugated metal culvert, approximately 6 by 8 feet, has been placed to allow Elim Creek to pass under the embankment.

We understand that during winter months, aufeis<sup>5</sup> may be present in Elim Creek, resulting in water and ice approaching the elevation of the water and sewer lines. This condition would place a lateral pressure against the lines that may exceed design conditions and potentially result in rupture.

Photographs taken of the surge events show the water level near the deck level of the Elim Creek bridge. Logs and water partially submerged the utilities under the bridge. This condition can result in a rupture of the lines and loss of water and wastewater services for the eastern portion of the community.

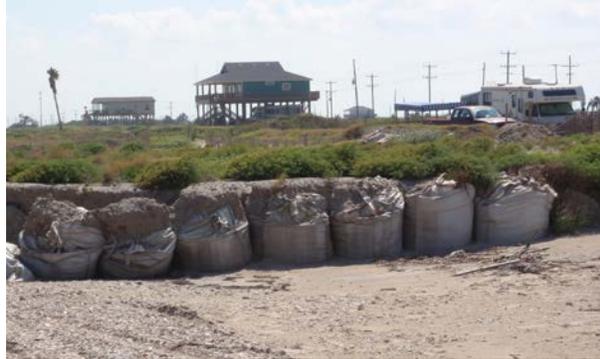
**Figure 11. Example of a Geotextile Container**

and placed prior to a storm for protection of landward structures. After the storm, the structures are removed and stored until needed again. These structures are generally significantly cheaper than permanent structures; however, they may not be as effective if not properly installed. An example of a temporary and demountable wave/surge barrier include a series of jersey barriers (hollow traffic barriers) filled with sand/water, geotextile tube/dam or a geotextile container (Figure 11). For more information on this type of structure, refer to DEFRA (2002).

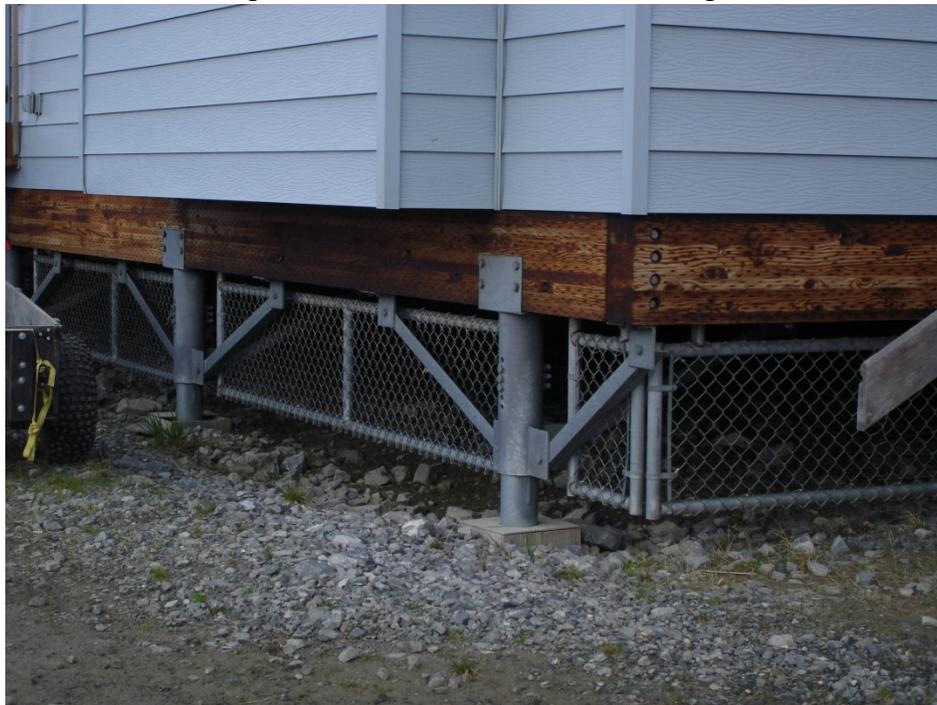
**Figure 13. Foundation of Head Start Building**

Several community residents identified “permafrost problems” with some of the existing housing. Based on their description of the problem, it appears to be related to a seasonal freezing and thawing of soils rather than a melting of the underlying permafrost. The community should consider requiring building foundations that are appropriate for local soil conditions. For example, in places where the bedrock is near the surface (within 3 or 4 feet), building footings should be placed on the bedrock or a gravel pad to reduce future frost heaving problems (see Figure 13). The community should also consider requiring new buildings to grade around the structure so the water flows away from the building. Additional research should be conducted to ensure this activity would be allowed under current wetland and water body regulations and if any mitigation or permits would be required.

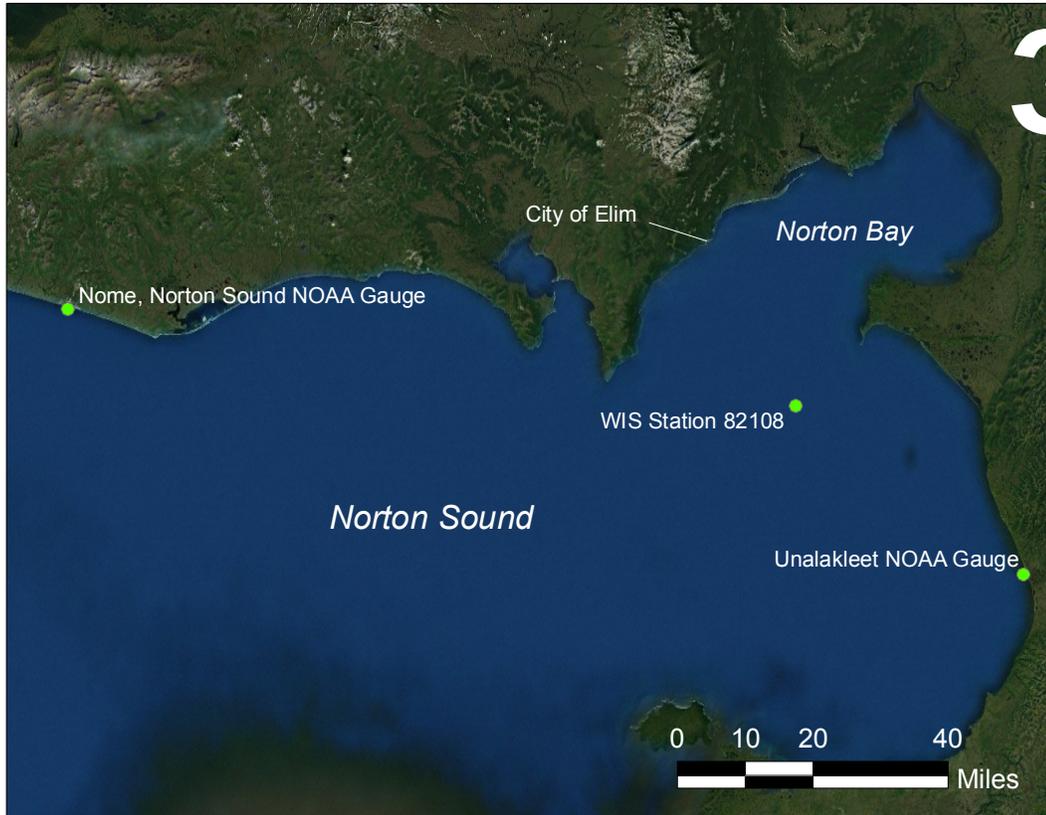
Figure 2.1 Location of gauges for data collection.

Readily available meteorologic and oceanographic (metocean) data as well as geotechnical conditions were assessed to develop a cursory-level characterization of environmental conditions at the site. Figure 2.1 shows locations of several existing data collection stations established by the U.S. Army Corps of Engineers (USACE) and the National Oceanic and Atmospheric Administration (NOAA).

The nearest location having readily-available wind data is Nome, Norton Sound (NOAA 2011), which is approximately 94 miles west of Elim (Figure 2.1). Wind data from 2001 to 2011 were obtained for this location and are shown as a wind rose in Figure 2.3. Wind roses provide a graphical means of describing the intensity and direction of wind. The plot suggests that winds from southern directions are less frequent.

Figure 2.4 shows a wind rose from USACE WIS Station 82108 for 1985 to 2009; this station is approximately 25 miles southeast of Elim (Figure 2.1). The WIS wind rose, in general, shows greater occurrence of winds from the southern directions than reported for the Nome, Norton Sound gauge. However, it can be seen that the predominant winds are from the north to east directions, similar to the Nome, Norton Sound data. Differences in the wind roses may be attributed to the increased amount of land surrounding the WIS station or inaccuracies in the hindcast model.
