GEOTECHNICAL REPORT

MERTARVIK AIRPORT

LOCATION STUDY- PHASE III

RECONNAISSANCE INVESTIGATION

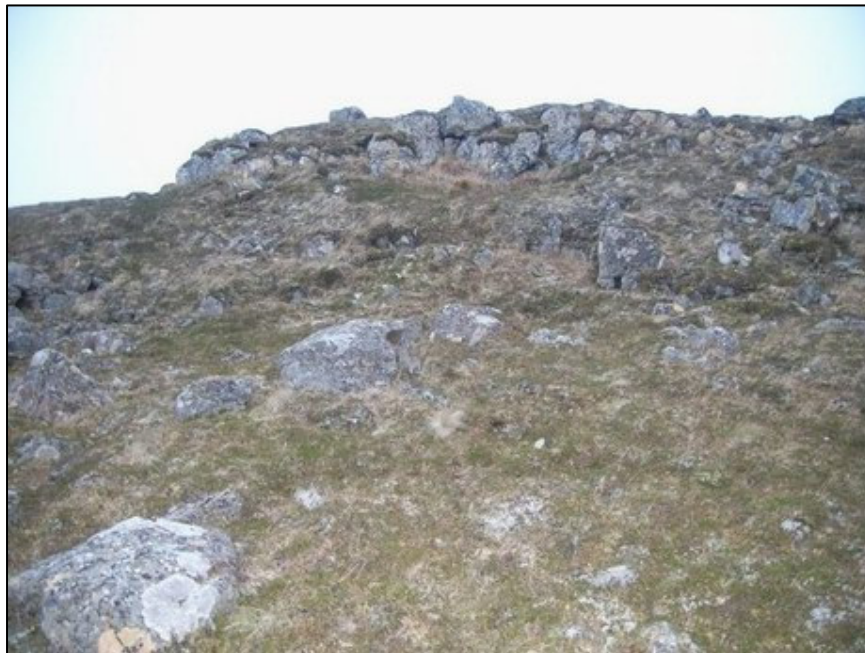
FIGURE 5: HILL 460 – NORTH BEDROCK EXPOSURE (OCTOBER 2008)

The proposed material site, Hill 460, encompasses an outcrop of massive bedrock exposed (Figure 5) along the northern flank of the east-west trending ridge located about two miles west of the proposed new townsite (Figure 3). The terrain across the top of Hill 460 is well drained; sloping gently to the south and east (<5-10%), but more steeply to the north and west (\approx 15-20%). The ground surface is covered with grassy tussock tundra, comprised predominantly of short grasses, mosses and lichen (COE, 2005).

The bedrock exposed along the northern flank of Hill 460 (Figure 5) ranged from approximately 30 to 100 feet high (highest exposure at the western end of the ridge); however, minimal rock was exposure along the top and southern flank of the hill. Based on visual-inspection, the bedrock, as well as the tabular boulders (up to five feet long) and rubble covering the northern slope of the hill, were described as hard, massive, dark gray to black vesicular basalt, with about 10 percent voids (Figure 6).

This exposure was interpreted to be a hard cap rock, more resisted to the geologic processes that have eroded and shaped the surrounding land. It should be noted that basalt is often formed in flows (layers). Each of these flows may have different composition, structure and weathering characteristics. Thus, the rock may transition from hard and unweathered to softer and more highly weathered with depth.
