Atmautluak Hydrological Study and Community Drainage Plan

Issued as Final

June 27, 2016

AECOM

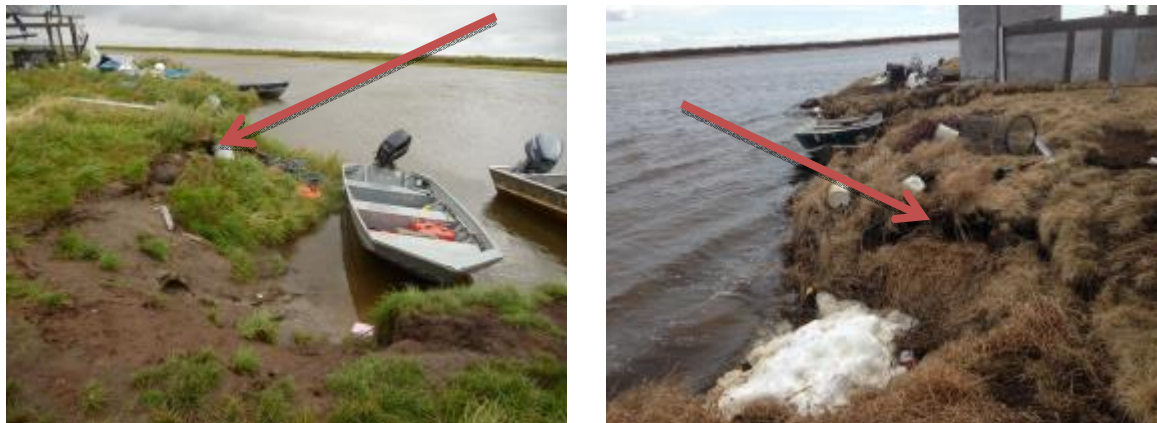
Figure 3: Pitmiktakik River Bank Erosion, Bank Sections Sloughing Into River

A comparison of the 2007 aerial photo with a 1971 photo shows that, on average, the bank has eroded about 47 feet over 36 years, or about 1.3 feet per year. The WH Pacific study showed a similar erosion rate, on average, of 32 feet over a 24 year period (1.3 feet per year).

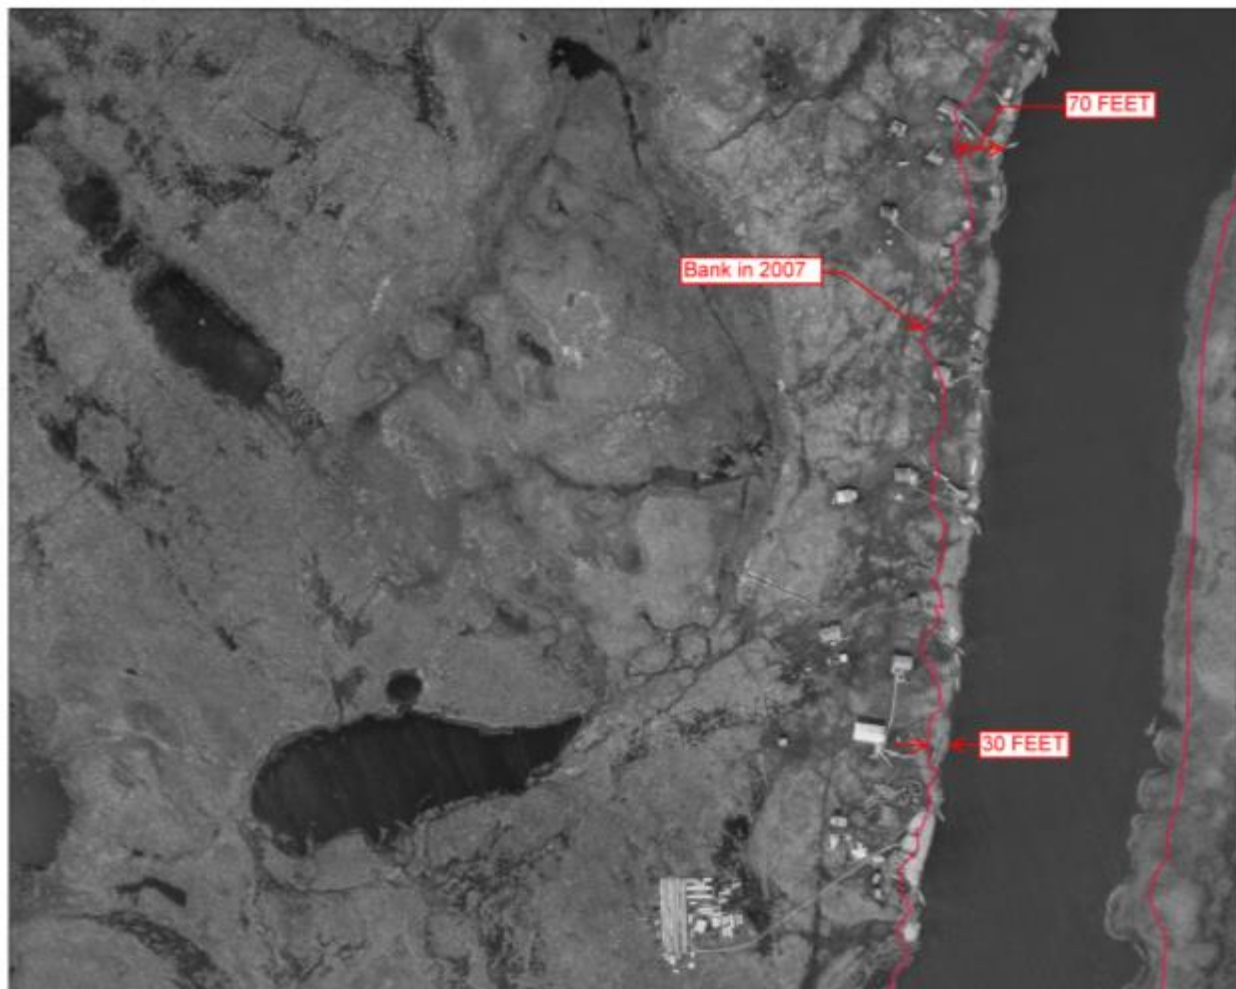
Figure 4: Bank retreat from erosion on Pitmiktakik River, from 1971 (photo) to 2007 (red line).

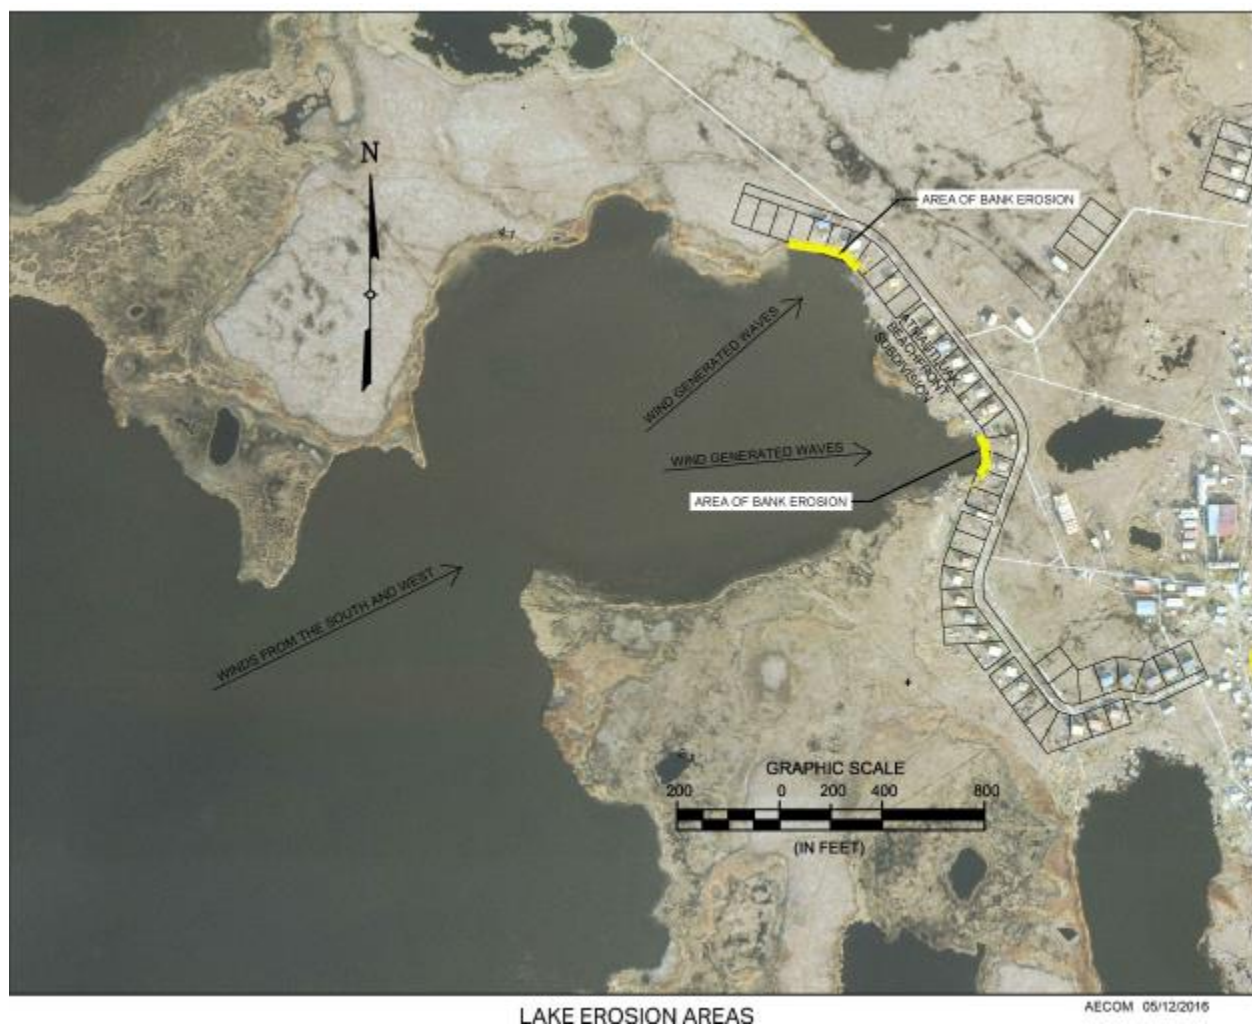
Figure 5: Lake Erosion Areas

Erosion has been a problem at two locations on the lake to the west of the community at the Atmautluak Beachfront Subdivision (see Figure 5). Erosion appears to be primarily the result of wave action. Local residents report that wind driven waves are more pronounced at these locations due to their location at the end of a 7000 foot long fetch of the lake (fetch length measured from google earth). The erosion rate is approximately 1 foot per year, based on a comparison between a 1971 aerial photo and a 2007 aerial photo.

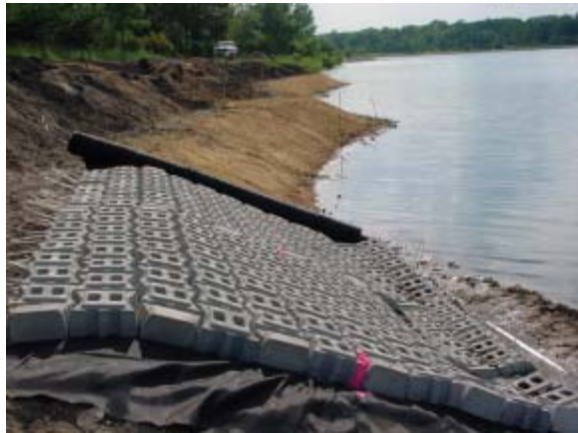
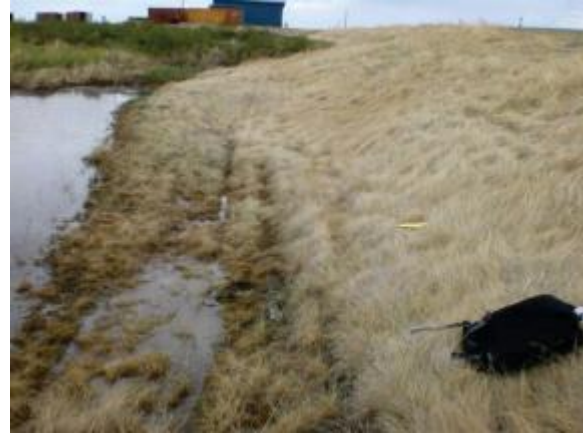
Figure 9: Examples of ACB Installations. The right photo shows the revegetated ACB installation at Nunapitchuk.

ACB matting installed to stabilize an adjacent riverbank at the nearby Nunapitchuk airport has held up well since it was installed in 2007. The ACB matting was installed along the Nunavakanukaksiak River, which has similar icing conditions to the Pitmiktakik River. AECOM made a site visit in April 2016 and found there was no noticeable settlement of the embankment slopes where ACB had been installed, or evidence of ice damage. Additional details and photographs of the ACB inspection are found in a trip report in Appendix C.

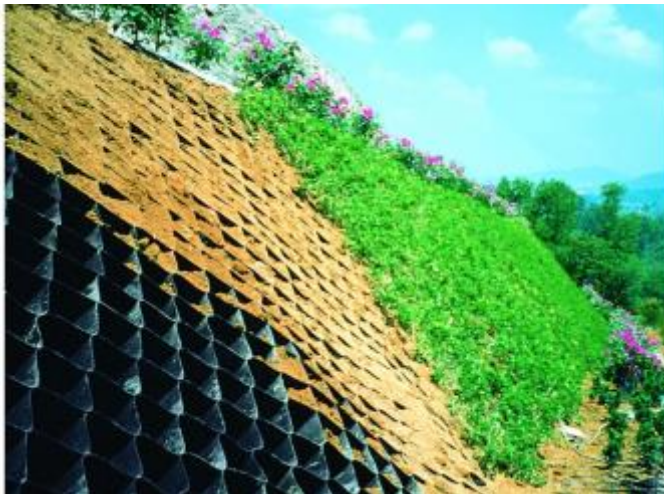
Figure 12: Cellular Confinement System (Geo-Cell) Re-Vegetated

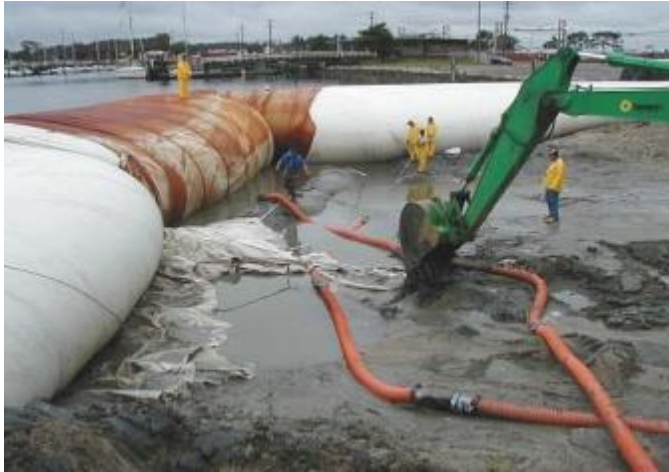
Figure 13: Temporary Cofferd Dam

Construction of either the ACB or CCS bank protection methods would require diversion of the river away from the bank toe so that a toe trench can be excavated. A temporary cofferdam could be used to divert the river during construction. There are several rapidly deployed and easily dismantled bladder-type cofferdam systems on the market that could be used for this purpose, which would allow the excavation and installation of the ACB matting or CCS revetment to be completed in segments. See Figures 13 and 14.

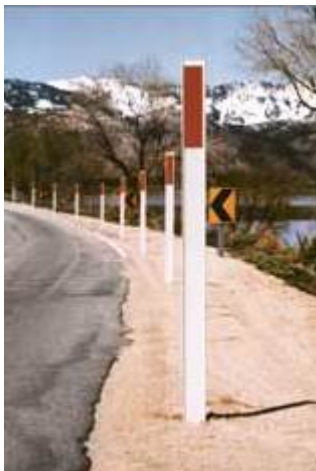
Figure 21: Carsonite Flexible Delineators

The Atmautluak Traditional Council commented during the April 25th 2016 Community Meeting that winter travel routes would traverse the proposed swale alignment. Two winter crossings for vehicle traffic were added to the swale design. Shallower swale slopes (8 Horizontal:1Vertical) were incorporated at two locations: one just north of Pig Lake and the second about 500 feet north of Pig Lake near where a public right-of-way corridor is located between the river and the gravel road (see Figure 17). The crossings should be marked with reflective delineators, four for each crossing. Carsonite flexible delineators, with reflectors, are recommended (Figure 21). The delineators can be driven into the tundra during summer and remain throughout the year.

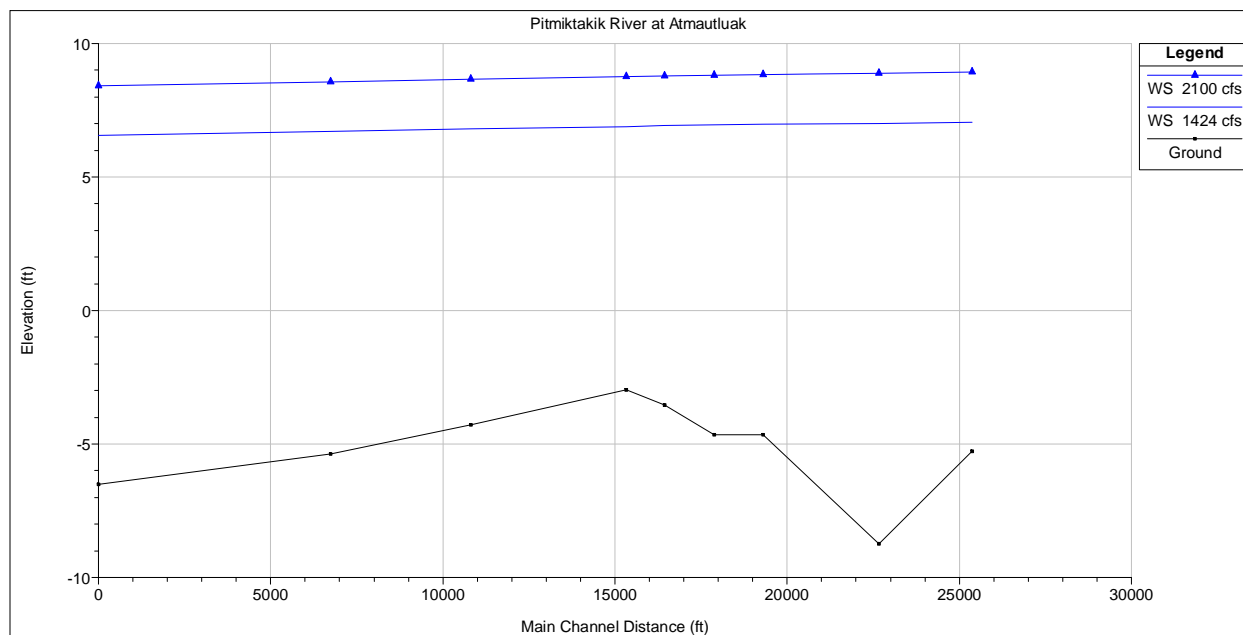
Figure 4. Water surface profiles from HEC-RAS analysis.

The surveyed cross-sections, with water surface elevations from the HEC-RAS results for 1420 cfs, are found in Appendix 1. Appendix 2 includes tabular results from the HEC-RAS analysis at 1420 cfs and 2100 cfs.

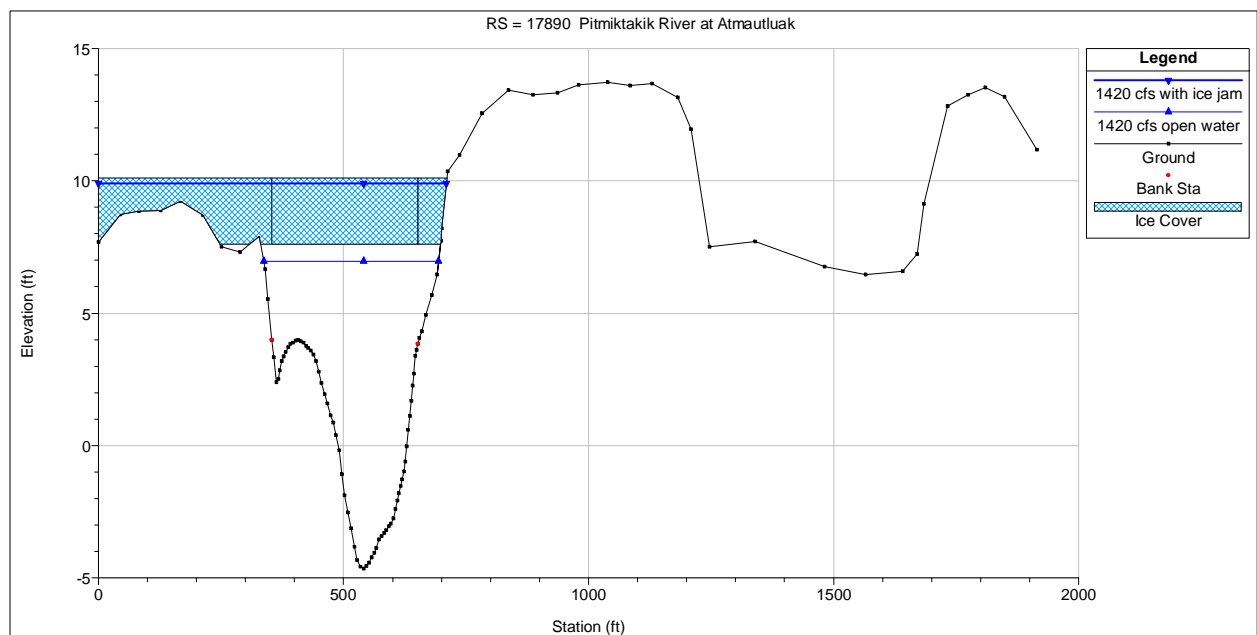
Figure 6. Water surface elevation comparisons at RS 17890 for Open Water and Ice Jam models. Cross-section is looking downstream (south).

Results for the ice jam model are found in Figures 5 and 7 (channel profile) and Figures 6 and 8 (Cross-section 17890 at Atmaultluak). Note that the ice jam results in an increase to the water surface elevation of 2.5 to 3 feet, depending on cross-section location. The model indicates that an ice jam can create overbank flow even at low discharge levels that would normally stay confined within the channel. See Table 4 for comparisons of water surface elevation and average velocity at each cross-section.

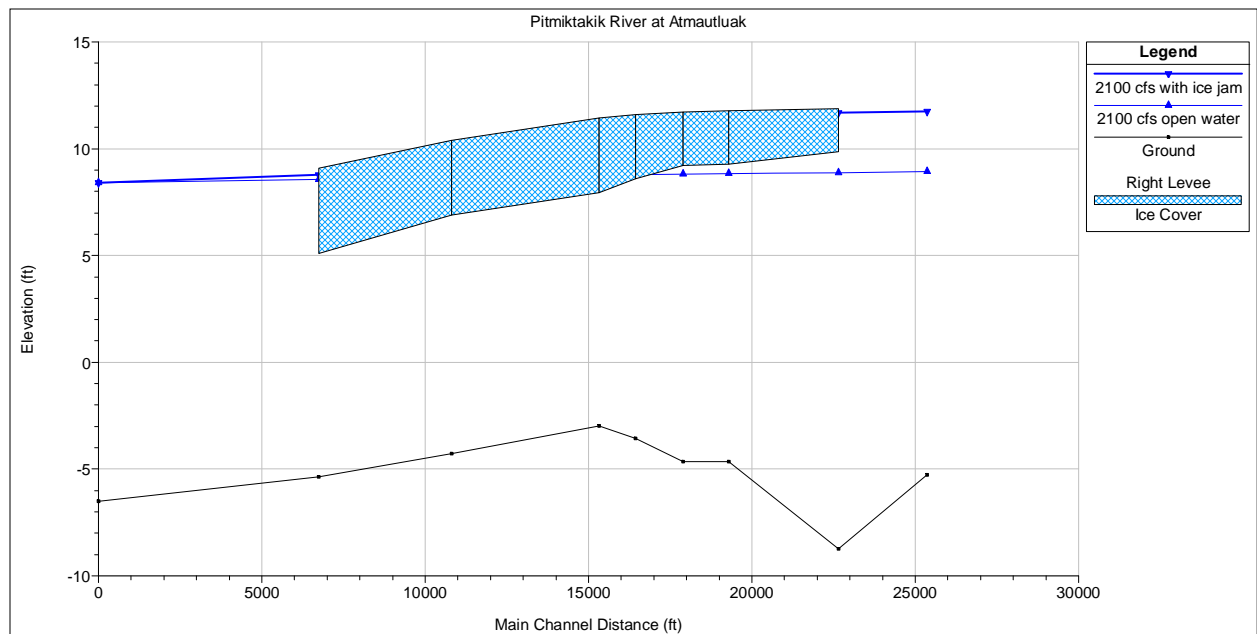
Figure 7. Water surface profile comparisons for Open Water and Ice Jam models at 2100 cfs. Flow is from right to left.

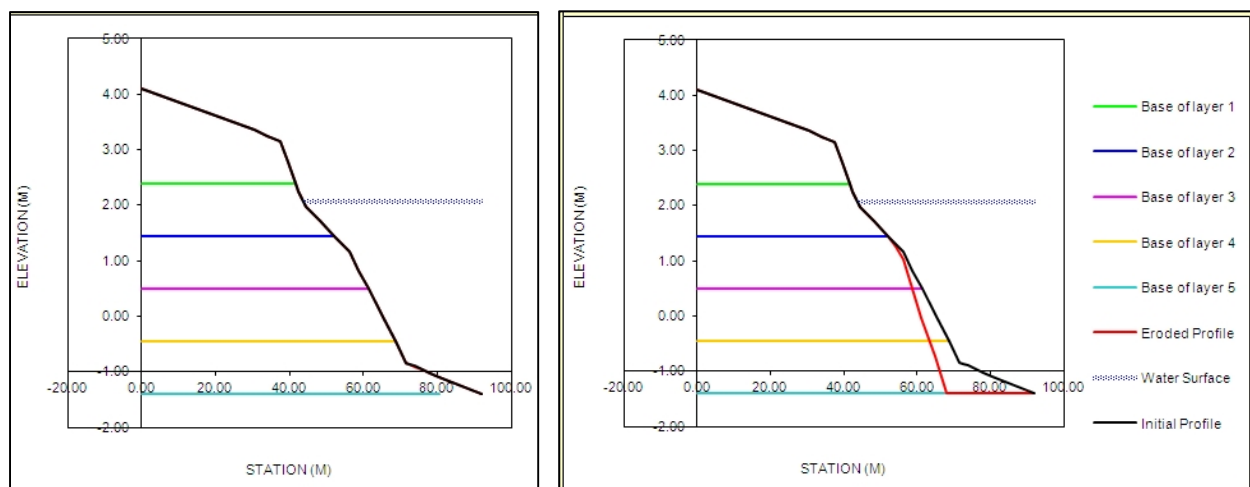
Figure 9. Estimated rates of bank erosion for 4 hours (left) and 1460 hours (right).

Estimated rates of erosion for the bank toe are found in Figure 9 and Table 5.

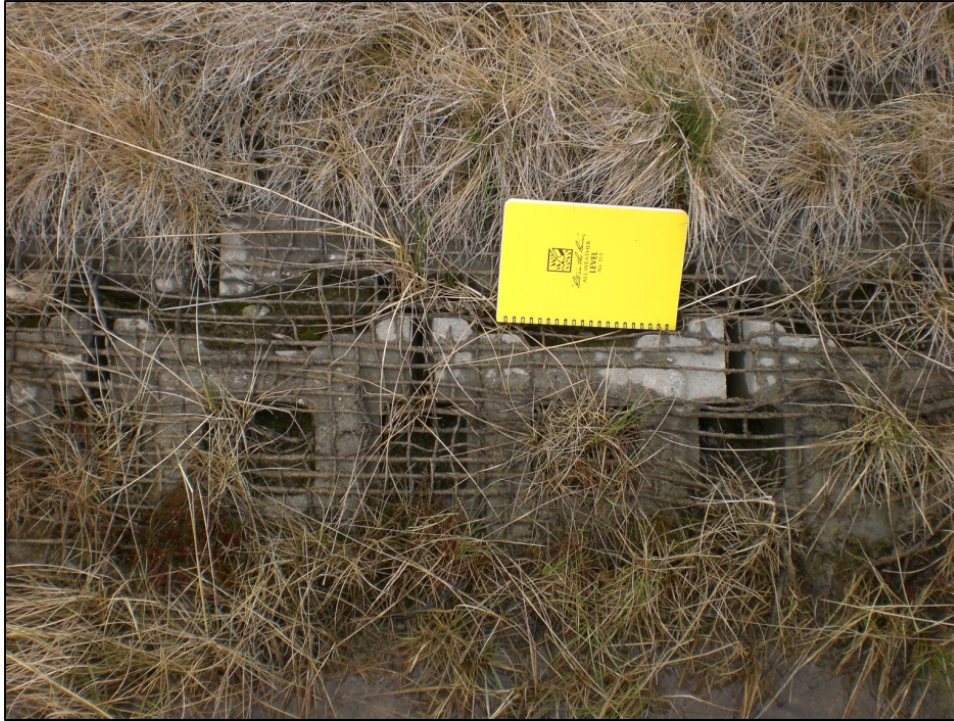
Figure 11. ACB at Nunapitchuk Airport embankment along Nunavakanukakslak River.

The erosion control utilized articulated concrete block (ACB) to protect against embankment scour. The articulated blocks were cabled together in large blankets and overlain on a geotextile filter fabric. The slopes were treated with seeds and rolled matting to provide additional protection. See Figures 11 and 12.

This project was inspected in 2011 in order to assess how well it has performed since installation. Some block slumping at the submerged toe of the blanket is apparent in a few areas, where the ACBs were not keyed in properly. The elevation of the blanket does not appear to be

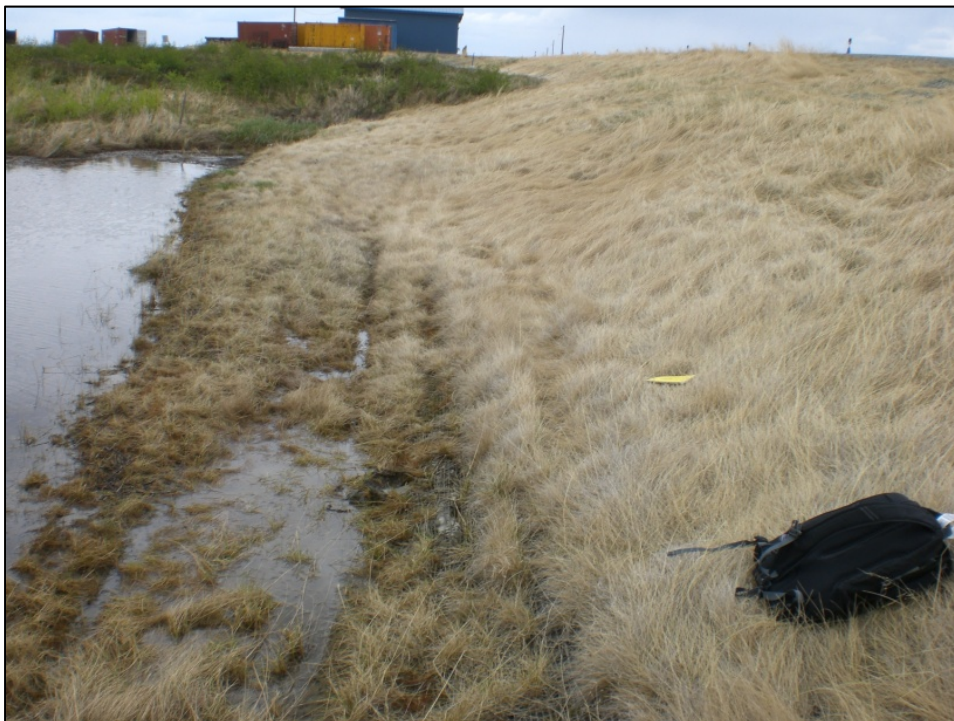
Figure 12. ACB installation at Nunapitchuk Airport embankment.

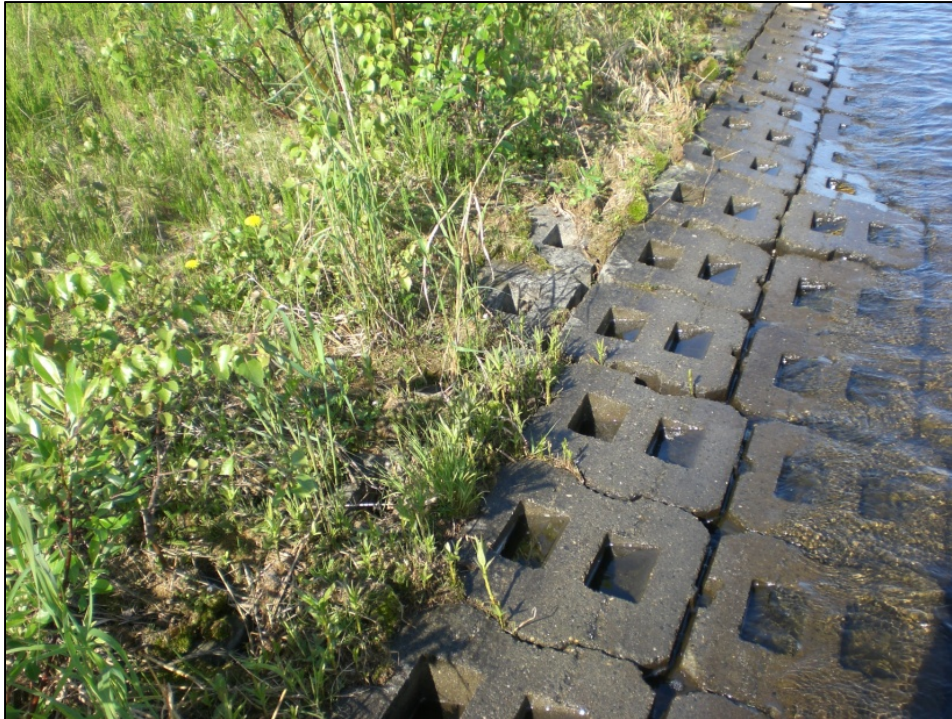
Figure 13. ACB installation at Lake Hood/Spenard Lake channel, Anchorage, AK.

Another bank erosion project that utilizes ACB was constructed in 2000 along the channel between Lake Hood and Spenard Lake. It protects the bank from waves generated during float-plane high-speed taxis. The ACB appeared to be slightly heavier and larger than the ACBs used at Nunapitchuk. Except for some very slight settlement, the ACB installation appeared to be in excellent condition, and the section above the OHW line had revegetated well, which enhanced the stability and erosion protection of the system. See Figure 13.
