Re: Akiak EWP Initial Site Investigation Report
Akiak, Alaska

Location: The Village of Akiak is located approximately 23 air miles East of Bethel on the Kuskokwim River.

Purpose: The community of Akiak requested NRCS assistance through the Emergency Watershed Protection (EWP) Program, due to significant erosion caused by spring snowmelt runoff, which is threatening homes.

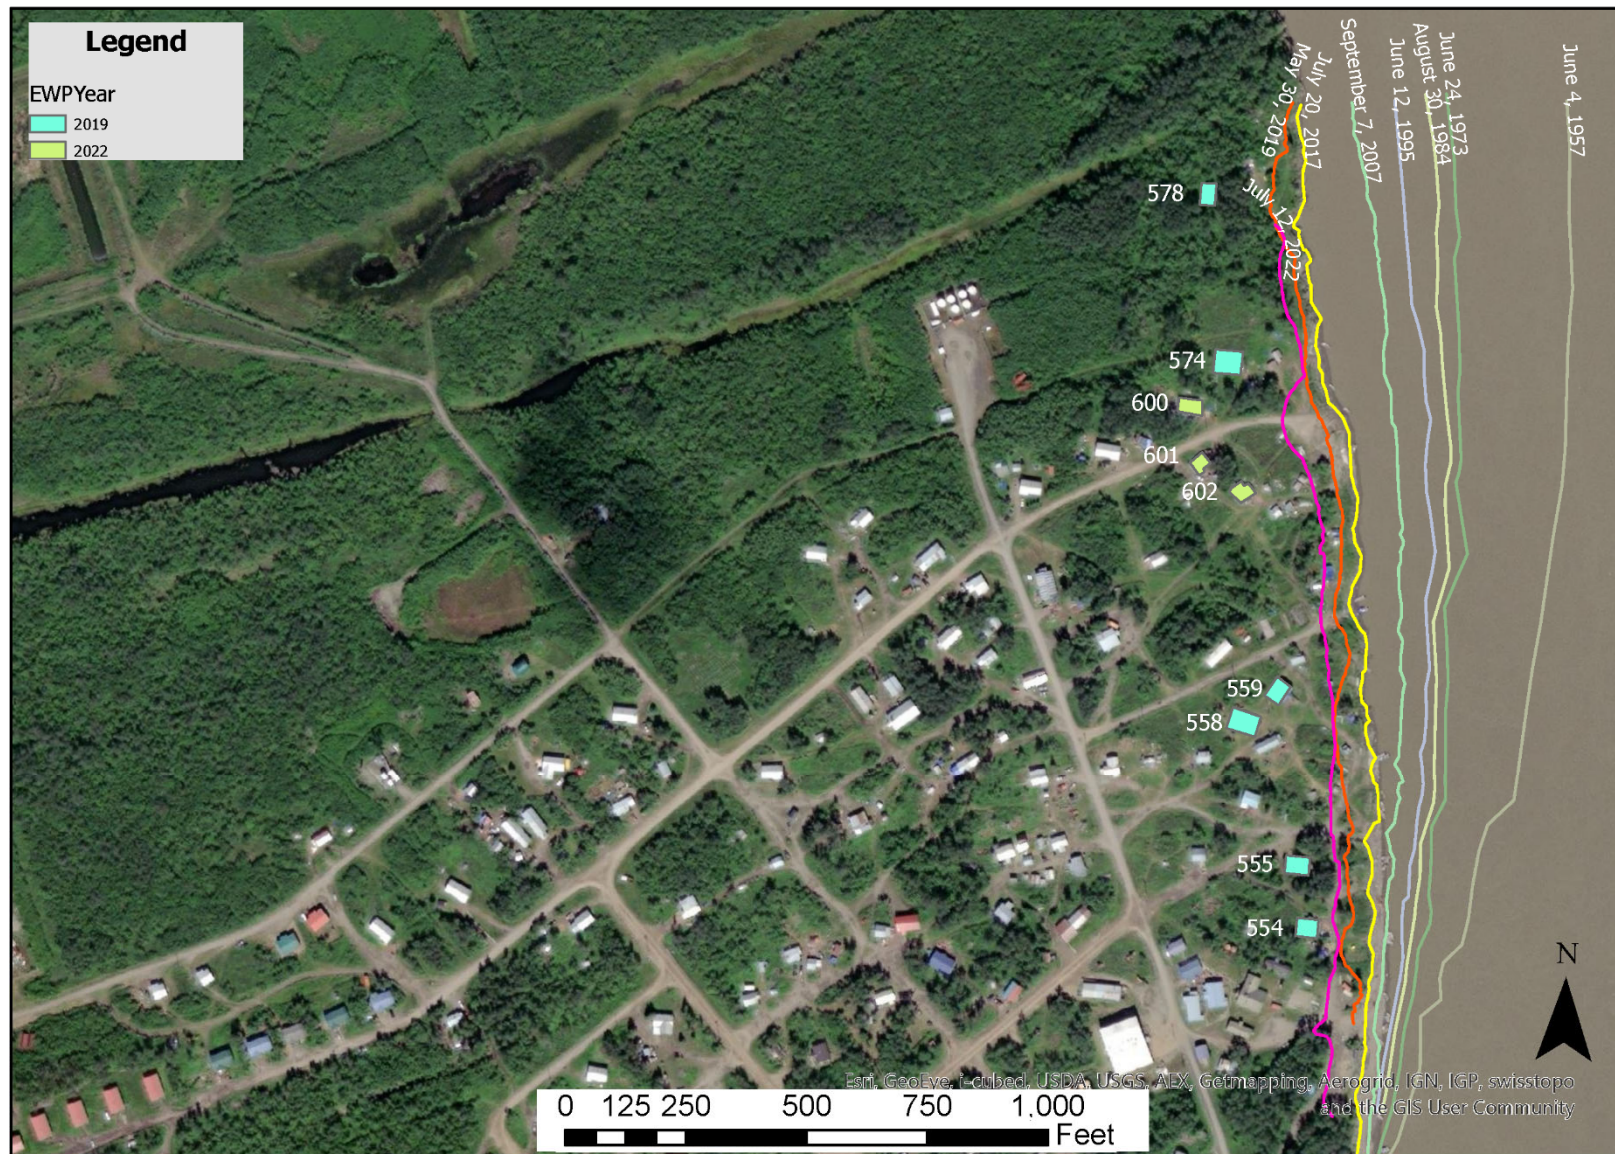
We used a handheld Bad Elf GNSS Surveyor GPS to record the current top of bank location. We then marked the three homes that the community measured the distance from the top of the bank to each structure. Figure 1 shows the results of this effort. This figure also illustrates how the bank erosion at Akiak has progressed from 1957 to 2022. Table 1 summarizes the data with the measured distance to the top of the bank.

Figure 1. This 2017 image shows the approximate location of the top of the bank in 2017, as well as the top of bank location for 1957, 1973, 1984, 1995, and 2007, 2019, and 2022. Also identified are the homes and other features identified during the July 11th, 2022 site visit.

Recommendations/Follow-Up: There are two occupied homes and one abandoned home that are immediately threatened (See Figures 2-5). The data presented in Figure 1 and Table 1 show that these homes are all between 116 and 167 feet of the top of the bank. Given the history of rapid erosion occurring over a very short period of time at this location, it is reasonable to consider these homes to be imminently threatened and to relocate them while it is still safe to operate heavy equipment in their vicinity.

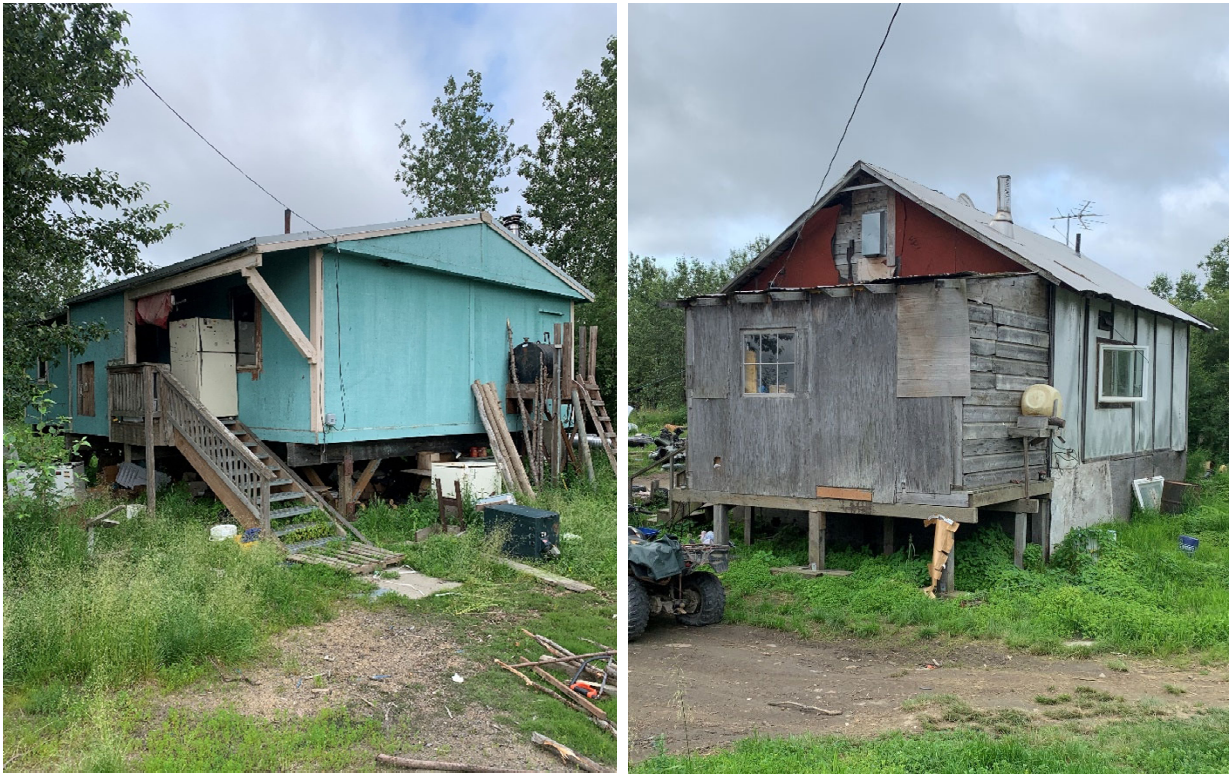
Figure 2: Structure #600 (left) and Structure #601 (right) identified for relocation.

The scope of this project is clear: Relocate two homes and demolish a third home. Ryan and I will be continuing to work with the community to develop a cost estimate for a potential EWP project. It seems likely that Akiak may be able to complete the project before this winter if NRCS can finalize an agreement fast enough.

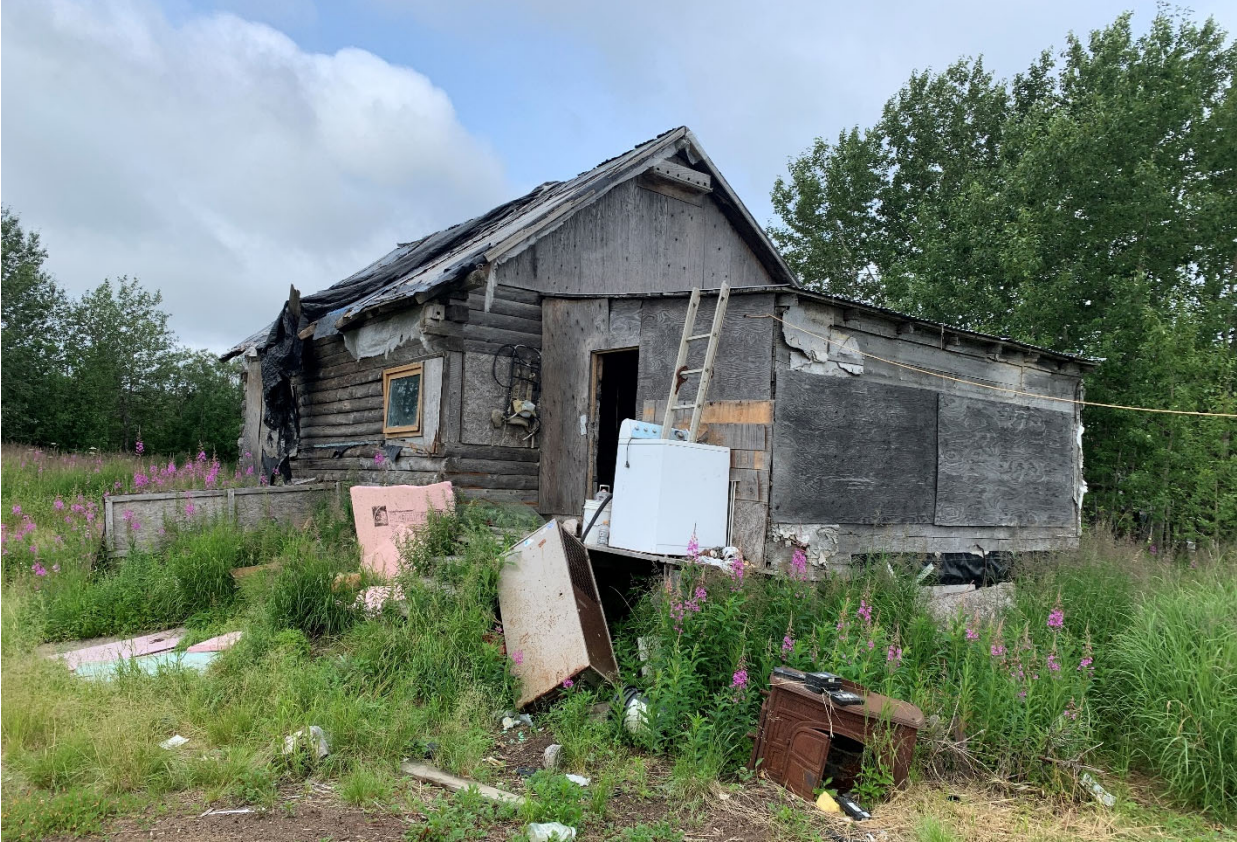
Figure 3: Abandoned Structure #602 identified for demolition and removal.

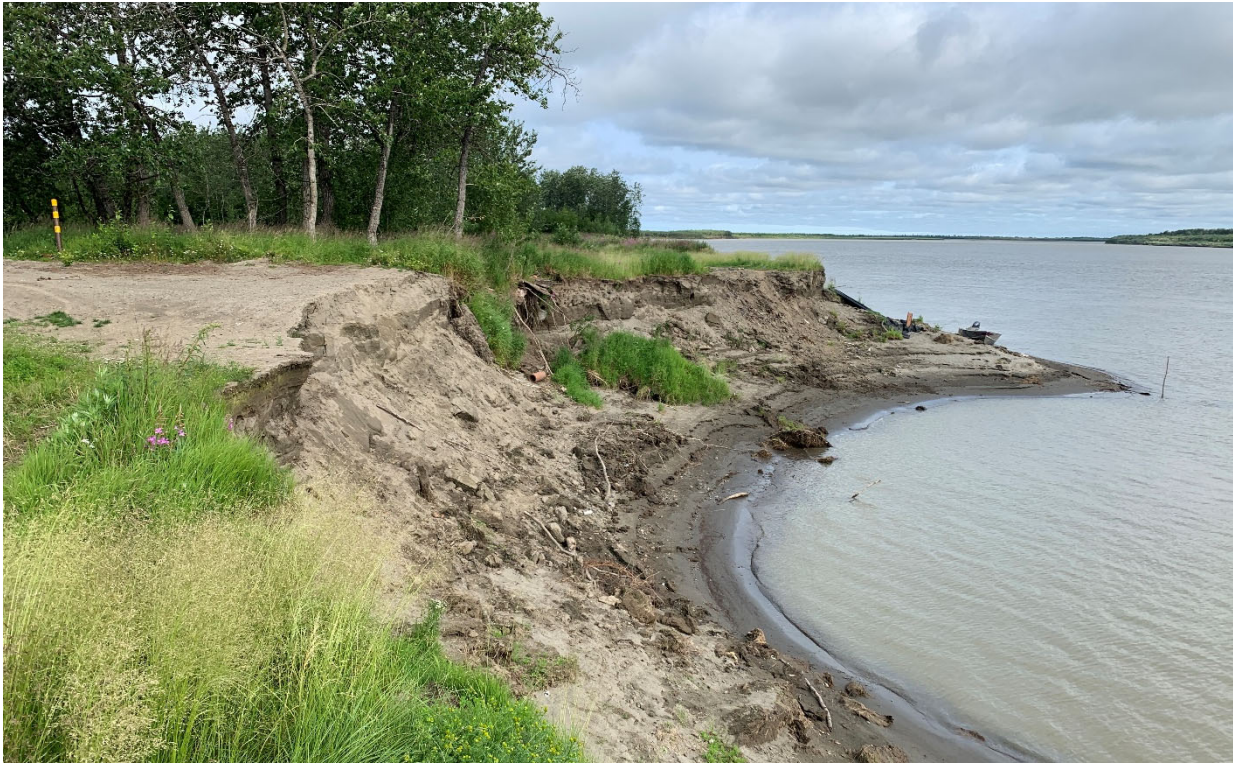
The hydraulic conditions of the Kuskokwim River at Akiak are severe. The erosion situation that we have observed over the last decade in Akiak has continued. Rather than a steady, continual erosion of land there appears to be some irregular scallop patterns, which given the considerable hydraulics of this section of the Kuskokwim River, can be very dramatic, with up to 100 feet of lateral erosion occurring in a very short amount of time.

Figure 4: Bank erosion in front of structures #600-602.

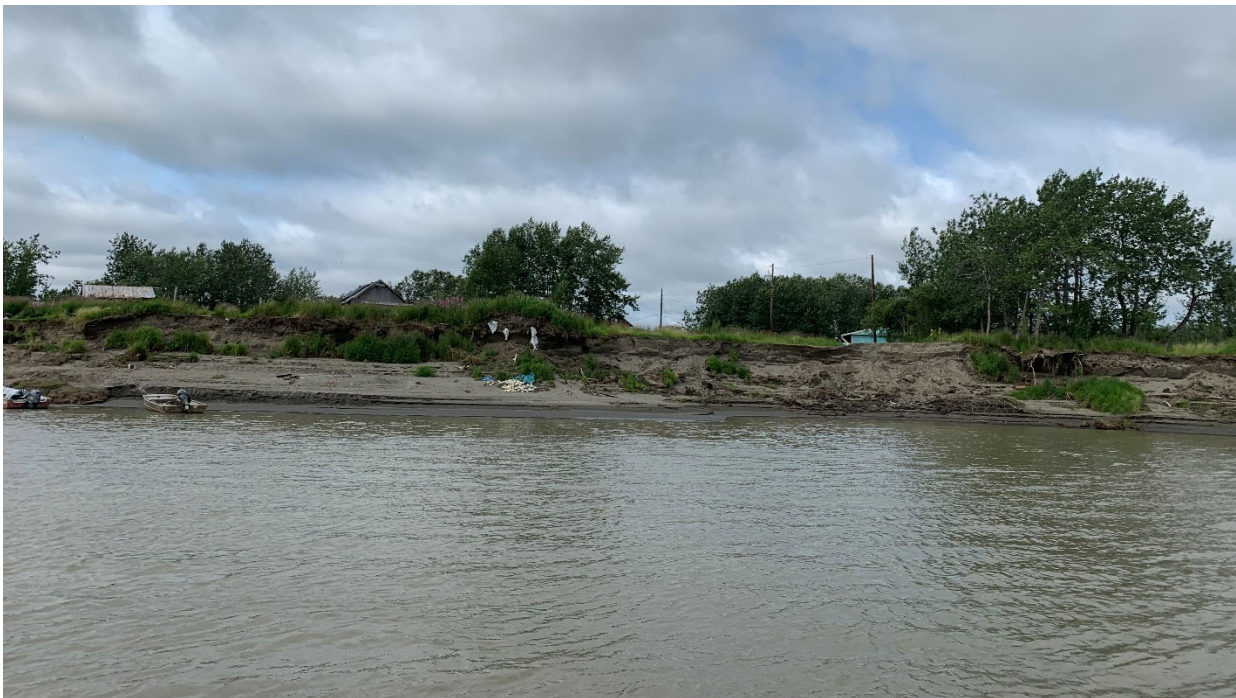
Figure 5: Bank erosion in front of structures #600 - 602 as seen from the Kuskokwim River.
