CHEFORNAK INTERAGENCY UPDATE

REVIEW OF THREATS, PROJECTS, SUCCESSES AND CHALLENGES

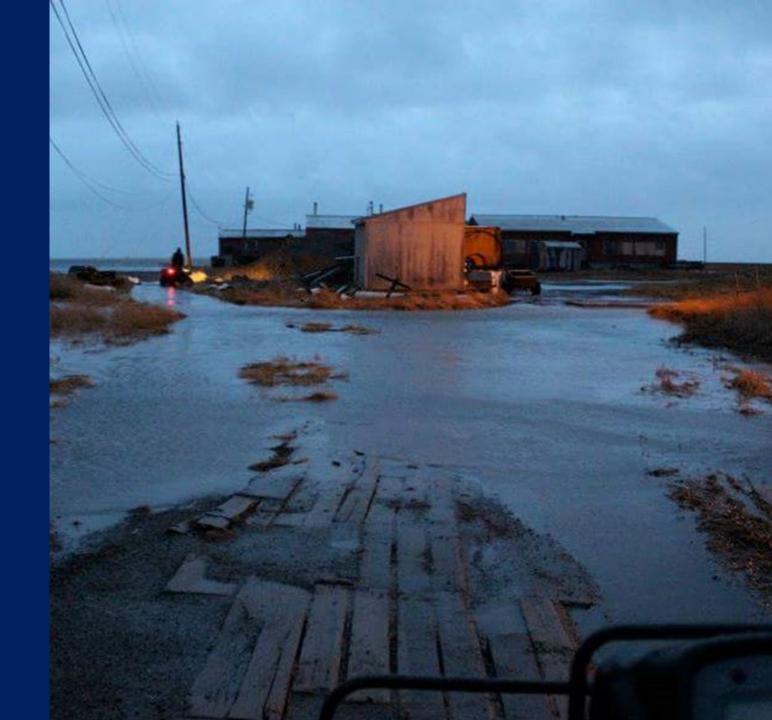
FLOODING

Flooding in Chefornak comes from three major sources including:

- Spring breakup
- Fall storm runoff
- Storm surge

Of these, storm surge represents the greatest threat and is also the largest unknown, as there is little to no tidal data in the region.

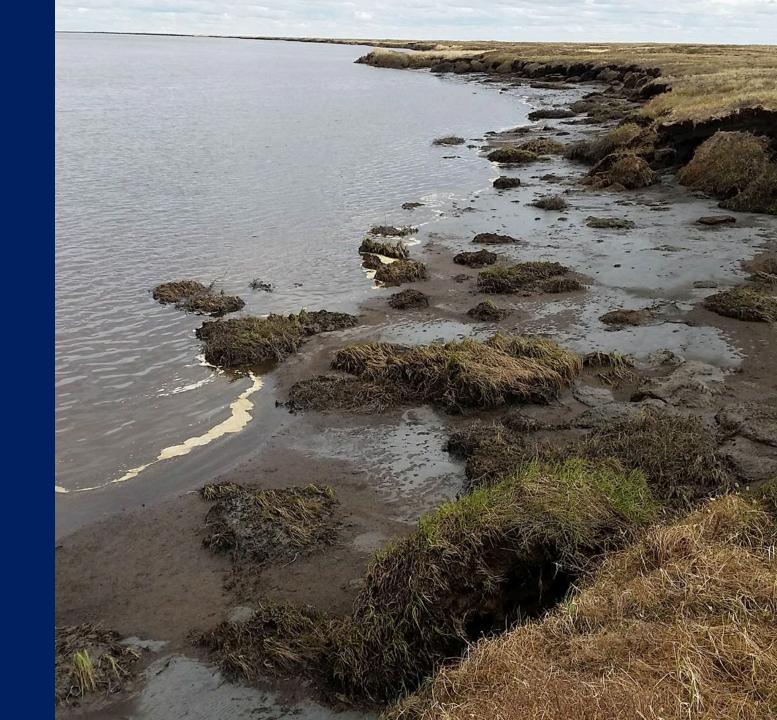
EROSION

While erosion and bank migration are a common occurrence along any river, especially along cut banks, changing climate has greatly accelerated this process in two ways:

- Riverine erosion- Accelerated by thawing permafrost
 - Saltwater intrusion accelerates thaw
- Wave action- Increased due to longer ice free storm season
 - Saltwater intrusion is more common due to extended season

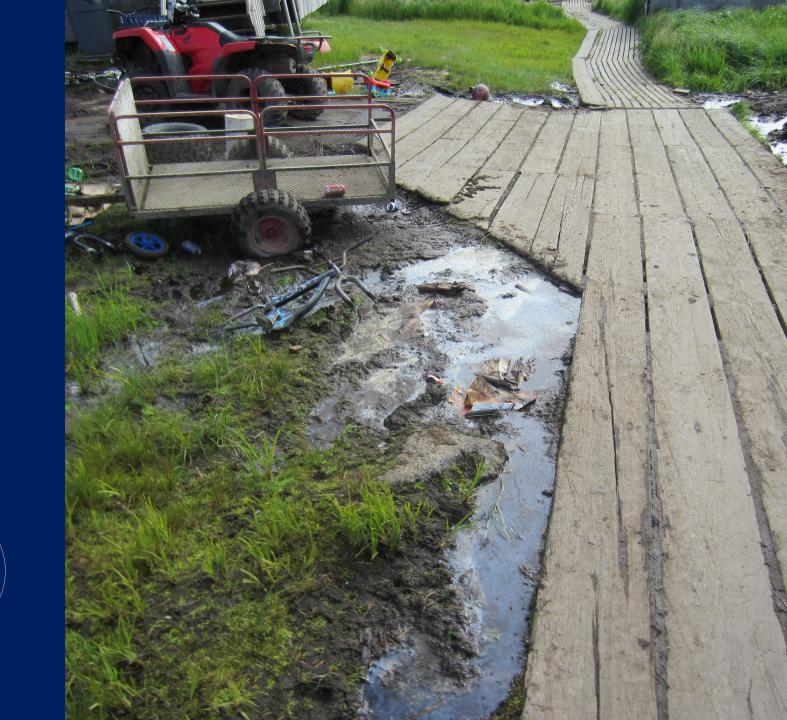
THAWING PERMAFROST

Thawing permafrost has introduced several new concerns in Chefornak. These include:

- Thaw settlement (building foundations)
- Sinkholes (safety concern)
- Accelerated erosion
 - Warmer temperatures
 - Seawater infiltration

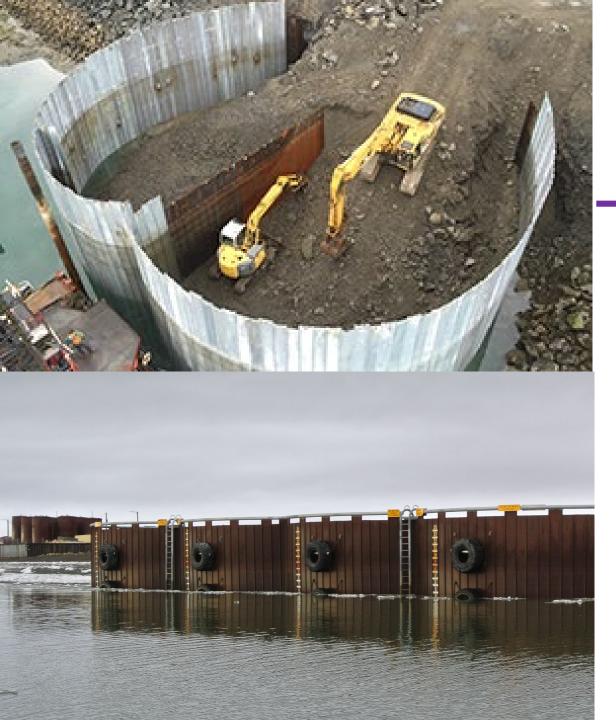
TASK 1: BARGE LANDING

The barge landing task consists of:

- Design a temporary barge landing to replace the damaged one.
- Develop concepts and provide an alternatives analysis and cost estimates for a permanent replacement.
- Temporary barge landing design is complete and construction is underway.
- Concept design work was completed on 9/12/2019 and a preferred alternative was selected by the Tribal review team.
- An OPEN CELL SHEET PILE (OCSP[©]) BULKHEAD was selected.

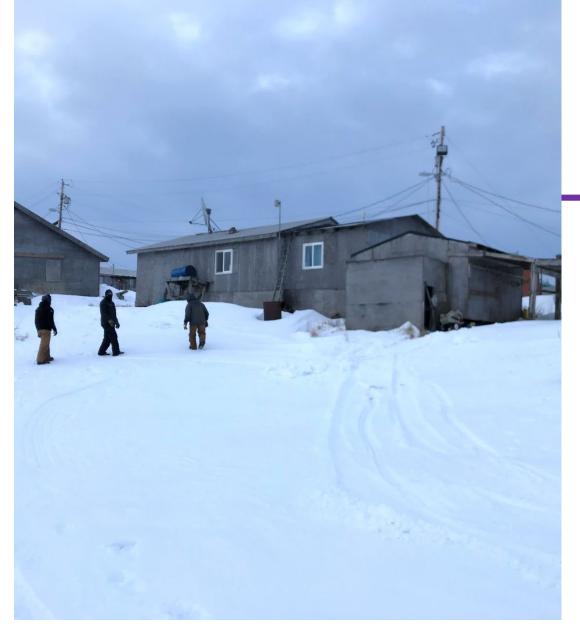
TASK 2: DOLLY'S HOUSE

Dolly's House was one of the first threats identified in Chefornak and in large part came to symbolize the larger problems facing the community.

- Flood waters remain very close to Dolly's House
- Plans have been completed for placement of erosion protection to mitigate the threat.
- Construction crews are in Chefornak and will be completing this work within the next few weeks as part of the larger temporary barge landing repair work.

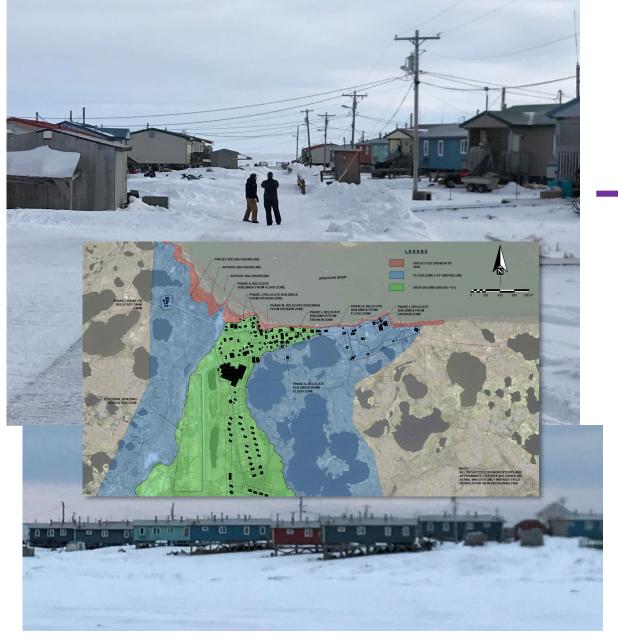
TASK 3: DETAILED EROSION ANALYSIS

Detailed erosion and flooding analysis is being conducted as part of the design of the permanent barge landing and to support and inform the effort to relocate at risk structures along the riverfront in Chefornak. To this end, several activities have taken place:

- Hydrological instrumentation has been placed at several locations up and down stream from Chefornak to measure water surface elevations and flow characteristics.
- Two weather stations have been placed, one in Chefornak and one at the mouth of the Kinia River to measure wind speeds, temperature and rainfall data to correlate with the hydrological instrumentation.
- Local workforce was engaged both in placement of instruments and in retrieving data.

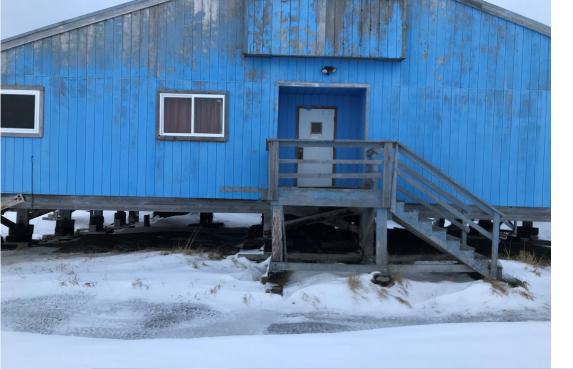
- Recently awarded task.
- Provides a geotechnical assessment that will drill boreholes at 10 locations, set thermistors at 6 locations
- Supports the Task 4 effort
- determines soil profile, temperature and salinity summarized in a geotechnical report for Chefornak for use in the design of numerous structures.
- This information will be crucial to development of building foundations that will be effective, efficient and last the duration of the life of the structure.
