**An Assessment of Streambank Erosion and a  
Revetment Concept Design on the  
Kuskokwim River at Akiak, Alaska**

**The Natural Resources Conservation Service**

**Akiak Tribal Council**

April 2013

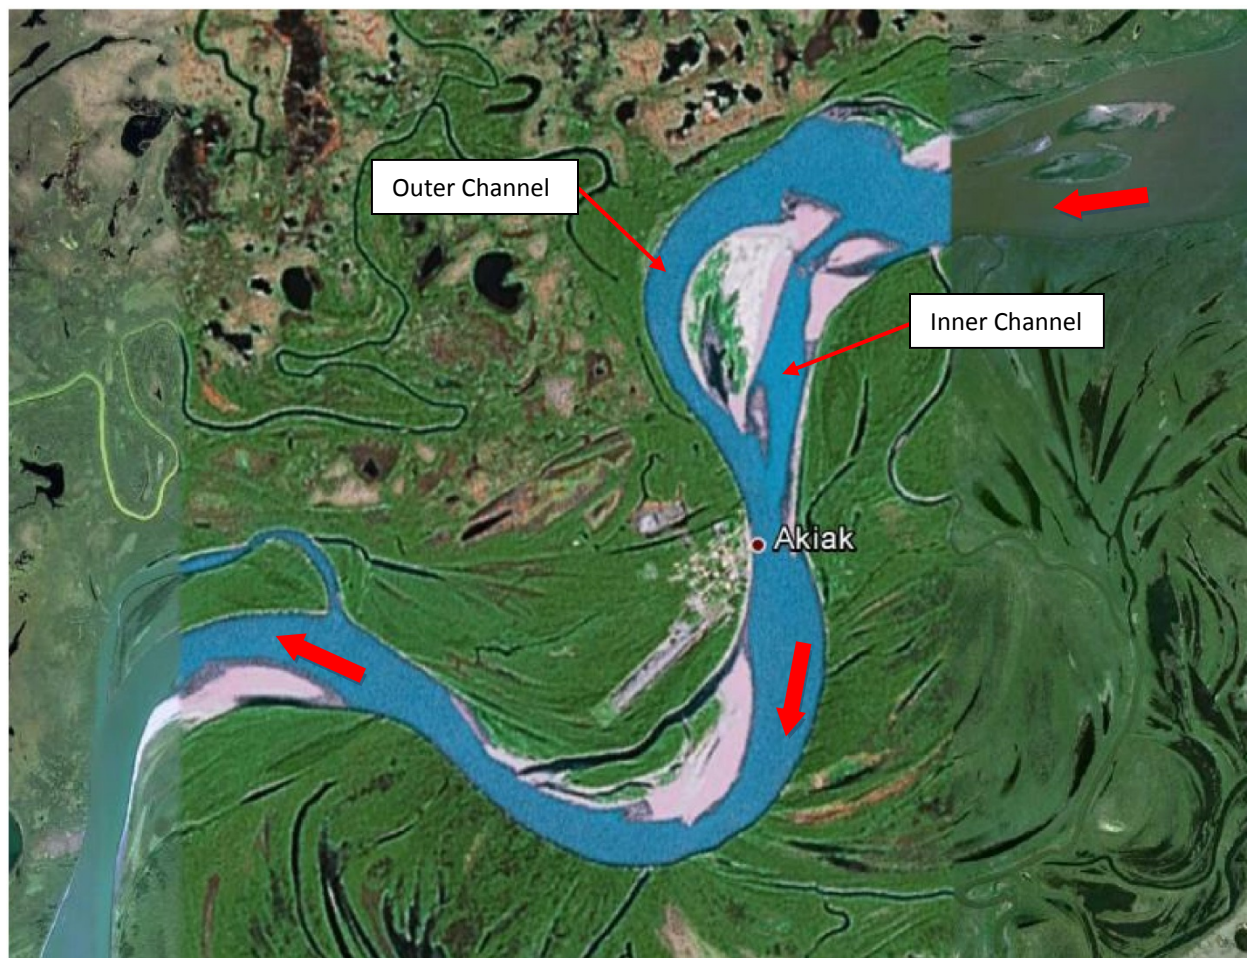
Figure 2. Aerial image of Akiak, Alaska. The outer channel is the primary flow path and the inner channel is the secondary flow path.

The community of Akiak is situated on West/North side of the Kuskokwim River, at the beginning of the inside of a bend in the river (Figure 2). The geology is typical of a large alluvial floodplain and comprised primarily of silt with intermixed layers of sand.

For many decades there has been gradual streambank erosion at this location. However in recent years there appears to be changes in the river dynamics immediately upstream from Akiak (Figure 2) that are likely increasing the erosion rate at the community.

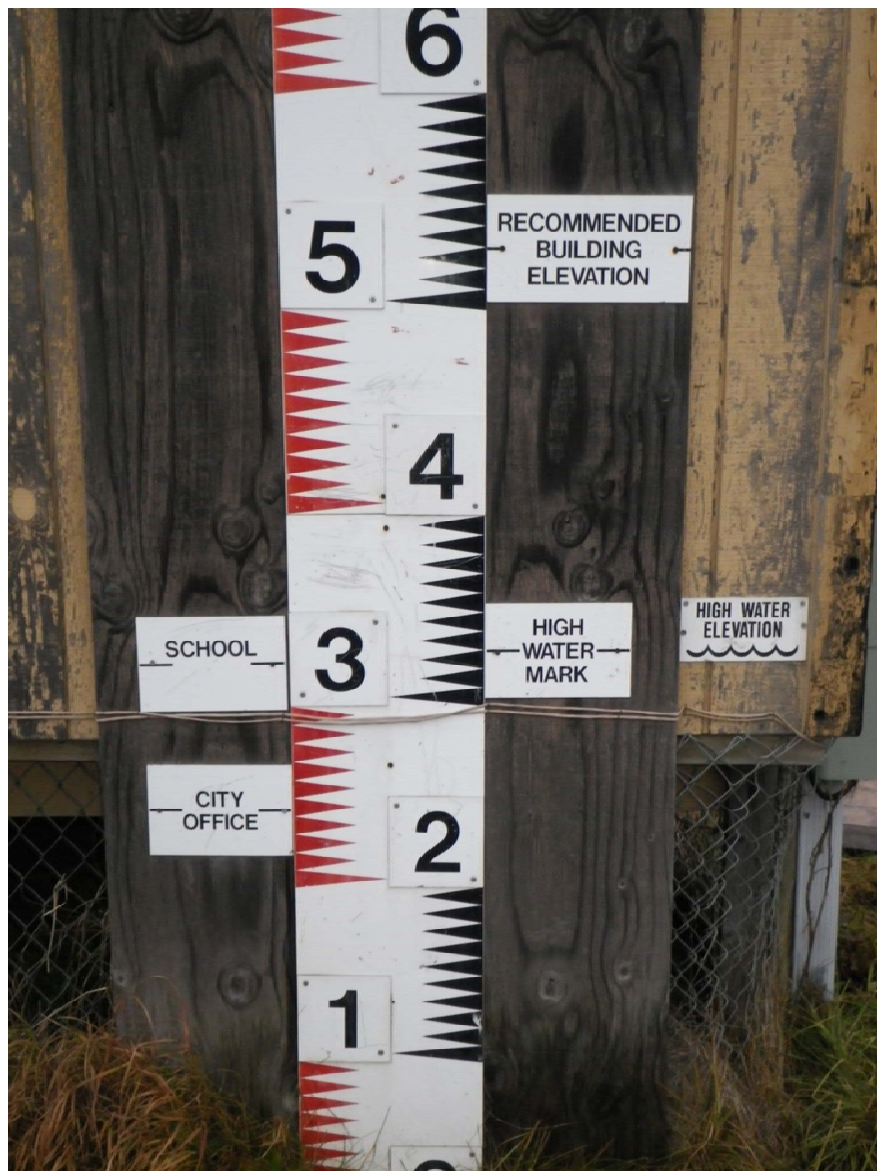
Figure 3. Staff gage at old school

The village is in the primary floodplain and has seen flooding as indicated by the staff gage shown in Figure 3.

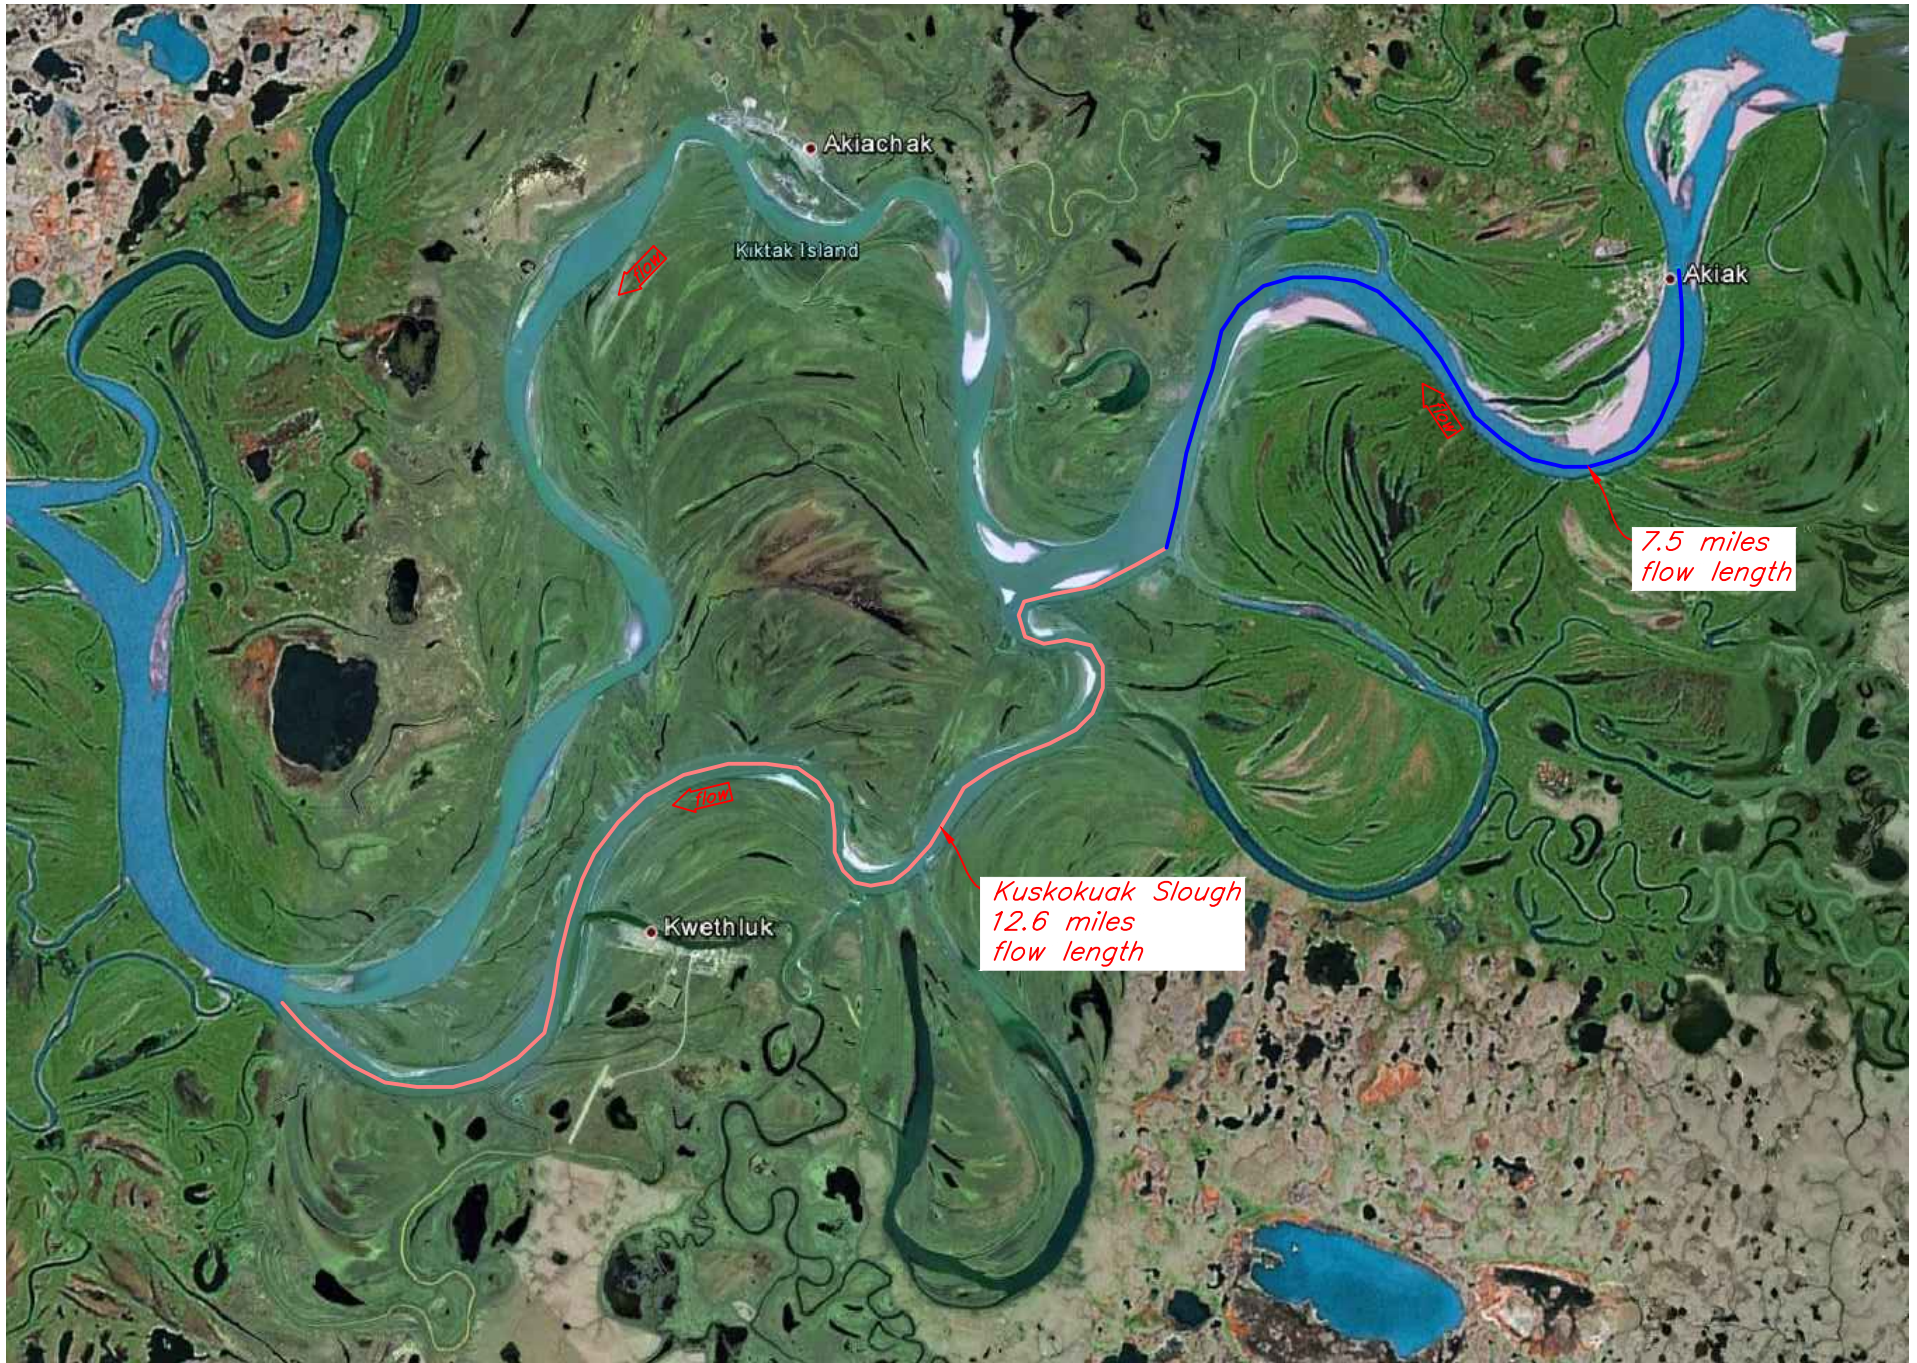
Figure 5. Aerial image showing the Kuskokwim River and Kuskokuak Slough alignment between Akiak and Kwethluk in 2005.

In comparing USGS maps that were generated using 1950's aerial imagery (Figure 4) to 2005 aerial imagery (Figure 5) it is obvious that the process described above has resulted in major planform changes to the section of the Kuskokwim River downstream from Akiak. In this section of the river the channel has abandoned two major oxbows. By abandoning these oxbows the length of the Kuskokuak Slough, which is one of the two channels of the Kuskokwim River at this location, decreased in length from approximately 26 miles to approximately 12.6 miles. This change more than doubled the channel slope, which has increased the conveyance of the Kuskokuak Slough.

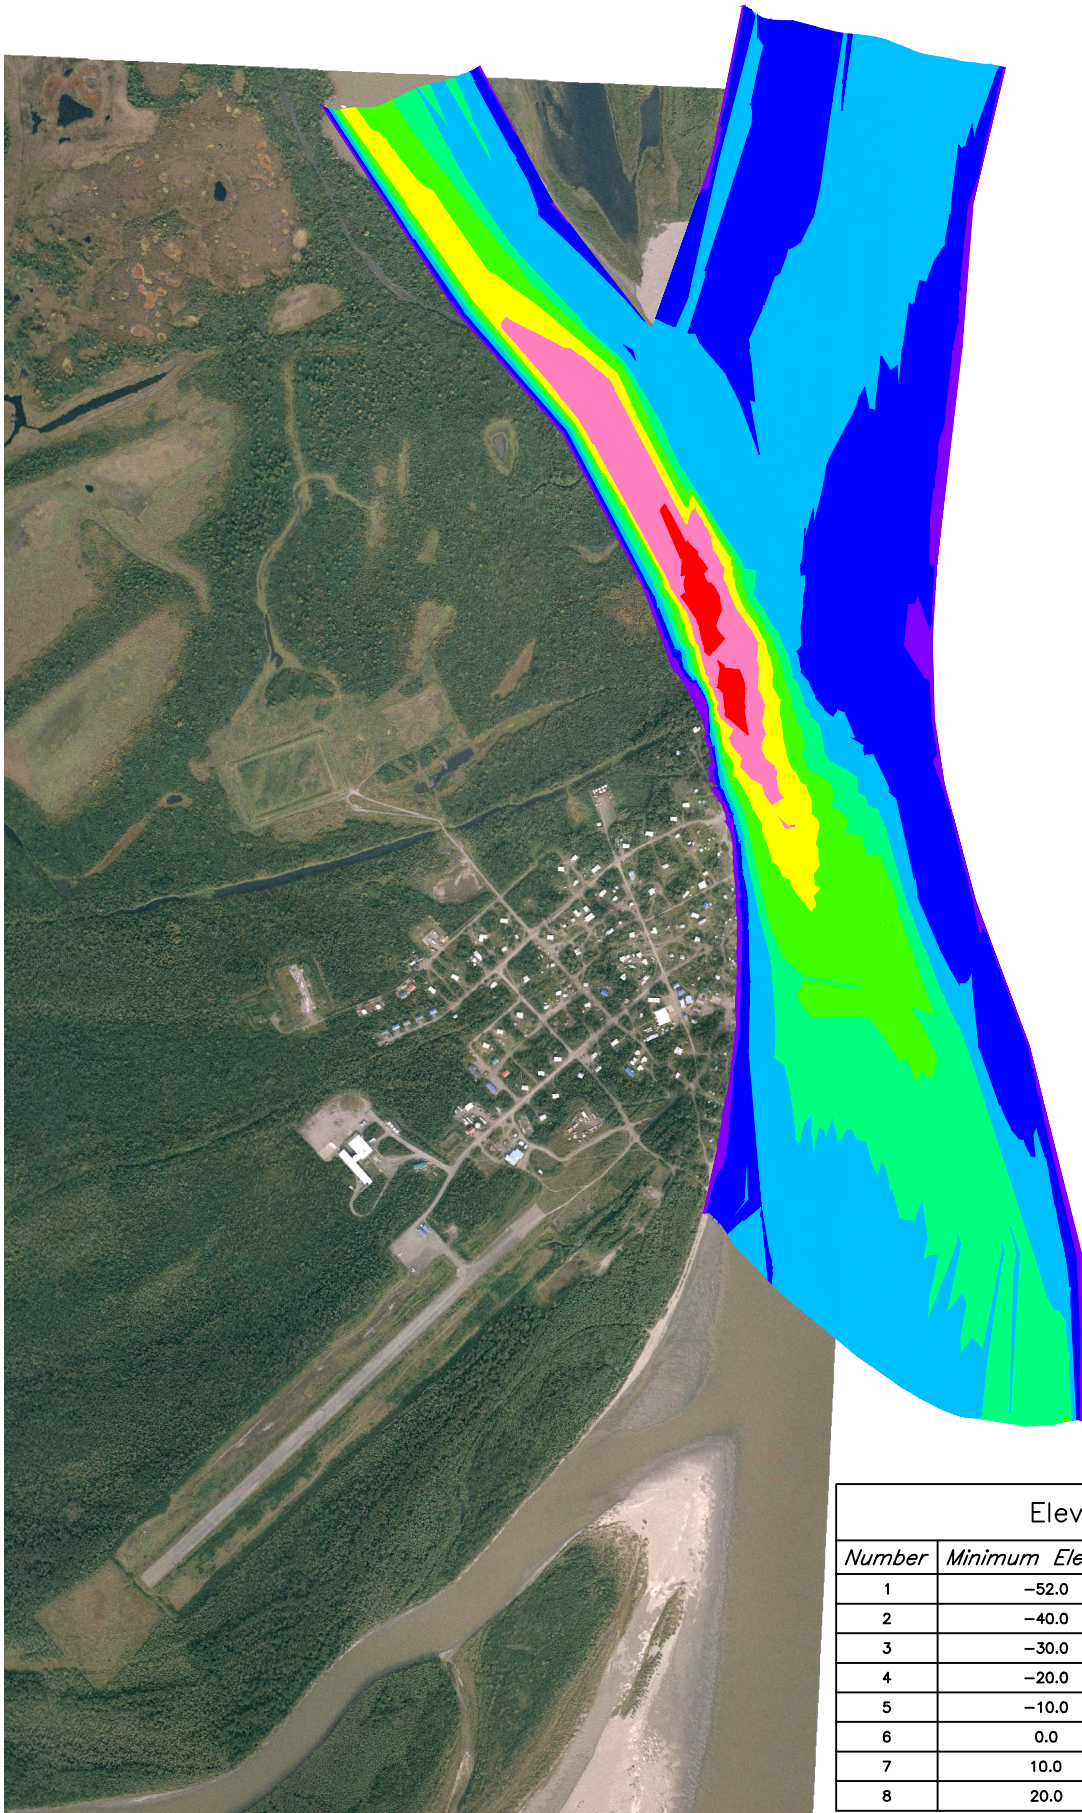
Figure 6. NRCS survey data from October 2012 showing channel bed elevation. Note: elevation of high water mark on staff gauge in Figure 3 is 32.8 feet, and the water surface elevation during the survey was 22 feet.

Where the two flow paths merge the flow in the outer channel is “pushed” against the streambank resulting in an increase in bank erosion. In addition where these flow paths merge there is an extremely deep scour hole, reaching depths as great as 78 feet below the top of the streambank elevation. Figure 6 shows a color banded elevation map of the survey data that was gathered by the NRCS in October, 2012.

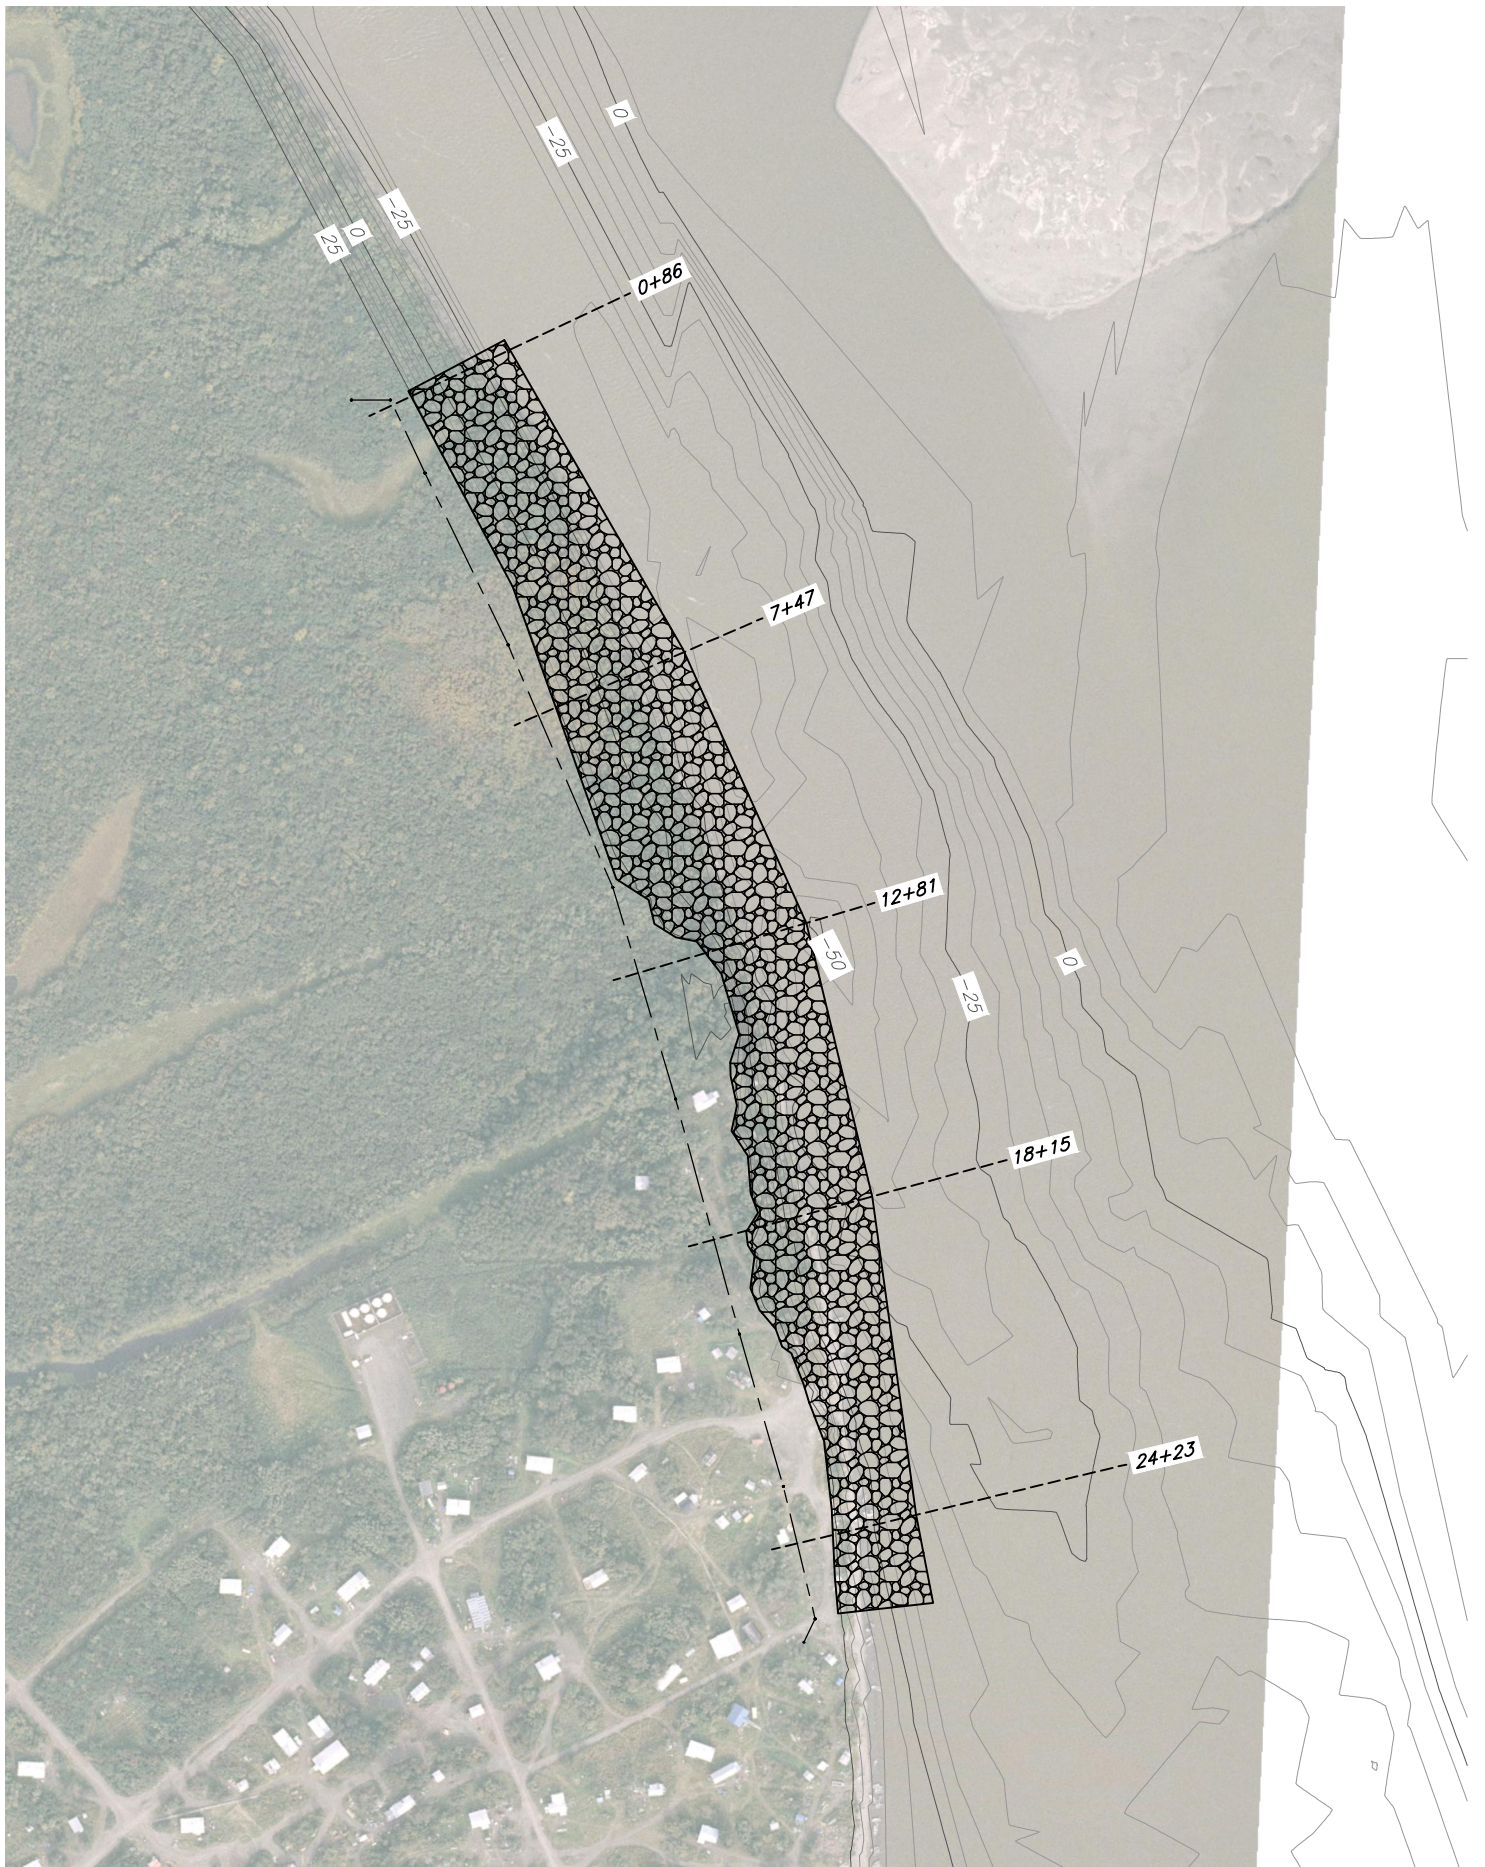
Figure 7. Rock revetment alignment and plan view.

Figure 7 is a Plan View drawing showing the proposed extent of the rock revetment with keyways on each end. The estimated overall length of the project is 2600 linear feet. The project must extend far enough upstream from Akiak to avoid being flanked by bank erosion due to the potential increase in discharge in the inner channel.

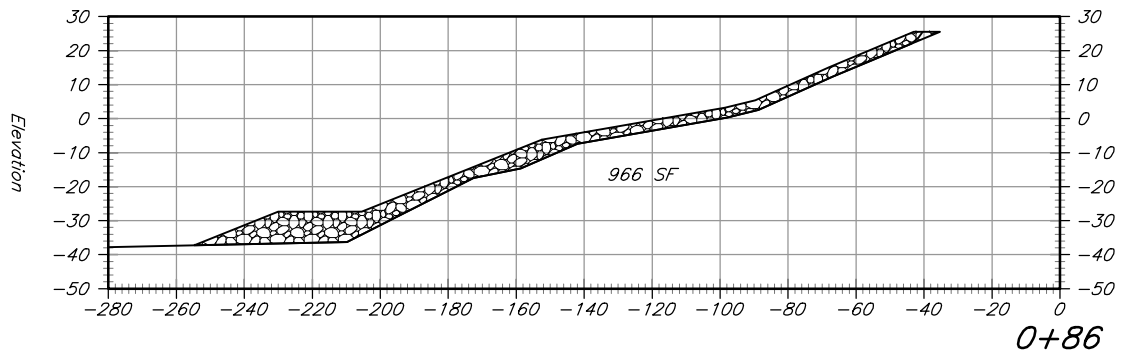
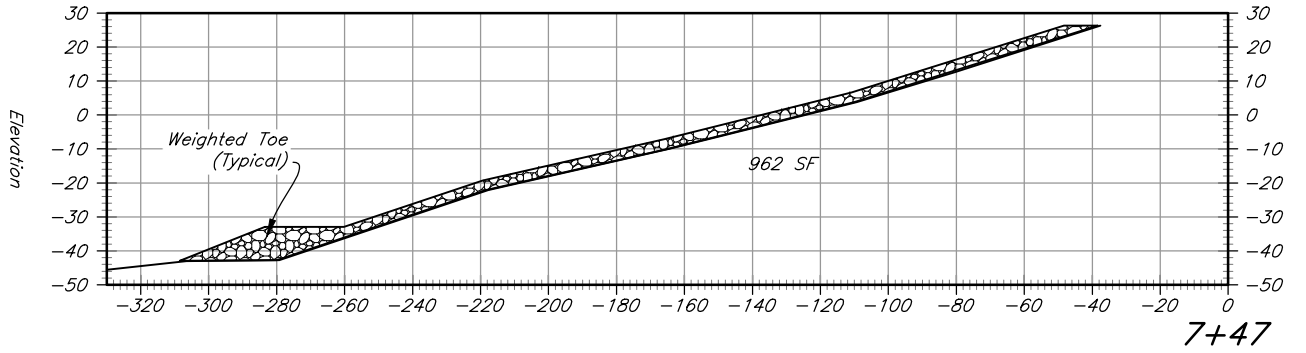
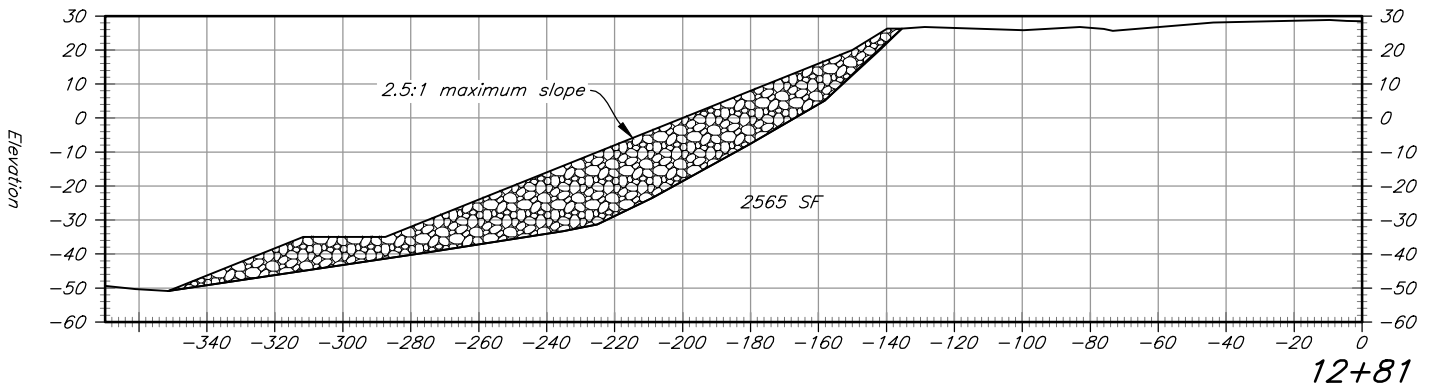
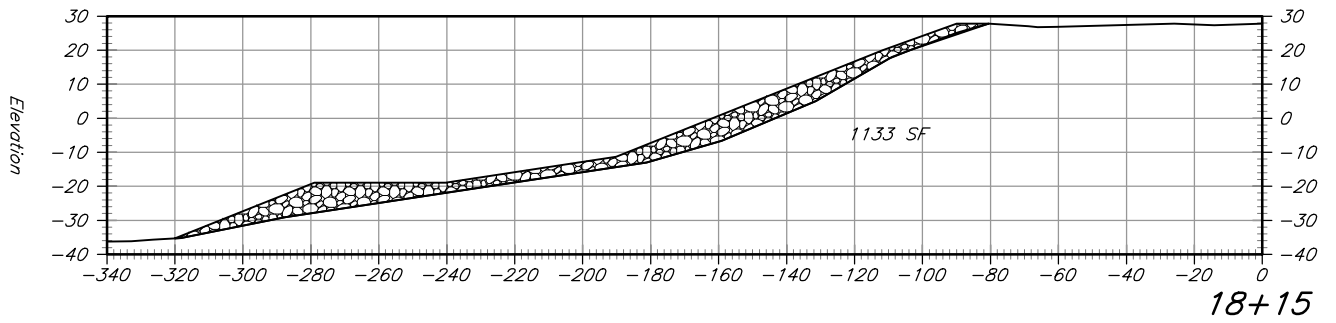
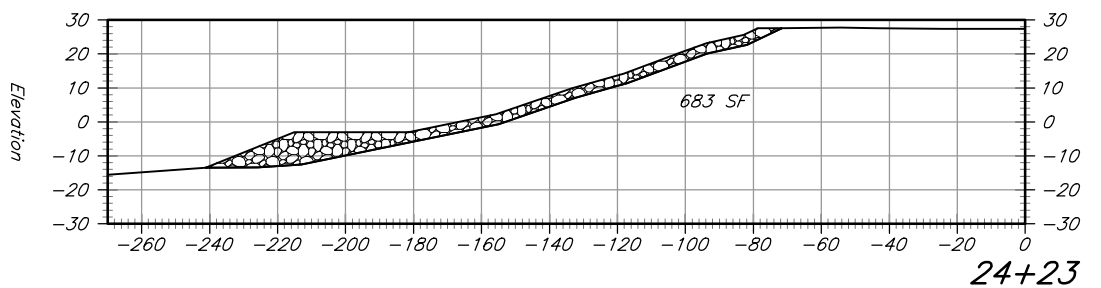
Figure 8. Rock revetment cross sections.

Figure 8 shows the proposed rock revetment cross-sections at the Stations 0+86, 7+47, 12+81, 18+15, and 24+23. The volume of rock riprap required to construct each of these cross-sections is 36, 36, 95, 42, and 25 cubic yards per linear foot of streambank, respectively. The two keyways will require additional rock riprap. The estimated total amount of rock riprap required to construct this design concept is 125,260 cubic yards.

The extreme depth of the channel at the potential project site creates several design and construction issues. A thorough analysis is likely to result in a finished rock slope of 2.5 feet horizontally for every vertical foot of drop, or possibly flatter. In a large portion of the site the existing ground is much steeper than the proposed rock slope, but the depth is too great to make excavation a practical solution. Thus, the required slope will likely be created by placing an excess of rock riprap as shown in Figure 8.

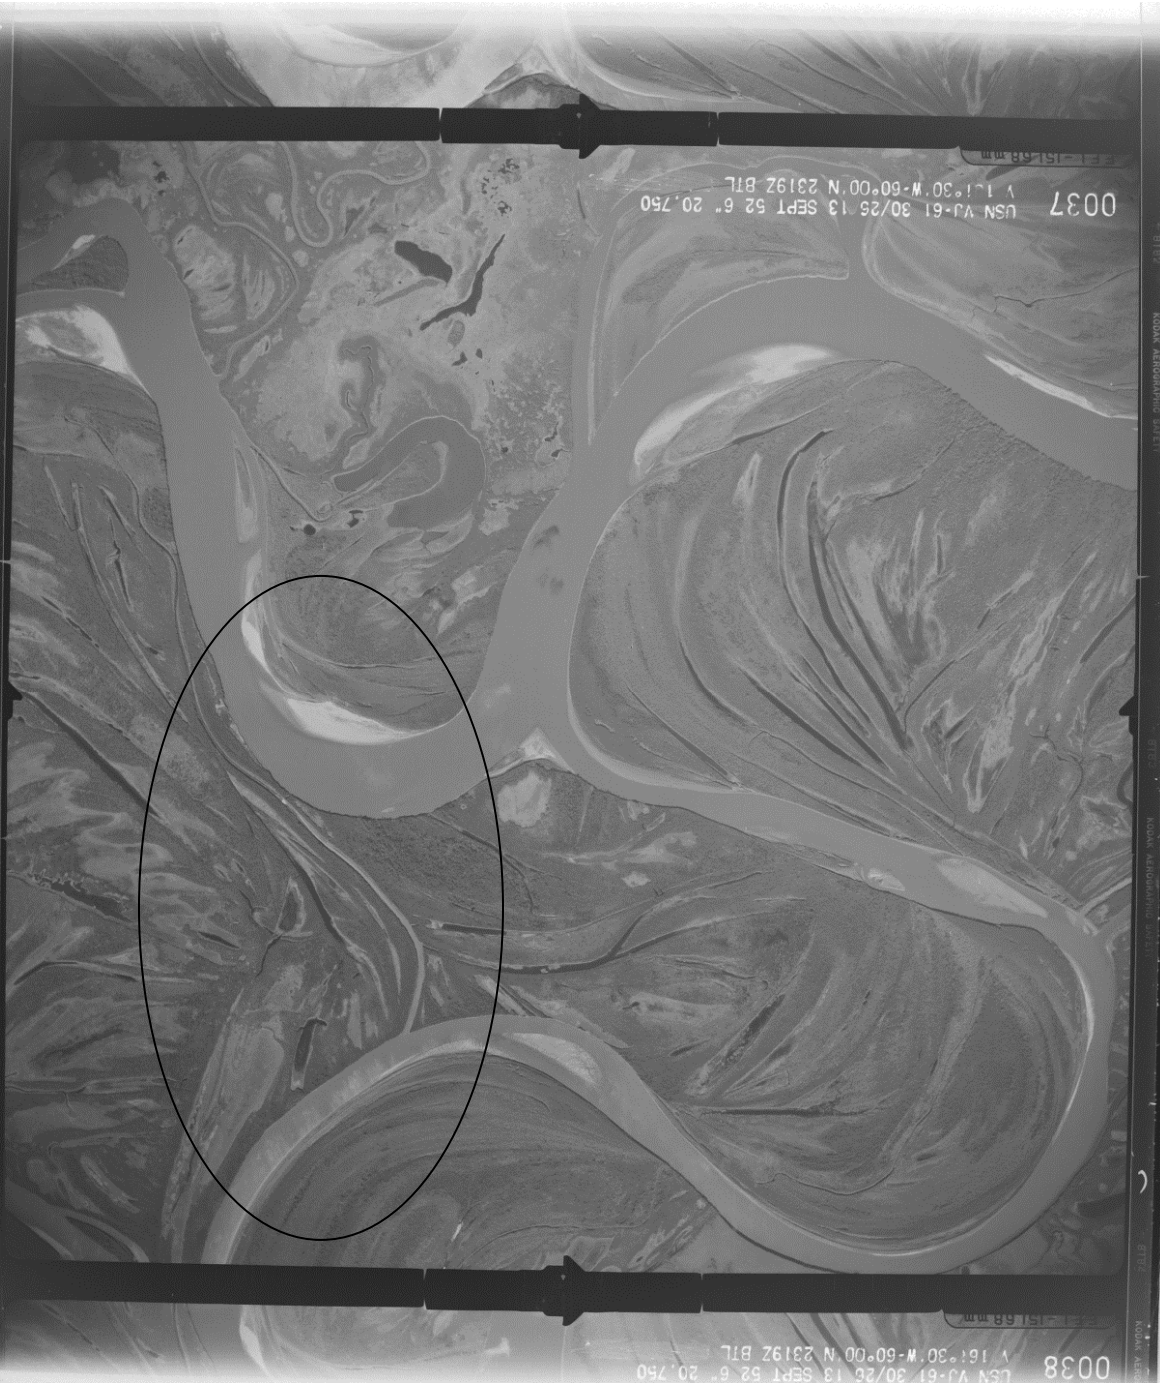
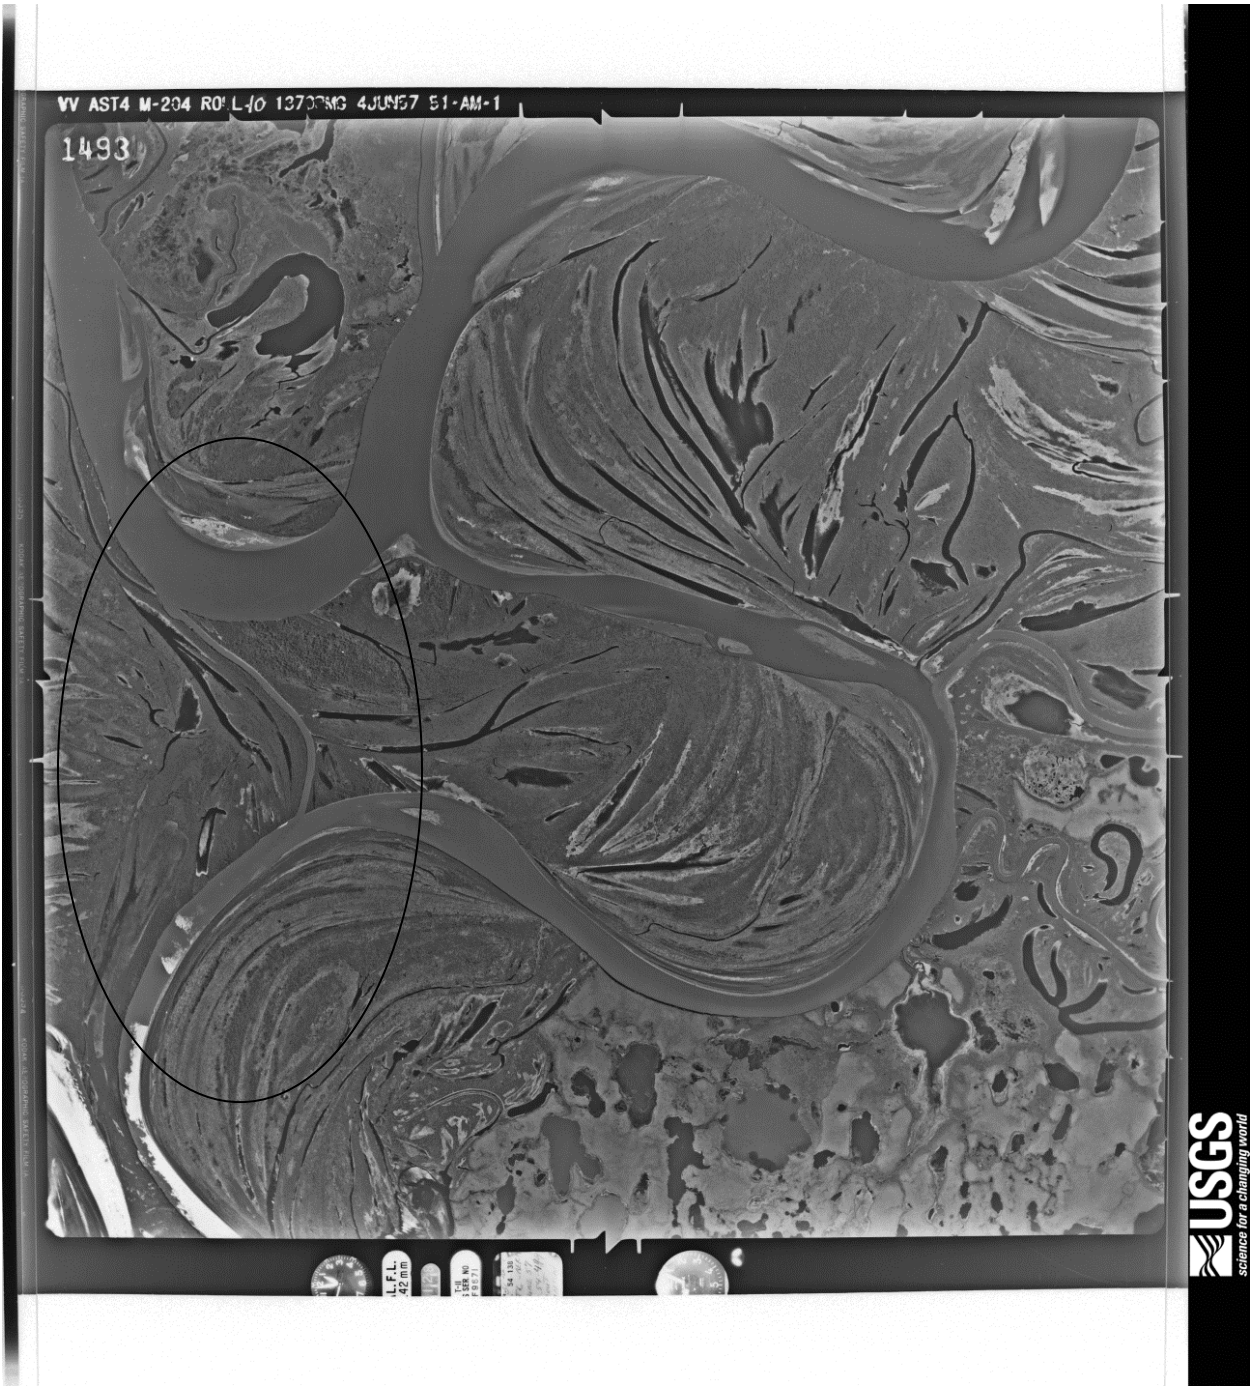
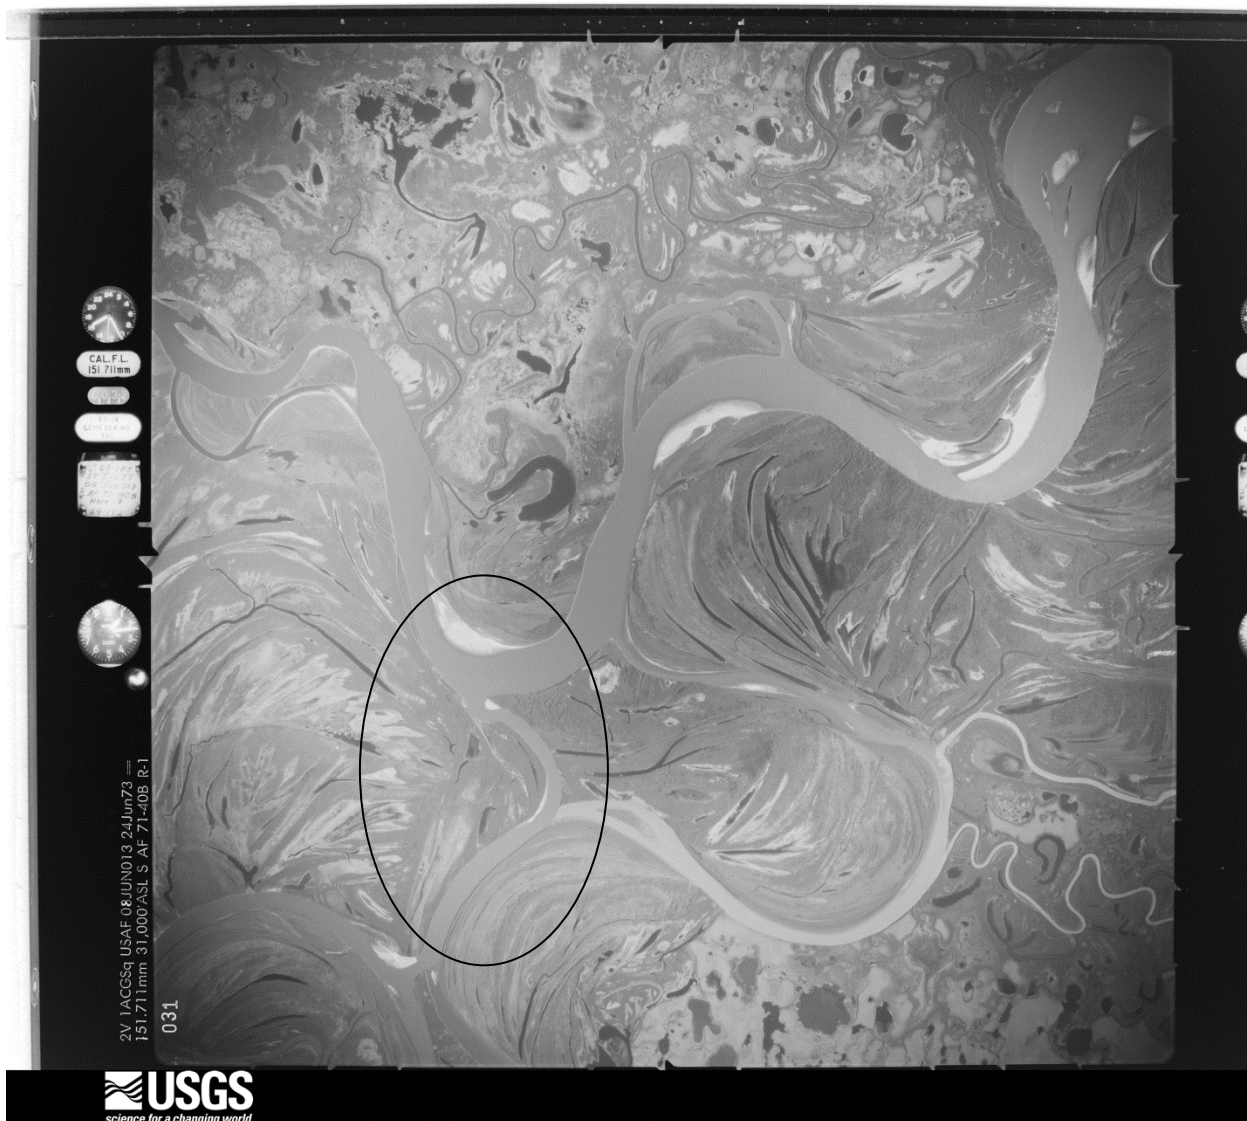
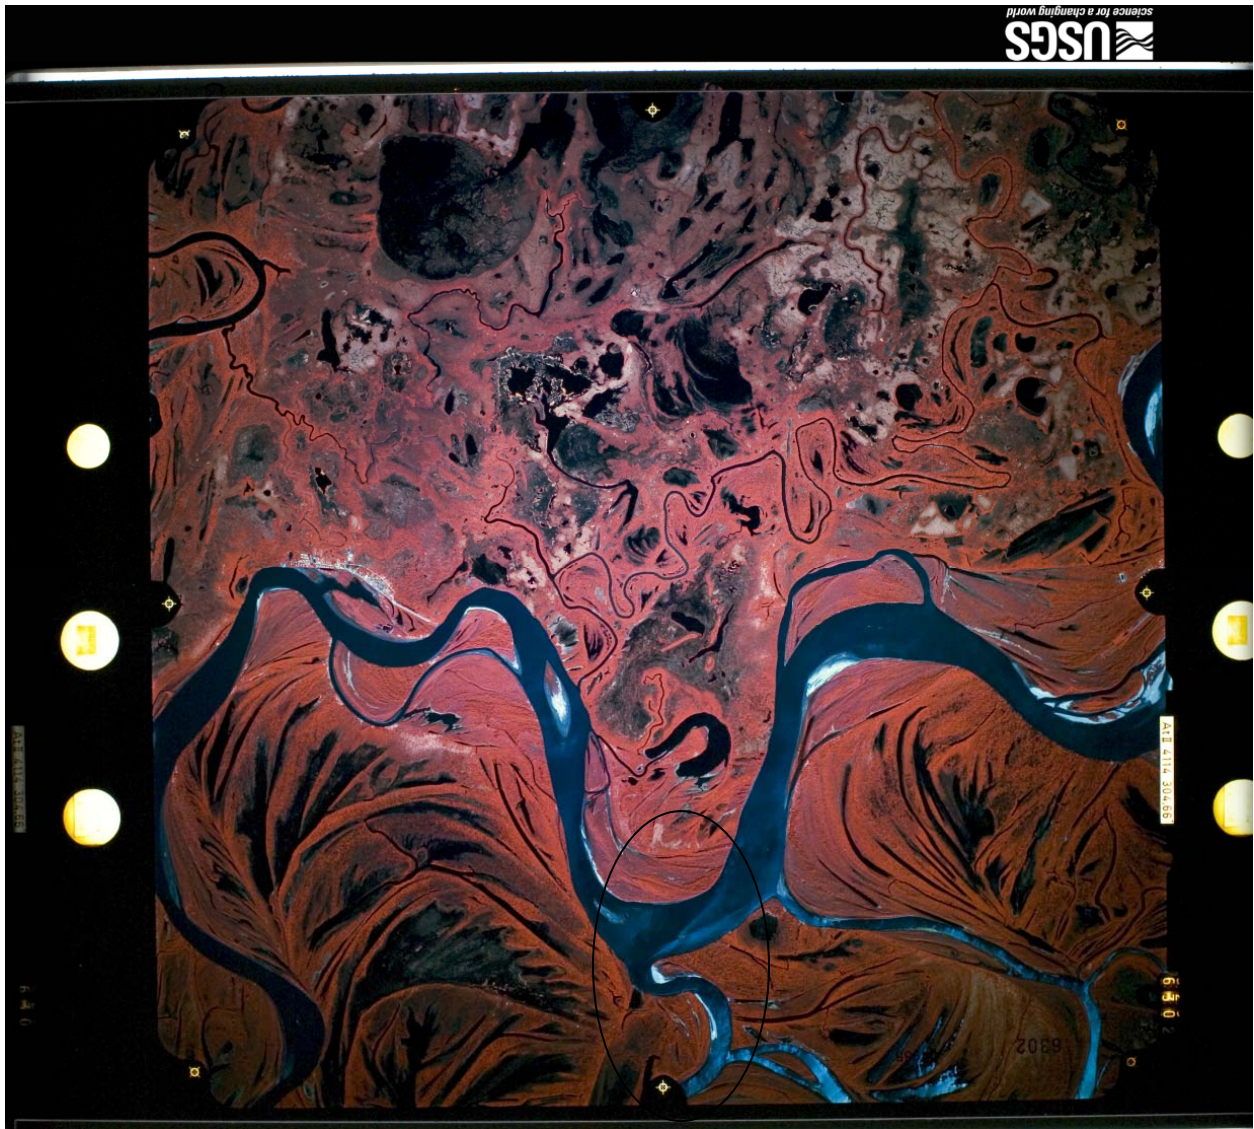
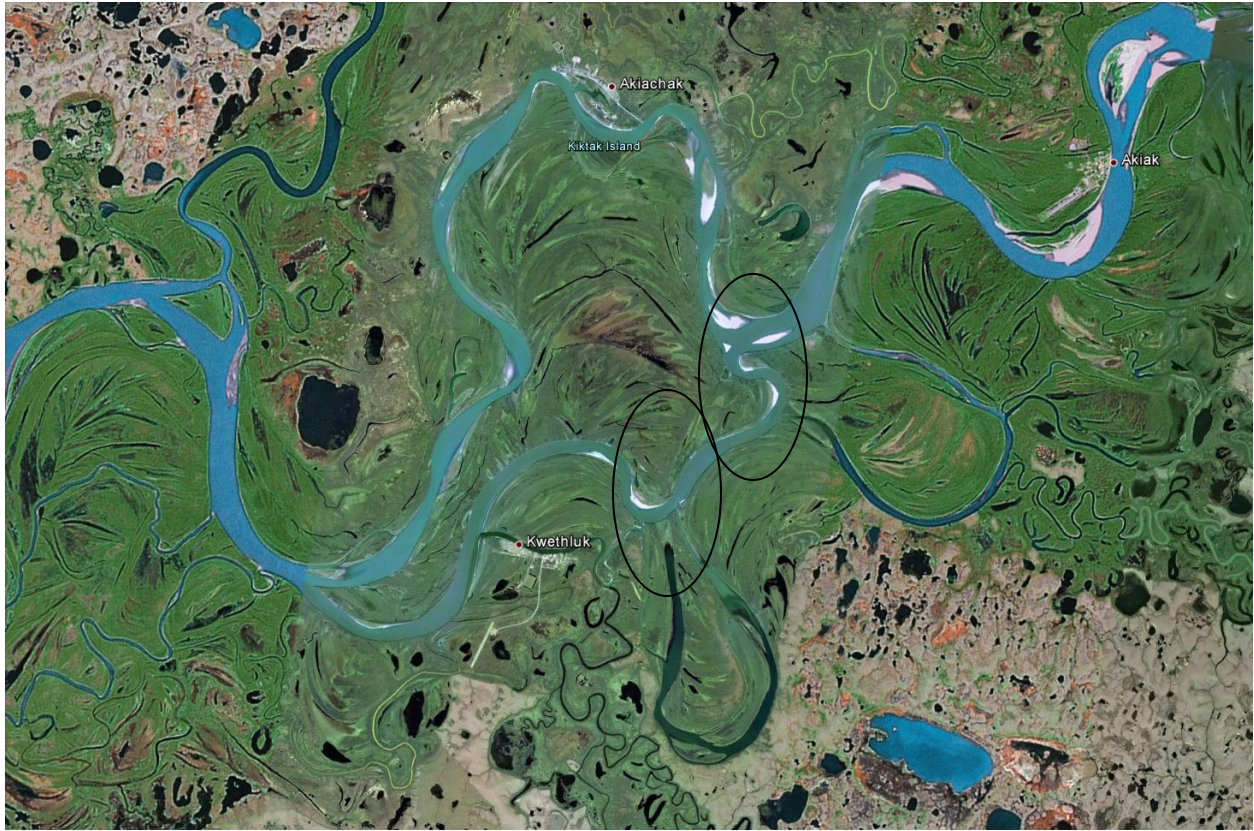
### **Aerial Photography of the Kuskokwim River Between Akiak and Kwethluk**

In Appendix I a series of aerial photos illustrate how portions of the channel of the Kuskokwim River and Kuskokuak Slough have gone through this evolutionary process between 1952 and 2005. These images show this to be a very gradual process that is ongoing. They show an abandoned slough channel that is connected to the Kuskokuak Slough being intersected by encroaching streambank erosion on the main channel of the Kuskokwim between the 1952 and 1957 images. That connection between the main channel and the slough channel continues to mature in the 1972, 1995, and 2005 imagery, as a major oxbow is gradually abandoned, reducing the length of the channel by several miles.

The imagery presented in Appendix I show that this has been a gradual process that has been ongoing for over 50 years. The Kuskokuak Slough has enlarged throughout this time period and appears likely to become the primary channel of the Kuskokwim River in this area. It is reasonable to expect that these changes would result in increased erosion upstream in the river system.

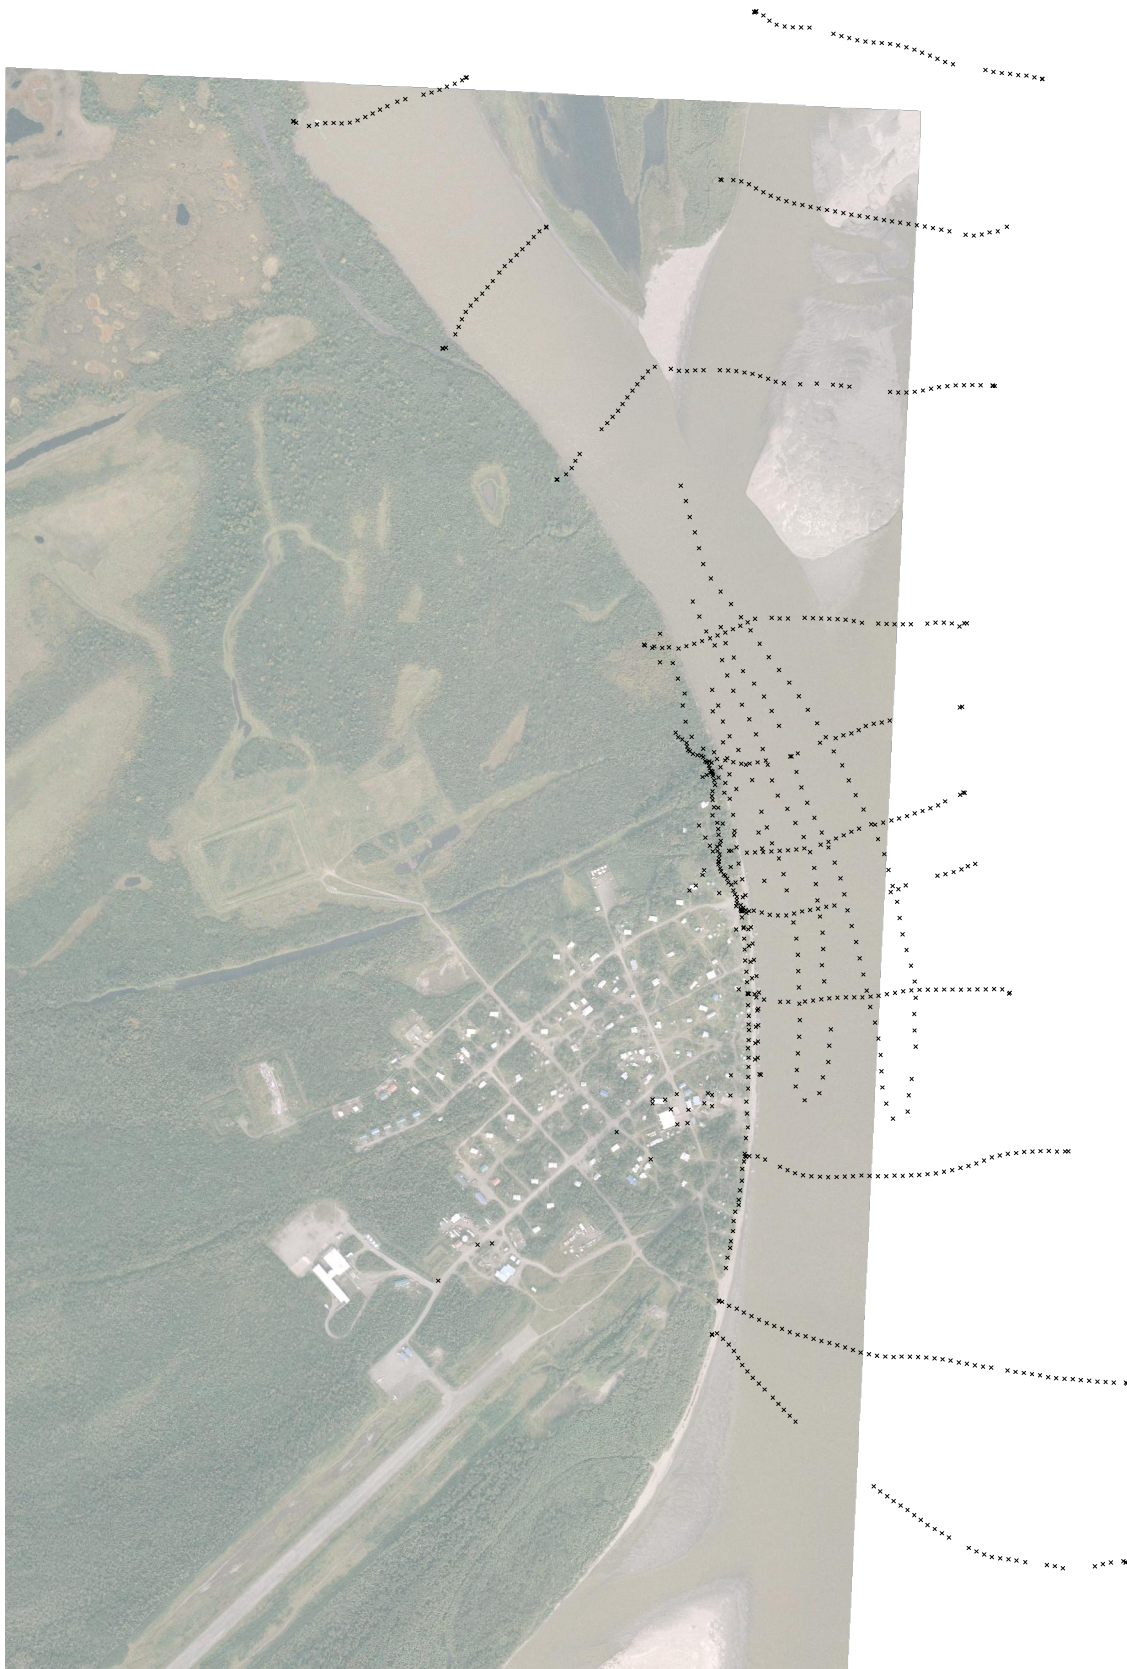
Survey points collected by NRCS. October 2012.

The survey data is presented graphically in Appendix II.
