Subject: Resource Conservationist -Trip Report
Napakiak Village Visit
Napakiak, Alaska

Date: May 22, 2018

Purpose: The Napakiak Village Council requested that NRCS investigate a possible EWP project due to erosion of the banks of the Kuskokwim River (See attached letter May 17th, 2018). The purpose of the site visit was to perform the EWP assessment and complete a DSR.

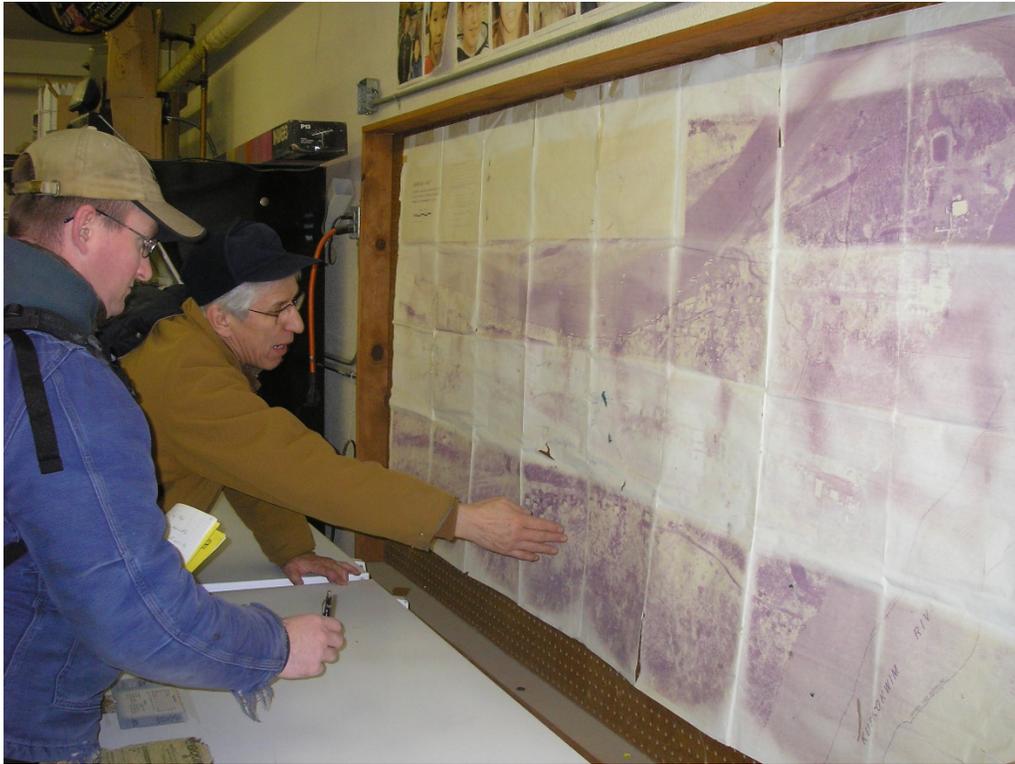
Background/Findings: R. Maroney and A. Oxford (previous DC) traveled in the winter of 2006 to look at erosion in Napakiak. While there, they met with Richard Jung and learned about the long history of erosion occurring along the river bank where Johnson Slough meets the Kuskokwim River (see Figure 1).

Figure 1: NRCS EWP 2006 site visit. Photo of Richard Jung showing A. Oxford historic extent of community and noting the continual erosion that has occurred over the years.

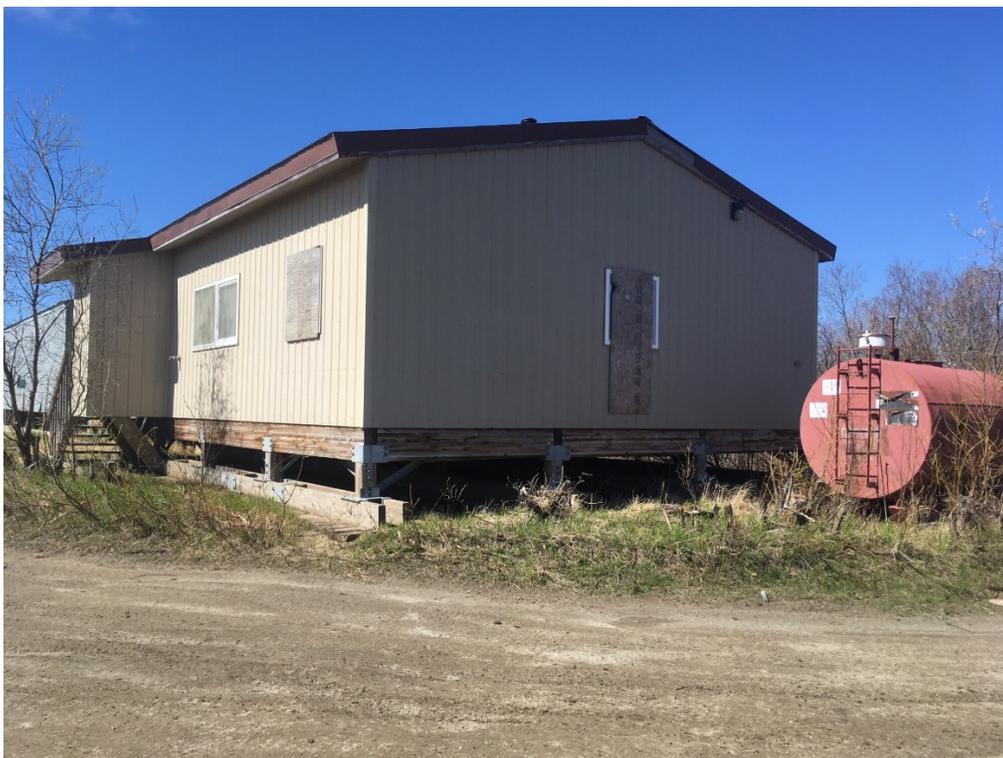
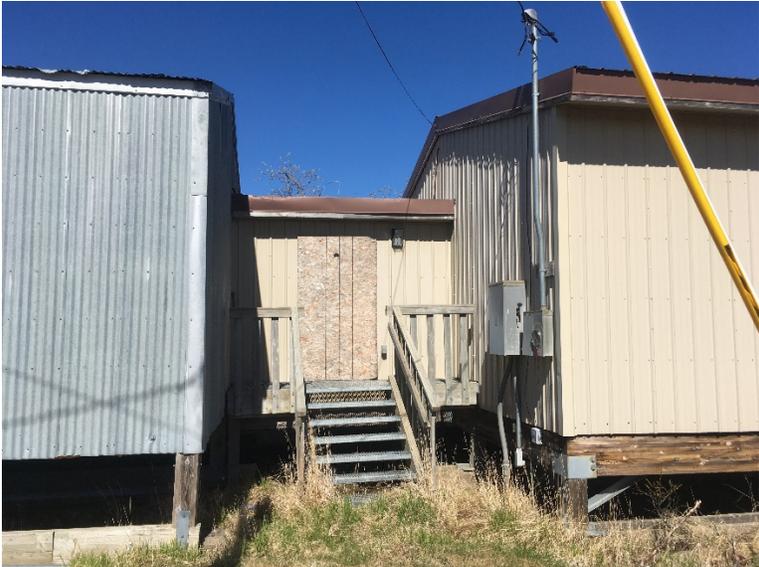
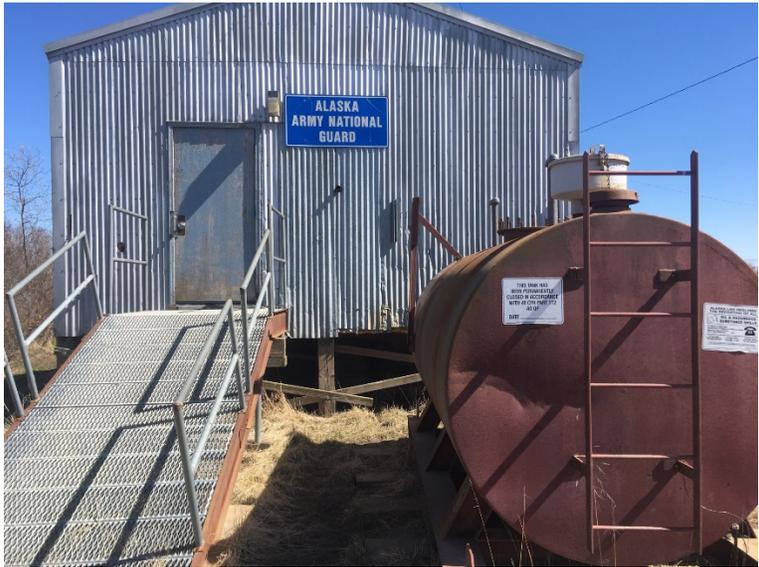
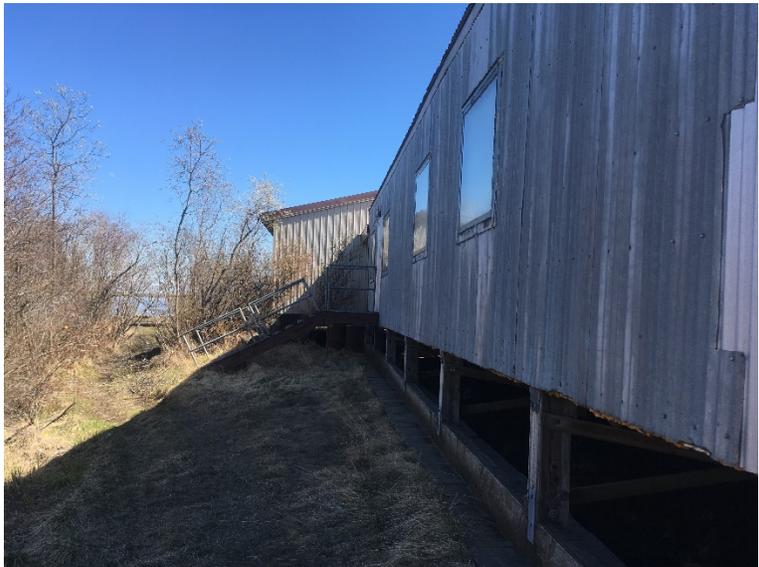
Figure 2 Continued

- **Former Army National Guard buildings** (old and new): The two buildings are on post and pad foundations and are connected by a small covered walkway that would require disassembly. Both

old and new buildings have +1000 gallon fuel tanks as well as steel access ramps attached to them (see Figure 2). The older building is reported to have asbestos, but will be used as a cold storage unit. The new building is more modern and will be used as a multi-purpose building. The Army National Guard turned over ownership of the buildings to the community many years ago.

Figure 2: Form Army National Guard Amory identified for Relocation consists of two buidlings.

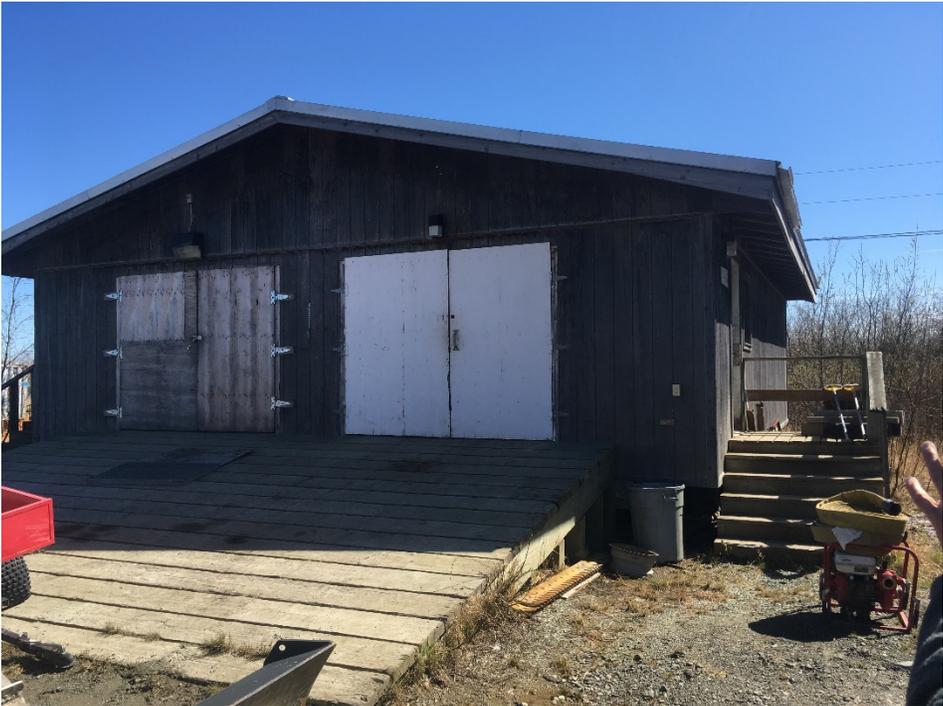
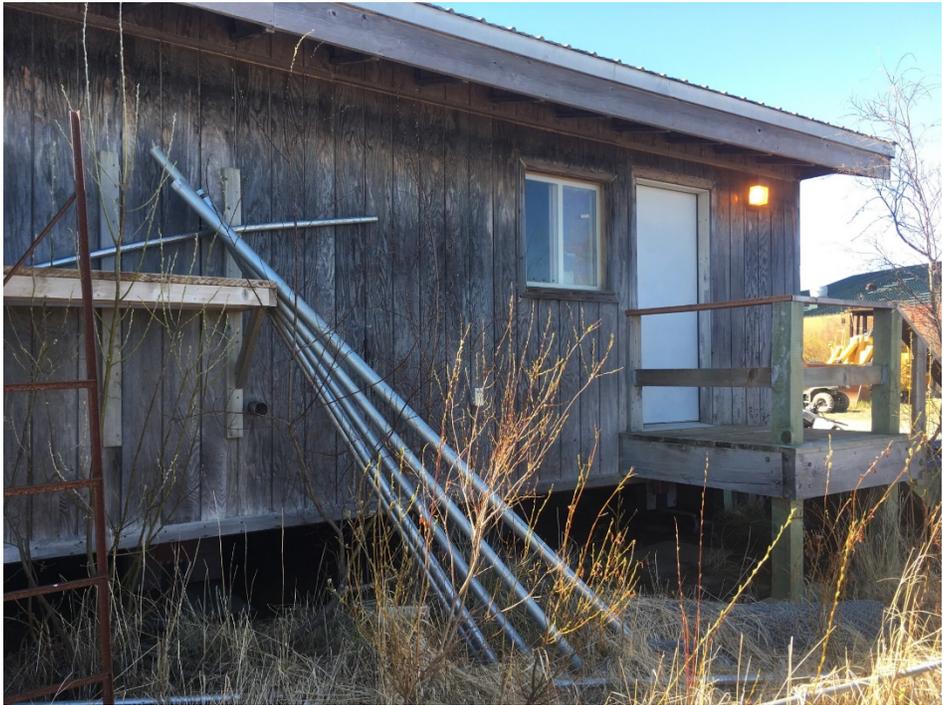
- **City Garage:** This building provides critical infrastructure and is used by the city to maintain its fleet of four-wheelers, vacuum pumps and tanks on trailers to support the community's water-sewer flush/haul system. This building is approximately 36'x36' and built on post-and-pad foundation elevated off the ground. It has a sizeable wooden access ramp to access garage doors (see Figure 3).
- **City Fire Station:** This building currently houses a fire truck that has not been used for many years and provides covered storage. The community would like to move this building and utilize it for storage. The building is approximately 36'x24' and may present a challenge for relocation due to the foundation support beams resting directly on pads very close to the ground (see Figure 4). Some excavation will be necessary to jack up the foundation.

Figure 3: City Garage identified for relocation.

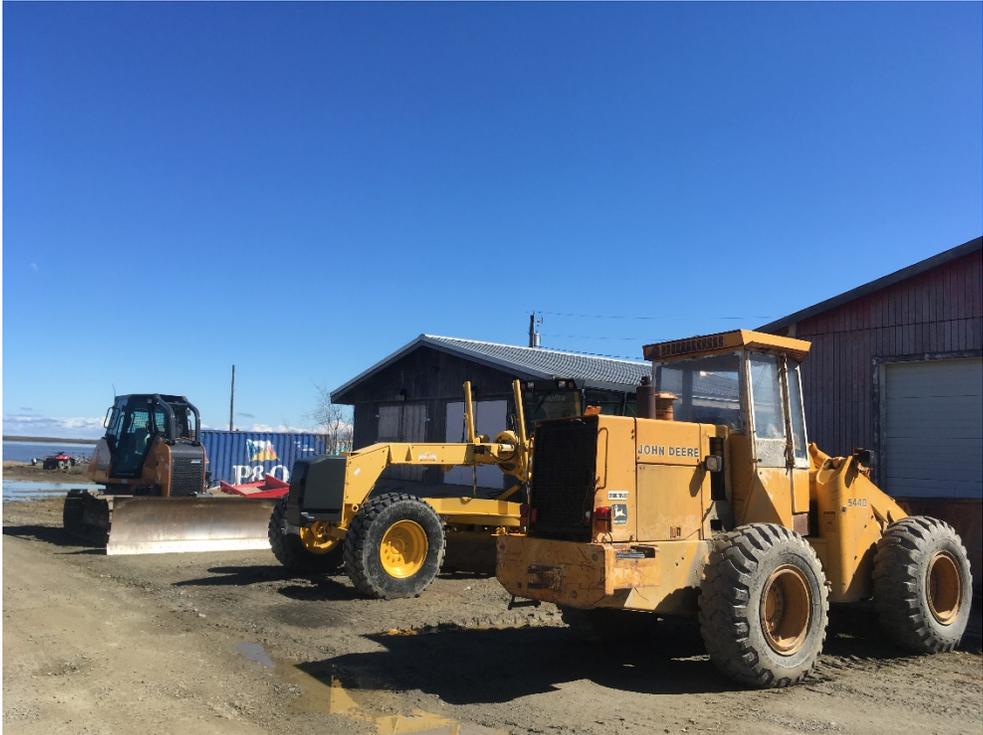
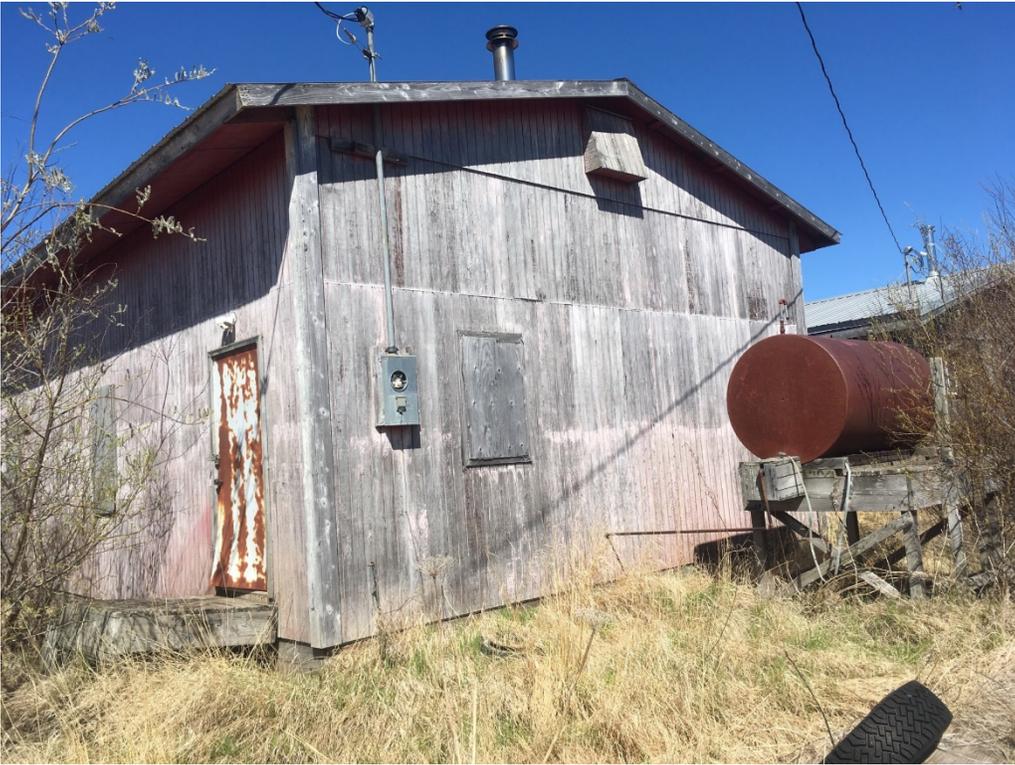
Figure 4: City Fire Station identified for relocation - building to right in top photo.

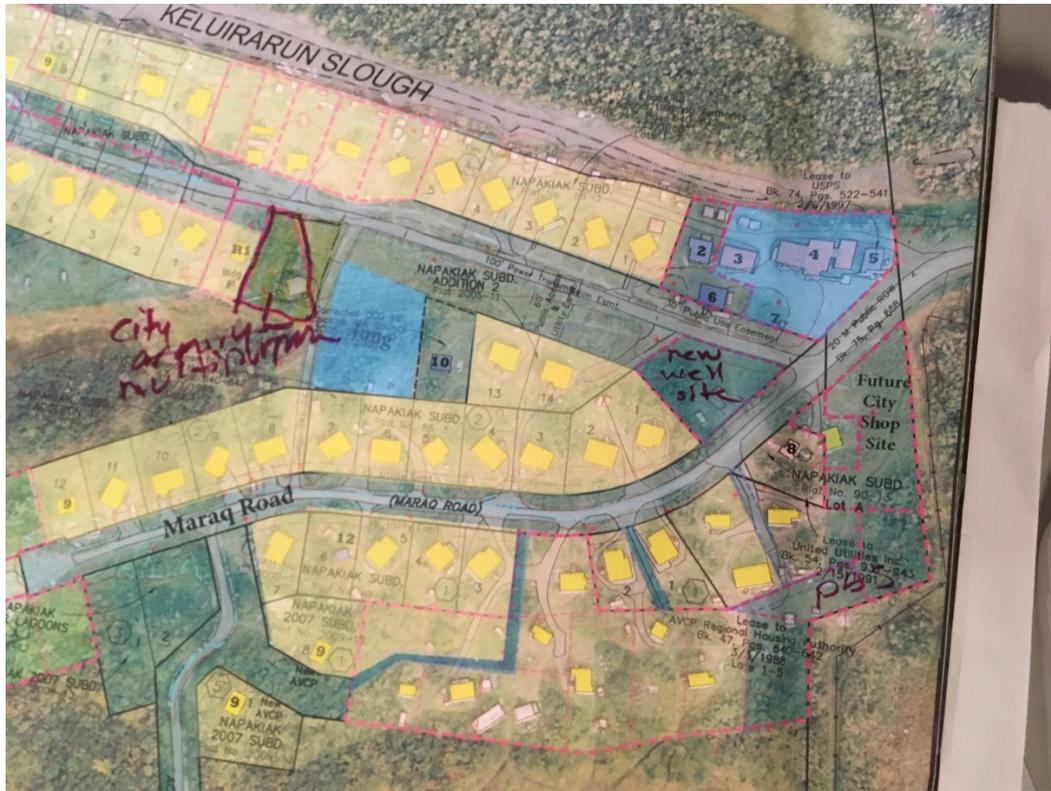
We reviewed maps identifying relocation sites well away from the Kuskokwim River bank for the identified buildings (see Figure 5) and also evaluated the road condition. Mr. Nelson indicated that relocation of buildings would need to wait until freeze up as the wet roads would not support moving the buildings in the summer (see Figure 6). Additionally, road upgrades are scheduled in the community this summer which would make relocation efforts easier once roads are repaired and improved.

Figure 5: Relocation sites identified for the buildings proposed for relocation: Armory building site in marked with red, and Future City Shop Site (Garage and Firehouse) indicated in type on right of map.

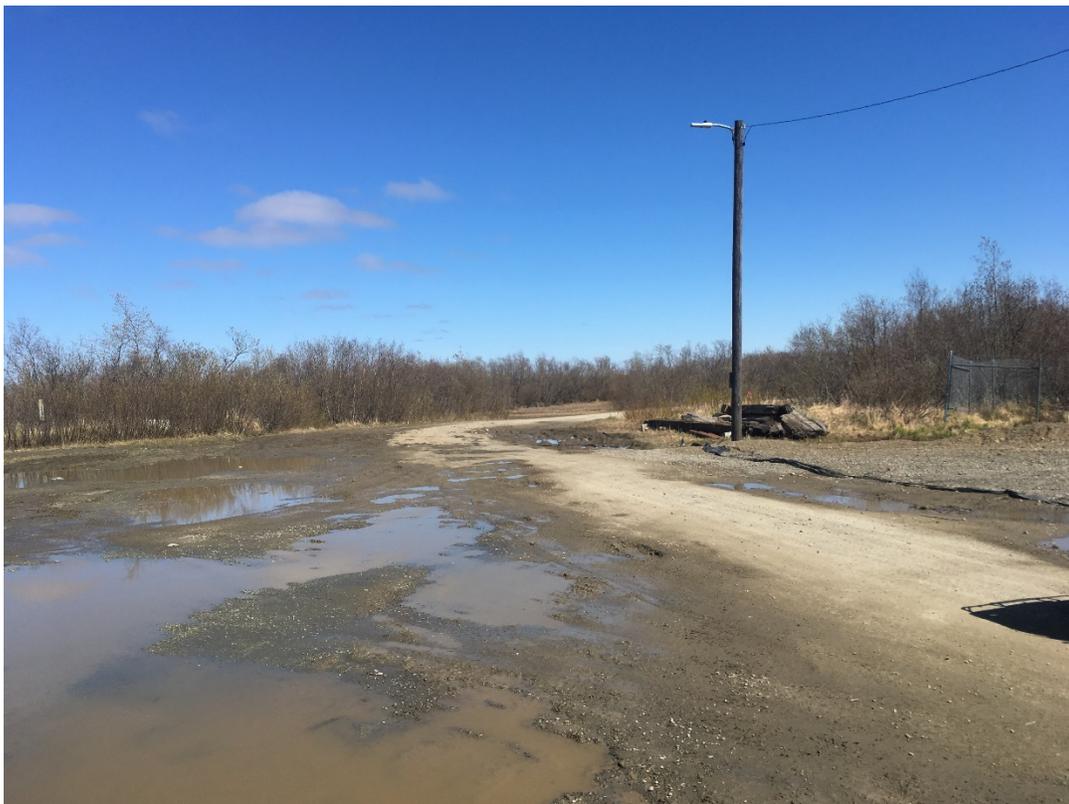
Figure 6: Road condition is uneven and wet and muddy in places.

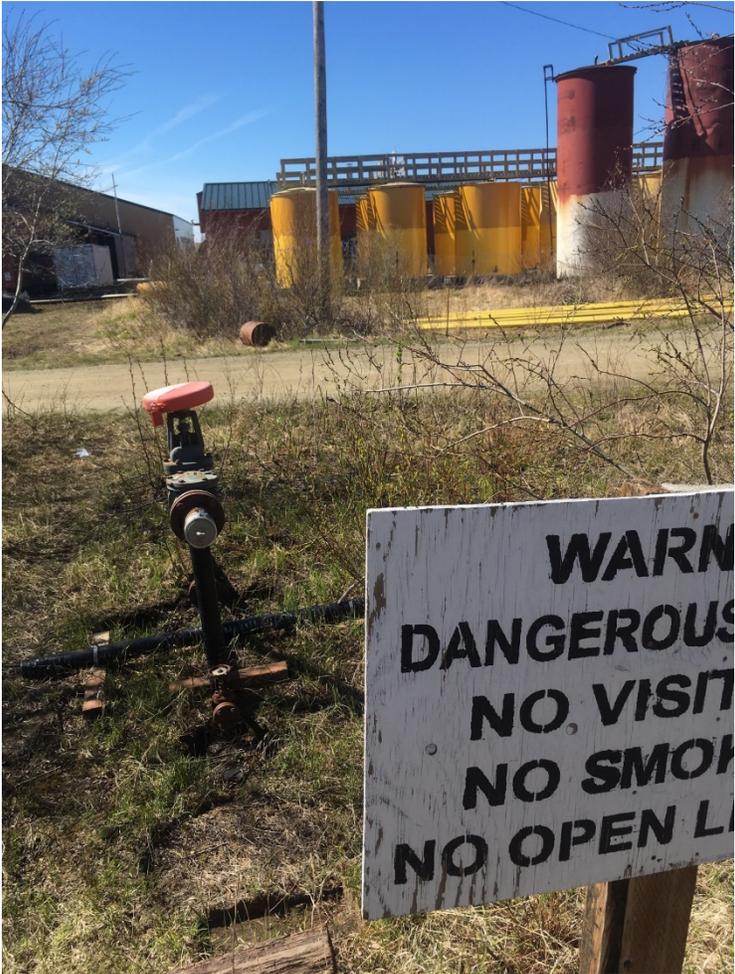
In addition to the three identified structures for relocation, we observed that the Lower Kuskokwim School District School and its tank farm are also imminently threatened by erosion (see Figure 7). The State of Alaska is reportedly working to plan a response for school relocation and/or demolition. Mr. Nelson also informed us that the community will eventually relocate its primary well house that is currently located adjacent to the Fire Station. We asked if they would be interested in moving the well as part of the relocation of the 3 identified structures and Mr. Nelson and Mr. Andrew said the new well was not ready and the community would therefore need to wait on relocating the well house.

Figure 7: School Tank Farm and Fuel Header. Note pipeline extension pile to right.

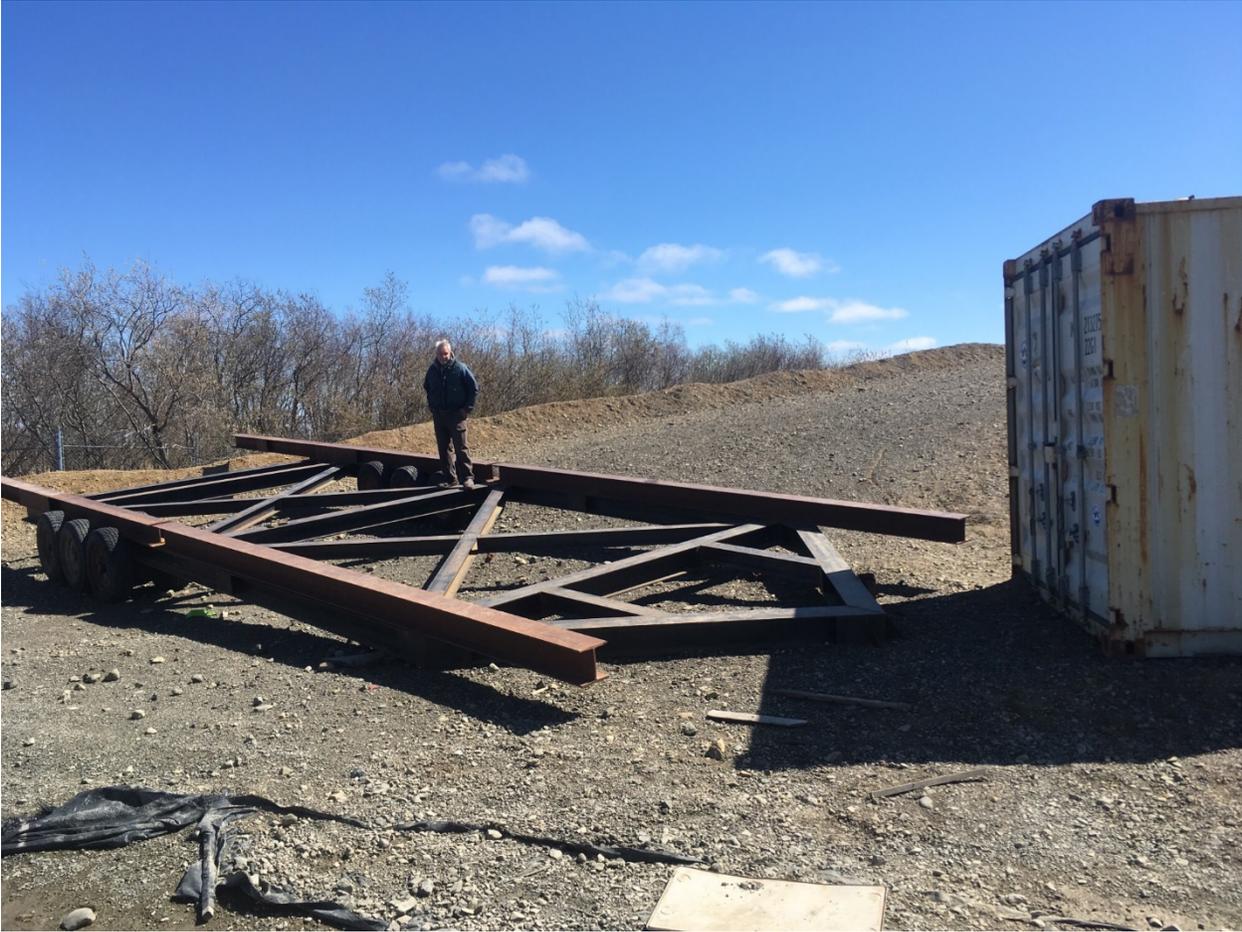
Figure 9: Shorty's Shop in Bethel built a low boy that the community has moved several homes and building with in the past.
