# Kipnuk Engineering Analysis and Design Study

**Kipnuk Traditional Council**

**Issued as Final June 30, 2016**

**AECOM**

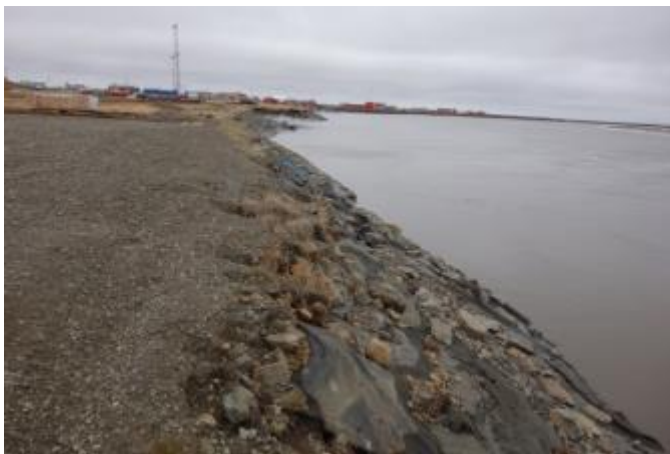
**Figure 2: Kuguklik River, Reach 2**

The Kuguklik River is a meandering stream that originates about 30 miles east of Kipnuk in an area of flat tundra and lakes. Kipnuk is located on the outer bank of an actively eroding bend of the river.

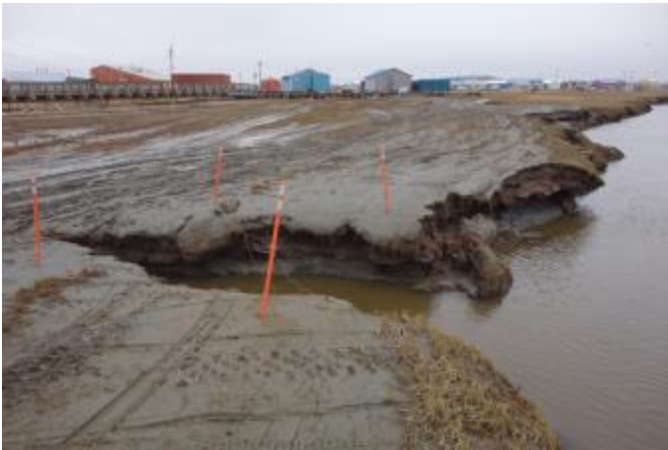
**Figure 3: Kuguklik River, Bank Erosion**

Because the most erosive discharge in the tidal channel is from upstream high-tide storage, velocities based on tidal influenced hydraulics were selected as the basis of erosion analysis (see Appendix A). According to geotechnical boring logs, natural soils in the area are composed of fine silts, which can easily erode even with mild currents. Scour undermines the bank, which leads to sloughing of the bank into the river, see figure 3. Without erosion protection the river current and wave action during storms will continue to erode the fine grained soils in the river bank. The estimated height of storm generated waves is about one meter (3 feet). Village elders report that waves typically do not travel past the bank during storm surges.

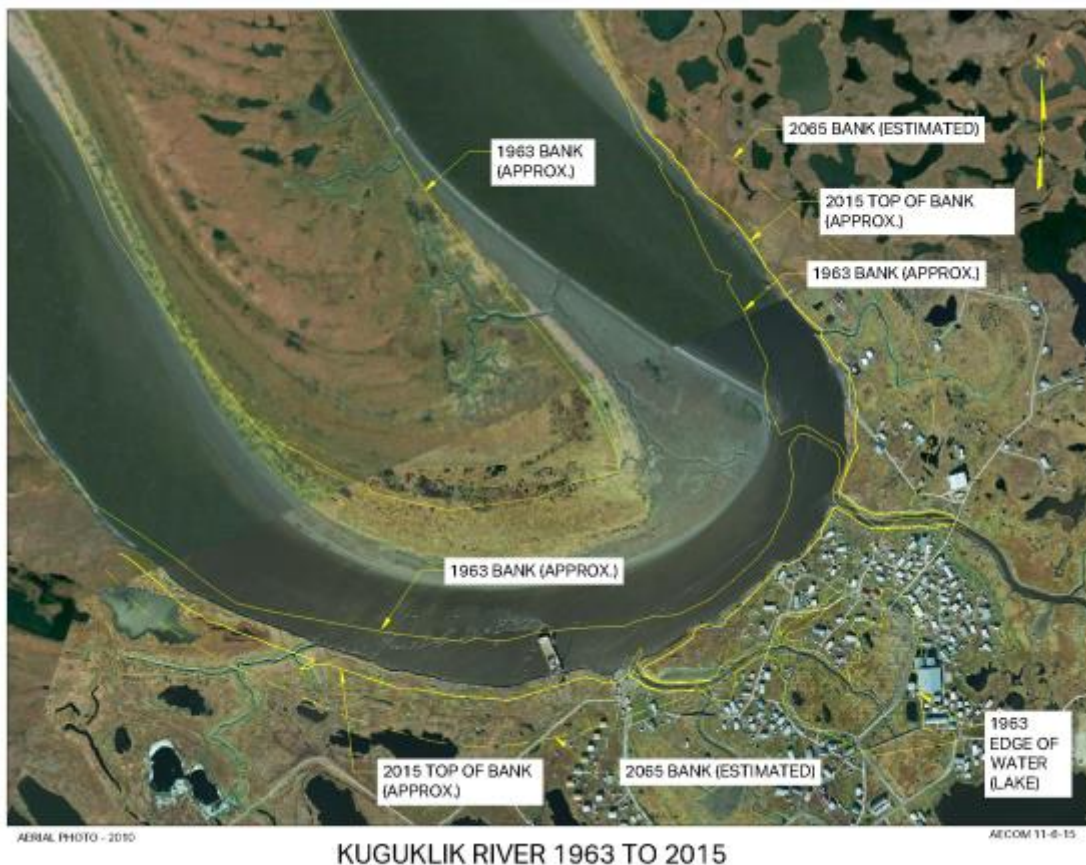
**Figure 4: Kuguklik River, Past, Present, and Future**

Based on previous surveys and aerial photographs, the historic and predicted changes in bank location due to river erosion are shown in Figure 4. The projected 2065 bank location assumes the measured erosion rates from 1963 to 2015 will continue for the next 50 years. The estimated 2065 bank is similar to the 2057 estimate by the U.S. Army Corps of Engineers (USACE) in the 2009 Community Erosion Assessment.

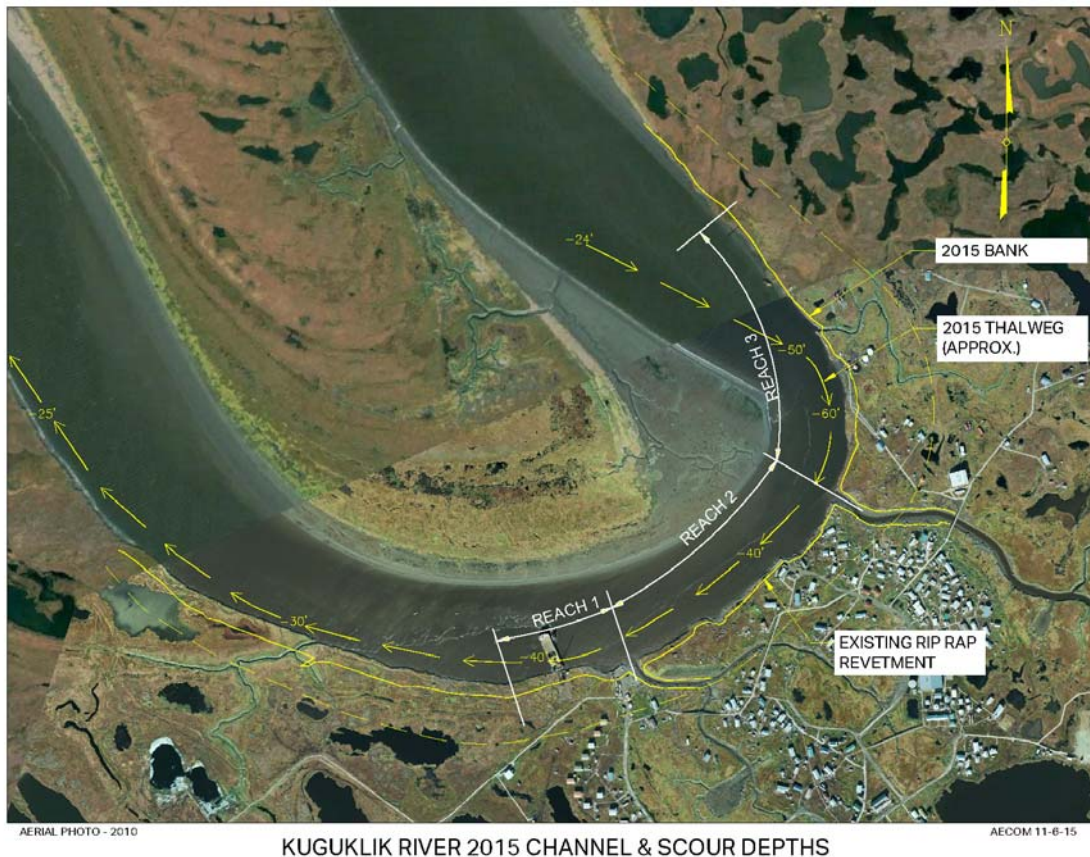
**Figure 5: Kuguklik River & Scour Depths in 2015**

Existing Class II riprap along reach 2 (see figure 5) was installed over 25 years ago. The rock protection has mostly disappeared above the water and only the fabric remains, see figure 6. Much of the rock has either been carried away by ice or dislodged by erosion and wave action. The condition of the rock below the water is unknown, though the revetment appears to have kept the bank erosion in check for many years.

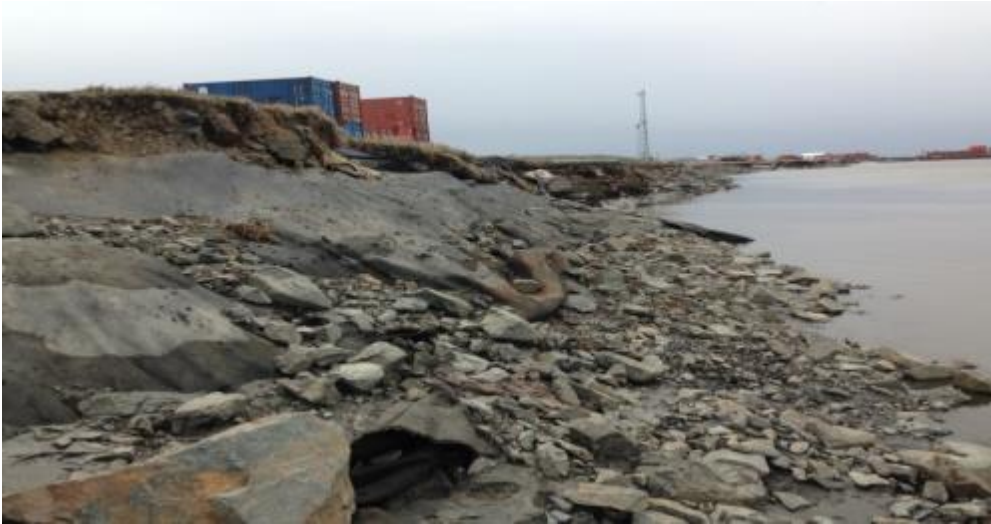
**Figure 6: Existing Riprap Revetment Reach 2**

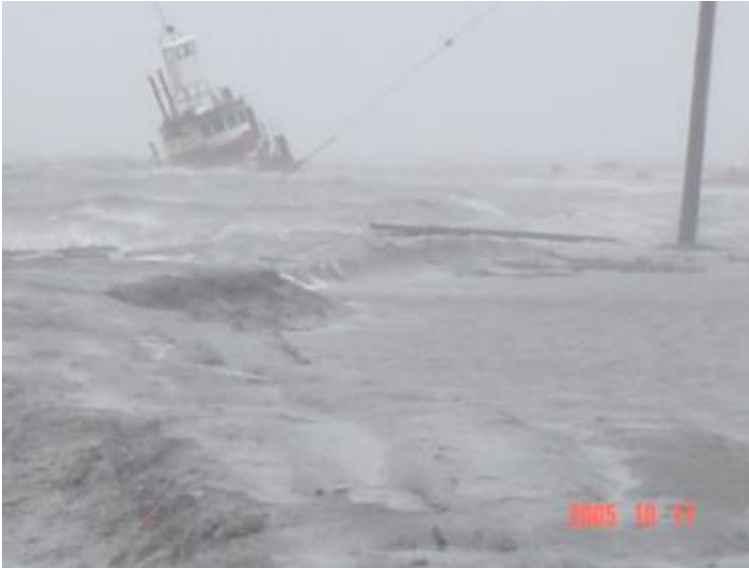
**Figure 8: Wave Run-Up During October 2005 Storm**

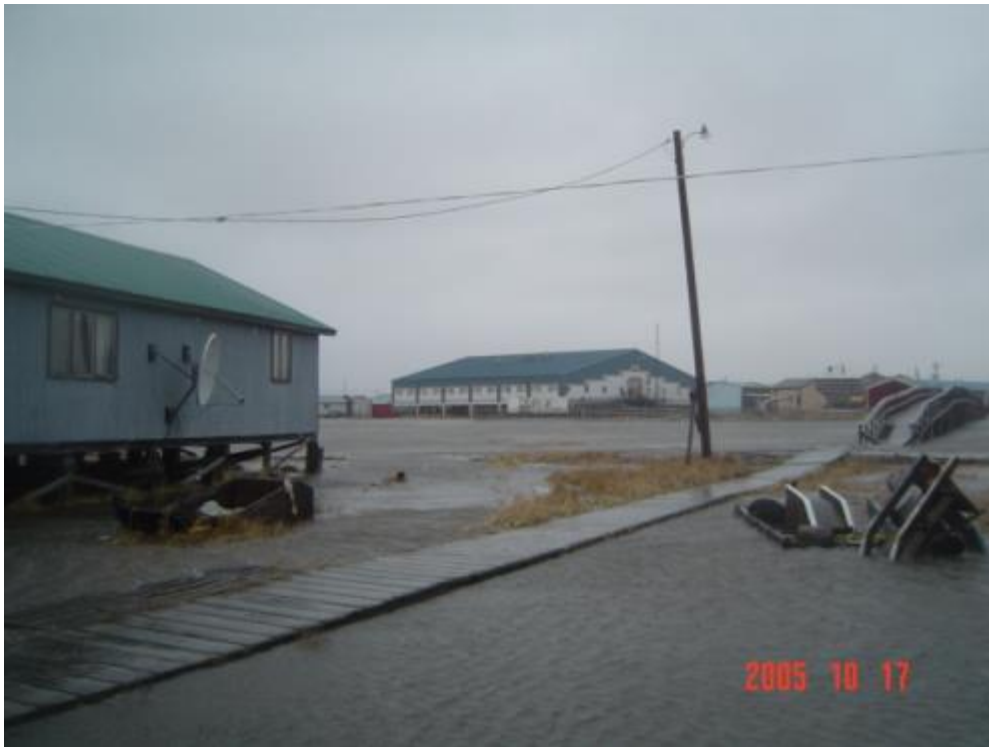
**Figure 9: Storm Surge October 2005**

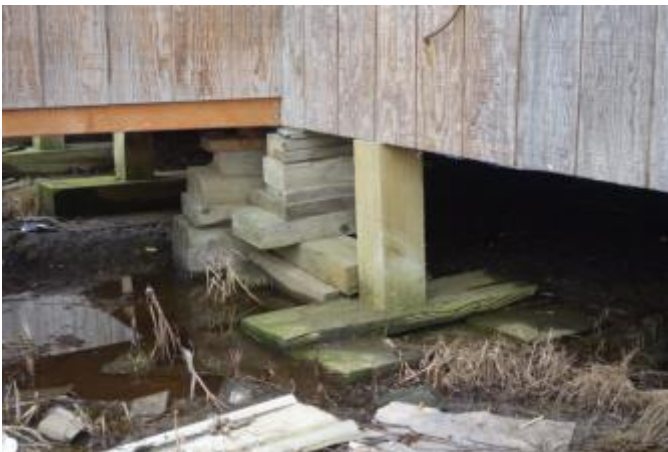
**Figure10: Footing on Undrained Soil**

It is difficult to determine if settlement of foundations is the result of permafrost thaw or soft soils without a site specific permafrost investigation. Non-insulating materials placed directly on the ground surface can help transfer heat to permafrost, leading to permafrost thaw. These materials can include wood or gravel. A layer of foam board insulation placed under wood bearing pads could reduce heat transfer to underlying soils and help keep the permafrost in a frozen state. Standing surface water can also warm underlying soils and induce permafrost thaw. Foundation settlement in many cases appears to be the result of undersized footings placed on top of soft soils. Recommendations

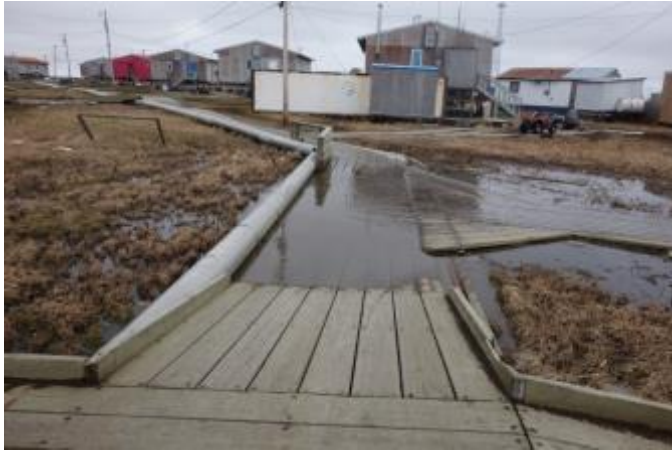
**Figure11: Boardwalk Settlement, Low Wet Area**

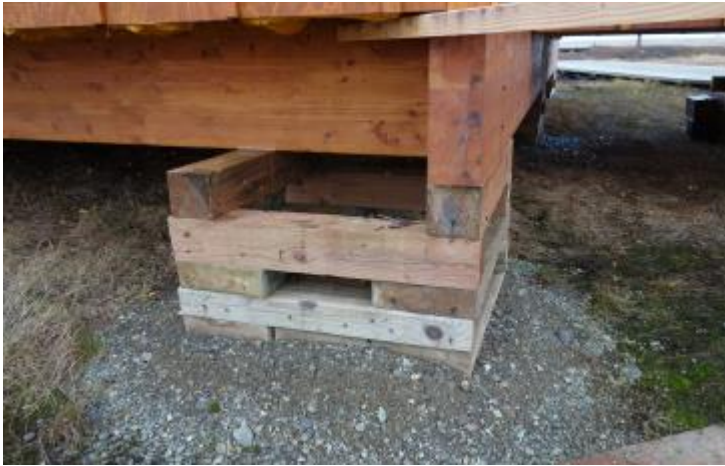
**Figure 13: Foundation Pad on Perched Ground**

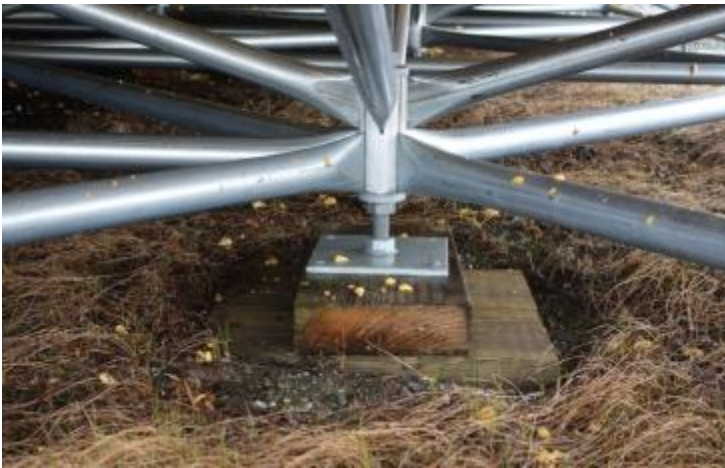
**Figure 14: Adjustable Triodedic Frame**

- Buildings not built on piling should be founded on triodetic frames, or similar, with adjustable legs to facilitate easy re-leveling and establish even load distribution into the floor structure.
- A layer of foam board should be placed under the bottom-most timber layers where buildings are founded on timber foundation pads. This will provide a thermal break which will reduce heat transfer from the surface to underlying soils.
- Consider an installation of a subsidence monitoring system in the community

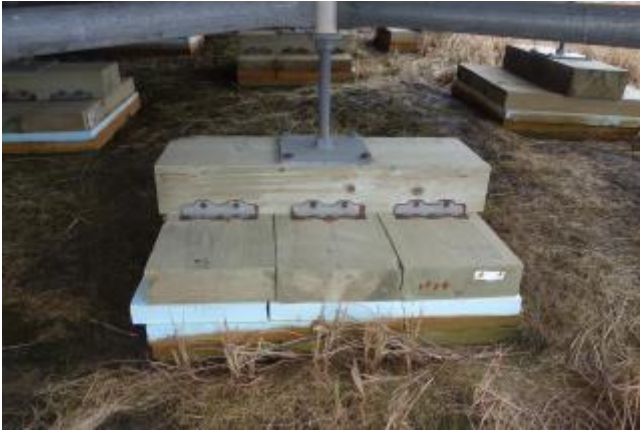
**Figure 15: Insulation Between Timber Pads**

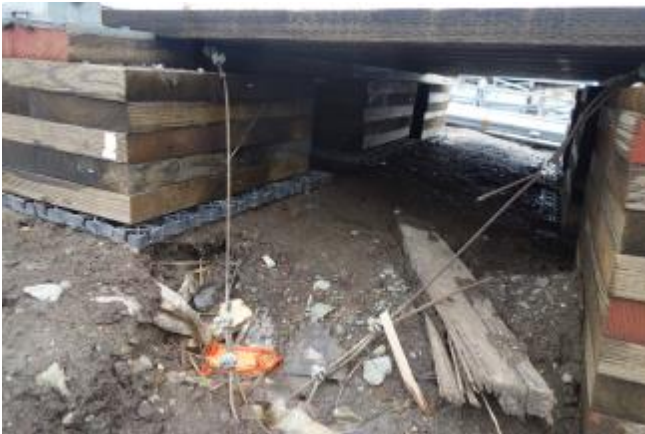
**Figure 16: Boardwalk Footing Placed on Well Drained Soil**

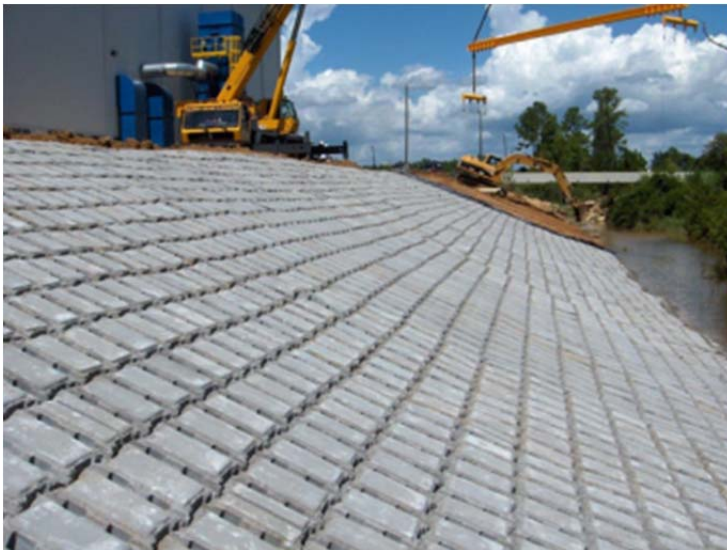
**Figure 19: Articulating Concrete Blocks**

**Articulating Concrete Block.** As an alternative to Class IV riprap, Articulating Concrete Block (ACB) could be installed at the top of the bank above Low Water. The estimated cost to install ACB matting is approximately equal to the estimated cost for rip rap (see Appendix C Cost Estimates). The ACB mats would be less susceptible to removal by ice than riprap due to their smooth surface. A filter fabric layer would be required under the ACB mats. The top edge of the ACB mats would be buried into the top of the river bank. Organic soils can be placed inside the cavities of the articulating concrete block mats and seeded to re-establish vegetation between the blocks.

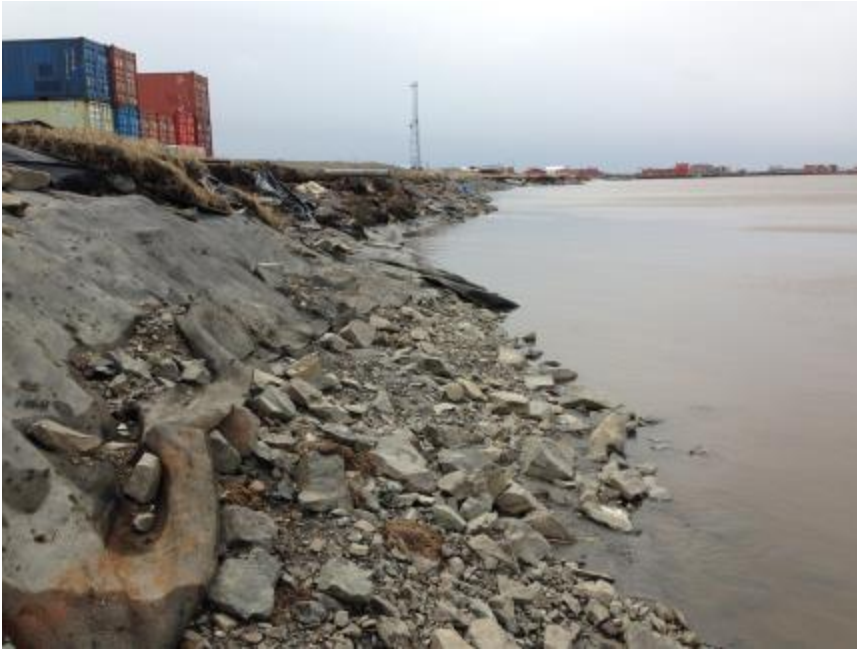
**Figure 22: Riprap In Disrepair, Reach 2**

Reach 2 Riprap would terminate at the Kipnuk Traditional Council (KTC) Lodge and tie into the existing riprap revetment. The existing revetment is in disrepair (see figure 22 and Section 6.2). The revetment has held erosion in check for many years though it is unclear the condition of the riprap below the water line and how effective the revetment will remain without repair or replacement. Under this alternative a barge landing would be located near the KTC lodge. The southern portion of Reach 2 and Reach 3 would remain unprotected and continue to erode.

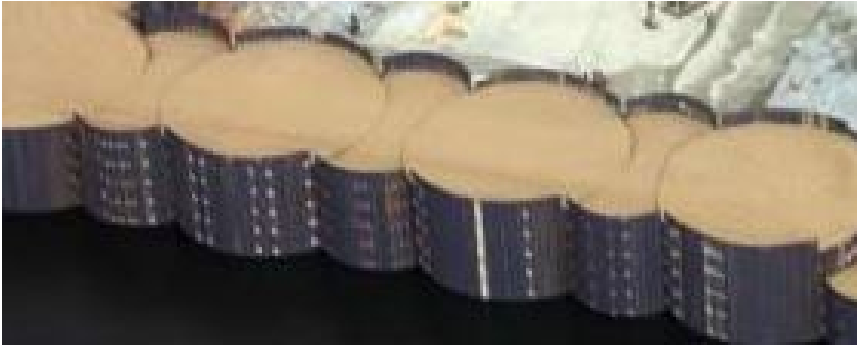
Figure 27: Circular Sheet Pile Wall System

The circular cell system would consist of a series of flat sheet piling members connected together to complete a 60 foot diameter circle. The system does not require tiebacks and has worked well at many port facilities with tall dock faces up to 60 feet high. The circular sheets would be installed to depths of 95 feet below the top of bank. The cost would be similar to that of Alternative 4. A detailed cost estimate was not developed for this alternative because the riprap alternatives would provide a more cost effective solution.

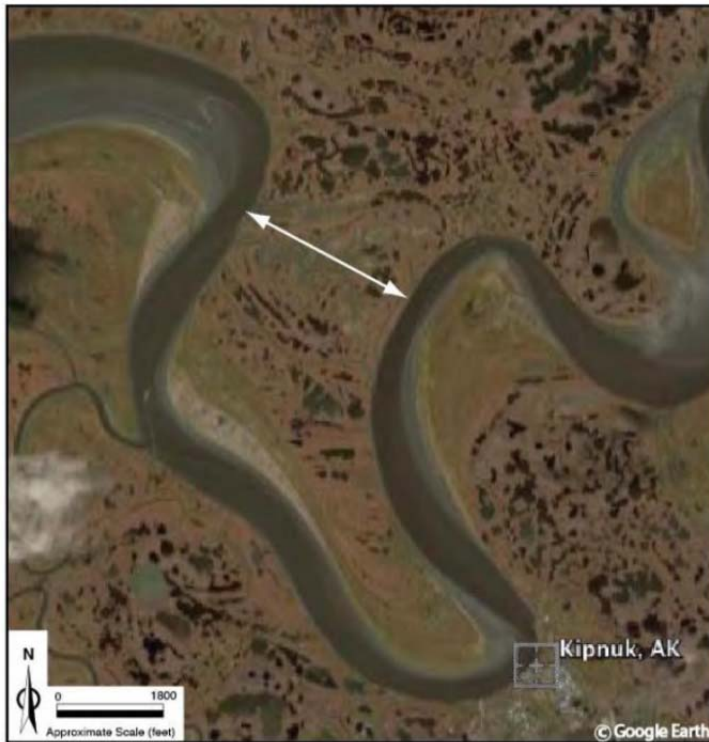
**Figure 29: Suggested Location of Cutoff Meander (From Golder 2011)**

This alternative would attempt to mimic natural river behavior by creating a ‘cutoff’ meander; this would be accomplished by excavating a channel across the inside meander loop, approximately one mile north of Kipnuk (see Figure 29). This alternative was dismissed and not developed based on the high cost to construct and difficulties described below.

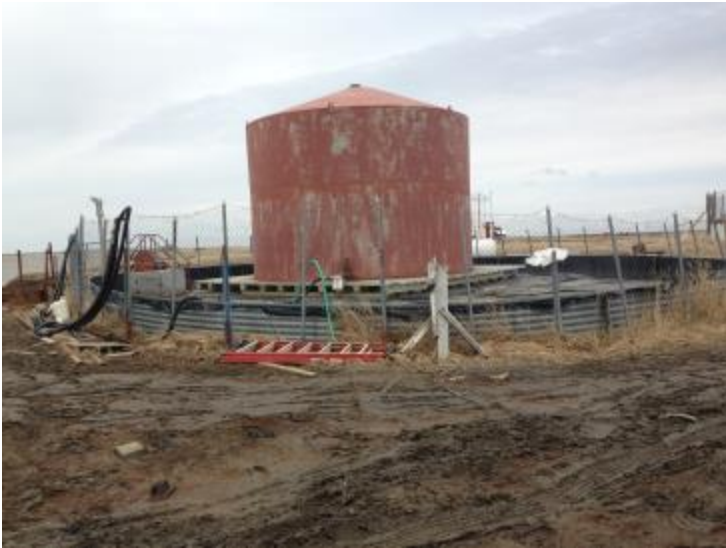
**Figure 33: Kugkaktlik Limited (Corp) Tank**

as soon as possible. The tank was less than 20 feet from the edge of the bank as of May 2015. The tank is supported on a timber foundation within a lined containment area and fenced perimeter. Several connexes and miscellaneous fuel tanks should be relocated in the first phase.

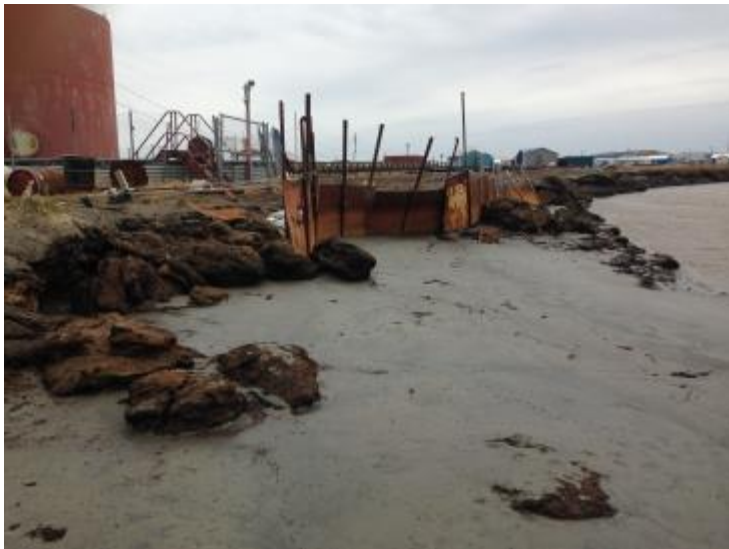
**Figure 34: Eroding Bank Near Kugkaktlik Tank**

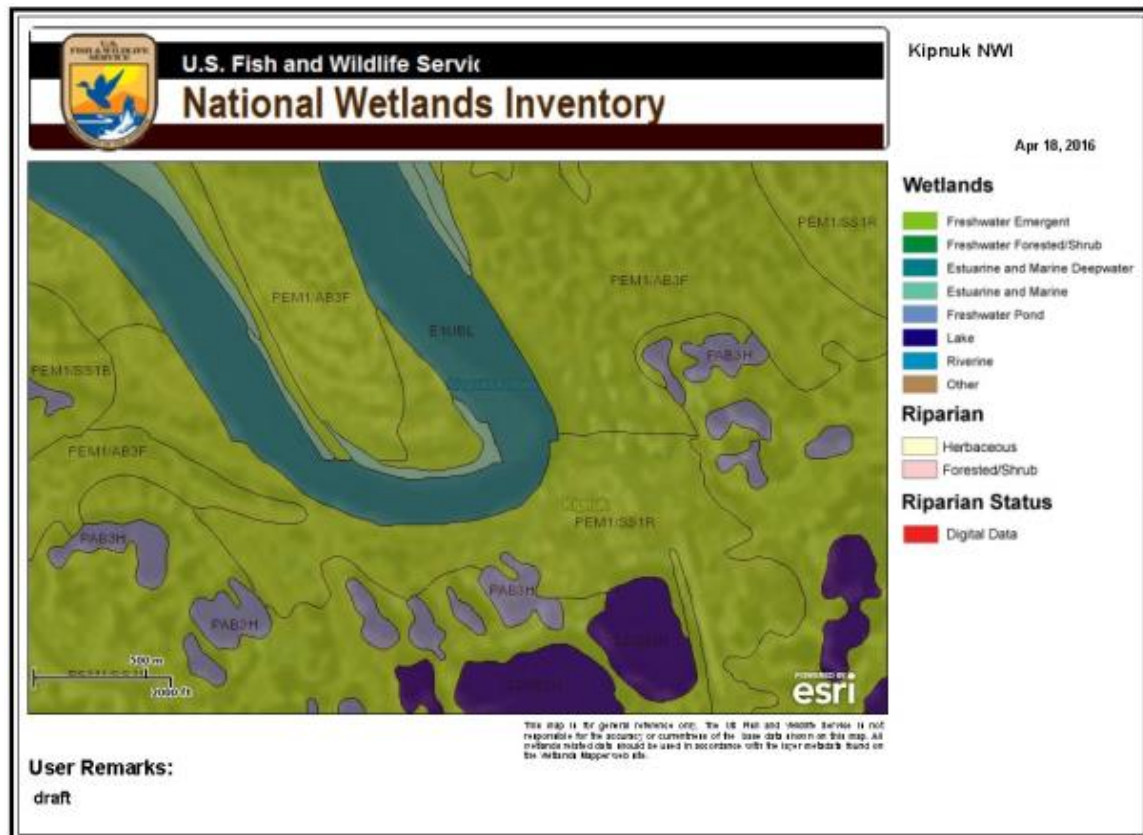
Figure 39: Kipnuk Area Wetlands Map

The National Environmental Policy Act (NEPA) of 1969 requires that prospective impacts of projects be understood and disclosed prior to a Federal agency issuing a permit or providing funding for a project. If USACE can determine that the environmental impacts from the project fall in a category of actions which do not have a significant effect on the environment then neither an Environmental Assessment (EA) nor an Environmental Impact Statement (EIS) would be required. If the significance of environmental impacts from the proposed action is not clearly established and the activities do not fall under a list of categorically excluded actions from NEPA, the USACE as the lead permitting agency, would need to prepare an EA and may require the applicant to provide appropriate information necessary for the preparation of the EA. The purpose of the EA is to determine if the project will cause significant effects. If the EA concludes that no significant impacts will occur, a Finding of No Significant Impact is prepared and is used to support USACE's permit decision. In the unlikely event that the EA for the proposed activity identifies significant impacts, an EIS would be required. Preliminary discussions with USACE in 2016 indicate that a small EA would probably be required for a river bank erosion revetment project (Riprap) or a community drainage project.

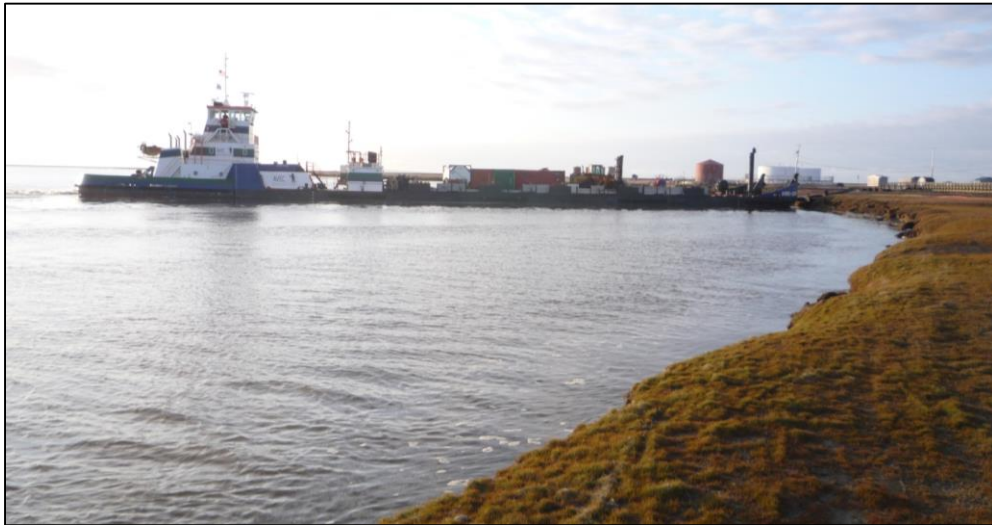
**Figure 5.** The AVEC-CAVEK 208 fuel barge offloading at Kipnuk, May 2015.

During our May field trip to Kipnuk, the fuel barge arrived in the evening and offloaded fuel and other supplies. The articulated tug-barge Cavek and AVEC-208 is large: the tug is 76 feet in length, and the barge is 208 feet in length. The tug is powered by three diesel engines delivering a total of 1800 horsepower. The engines drive 40-inch propellers in nozzles (Professional Mariner, 2015). Though the barge is designed to pin itself against the shore in fast moving rivers, we noted continuous prop wash occurred during maneuvering and the entire period that the barge was stationary and offloading. See Figure 5 and 6.

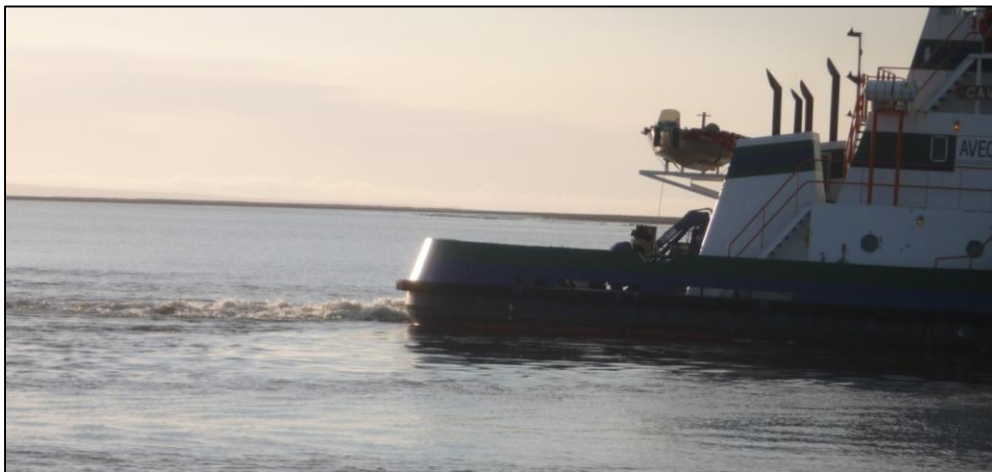
**Figure 6.** Prop wash from the AVEC barge, while stationary against the bank.

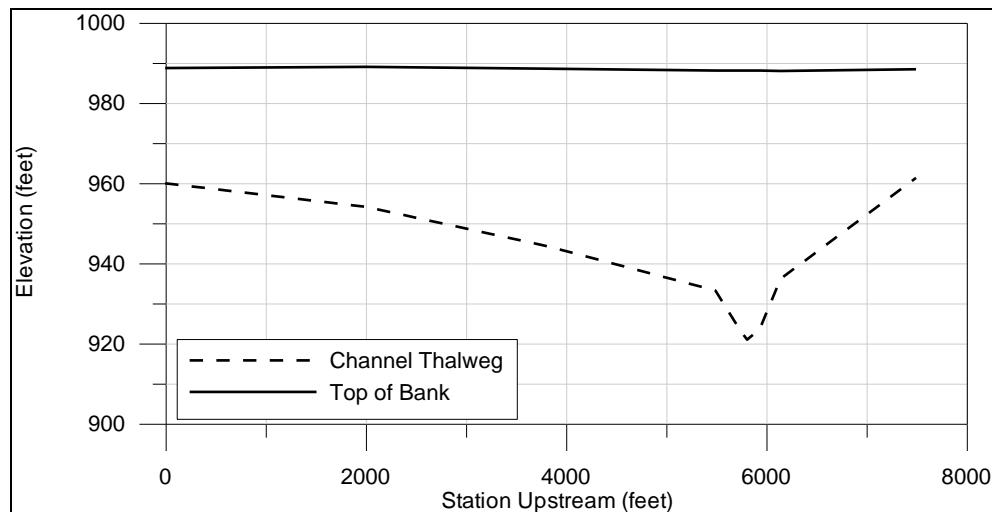
**Figure 7.** Profile of Kuguklik River channel at Kipnuk.

To help define the extent of the scour hole in the Kuguklik River, the cross-section survey conducted in May 2015 included multiple shots of the channel bed thalweg. A profile of the river channel, including the thalweg and adjacent bank, is found in Figure 7. A contour map of the scour hole is found in Figure 8.

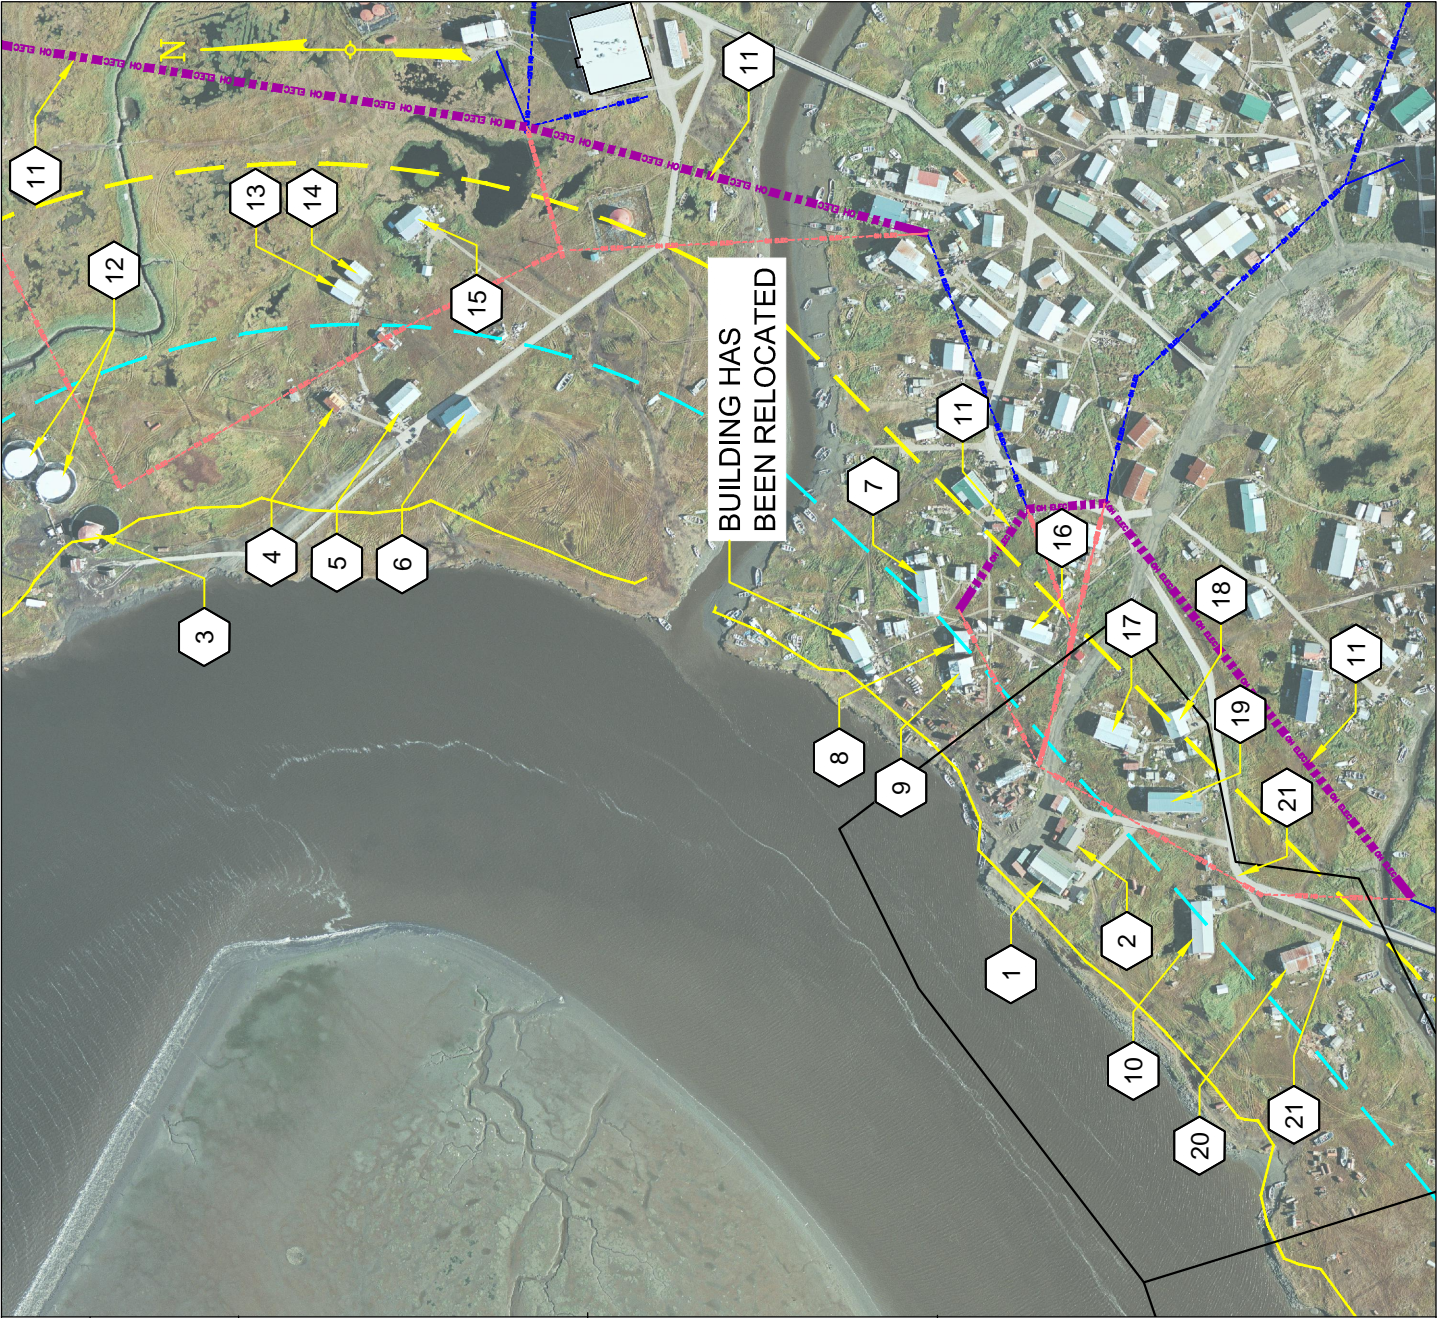
1 SHEET KEYNOTES	
PHASE I	
1.	KTC LODGE
2.	KTC GARAGE
3.	KUGAKTLIK CORP TANK
PHASE II	
4.	BUILDING 4
5.	BUILDING 5
6.	BUILDING 6
7.	BUILDING 7
8.	BUILDING 8
9.	BUILDING 9
10.	BUILDING 10
11.	OVERHEAD ELECTRIC & TELEPHONE RELOCATION
12.	KUGAKTLIK CORP TANKS (2)
PHASE III	
13.	BUILDING 13
14.	BUILDING 14
15.	BUILDING 15
16.	BUILDING 16
17.	BUILDING 17
18.	BUILDING 18
19.	BUILDING 19
20.	BUILDING 20
21.	BOARDWALK
NOTE: MISCELLANEOUS STRUCTURES SUCH AS SMALL TANKS, CONEXES, AND SHEDS, NOT LISTED ABOVE, WILL ALSO REQUIRE RE-LOCATION  <b>LEGEND</b> — 2015 BANK — 2040 BANK (ESTIMATED) — 2065 BANK (ESTIMATED) --- OH ELEC --- EXISTING OVERHEAD TRANSMISSION LINES --- OH ELEC --- OVERHEAD TRANSMISSION LINES TO BE RELOCATED --- OH ELEC --- RELOCATED OVERHEAD ELECTRICAL TRANSMISSION LINES

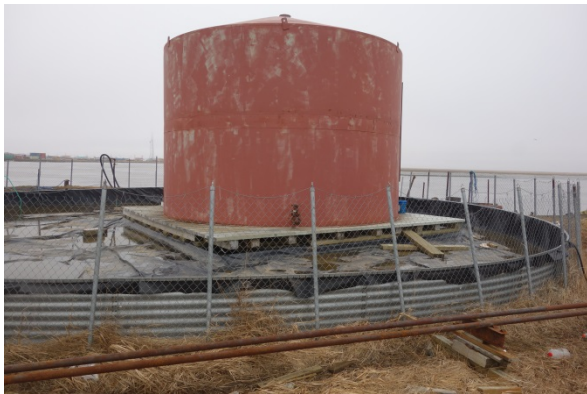
**Figure 1: Smaller Tank**

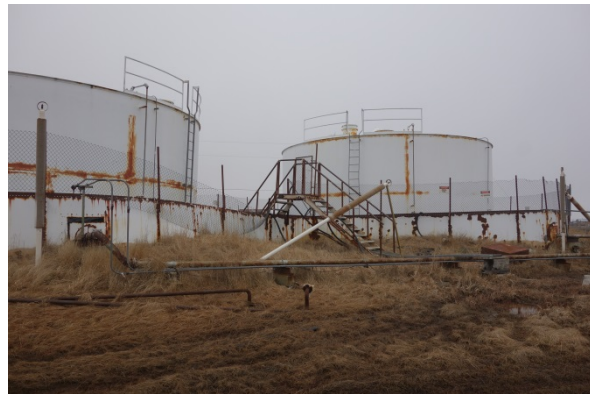
**Figure 2: Two Larger Tanks**

The two larger tanks are located at least 100 feet from the riverbank and were constructed on raised cement treated (Golder, 2011) embankments. These embankments raise the base of the tanks approximately 3 feet above the surrounding ground surface. Additionally, four thermosyphon's extend beneath these tanks, however two of the four thermosyphon's are damaged. Due to the vegetation and spill containment surrounding the tanks, it was difficult to visually assess if these larger tanks foundations are moving.

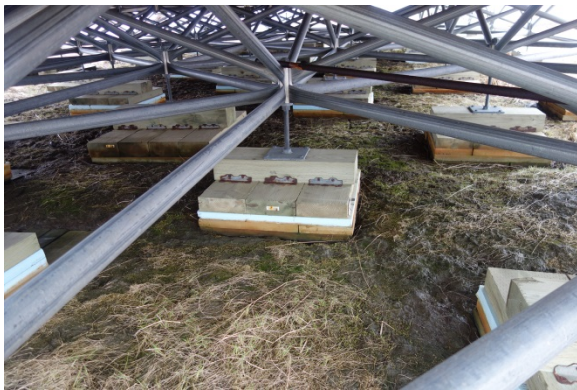
**Figure 3: National Guard Armory**

**National Guard Buildings:** Three buildings in this group are all supported by triodetic steel frames and pad footers. The Southernmost building showed minimal-to-no movement and was in the best condition of the three buildings. It has adjustable (12-inch adjustment) legs connecting the triodetic frame to the footers. These footers were the largest pad footers (3-foot x 3-foot) of the three buildings and each contained 2 to 4-inches of insulation between the tundra and wooden footers. Some of the footers have compressed up to 3-5 inches into the ground surface. The main (painted green) building was tilting significantly towards the west and the triodetic frame was disconnected from some of the footers on the east side. Installing adjustable legs between the triodetic frame to the footers would facilitate re-level the building. The triodetic frame of the older building (constructed in the 1960's) to the east, was supported by small (1-foot to 1.5 foot square) footers and in some places the footers were missing and the frame was sitting directly on the ground surface. The frame should be elevated and re-leveled on adequately sized footers installed beneath it.

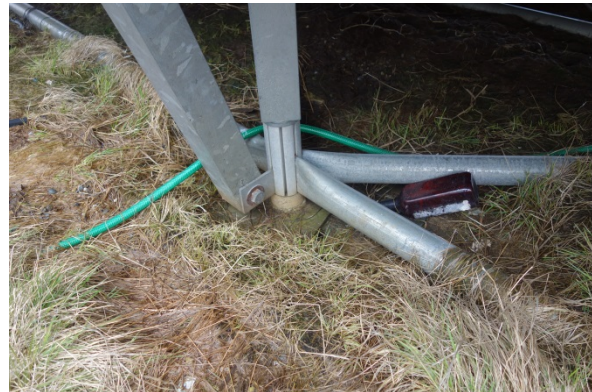
**Figure 4: Sunken Footer**

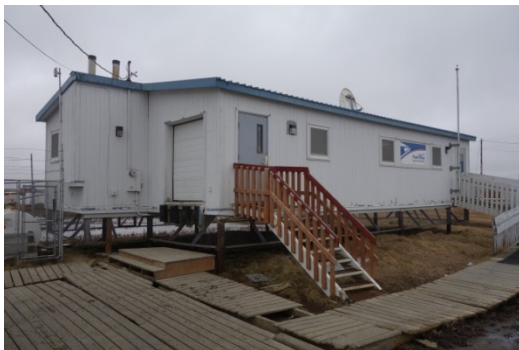
**Figure 5: Post Office**

**Post Office:** in the post office building is supported by 6-inch diameter pipe piles and is raised approximately 4 feet above the ground surface. The foundation experiences differential movement and is routinely jacked/re-leveled every couple of years. This was evident when inspecting the foundation as the pile caps were not level and timber shims were observed at many of these caps. Some of the internal walls were cracked and the post office staff reported some doors jamming during winter months. Corrosion was observed on all piles.

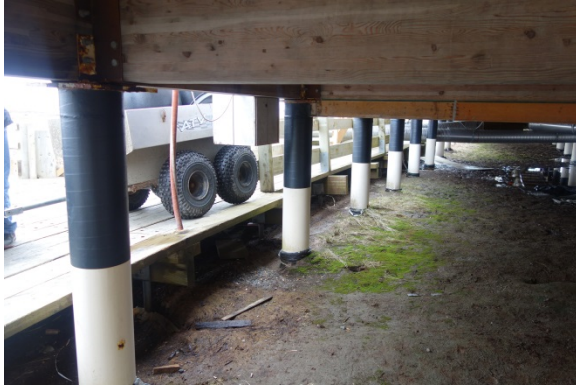
**Figure 6: Washeteria Piling**

**Water Treatment Plant and Washeteria:** Was constructed in 2009 and is located on the south edge of town. The foundation consists of steel piling with black polyethylene used to reduce the adfreeze bond strength within the active layer. The building is raised approximately 5-6 feet above the ground surface to cool the foundation using natural convection. This foundation appears to be performing well with no signs of differential movement of the pile caps or distress to the interior of the building.

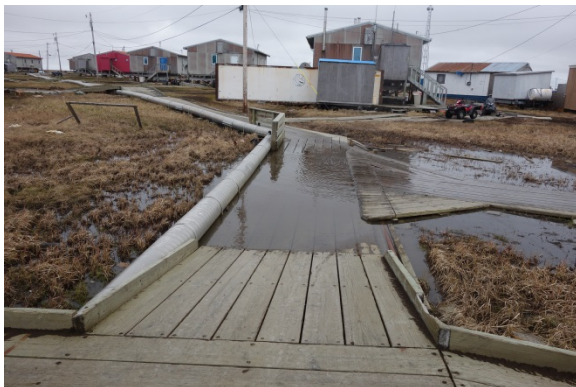
**Figure 7: Boardwalk in Ponding Water**

**Board Walks:** Some intersections are located in standing/ponded water. Some older boardwalks (pre-2006?) are not anchored and could float during floods. This has not been a problem over past decade and unlikely they will move due to minimal current.

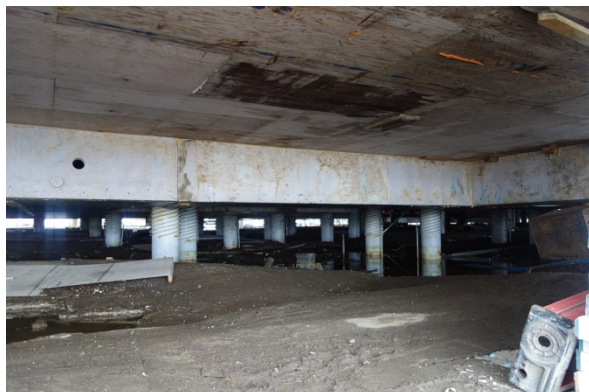
**Figure 8: Old School**

**Chief Paul Memorial School** is constructed using passive refrigerator piling (thermal piles) and has a history of differential movement since construction. Test borings performed in 1988 at the school site encountered frozen soils consisting of surface peat, organic silt and silt. In the 1990's differential movement was reported and in 1996 Artic Foundations Inc performed a pile cap survey. The survey measured differential movement since construction of  $\frac{1}{4}$  to 4.5 inches. At this time it was determined the movement was caused from heave due to over cooling of the piles and a number of thermal pile were decommissioned. In 2011 Golder also performed a pile cap survey and reported differential movement since the 1996 survey of  $\frac{1}{4}$  to 4.5 inches.

During our inspection of the Chief Paul Memorial School foundation, insulation damage and standing water observed beneath the school floor in 2011 (Golder, 2011) was still present. It appears the ponding water is periodically pumped from beneath the school as a small 2-inch trash pump was set-up beside one of the ponded areas. At the time of the site visit, the interior of the school was being renovated and was not inspected for structural or cosmetic damage to the internal walls/doors. The pile caps were visually assessed for differential movement and settlement on the perimeter piles of the West, North and East sides of the building. Some piles on the west side of the building showed upwards movement of up to 1-inch, indicating these piles may have heaved in this location. Piles on the east side of the building appeared to be relatively consistent with each other when visually assessed. Two piles on the north side of the building showed up to 1-inch settlement, however it was not clear if these were constructed this way as there were old shims that were inserted in the gap and appears to have been there for many years. The observed movement of the pile caps on the perimeter of the building were within the range ( $\frac{1}{4}$ -inch to 4- $\frac{1}{2}$  – inch) of differential movement previously recorded during pile cap surveys and the differential movement does not appear to be increasing at this date.

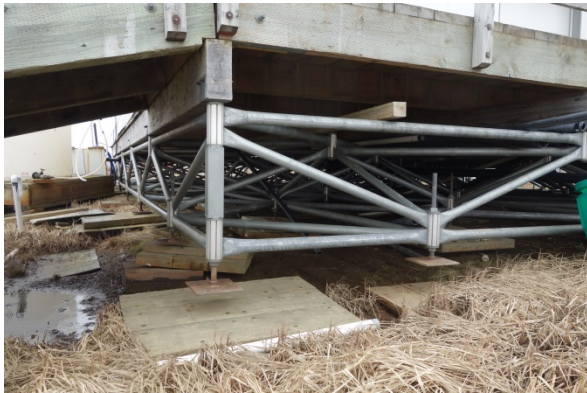
**Figure 10: Halibut Plant, Unsupported Legs**

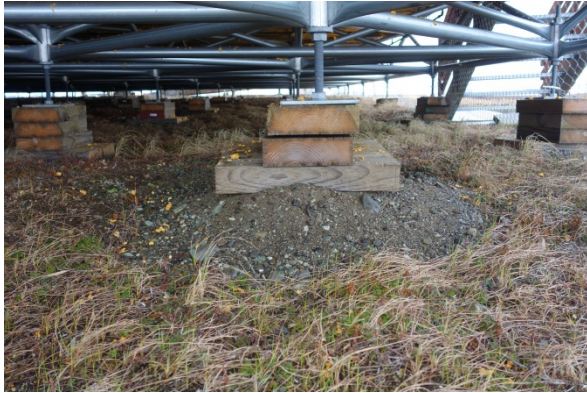
**Figure 11: Church Footings**

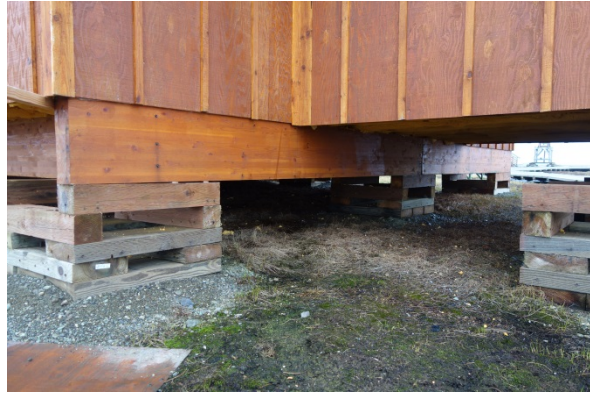
**Figure 12: Church Residence Footings**

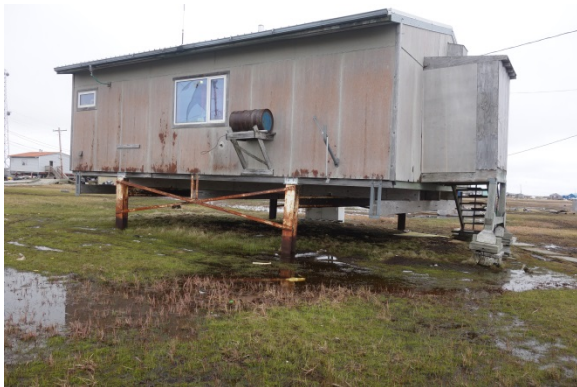
**Figure13: Pile Supported Residence**

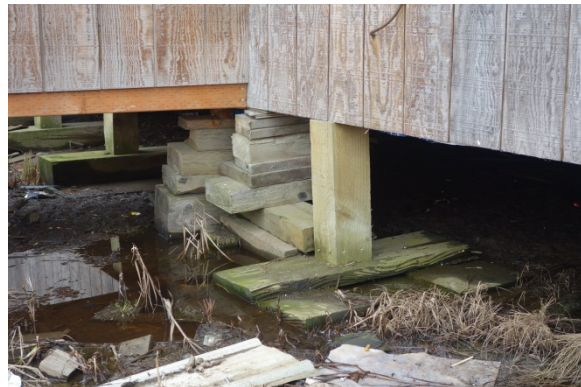
**Figure14: Residence Footing on Undrained Soil**
