NINGLICK RIVER EROSION ASSESSMENT

ADDENDUM

NOVEMBER 29, 1984

by
Woodward-Clyde Consultants
Anchorage, Alaska 99503

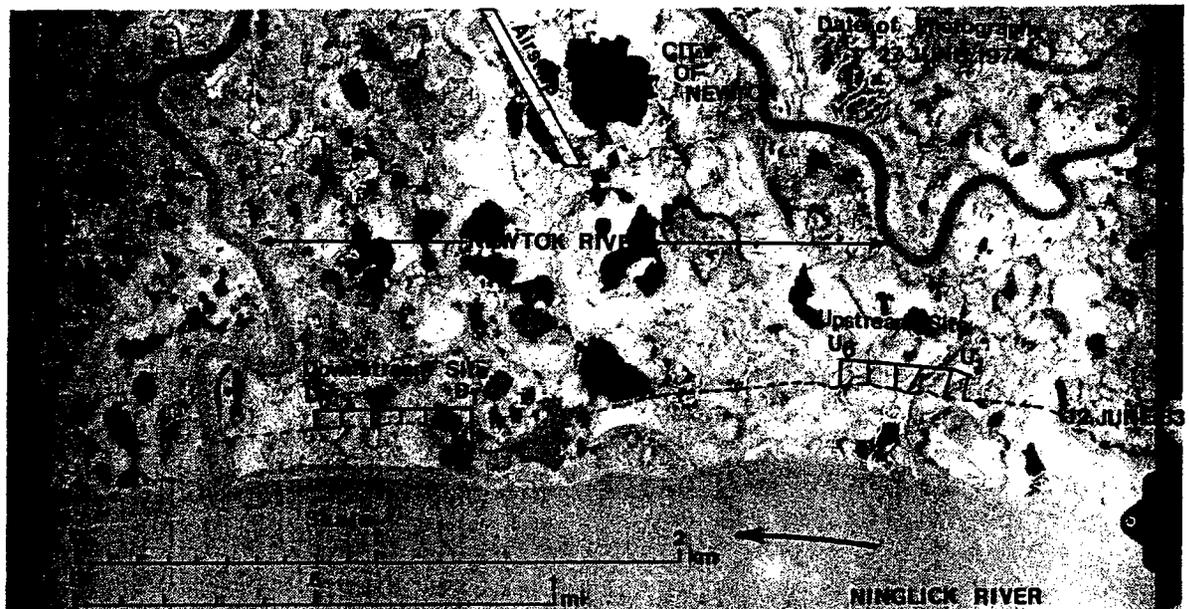
Figure 4. Aerial photographs illustrating a) approximate historic bank locations and b) locations of 1983 study sites.
