Quinhagak Hazard Impact Assessment

City of Quinhagak

February 10, 2012

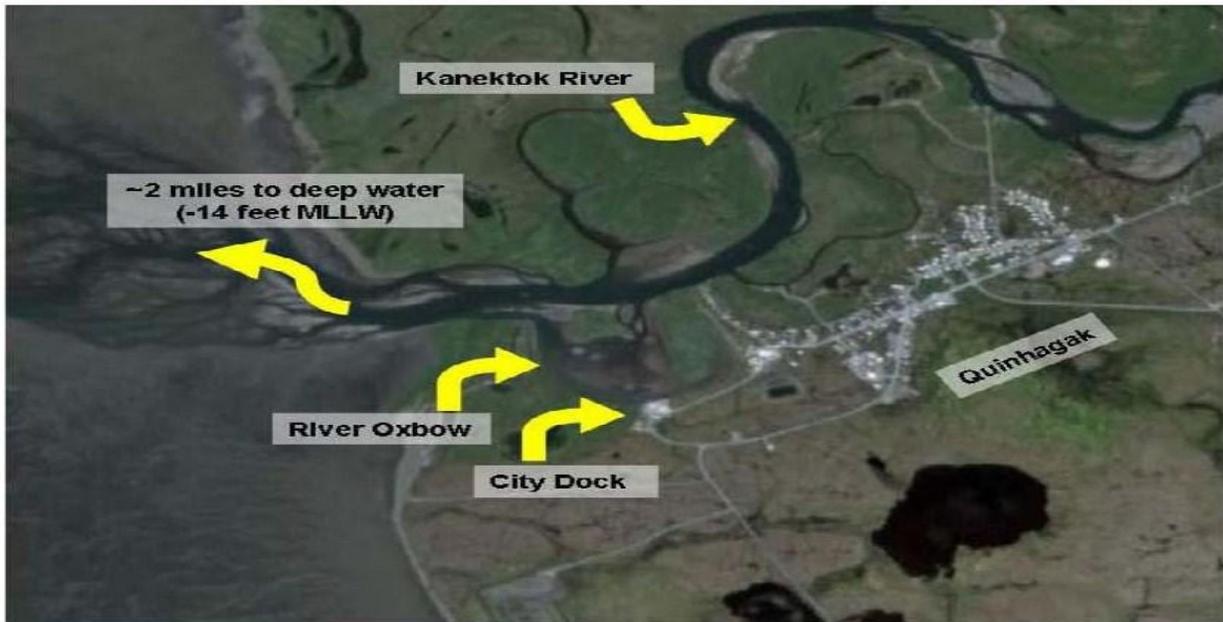
Map showing Kanektok River and City Dock on river oxbow is from the ***Dock and Marine Infrastructure Improvements Technical Report***, USACE & Denali Commission, (June 2010).

The Quinhagak City Dock is located in a bend of the Kanektok River that is slowly silting in and will eventually form an oxbow lake. The channel from this oxbow exits into the Kanektok River near its confluence with the Kuskokwim Bay. Silty conditions and large tidal action in Kuskokwim Bay have left multiple deposits at the mouth of the Kanektok River leading to these challenging navigational conditions for vessels trying to access the City Dock (USACE, 6/2010). In the last 20 years, navigational conditions at Quinhagak have deteriorated from local fishermen being able to utilize 26 foot boats equipped with outboards. To the current situation in which fishermen must use shallow draft boats equipped with jet motors according to local residents interviewed.

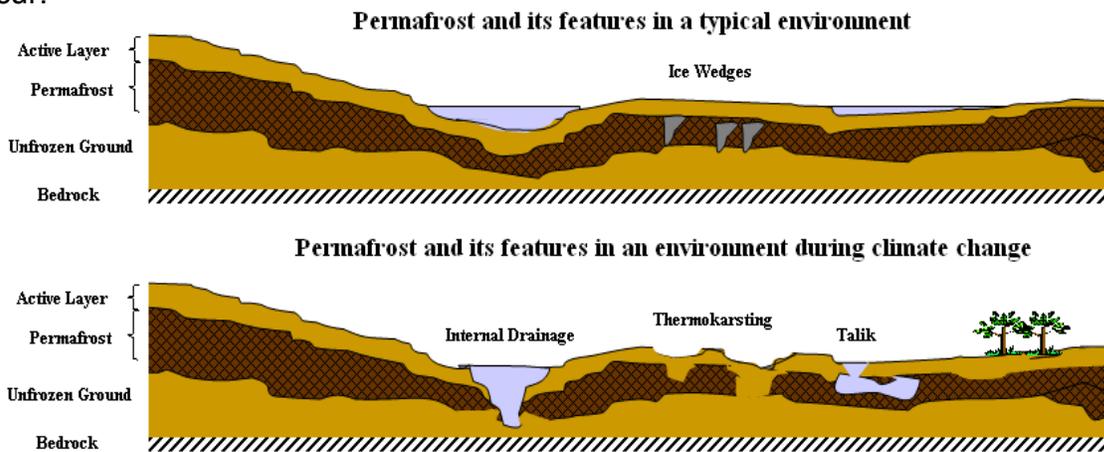
Figure 1. Consequences of a climate warming on permafrost and hydrology. Thawing of permafrost result in drainage of ponds, thermokarsting where ice rich soil and ice wedges degrade, talik formation and deepening of the active layer.

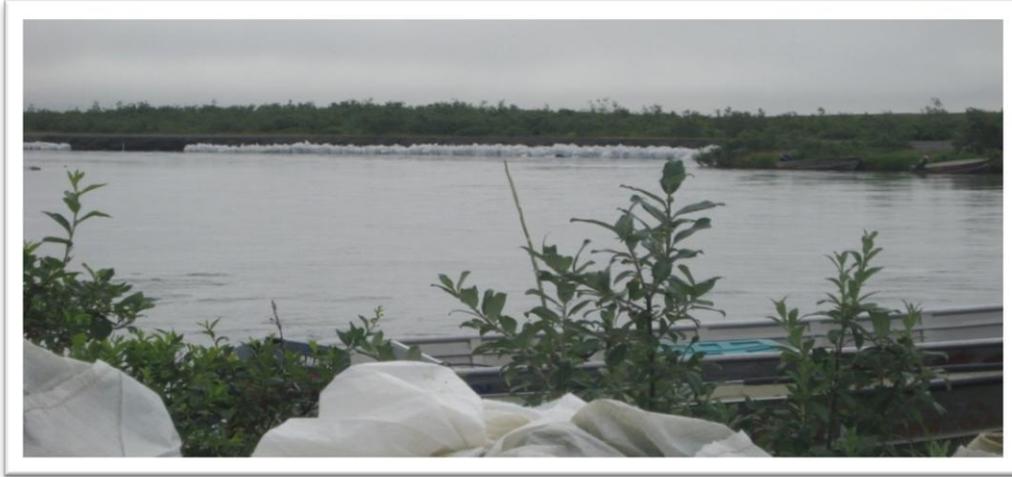
Figure 1. Super sacks foreground, and in the distance, along Kanektok River shoreline adjacent to the old airport runway placed in an attempt to curb erosion.

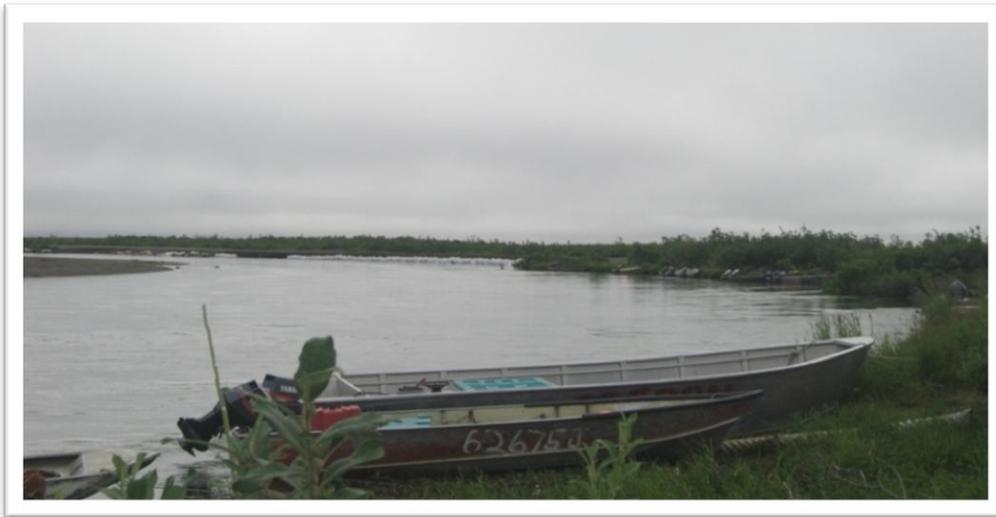
Figure 2. Along the Kanektok Riverbank in the distance white super sacks are placed to curb erosion along an outside meander bend of the river adjacent to the old airport runway.

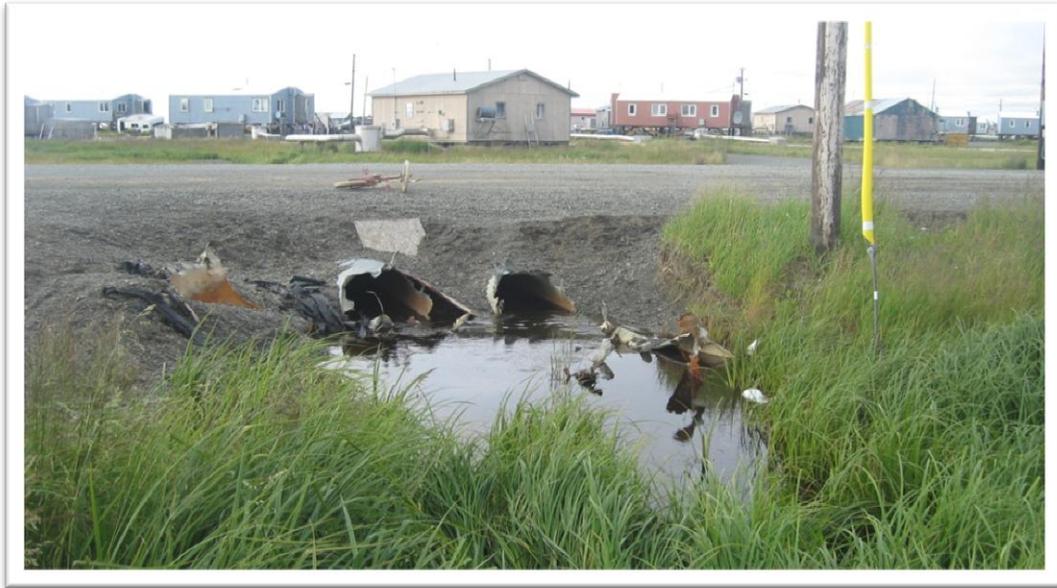
Figure 3. View is to the north at two 24" culverts under Old Quinhagak Airport Road (Qunirtuuq Drive) near intersection with Agalik Avenue. Road has been over topped and washed out.

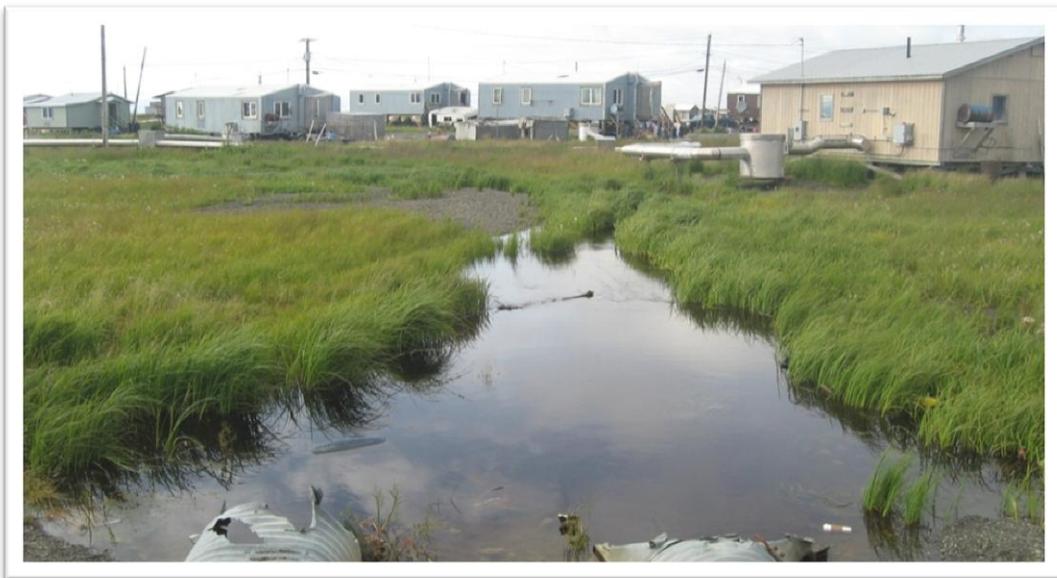
Figure 4. Downstream side of two 24" culverts under Old Quinhagak Airport Road (Qunirtuuq Drive). Note the large sediment deposits carried into the wetlands below the road.

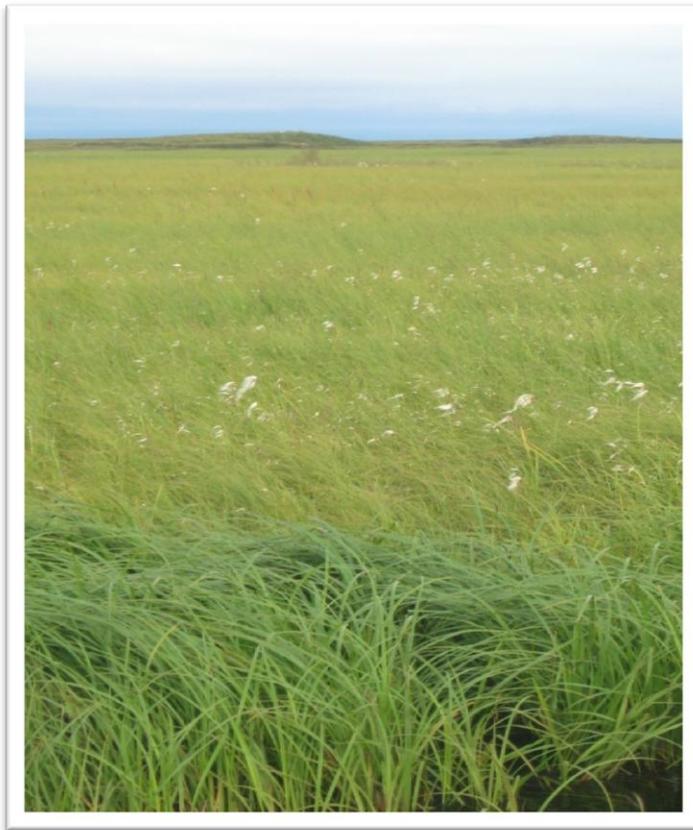
Figure 5. Mounds in distance are sewage disposal site and old dump site near John O. Mark Road to new airport, locally known as Qemirrayagaak Nanvaak.

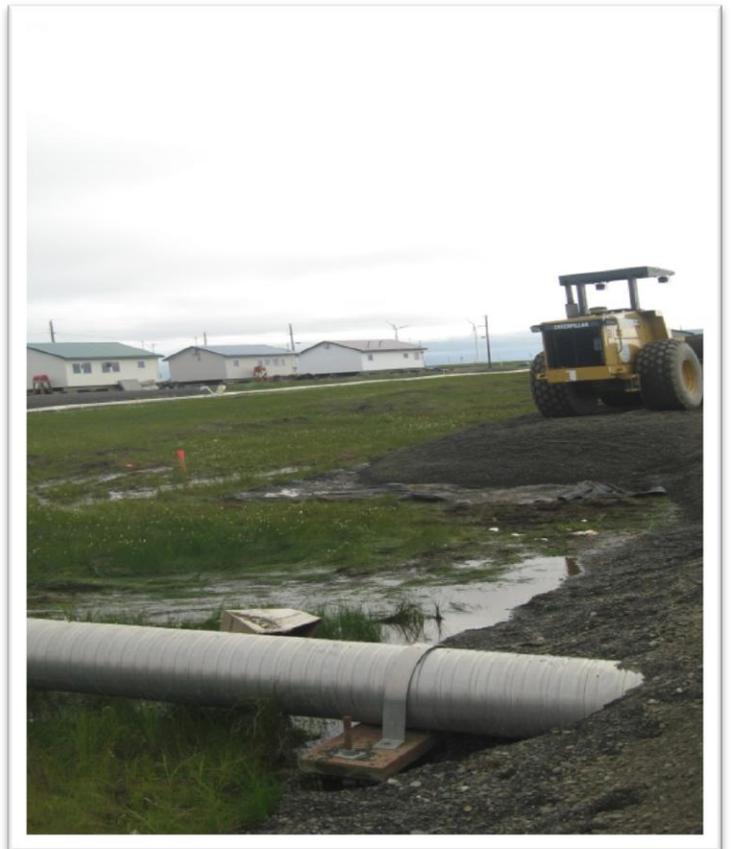
Figure 6. New building pad being placed and utility line near washeteria/clinic building.

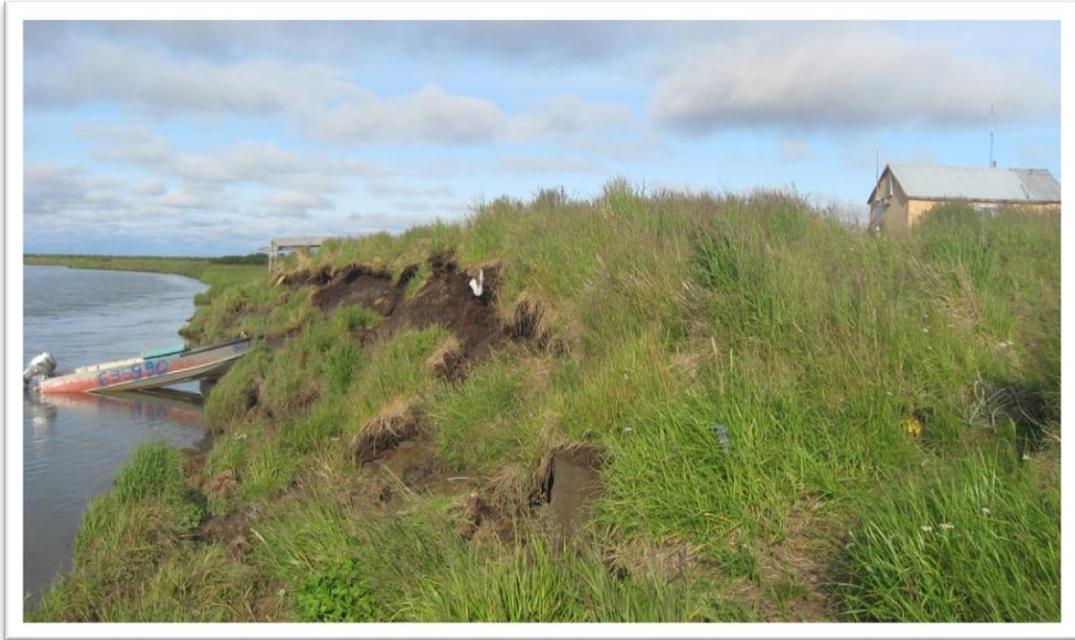
Figure 7. View looking upstream of Kanektok River at end of the Old Village point, Adolf Pleasant home is on right.

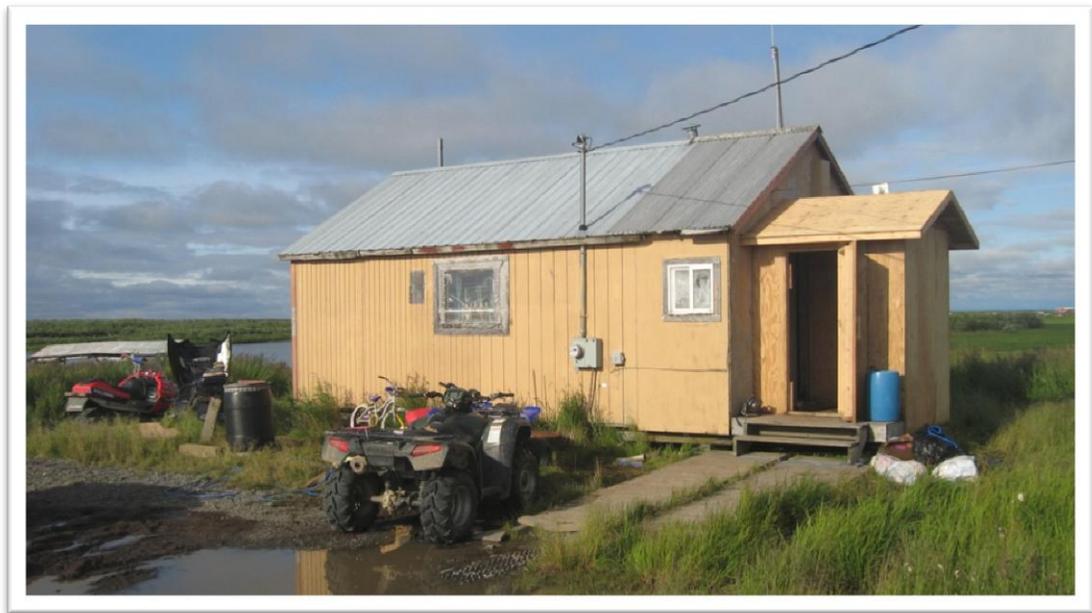
Figure 8. Adolf Pleasant's home was approximately 50' from the top of the eroding river bank on August 9th, 2011. Home is at end of Old Village, also called Nuuk area.

- Two homes are at particular risk from river erosion and are both less than 50 feet from experiencing loss or damage.
- Two additional homes received some flood waters inside, with a total of four homes surrounded on three sides during the November 9th & 10th, 2011 coastal storm surge flooding.

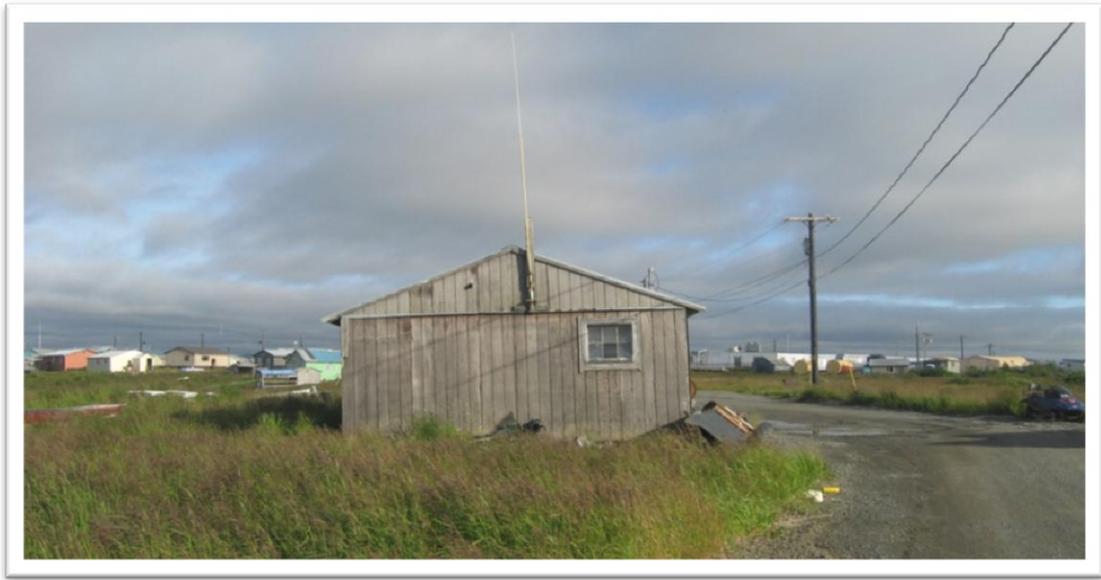
Figure 11. Wilbur Small's home in Nuuk area. Note the home is settling to the left.

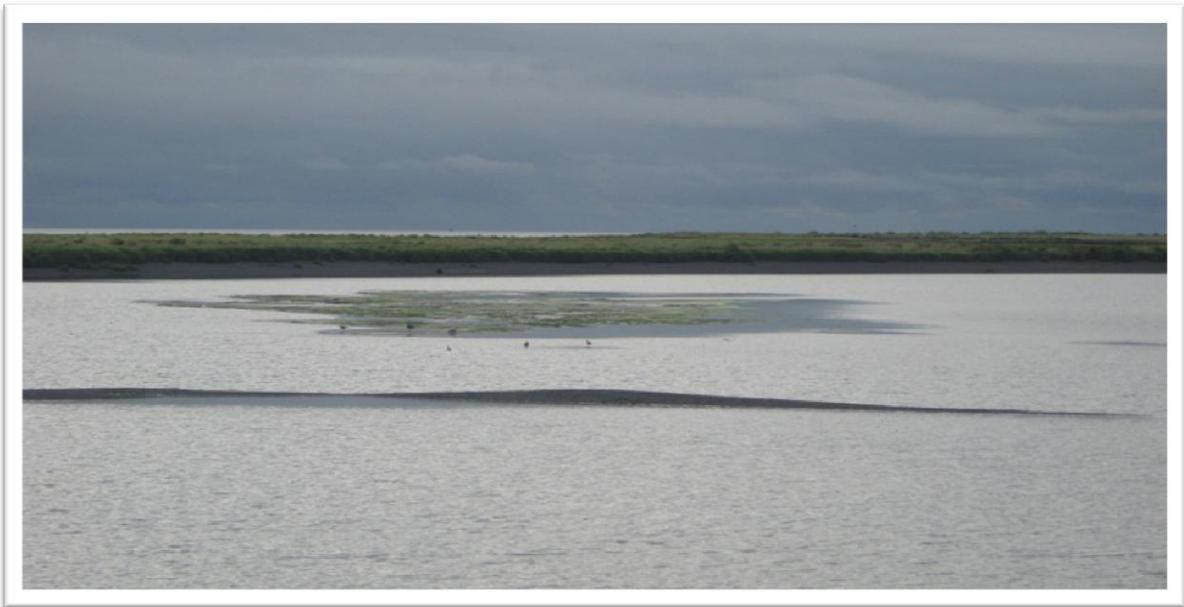
Figure 15. Shoals and sand bars in front of City Dock.

- Shoals in front of the City Dock caused by siltation, sedimentation, and shifting river channel disrupt access.
- The length of the old airport runway, the runway apron, and the east end of runway are impacted by river erosion.
- The Clinic/Washeteria Building has differential settling caused by melting permafrost.

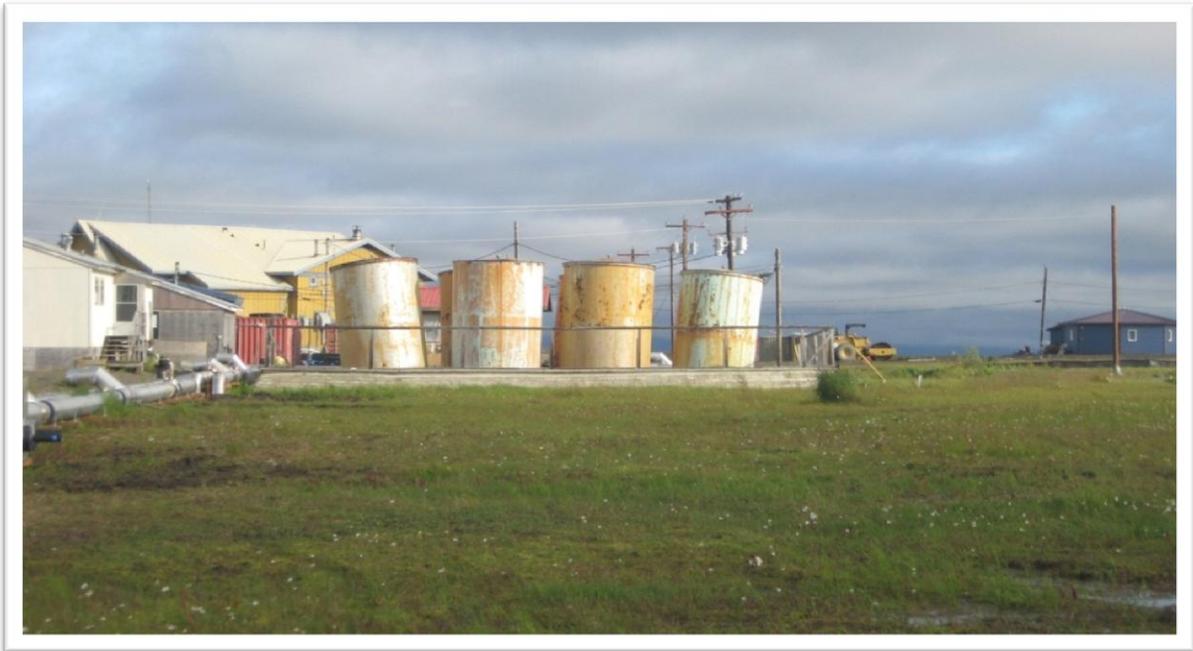
Figure 18. AVEC tank farm. Note: the tilt of the tanks.

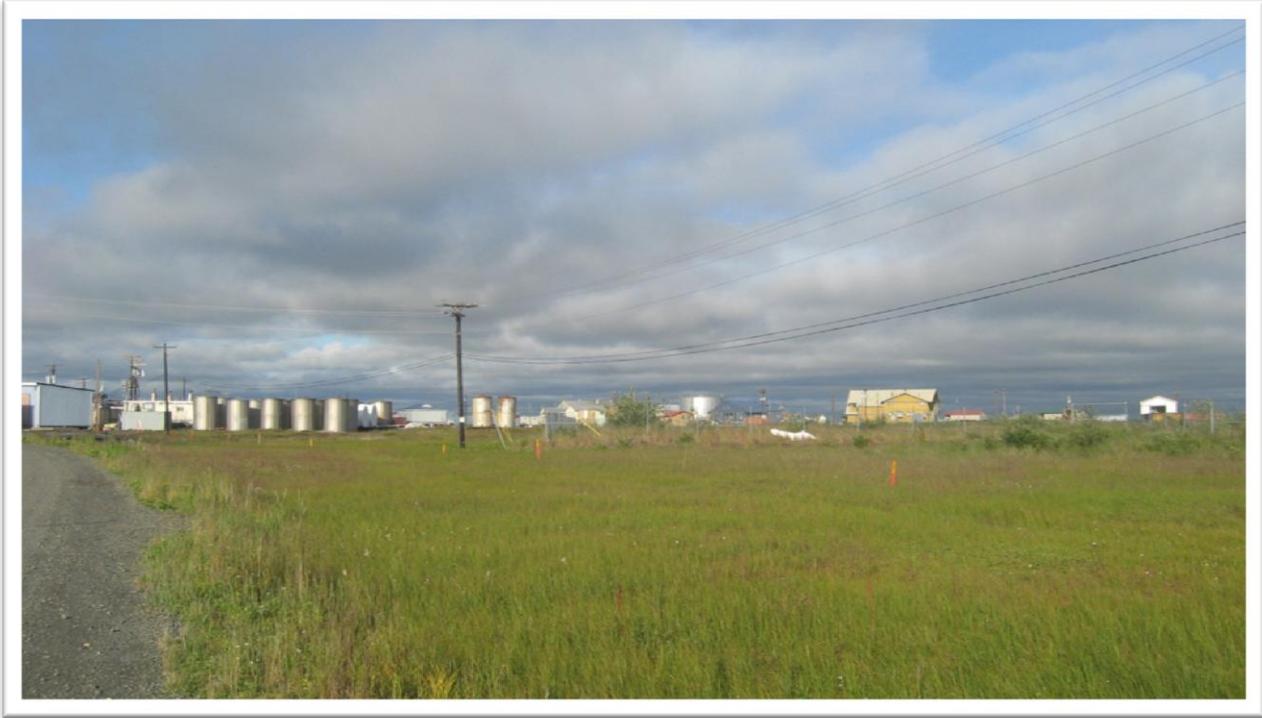
Figure 19. Fenced Clinic/Washeteria sewage lagoon in center extending to right of photo; AVEC tank farm on left.

- The deteriorating condition of the clinic building has a failing foundation system with which puts the overall building at risk of condemnation;
- Surface and groundwater contamination from the Footprint Lake landfill/sewage lagoon, while not directly related to climate change, are public health threats.

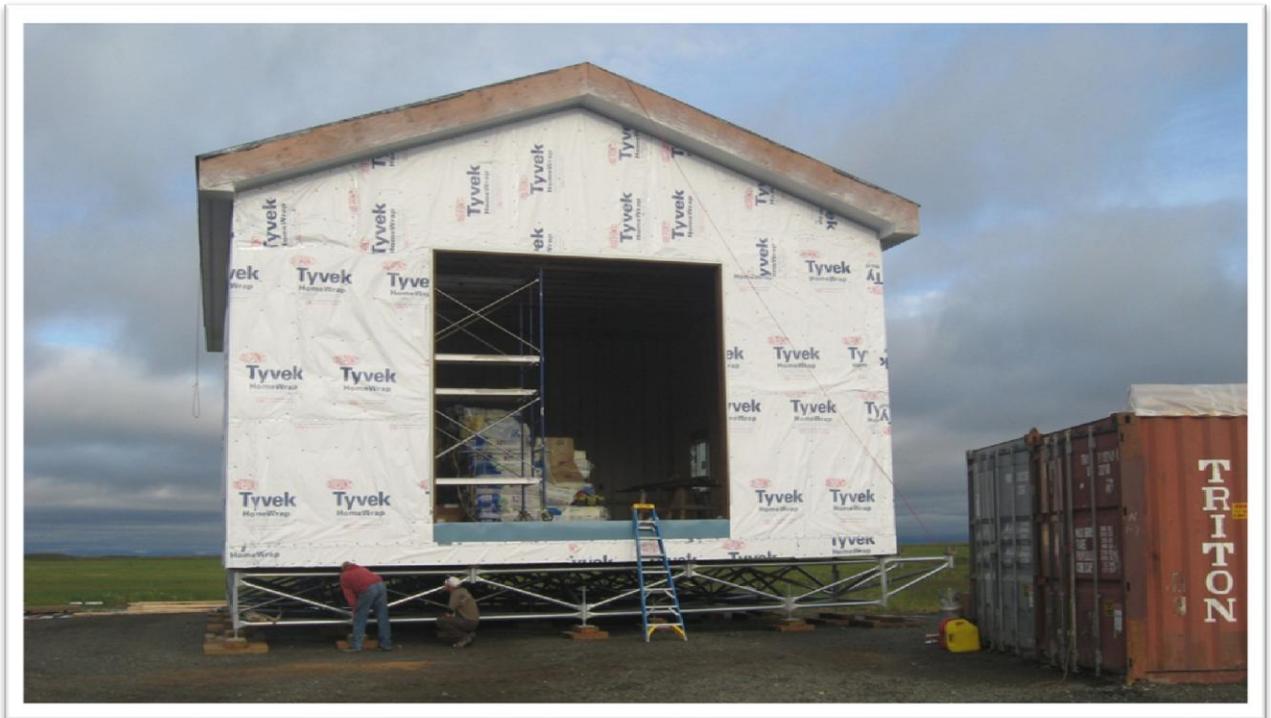
Figure 24. Jeff Hoffman inspecting Triodetic foundation system on new Community Service Center being built for Coastal Villages Seafoods (CVS).

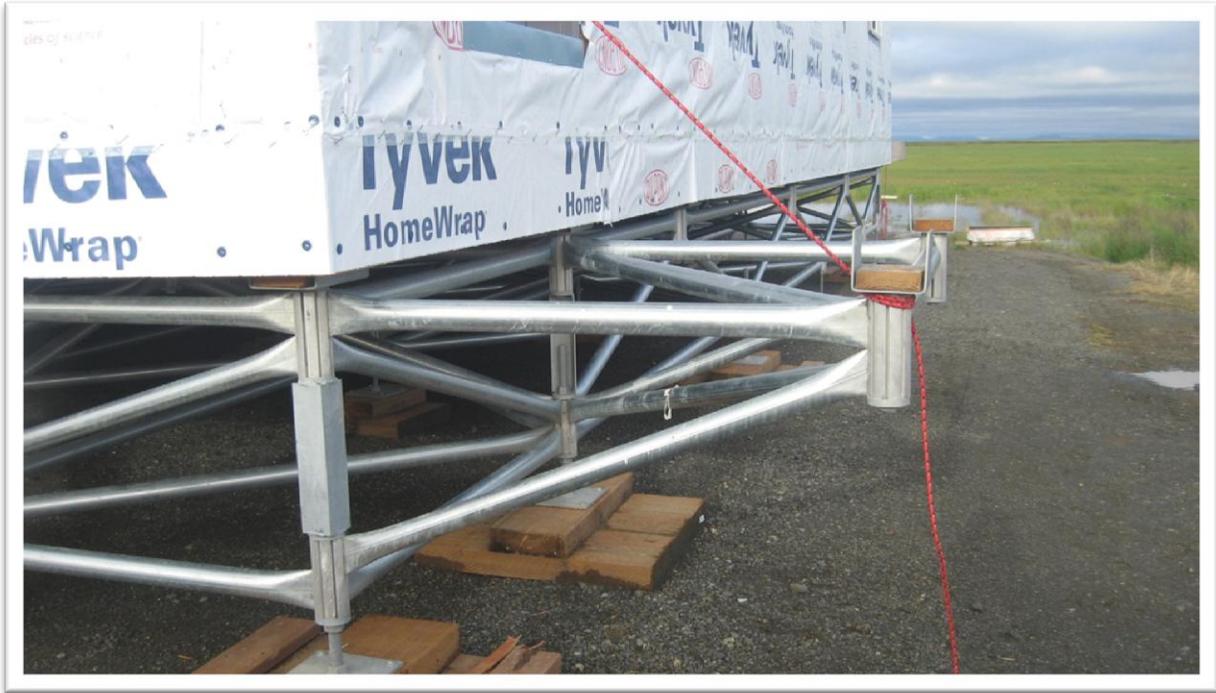
Figure 25. Close-up of new Triodetic foundation system under Community Service Center building.

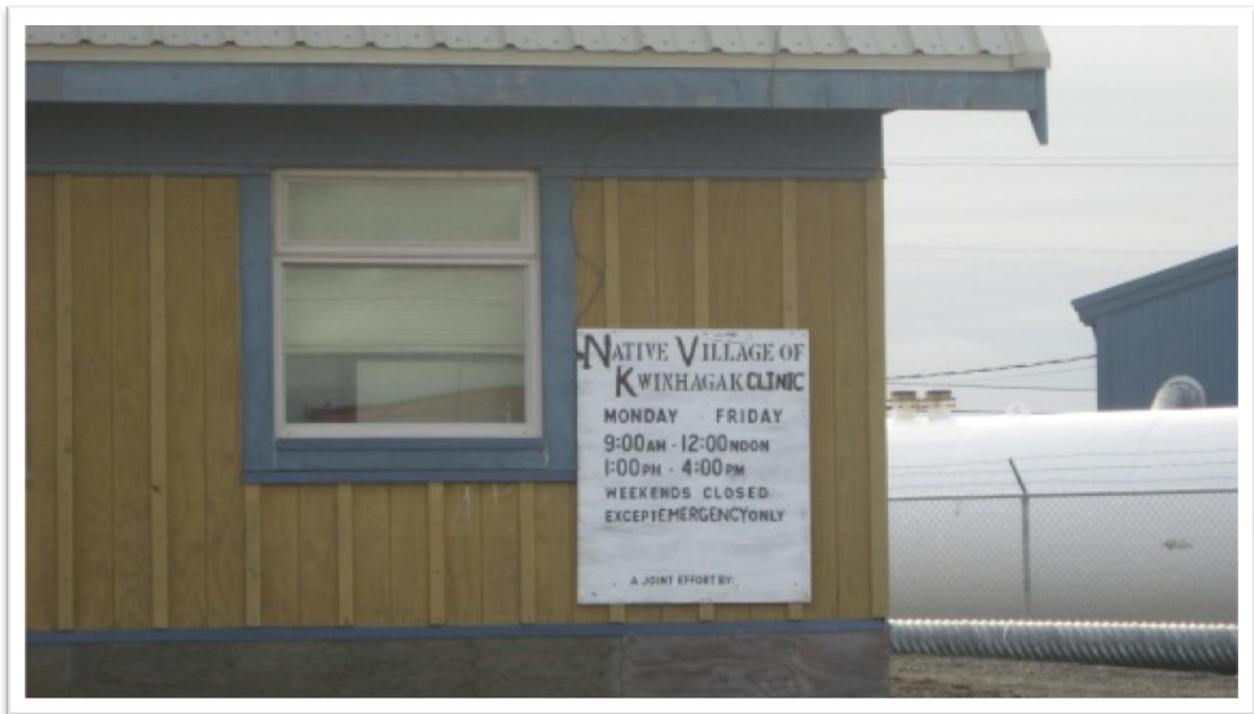
Figure 28. NVK Clinic and washeteria building.

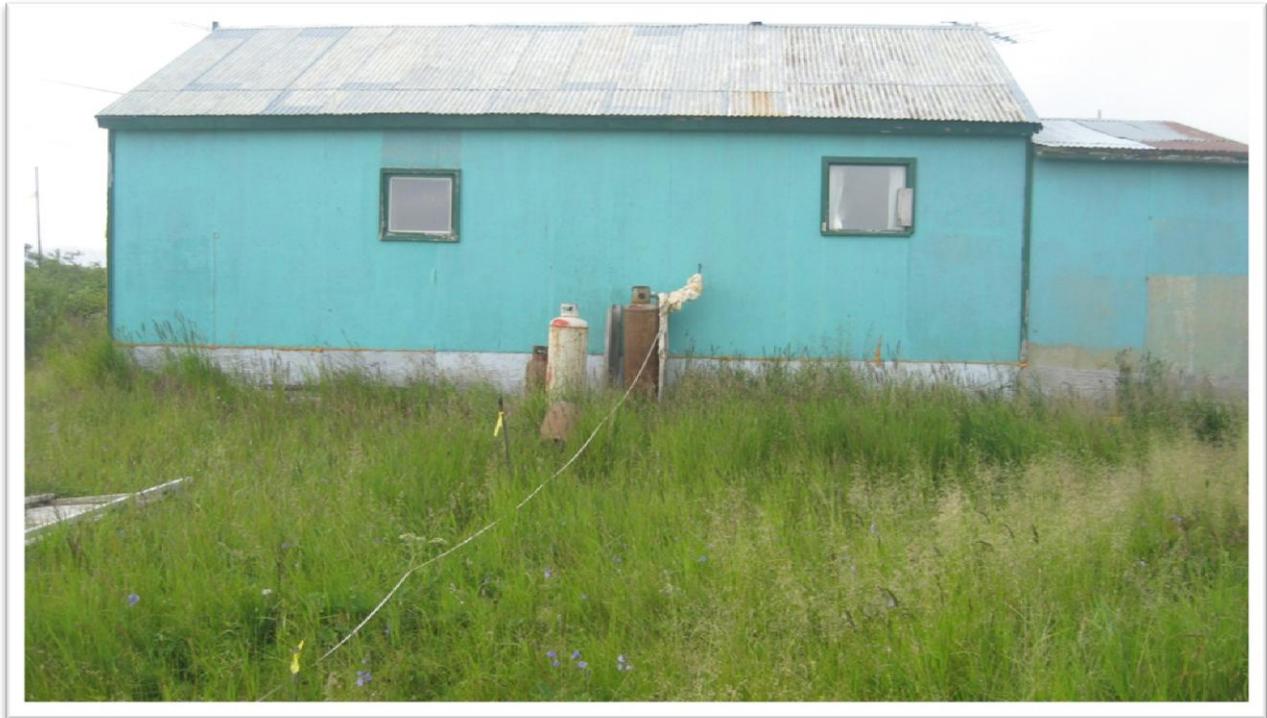
Figure 29. Katie Cleveland's home was 43' 7" from top of river bank on August 10th, 2011. Home is approximately 40 years old and is poorly insulated.

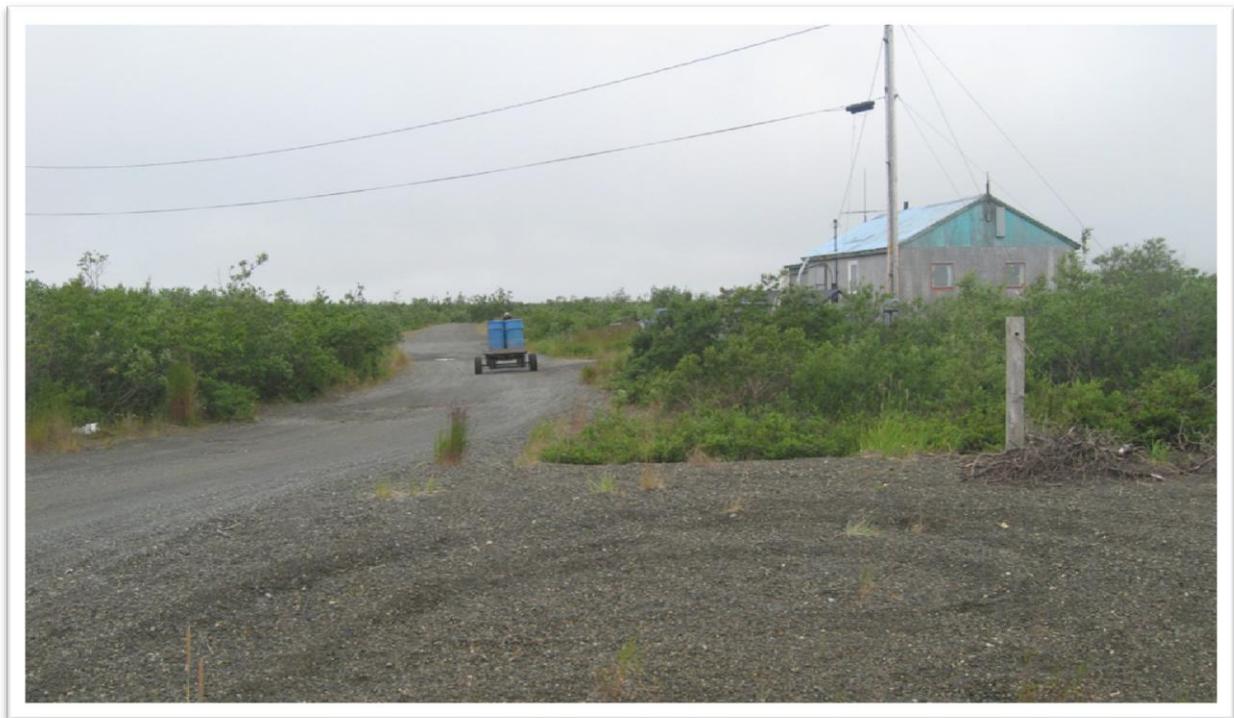
Figure 30. View of road into Katie Cleveland's home. Kanetok River is to right and in back of home. This low area reportedly floods annually.

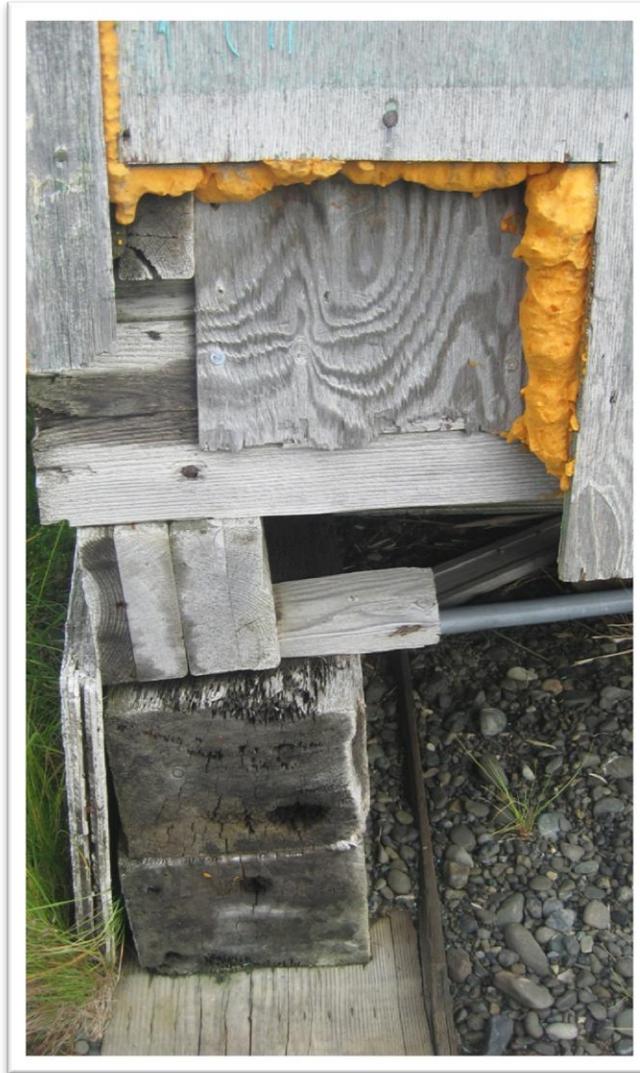
Figure 31. Katie Cleveland home foundation corner. The understructure of the home likely could withstand a move but heat loss is an overriding concern. Elevated structure is sitting on wood blocking foundation system with sturdy cross members.

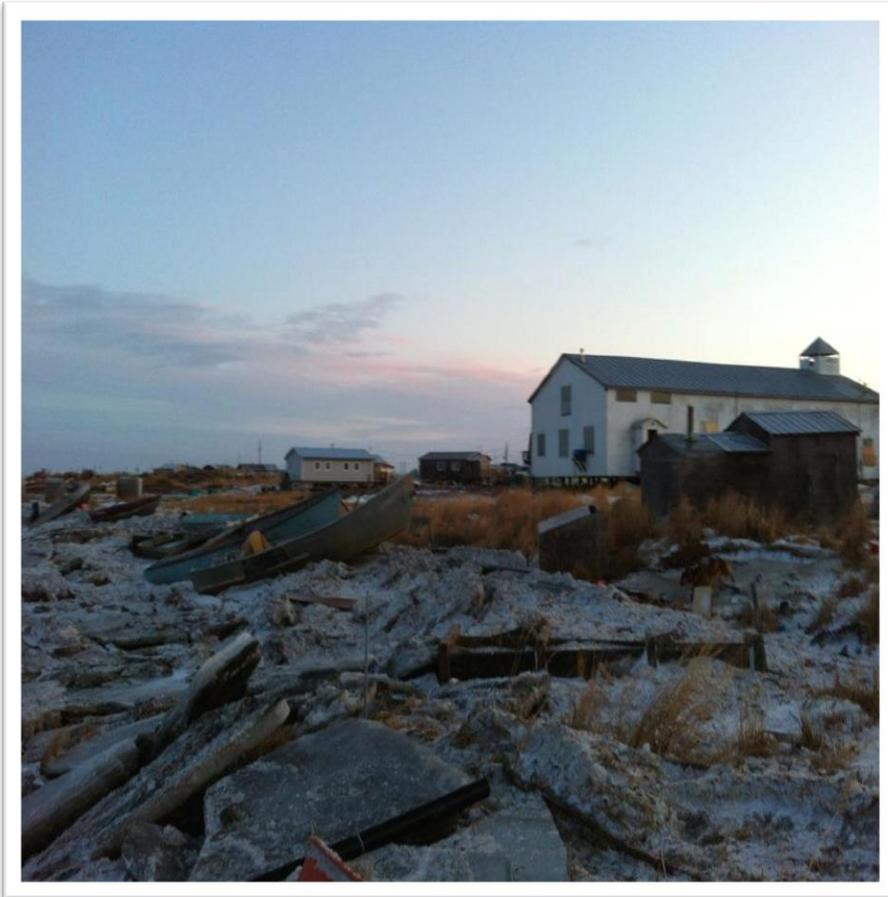
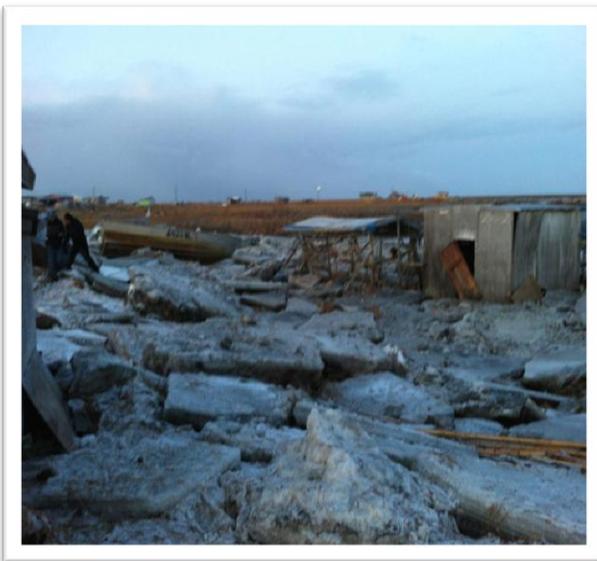
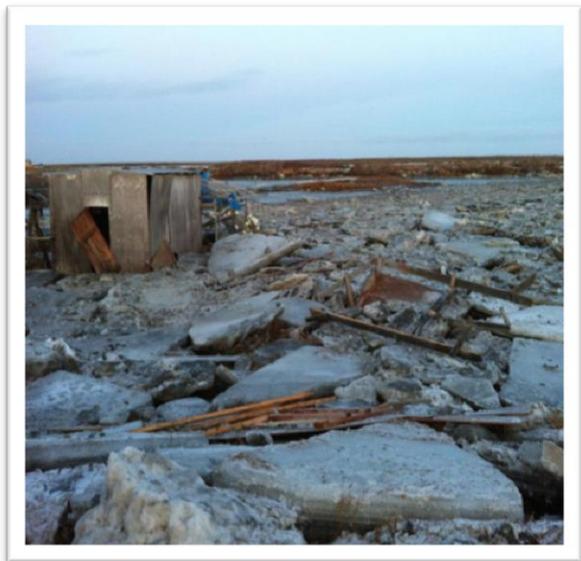
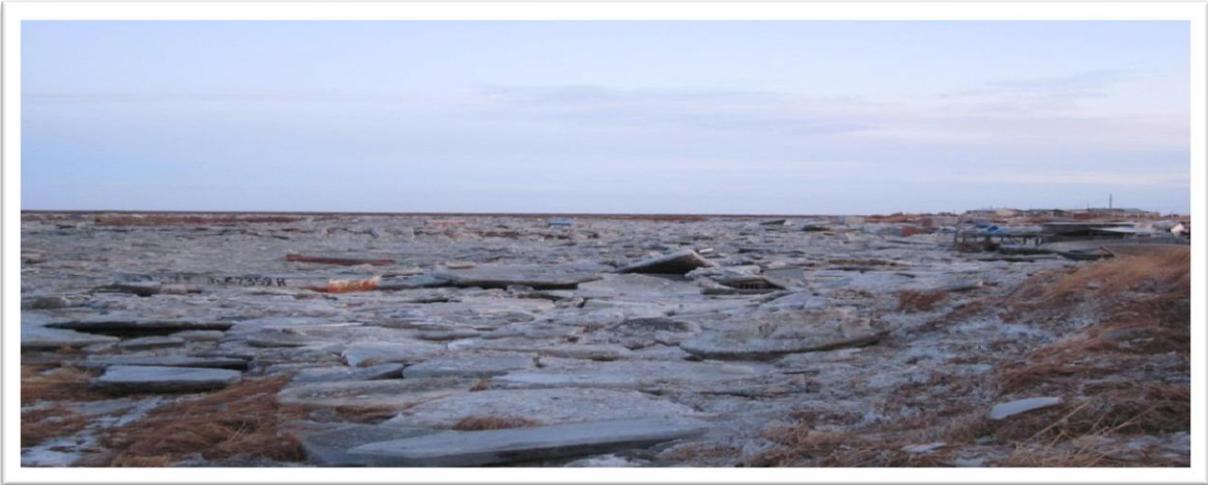
Figure 32-35
Photos of flooding
and ice provided
by Rebecca
(Church) Wilbur
on October 12,
2011.

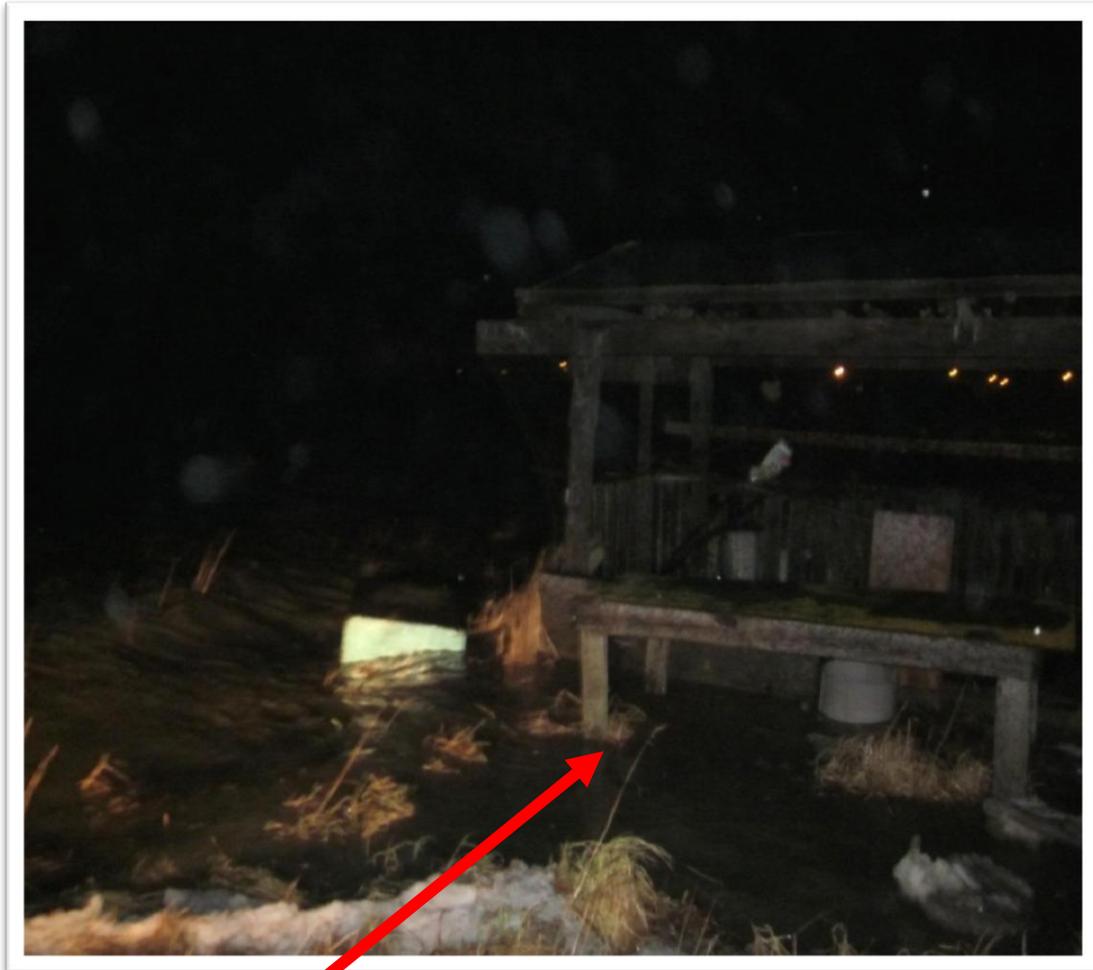
Figure 35. Note the height of the water.
