CIAP WEAR Trip Report  
Kotlik (population 628)  
July 11, 2012

Alaska Department of Environmental Conservation (ADEC) Solid Waste Program and Contaminated Sites Program (Doug Huntman and Grant Lidren) conducted a Coastal Impact Assistance Program (CIAP), Waste Erosion Assessment and Review (WEAR) site evaluation in the Village of Kotlik on July 11<sup>th</sup>, 2012. Lori Mike, City Manager for Kotlik, and Daniel Waska, also with the City of Kotlik participated in the visit. The following narrative is a brief description of our findings during the July inspection

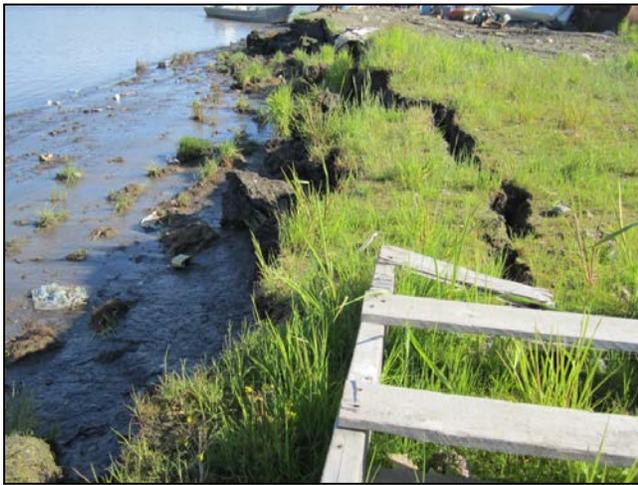
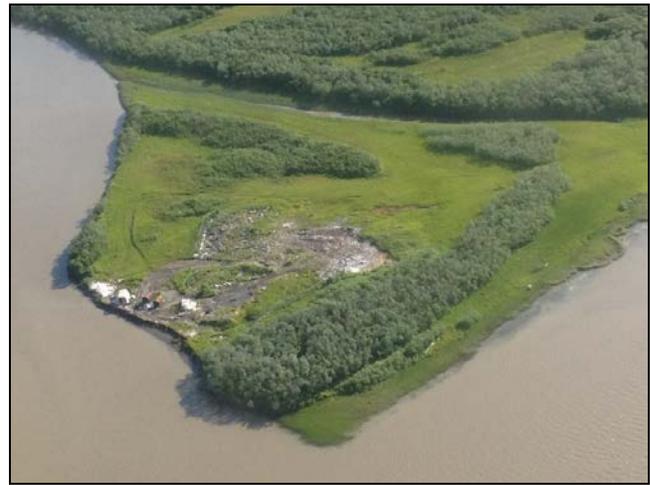
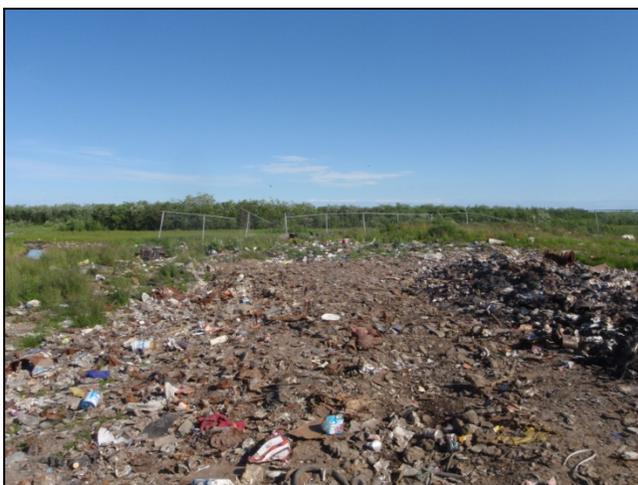
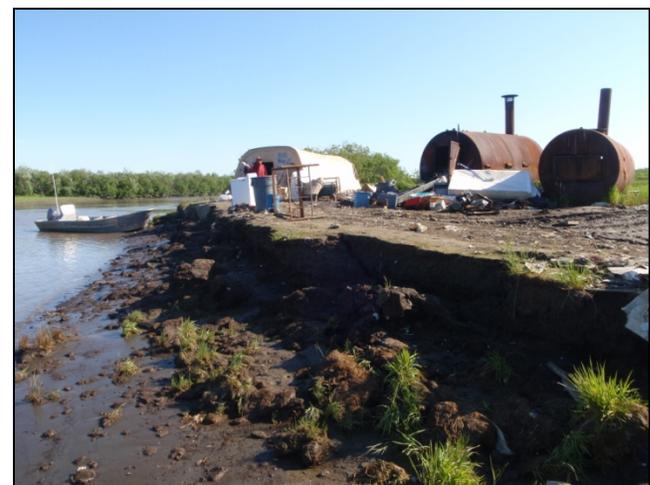
- **Landfill, 63.038045/-163.575294 (Active)** – The landfill is a self-haul landfill located upstream and across the river from the village. It is accessible only by boat in the summer and snow machine in the winter. The landfill is inaccessible during times of break-up and freeze-up. The site has two part-time operators. The site is approximately 4.5 acres with waste spread out throughout the site. An excavator is driven across the river each winter for landfill maintenance and trash consolidation. The site was organized but, it was not covered. The operators do a good job at the site, but self-haul customers often open-burn their waste. The site is 15 feet from the Kvichavuk Pass which flows into the Yukon River. The area between the landfill and river is eroding. The waste has to be pushed back several times a year to prevent waste from washing away. The site floods in the spring and fall. The US Army Corps of Engineers 2009 study Alaska Baseline Erosion Assessment lists an estimated erosion rate of 3 feet per year.

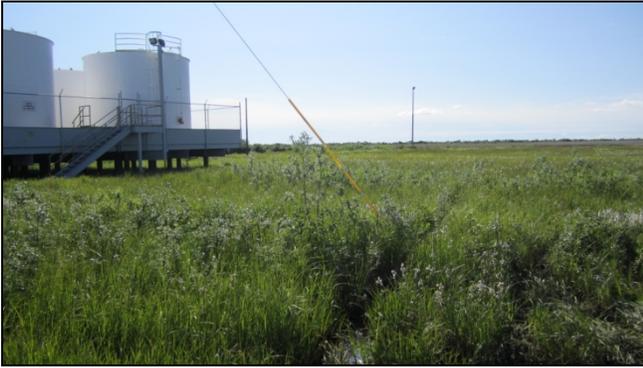
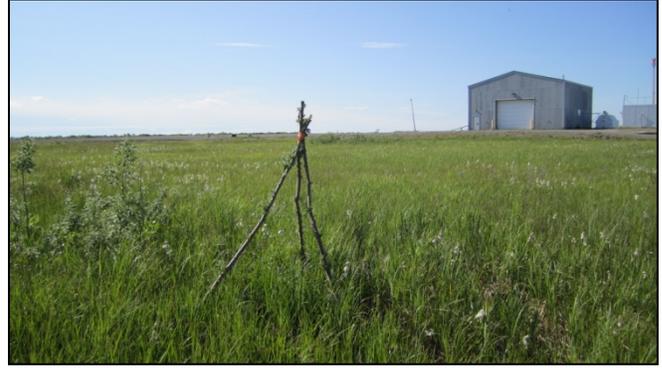
- **Yupik Corporation Former Bulk Fuel Tank Farm, 63.036795/-163.528904 (Active)** – This former tank farm is located adjacent of the new consolidated tank farm. The six fuel tanks from this site have been removed, but contaminated soil from tanks remains on site. This is a known Contaminated Site (File ID 2423.38.006) with Active status. This site is approximately 250 feet from the Kotlik River bank.

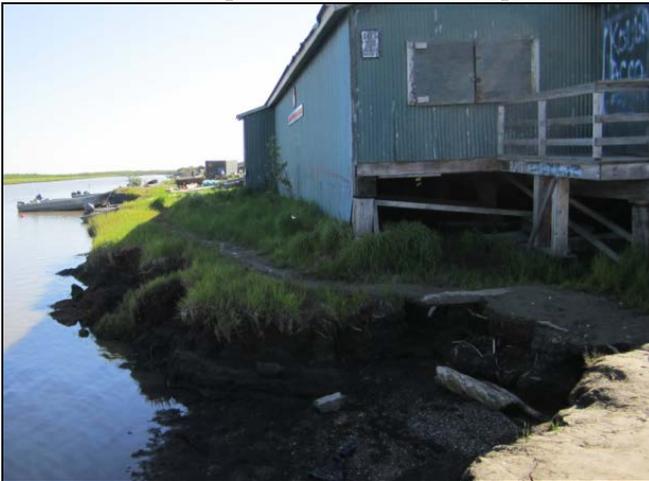
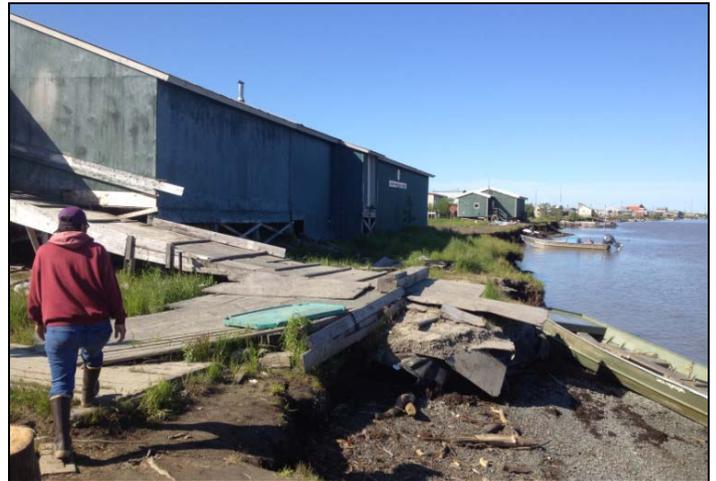
- **Old AC Store and Tanks, 63.034394/-163.542466 (Closed)** – This is the site of a diesel fuel spill in 1994 from the store’s day tanks, which were still operational at that time. The contamination from the spill was declared ‘Cleanup Complete’ under Contaminated Site (File ID 2423.38.003) in 2012. As of the site visit, the tanks have been removed, but the building still remains. Large portions of earth have eroded right next to the building. It is less than 10 feet from the Kotlik River.

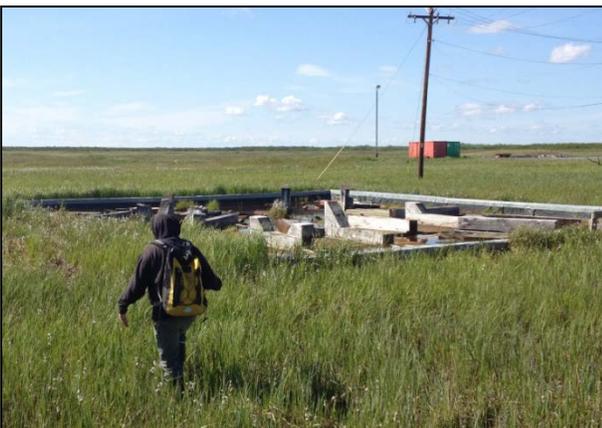
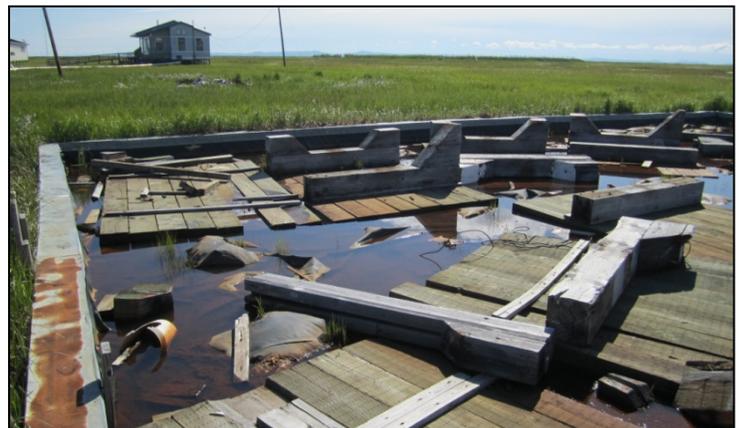
- **Kotlik Electric Former Tank Farm, 63.032236/-163.552541 (Active)** – This former tank farm is a known Contaminated Site (File ID 2423.38.002). It was the site of an approximately 7,000 gallon diesel fuel spill in 1993 with an estimated 1,000 gallons remaining after the initial cleanup. The tanks at this site have been removed and work is ongoing. The site is 445 feet from the Kotlik River.

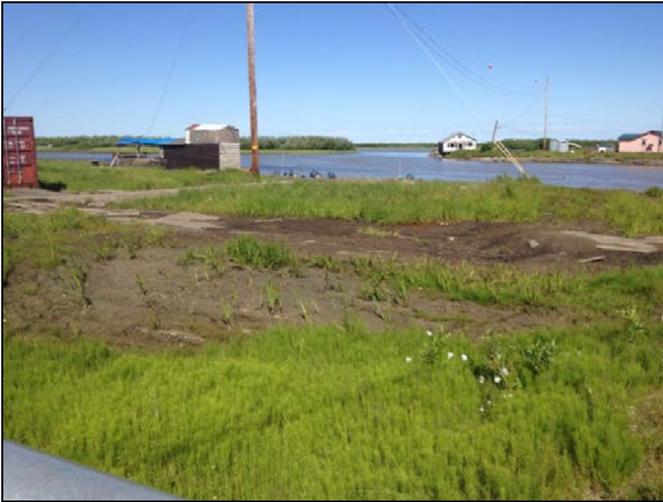
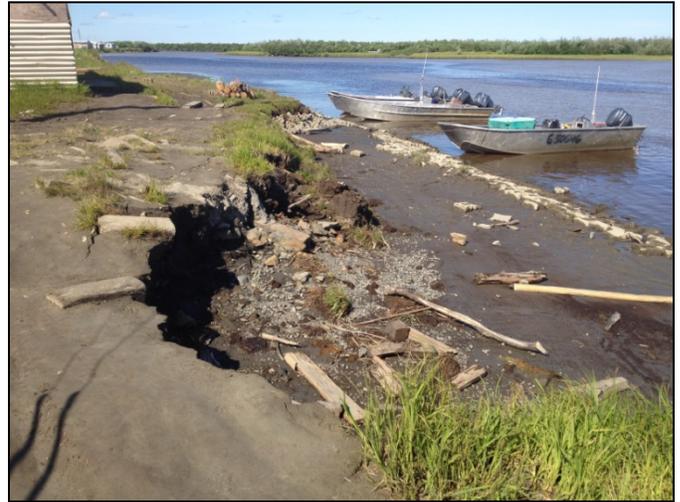
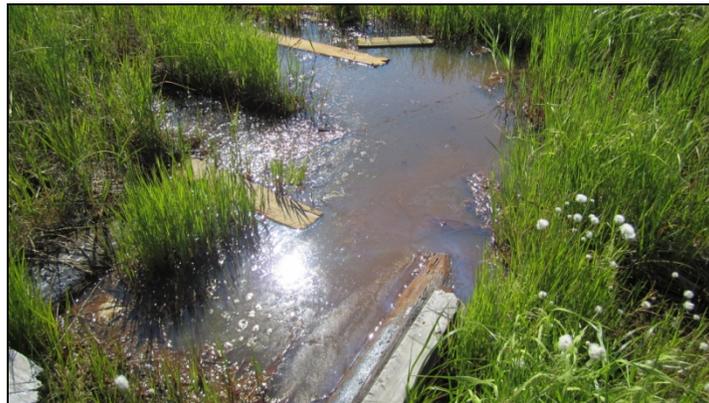
- **Lower Yukon School District Former Tank Farm, 63.033025/-163.556020 (Active)** – This former tank farm is a known Contaminated Site (File ID 2423.38.005) with the status of Active. There were six 8,000 gallon fuel tanks on this site that were removed between 2001-2006; however the liner and old wood boards remained at the site as of the 2012 visit. Sheen was also noted on the surface water to the south of the property along some creosote logs. The site, which has silty soil, is located in the middle of town approximately 50 feet from the actively eroding Kotlik River riverbank.

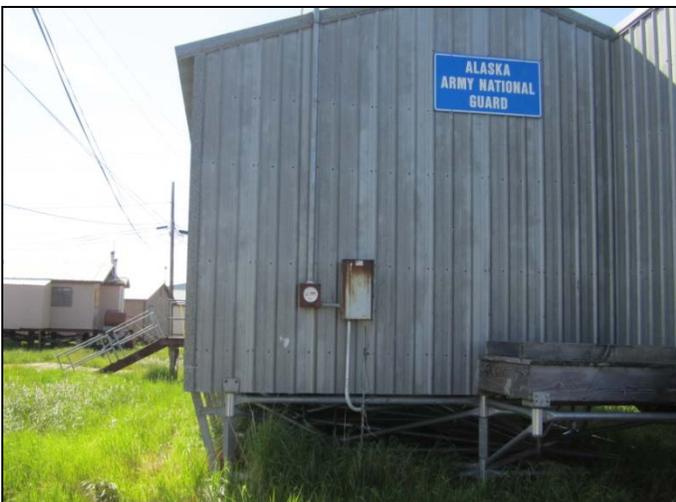
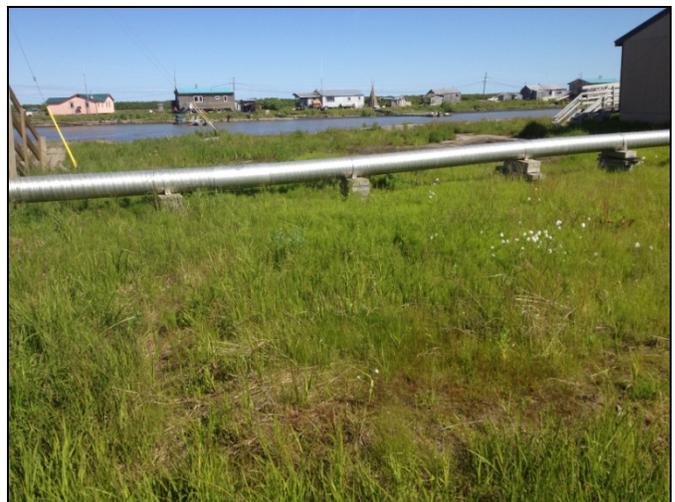
- **AKARNG Kotlik FSA, 63.032806/-163.556455 (Active)** – This Alaska Army National Guard site is a known Contaminated Site (File ID 2423.38.001) with Active status. It has petroleum contaminated soil dating back to 1997. There were 11 cubic yards of contaminated soil removed and treated off site in 2007. Some contaminated soil remains at the site and further work is ongoing. This site is located approximately 250 feet from the Kotlik River and is subject to flooding.
