ANIAK

Energy Action Plan

6/15/2019

Aniak Energy Efficiency Project

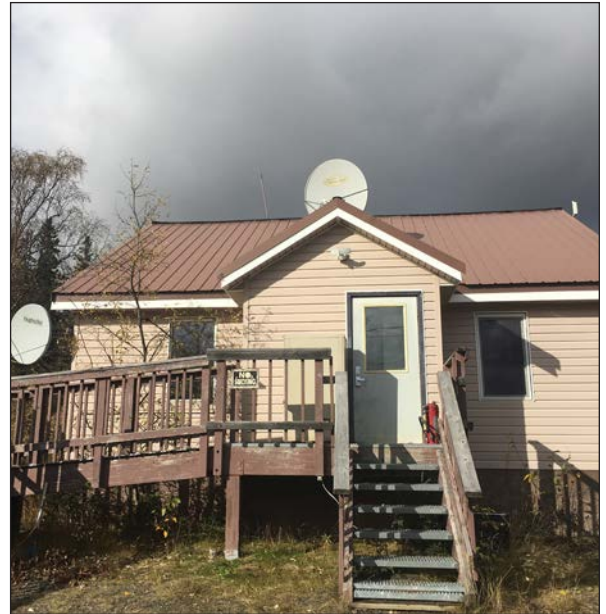
This office building, originally built in the 1940s, was renovated in 2000.

The 2,861 square-foot office building has a crawlspace foundation that was originally constructed in the 1940s for use by the Federal Aviation Administration (FAA). The building underwent a renovation and location change in 2000. Heating is provided by an oil-fired boiler that directs heat to two building zones, a unit heater in the crawlspace, and the hot water generator. The heating is controlled by a series of manual thermostats. The exterior lighting consists of an LED fixture and an HPS wall-pack. The interior lighting is comprised of a mixture of fluorescent, CFL, and incandescent lamps. Plug loads at the time of the energy audit were low due to the infrequent occupancy. The building has since been leased and occupied since spring 2018. The Aniak Traditional Council is hoping to reduce the energy use of this building in a future energy retrofit project.

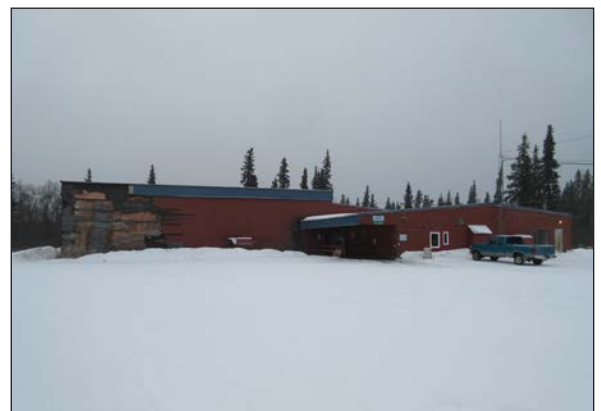
The community center building is in poor condition but continues to host social events and house laundry facilities.

The 9,352 square-foot building is a single story, L-shaped structure that was built in 1985. The building shell is in poor condition, especially in the northeast corner where a recent fire damaged the siding. Heating is provided by five oil-fired direct vent heaters. Formerly, heat was provided by two central forced air furnaces. The laundry facility has seven clothes washers and six electric clothes dryers. The exterior lighting is a mix of high-intensity discharge (HID) and light emitting diode (LED) fixtures. The interior lighting is a mix of fluorescent and incandescent fixtures and lamps. The plug loads for the facility are low with the exception of when the electric dryers are in use. The Aniak Traditional Council is hoping to reduce the energy use of this building in a future energy retrofit project.

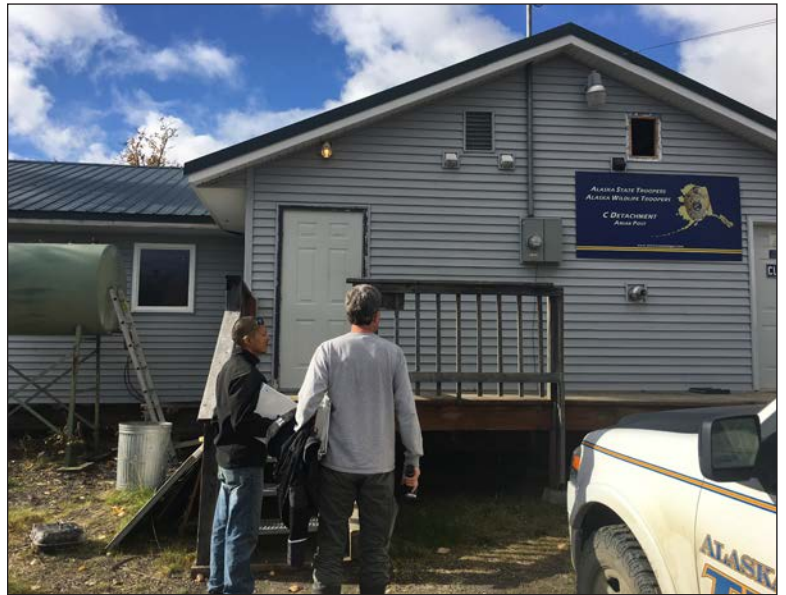
During the course of the project, the Aniak Traditional Council was working to renovate and lease out the space in the duplex.

The 1,904 square-foot building was built in 1995 and sits on an elevated pier foundation. The building shell is in average condition. Heating is provided by an oil-fired boiler that directs heat to three building zones. There are two oil-fired direct vent Toyotomi heaters that provide supplemental heat during the colder months. Domestic hot water in this building is created through an oil-fired Toyotomi tankless water heater. The exterior lighting is comprised of incandescent lamps. The interior lighting is a mix of fluorescent, CFL, and incandescent lamps. The plug loads at the time of the energy audit were low due to the infrequent occupancy of the building, which has since been leased and occupied (Spring 2018). The Aniak Traditional Council is hoping to reduce the energy use of this building in a future energy retrofit project and continue using the bunkhouse side as additional leasable office space.

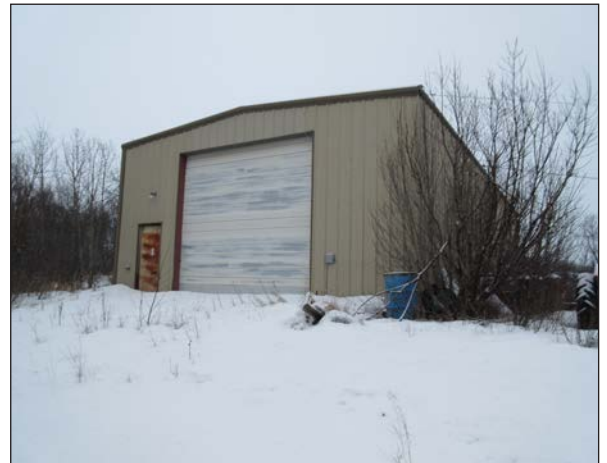
The large farm building is in poor condition and is currently serving as a cold storage facility.

The 1,920 square-foot facility was built in 2000 and sits on grade with a dirt floor. It is a steel-framed and metal-sided structure. The building shell is in poor condition. There is only insulation on the west side of the building. There is no heating or plumbing in this building. The lighting consists of fluorescent fixtures. The Aniak Traditional Council is hoping to convert this structure into warm storage with a focus on an energy efficient retrofit.

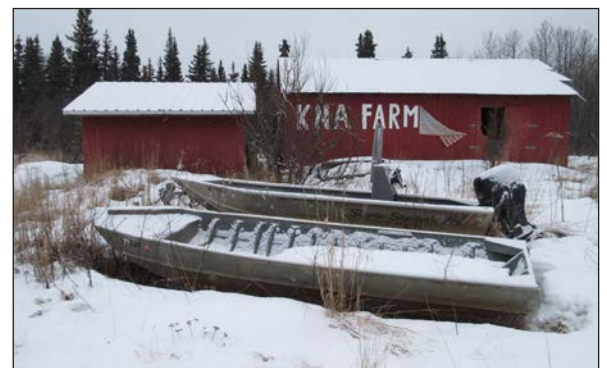
The small farm building is in poor condition and is currently serving as a cold storage facility.

The 600 square-foot building sits on grade with a concrete slab. It is a wood-framed and wood-sided structure. The building shell is in poor condition. There is no insulation in the building. There

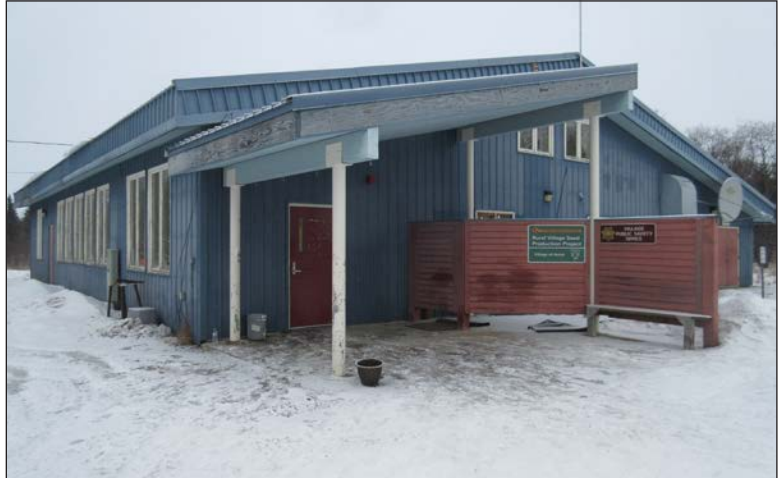
The tribal office houses 14 employees that administer tribal programs and help up to 20 visitors daily.

The offices are housed in a two-story, 6,561 square-foot building built in 1985. The building shell is in average condition. Heating is provided by an oil-fired Weil Mclain boiler that distributes heat via baseboard radiators on the first floor and an air handler with a heating coil on the second floor. At the time of the building survey, faulty zone valves have resulted in high heating temperatures in several rooms that cannot be altered by accompanying thermostats. There is potable water and domestic hot water plumbing throughout the building. The interior lighting is mostly fluorescent fixtures with defunct occupancy sensors. The plug loads are high in this building due to its high occupancy rate. The Aniak Traditional Council is hoping to reduce the energy use of this building in a future energy retrofit project.

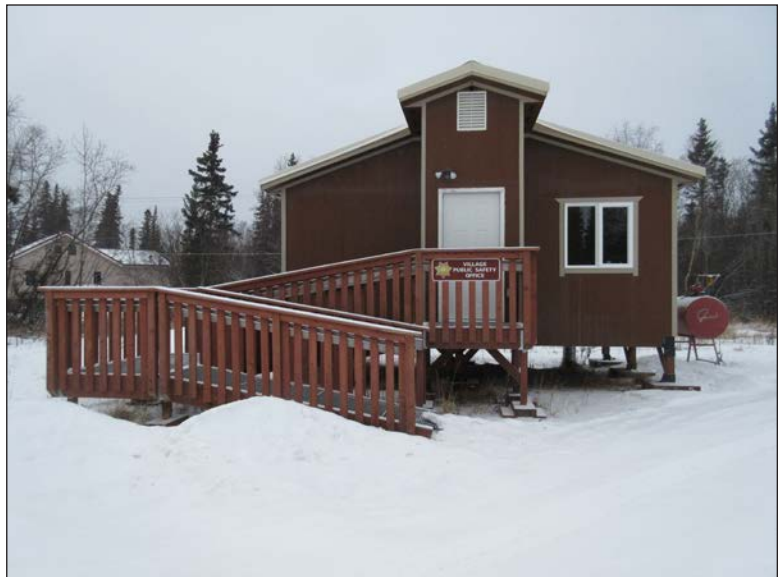
The VPSO office is in good condition and is mainly used when there is an occupant in the holding cell.

The 384 square-foot structure was built in 2013 and is situated on an elevated pier foundation. The building shell is in very good condition due to the building's recent construction. Heating is provided by an oil-fired direct vent Toyotomi heater. Exterior lighting is comprised of motion-detecting LEDs. The interior lighting is a mixture of fluorescent and CFL fixtures. The building has very low plug loads since it is occupied infrequently. The Aniak Traditional Council is hoping to reduce the energy use of this building in a future energy retrofit project.

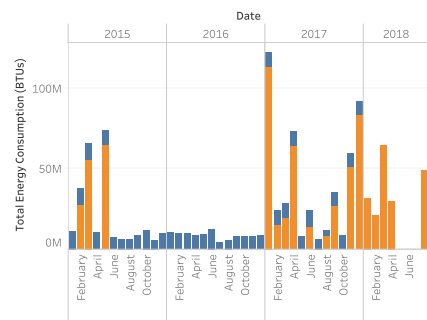
Tribal Office Monthly Energy Consumption Average per Year

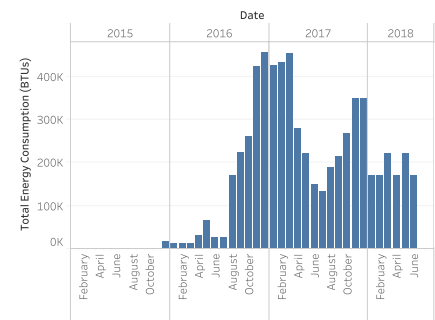
VPSO Building Monthly Energy Consumption Average per Year

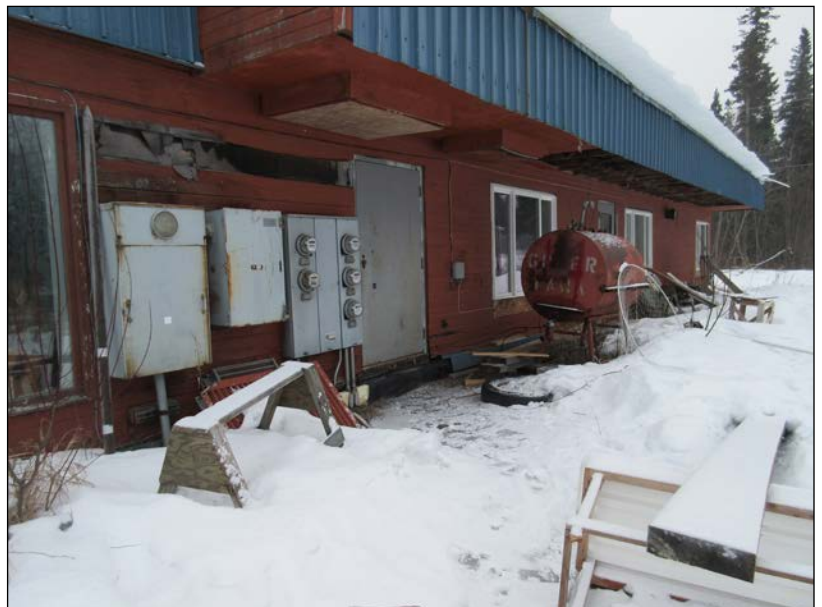
The majority of the energy costs for the community center are due to the large space heating load, so many of the audit recommendations address improving the building envelope and heating system.

1. Contact the electric utility provider and have the two power meters not currently receiving a PCE discount added to the PCE program.
2. Consider combining the existing five meters into one if it can maintain the PCE discount.
3. Reframe the old window openings on the south wall of the auditorium and add R-30 insulation, finish interior and exterior surfaces appropriately.
4. Replace the door in the south wall of the auditorium that is currently boarded up.
5. Replace the three Toyotomi stoves running in the auditorium with oil-fired cabinet unit heaters or unit heaters of appropriate capacity.
6. The lack of mechanical ventilation in the auditorium and the lack of operable windows may be a code violation – **this is a safety issue and should be addressed as soon as possible**

Other recommendations include installing setback thermostats in each room, replacing existing lighting with LEDs, replacing existing hot water heater with an on demand water heater, repairing or replacing the auditorium ceiling insulation adding R-11 to current value, and replace inadequate doors and windows.

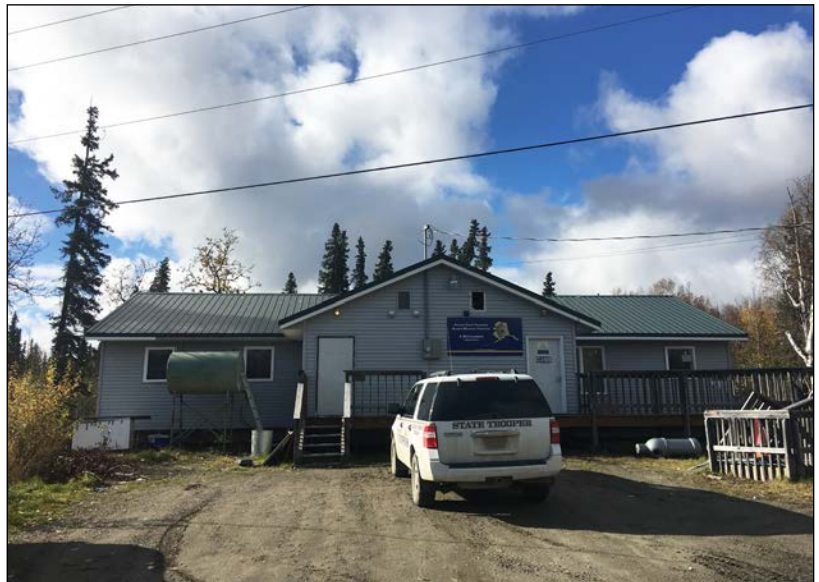
Energy efficiency recommendations for the duplex would payback in only one year, and realize an annual savings of over \$2,500.

1. Investigate attic insulation that has been disturbed or improperly replaced, properly placing two layers of fiberglass batt to maximize insulative value.
2. Use plug load management devices in the State Trooper office.
3. Program both Toyotomi stove clocks and utilize the set-back feature.

Other recommendations include installing setback thermostats in the State Trooper office and bunkhouse, replacing the existing bath fans with ones with humidistat and occupancy sensors, and replacing existing lighting with LEDs.

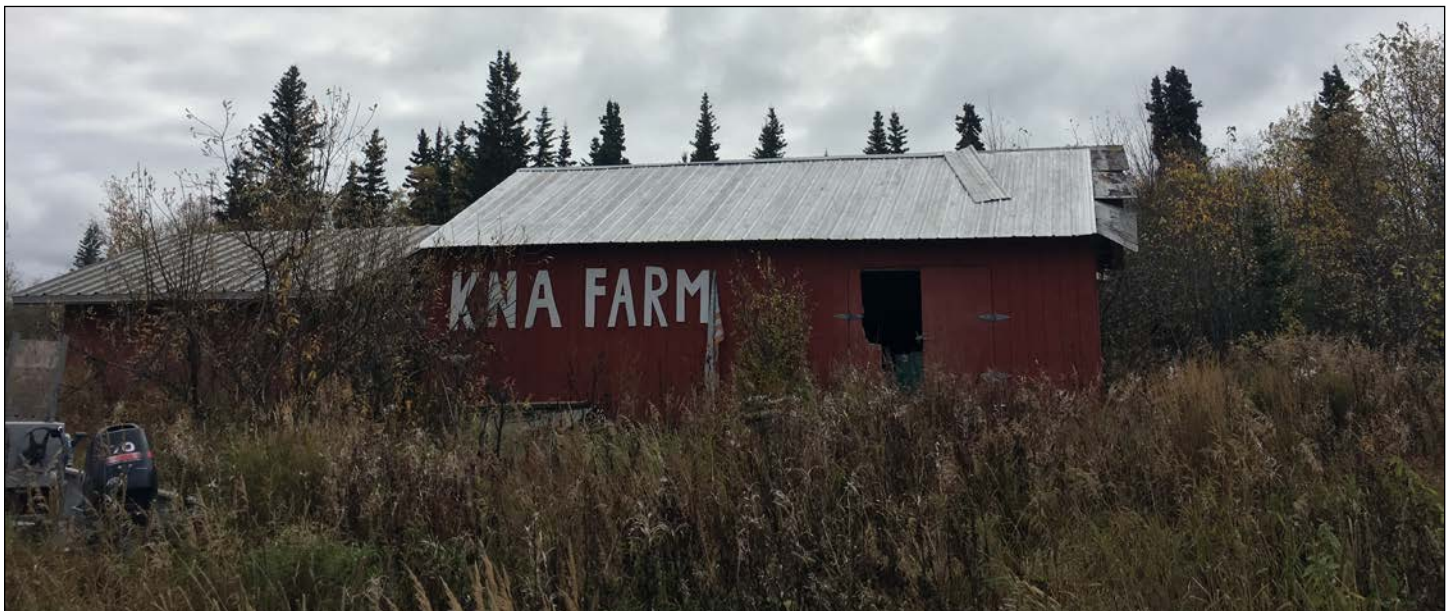
If this structure is converted into warm storage, energy efficiency upgrades to the building envelope would help save over \$5,000 per year.

Recommendations include setting an unoccupied setback to 60° F, installing R-38 fiberglass batt insulation in the 2x12 stud cavity, installing R-21 fiberglass batt insulation in 2x6 wall, installing vapor barrier and finish interior walls, replacing existing lighting with LEDs, replacing the entry door, and replacing the windows with triple pane windows.

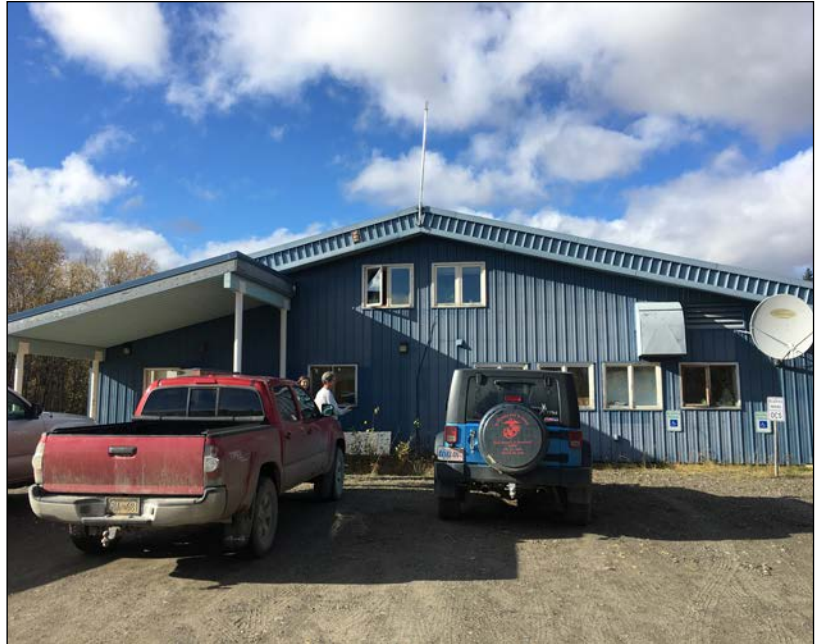
The tribal office is heavily used; efficiency upgrades to this building could help save over \$10,000 annually in energy bills.

1. Set the corridor light timer located in the boiler room to the correct time and confirm that it is working properly.
2. Retro-commission and re-balance HVAC systems.
3. Turn the air handling unit back on after cleaning the heating coil, replace the filters, reprogram the timer to the correct building schedule, and confirm the thermostats, three-way valve, and dampers are operating correctly.
4. Add a cumulative oil meter to fuel oil day tank to monitor monthly oil consumption.
5. Confirm that the thermostats and cabinet unit heaters in both of the south entries are operating correctly – they were both running continually during the site survey.
6. Reprogram the timer controlling the central bathroom exhaust fans and confirm that it is working properly.

Other recommendations include replacing existing lighting with LEDs, installing setback thermostats throughout the building and setback to 63° F when unoccupied, replacing existing circ pumps with variable speed models, replacing boilers at their end of their life with new 87% thermally efficient model, and implementing CO₂ based demand controlled ventilation in the air handling unit.

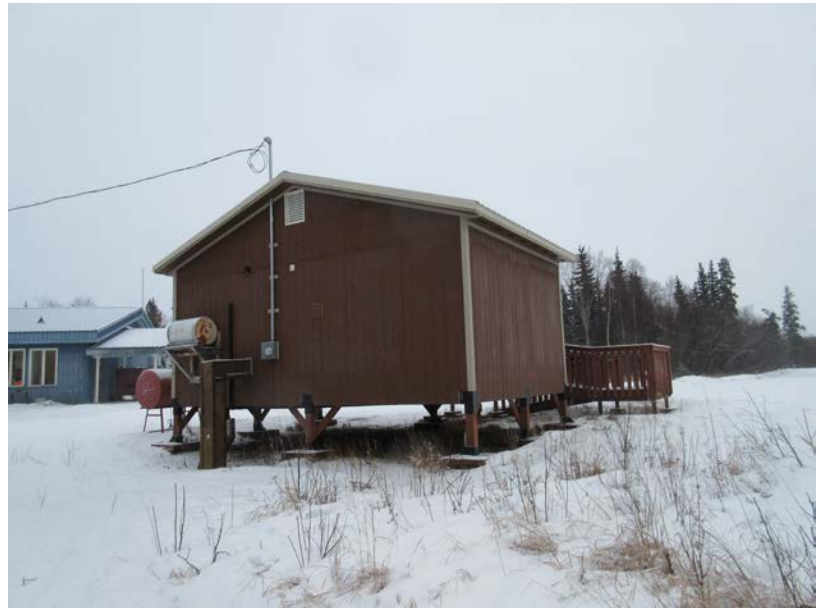
Energy efficiency recommendations for the VPSO would payback in only four months, and realize an annual savings of over \$398

If the Tribe is able to implement all recommendations, the annual energy use would decrease by 6.5 MBTU, resulting in an energy and maintenance savings of **\$398**. At an approximate installation cost of \$108, the simple payback of a retrofit project would be **4 months**.

The audit also includes suggestions for several ECMs, including ongoing energy monitoring, efficient building management, reducing air infiltration, turning off plug loads, and servicing HVAC equipment annually. Additionally, specific to the VPSO office, the Tribe should make sure to maintain the air sealing on the envelope, use electronic timers for large electronic equipment, and maintain the Toyotomi setback settings, especially after a power outage.

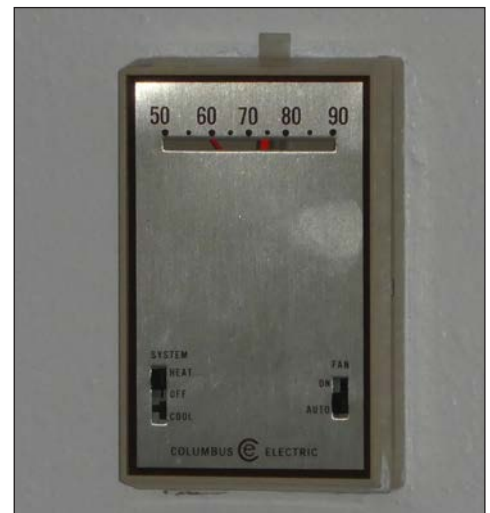
Check that the thermostat for the boiler is not excessively heating the space when there is no occupant in the building.

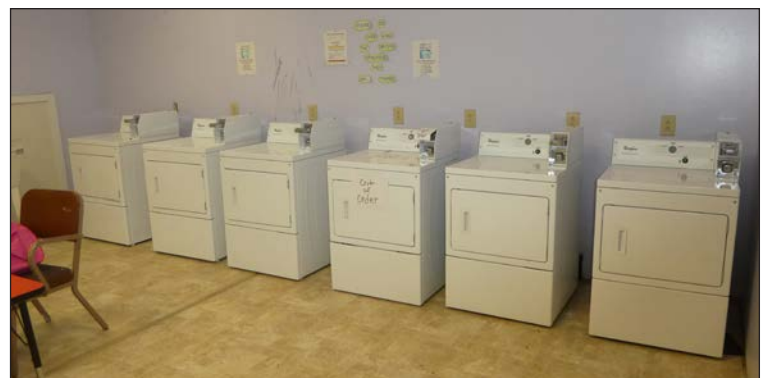
The laundry equipment should be checked each month to make sure they are working properly.

- Appliances: Check to ensure that laundry equipment is working properly. Document any failed machines. Replace with Energy Star appliances when possible. Check dryer exhausts for lint. Make sure they are clear to prevent a fire hazard.

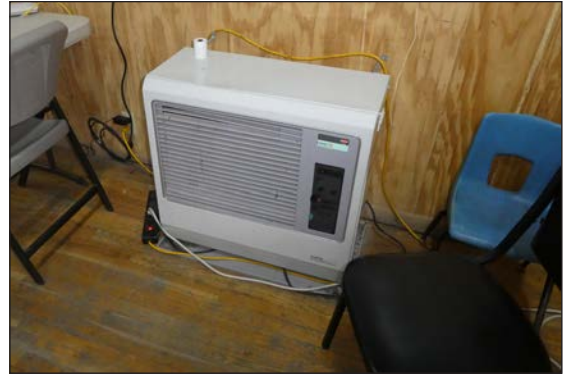
The Monitor and Toyotomi stoves should be checked monthly to ensure that the programmable thermostats are running correctly.

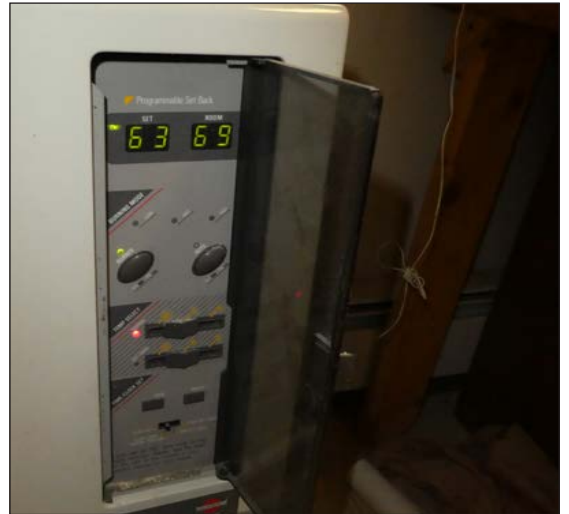
The Toyotomi stoves should be checked on monthly to ensure that the programmable thermostat is set at 63°F in the winter during unoccupied times.

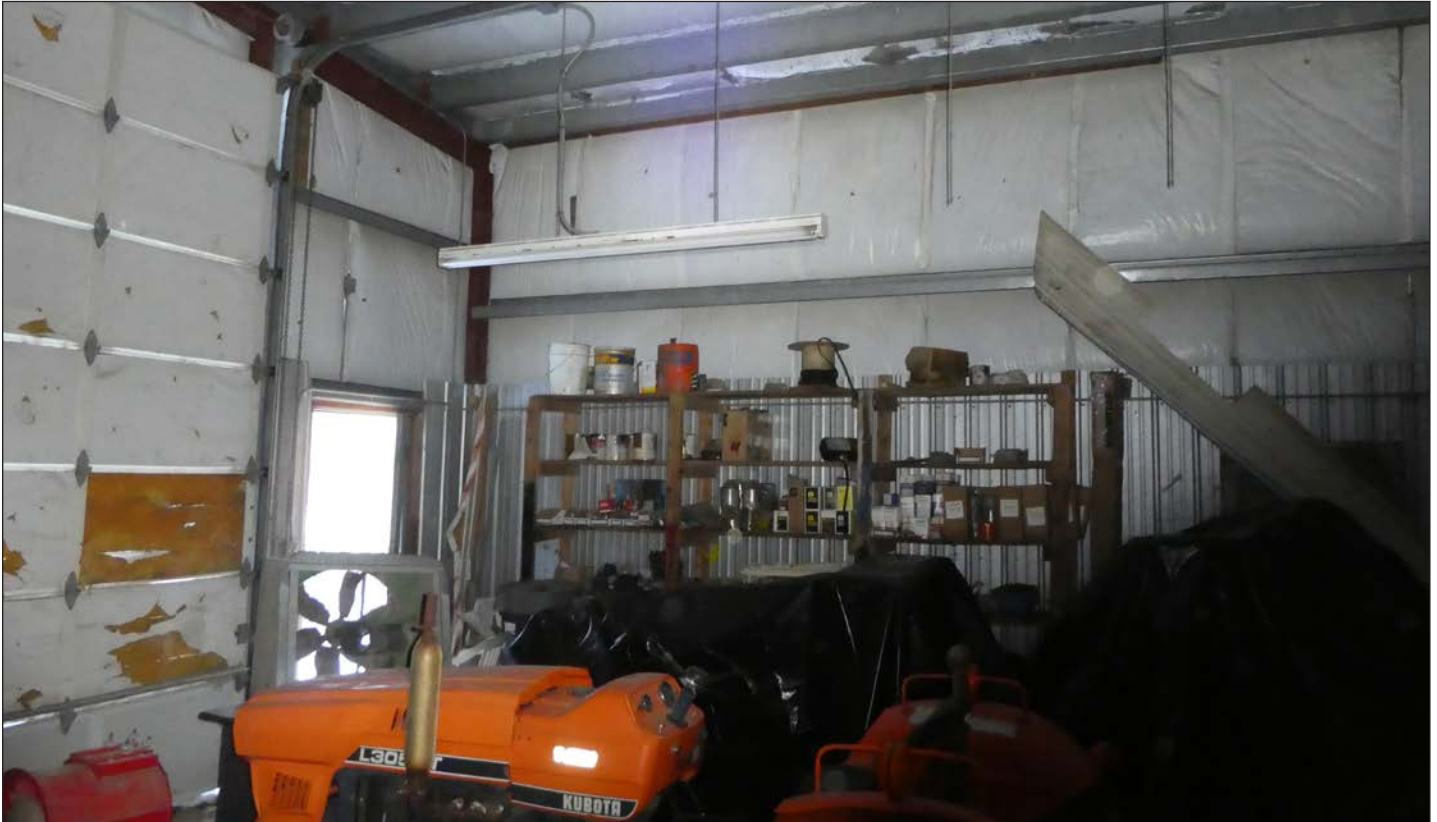
A visual inspection of the lighting fixtures in the large farm building should be done to document and replace any failures.

- Lighting: Ensure all lighting fixtures are operating and document any failed fixtures. Ensure replacements are LED.
- Envelope/Structure: Check the roof's structural integrity to ensure that future retrofits can occur.

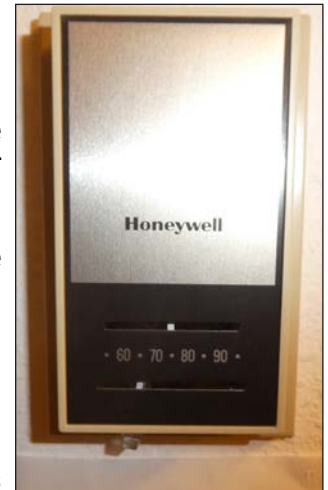
The thermostat, located in the attic, should be periodically checked to make sure that it is set at 65°F in the winter and 55°F in the summer.

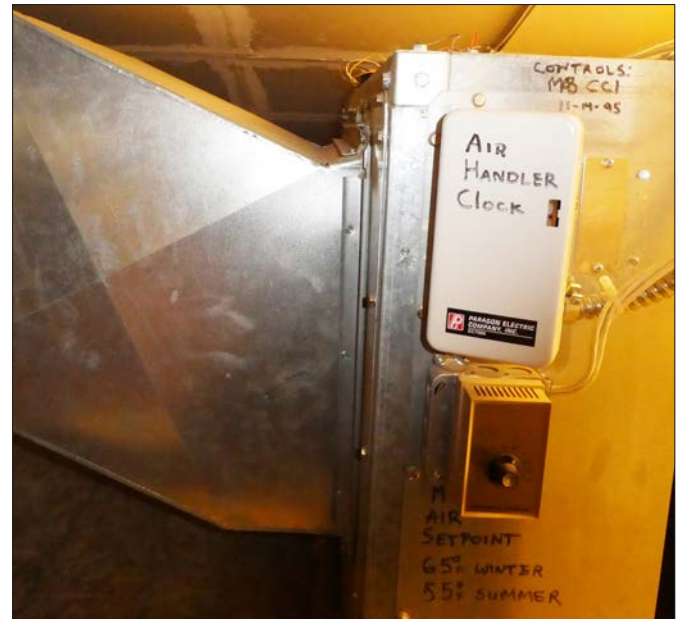
The digital timer for the AHU, located in the attic of the tribal office, should be checked monthly to make sure that the timer is set correctly.

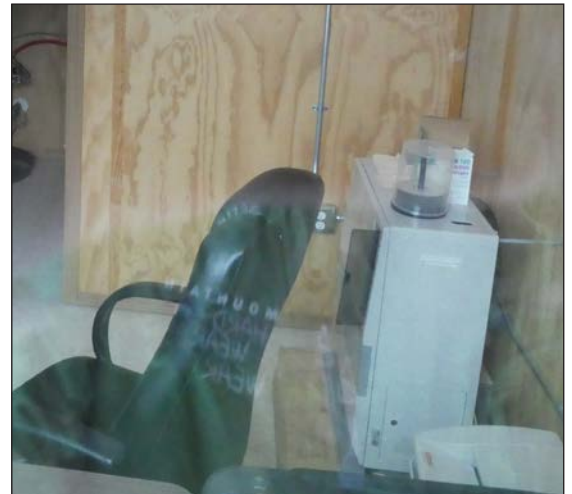
The Toyotomi stove should be checked monthly to ensure that the programmable thermostat is running correctly.

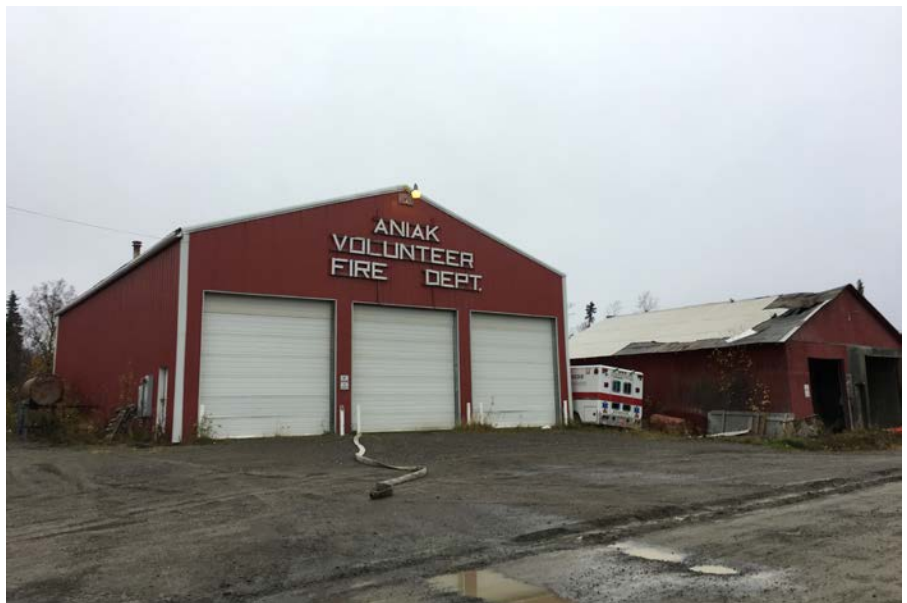
The fire station could reduce energy costs by employing its waste oil and cordwood boilers instead of the fuel-oil-fired boiler.

The fire station was originally built in the year 2000 and used as a volunteer fire station. It is normally unoccupied except for occasional training or community activities. This fabricated steel structure building is constructed on a concrete slab poured on grade. Eight inches of fiberglass batt with an estimated insulation value of R-25 likely fills the

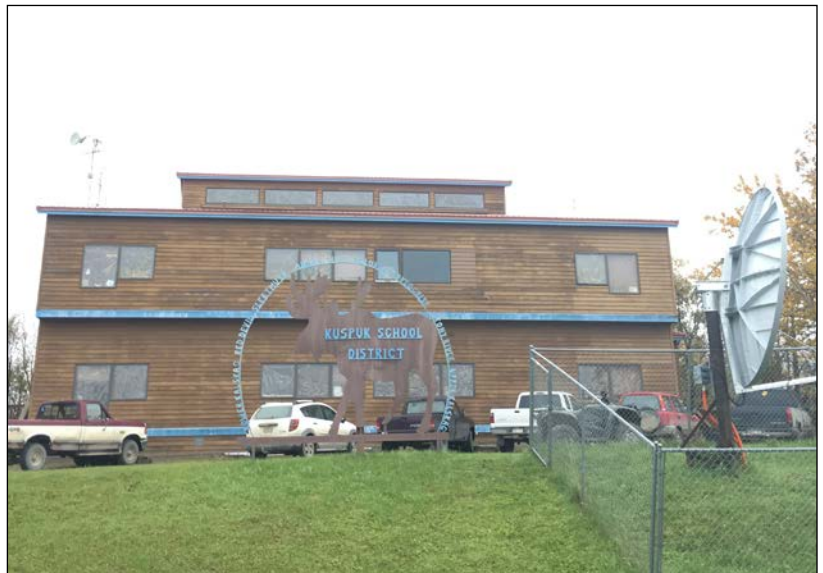
If the school district implements all audit recommendations, the resulting energy savings would pay back the retrofit costs in around five years

The energy audit includes a list of priorities that are cost-effective and have a fast payback period. The number 1 priority is temperature control. That includes implementing an unoccupied heating temperature setback of 50 °F in the crawlspace. This measure would cost roughly \$200 and save approximately \$1,868 a

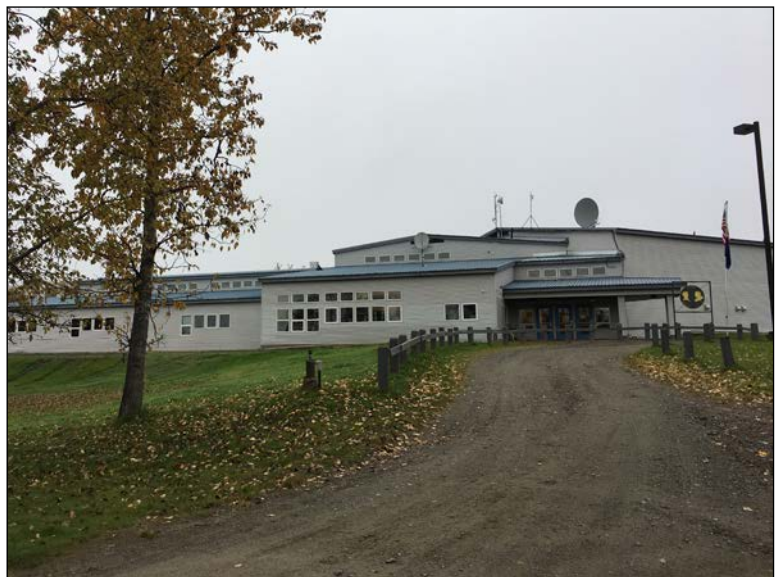
The school could reduce its energy costs by \$15,000 through an energy retrofit.

The energy audit includes a list of priorities that are cost-effective and have a fast payback period. The number 1 priority is temperature control, which includes setting the temperature for the gym and school space to 60 F when unoccupied. This measure would cost \$400 and save approximately \$4,000 per year, paying back in a little more than one month.

Lighting was another priority. The building currently uses fluorescent lighting. Converting to more efficient lighting provides a significant increase in

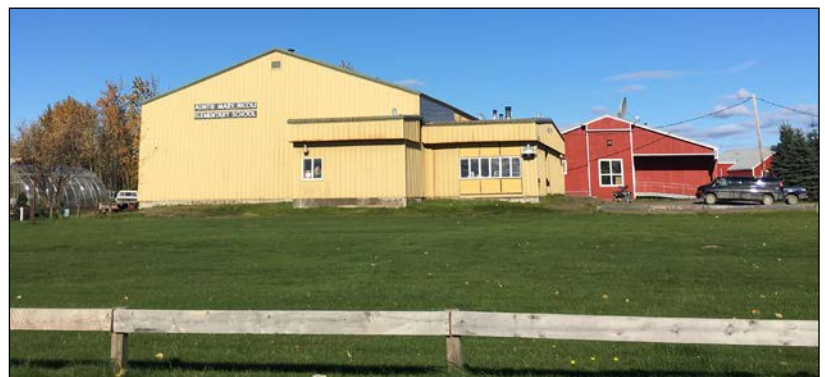
The number one recommendation for the elementary school is to implement temperature setbacks.

The greatest portions of energy cost are envelope air losses, lighting, wall/door and other electrical heat losses, which indicate that the greatest savings can be found in air tightening and potentially reducing the amount of outside air provided to the building using Demand Control Ventilation, more efficient lighting, and reducing school plug-loads.

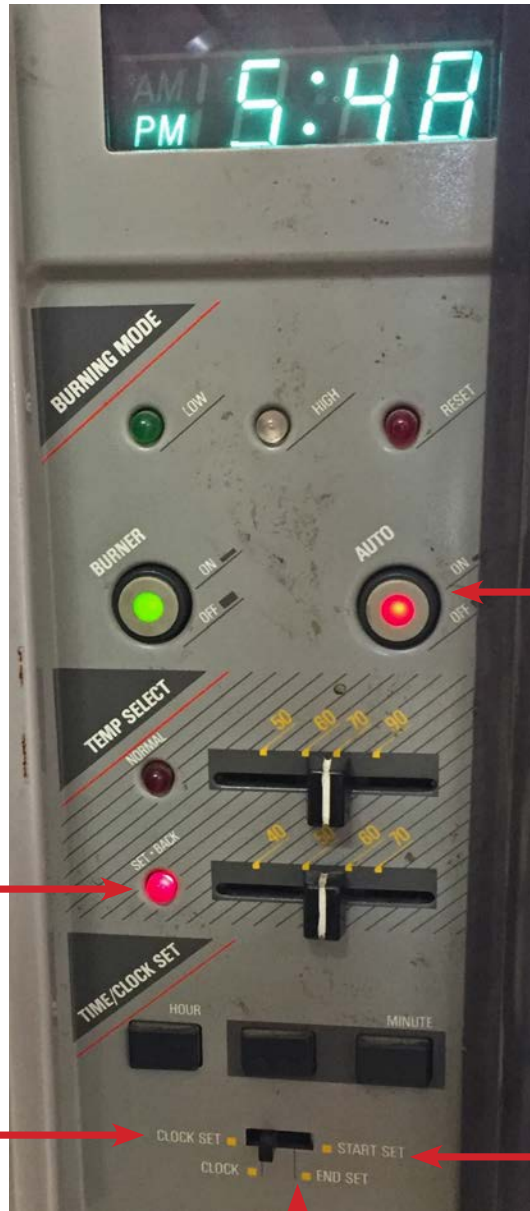
TOYO SET BACK INSTRUCTIONS

IF CLOCK IS FLASHING,
TOYO NEEDS TO BE
RESET
