# Kotlik Community Profile

Figure 1: The Kotlik Riverfront, 2009.  
Division of Community and Regional Affairs Community Photo Library

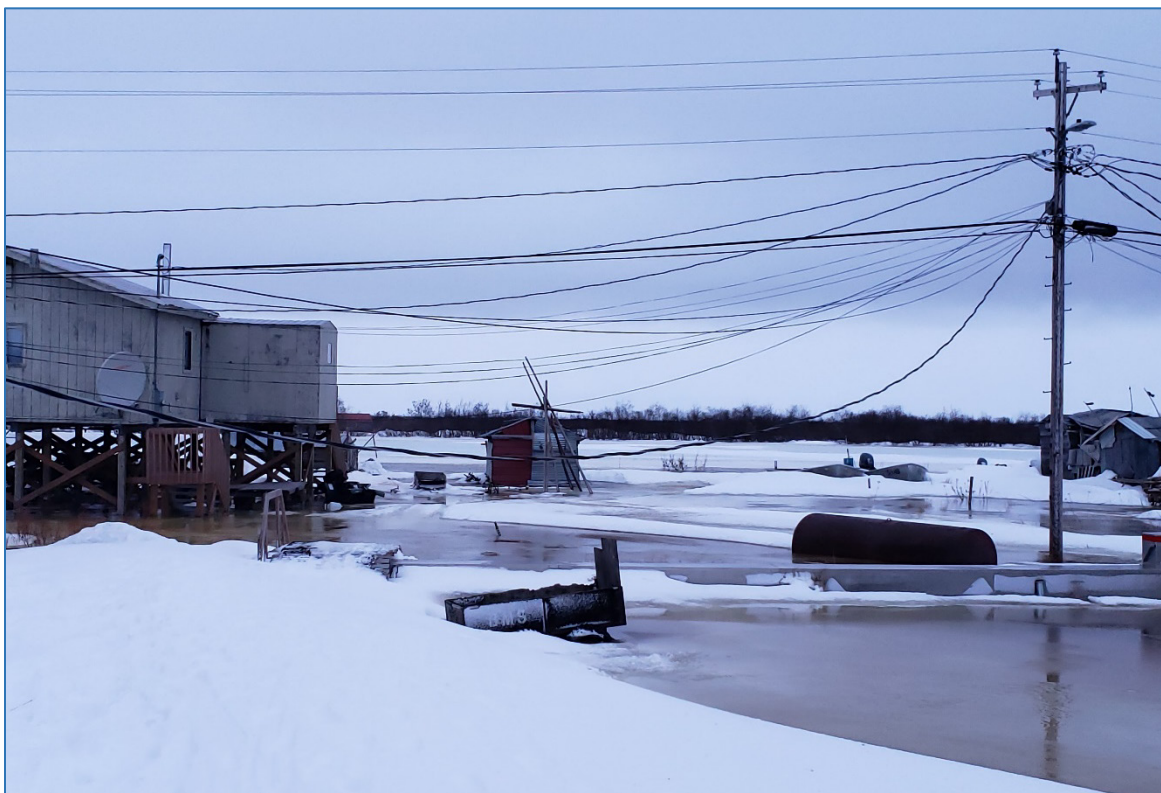
Figure 5: Unusual Flooding in February in Kotlik. Photo: Philomena Keyes, LEO Network

Community members first noticed flooding around midnight on February 11<sup>th</sup> and the water continued to rise into the early hours of February 12<sup>th</sup>. Flood water rose between four and eight feet. Although snow in the village prevented the community from being badly flooded, six homes suffered foundation and insulation damage. The Kotlik tank farm, which is an area of oil or gas storage tanks, and some private property (boats and snow machines) also had damage. (Alaska Native Tribal Health Consortium Center for Environmentally Threatened Communities, 2019)

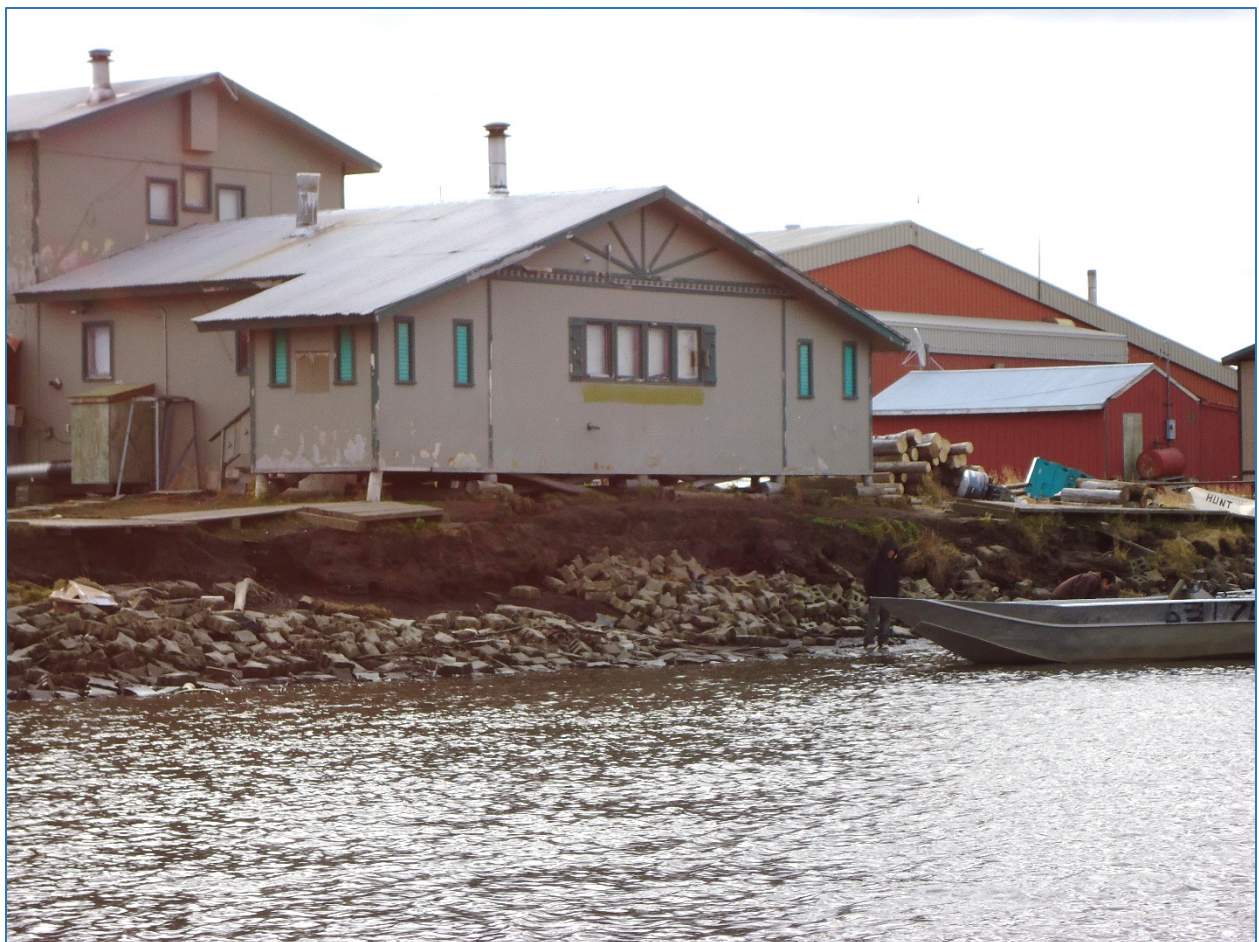
**Figure 6:** Erosion of the Kotlik River Bank in 2011. **Photo:** DCRA Photo Library

Kotlik's erosion is caused by several forces, including naturally-occurring fluctuations in water flows and levels, flooding, ice jams, spring break up, and wave action from boat wakes and wind. The semi-annual thaw-freeze cycle weakens the soil structure of the river bank, which is then eroded by ice abrasion, waves, and occasional high tides from Norton Sound. Additionally, foot traffic destroys vegetation and prevents the establishment of new vegetation which makes the riverbank more vulnerable to erosion forces. (R&M Consultants, Inc., 1986) (City of Kotlik, 2013) (Himes-Cornell, et al., 2013)

In 2016, the Natural Resources Conservation Services (NRCS) made a site visit to Kotlik as part of its Emergency Watershed Program. NRCS determined that there was clearly an on-going erosion problem in Kotlik, although the erosion rates were relatively low: a comparison of historic imagery and maps of the area indicated the average erosion rate was approximately two feet per year. Because threatened homes are built parallel to and within close proximity to the river bank, there is very little land buffer and the erosion is threatening many structures. NRCS found that approximately 40 homes were threatened by erosion, of which a few structures were in the process of being lost to erosion and at least one home which had been
