Options for Near-Term Infrastructure Protection Kotlik, Alaska October 2018

Alaska Native Tribal Health Consortium Center for Environmentally Threatened Communities Michael G. Roberts, PE, REHS; Max Neale, MS; Katie Lund

Executive Summary:

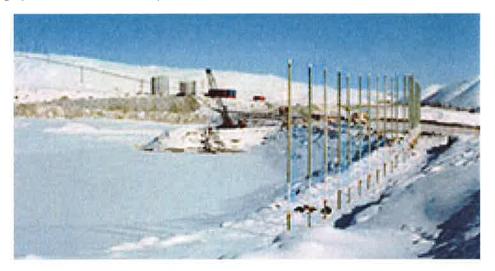
Photo of thermosiphon dam at the Kubaka Gold Mine; Russia Far East Photo Courtesy of Arctic Foundations, Inc.

Thermosyphons are used with great success in many areas throughout the arctic in multiple applications. The application most similar to erosion control in Kotlik is the use of thermosyphons for dam building. Often thermosyphon-supported dams are used to contain tailing/waste ponds, clean water storage ponds, or flow control ponds.

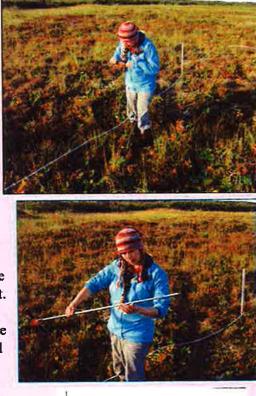
Data Logger

Soil Temperature & Moisture Sensors

The general project design for the ALN follows the design of other CALM projects. All sites consist of 50 meter by 50 meter grids. The depth of the active layer is measured each year at these grid locations. Measurements are taken every 5 meters for a total of 100 measurements. Measurements are made with a calibrated 1.1 meter steel metal rod with a blunt tip and a T-handle grip. The rod is pushed into the active layer until it makes contact with the permafrost. The depth is then measured and recorded on a field sheet. The results of these measurements from your community are provided on the following pages. In addition to manual active layer measurements soil temperature, soil moisture, and air temperature data are all recorded at the ALN site in the center of the grid. Each site is equipped with two soil temperature and two soil moisture sensors. One soil temperature sensor and one soil moisture sensor is placed just above the permafrost and the others are placed just below the soil surface. The sensors collect data every 30 minutes. Each year this data is downloaded onto a laptop computer from the data logger box which is also placed at the ALN grid.
