**Shishmaref Site Analysis
for
Potential Emergency Evacuation
and
Permanent Relocation Sites**

The Natural Resources Conservation Service

The Shishmaref Erosion and Relocation Coalition

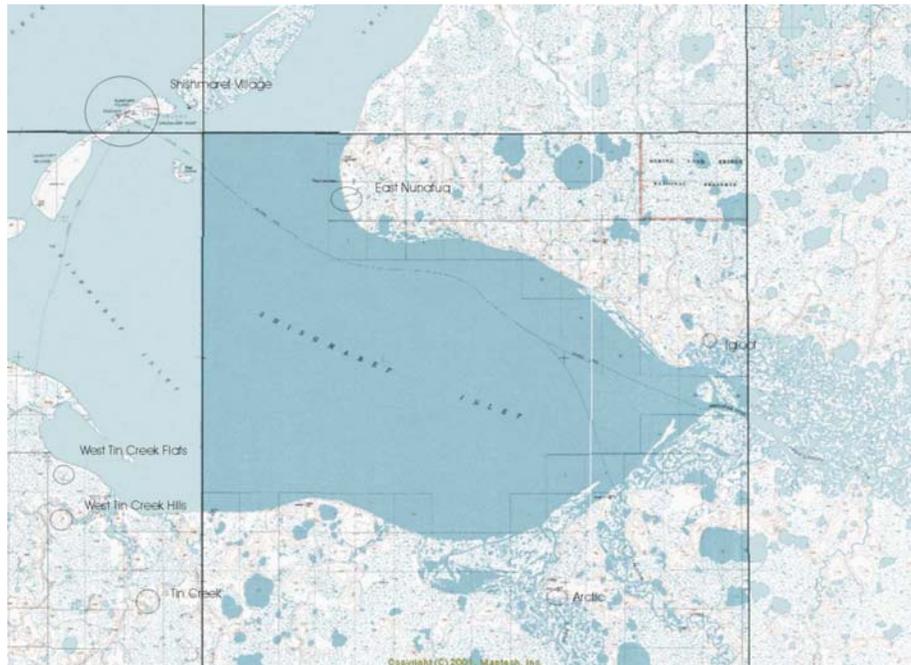
Figure 4 – Potential relocation sites.

Of the 11 areas identified, the Coalition and the citizens selected the five most likely sites and broadly represented these with 5 to 10 square mile blocks drawn on maps. These are shown in Figure 4.

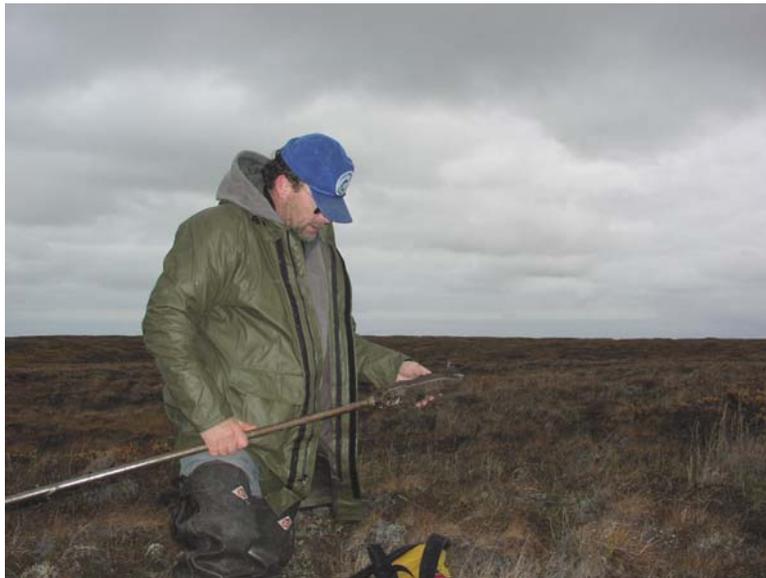
Figure 12 – Soils investigation at West Tin Creek Hills.

West Tin Creek Hills is the smallest, most compact site. Terrain is flat to gently rolling, and the soils are 12 to 16 inches of gray silt to permafrost. The site is accessed by boating about two miles up the main stem of Tin Creek. Like Tin Creek, this site would require an access road to the inlet. West Tin Creek Hills is close to several lakes.

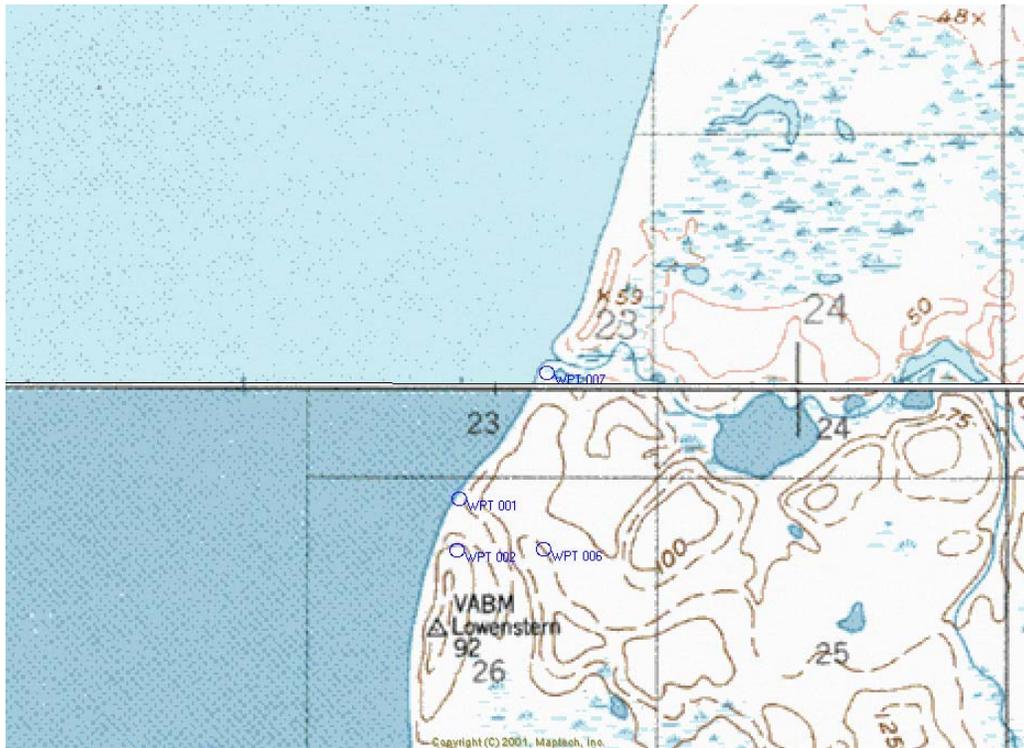
Figure B1 – East Nunatuq Soil Pit Locations.

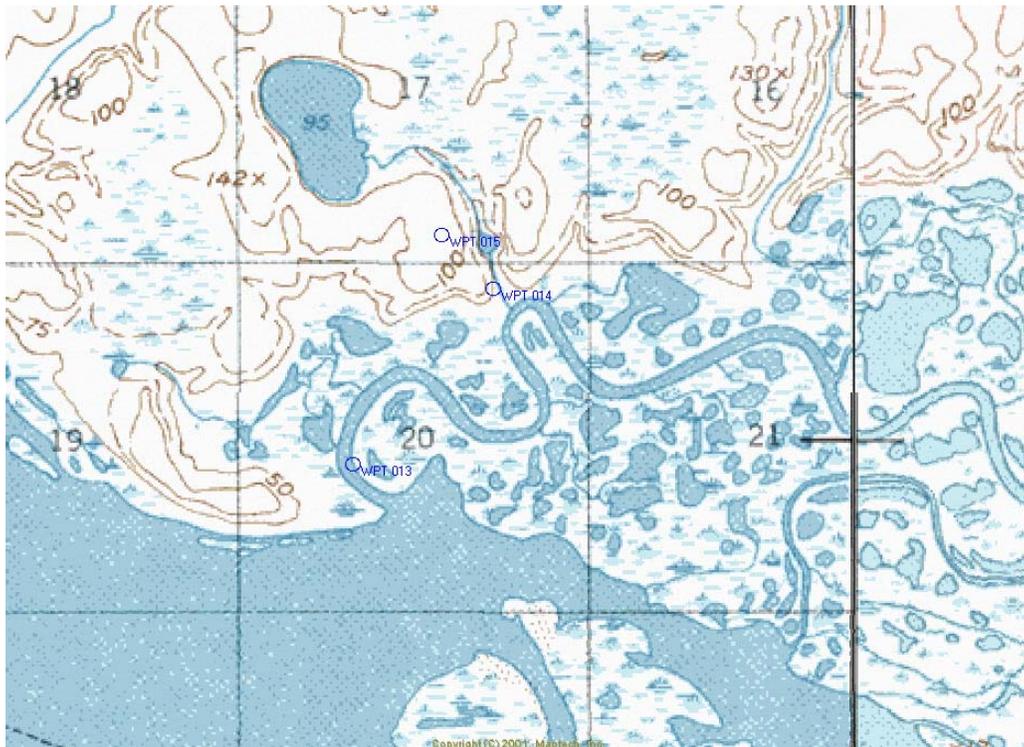
Figure B2 – Igloot Soil Pit Locations.

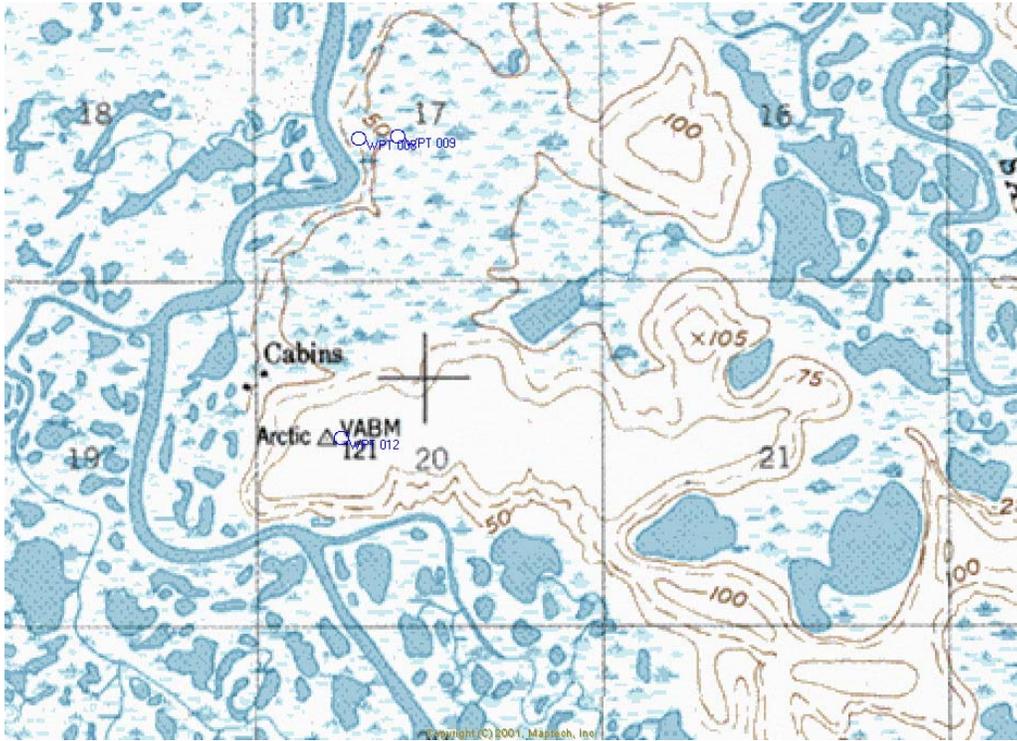
Figure B3 – Arctic Soil Pit Locations.

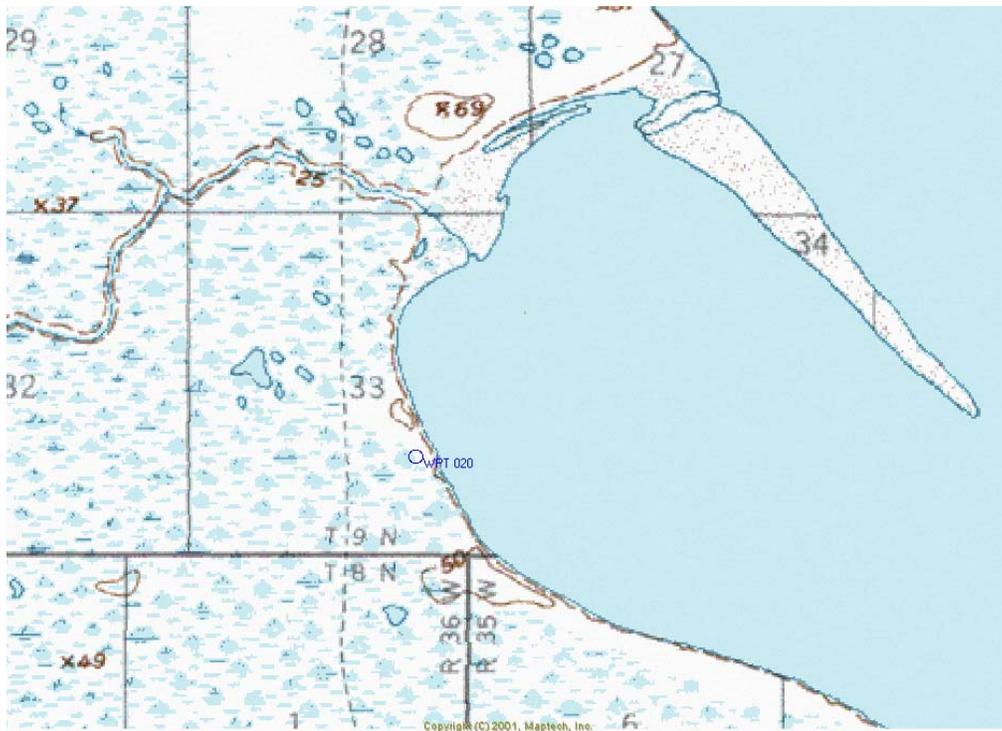
Figure B6 – West Tin Creek Flats Soil Pit Locations.
