ALASKA DISTRICT TRIP REPORT
Alaska Villages Erosion Technical Assistance
Newtok, Alaska

August 2005 Field Trip and Preliminary Observations

PURPOSE: Wetland delineation fieldwork and Archaeological surveys.

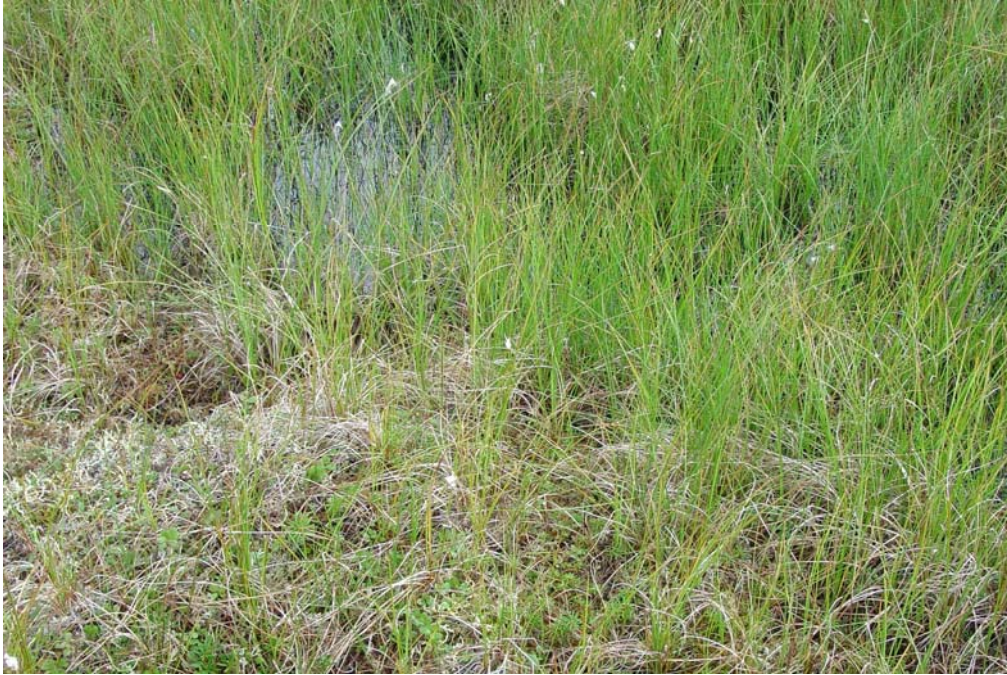
- At the top of the hills (runway 1 and hilltop above proposed quarry site), the general topography simulates an eroded plateau or peneplain, with shallow dendritic drainages. Palustrine scrub-shrub wetlands (similar to the ones found at the bottom of the hills) are usually located on slightly raised microtopography and form a wetland complex with palustrine emergent wetlands (located in lower relief areas or isolated depressions) (figure 4) (photos 1, 2, 3, 4, 5 & 19).

Photo 1: Palustrine emergent wetlands found in depressions. Runway 1 - Sample Site 2B.

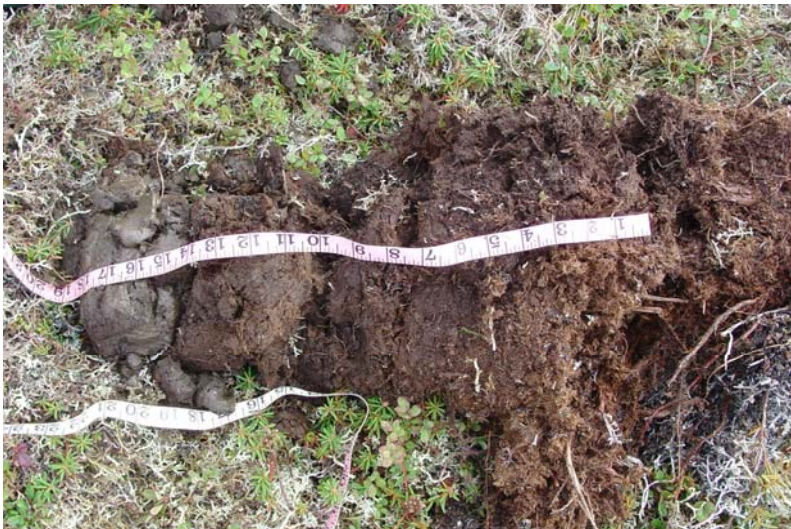
Photo 2: Palustrine scrub-shrub wetlands on slightly higher microrelief. Runway 1- Sample Site 2A

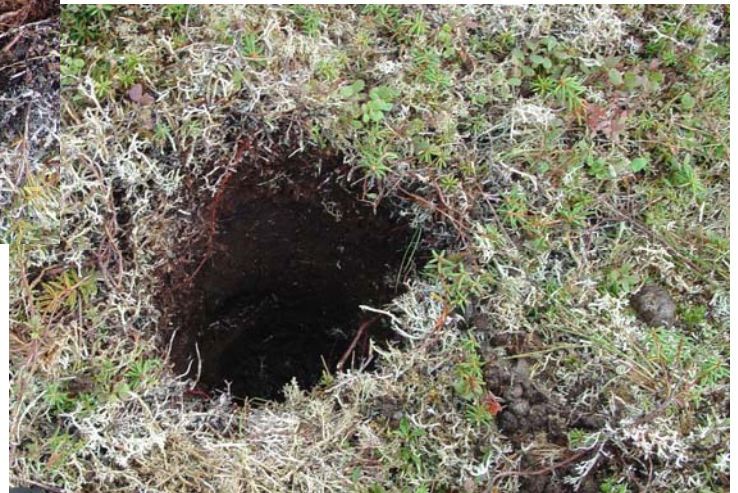
Photo 3: Palustrine scrub-shrub wetlands on slightly higher microrelief. Runway 1- Sample Site 2A

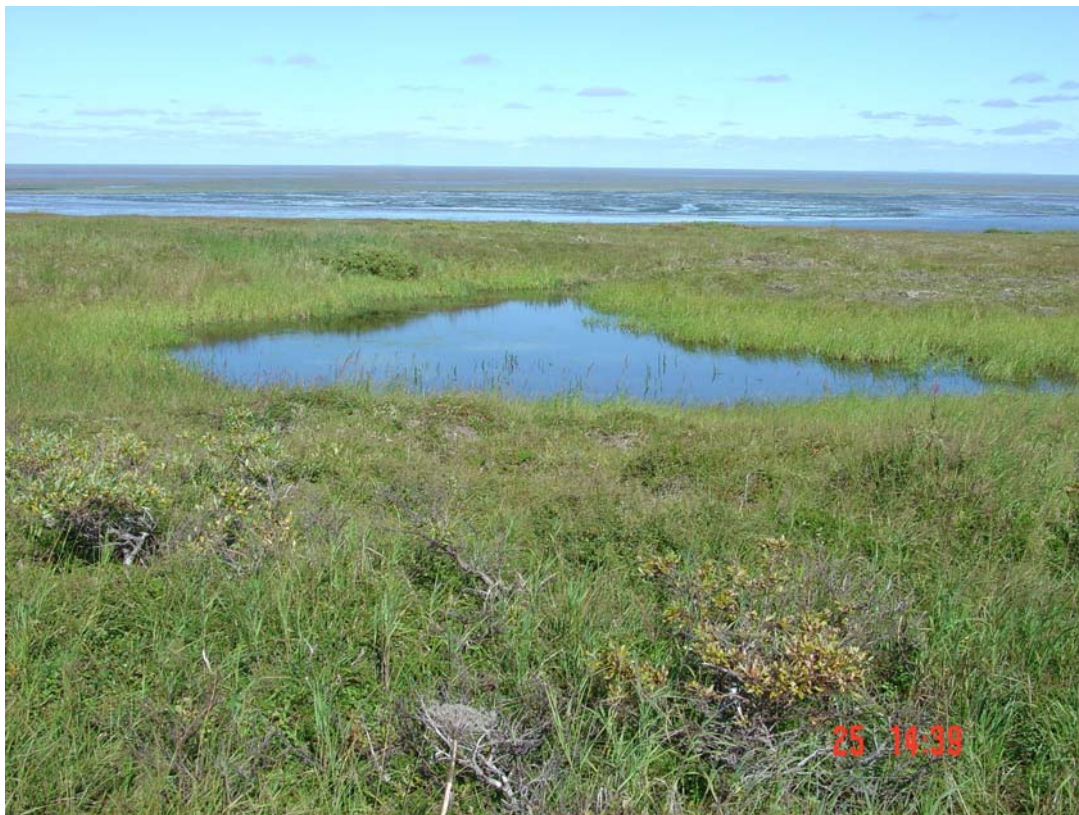
- Palustrine emergent persistent wetlands are found mainly along seasonally flooded drainages, small depressions, and ponds fringes located at the foothills (figure 3) (photos 11, 12 & 13). They are also found at the hilltops, in low relief, and in depressions fed mainly by snow accumulation and rainfall (photo 5). On these hilltops wetlands are part of an intricate shallow drainage system that feeds into headwater tributaries of the East and Takikchak creeks. Most of these tributaries are seasonally flooded and are classified as intermittent streams. They form intertwined wetland complexes with palustrine scrub-shrub wetlands (dwarf scrub and low-scrub vegetation based on Viereck et. al 1992). Takikchak Creek watershed covers approximately 14,700 acres, whereas East Creek is a small watershed with about 2,800 acres (figure 4). Both Takikchak Creek (proposed as source of freshwater for the relocation site) and the potential quarry site are in the same watershed system, so consideration should be given to the potential impacts quarry activities could have on these wetlands and hilltop drainages.

Photo 5: Palustrine emergent persistent wetlands on pond fringes – runway 1 general area.

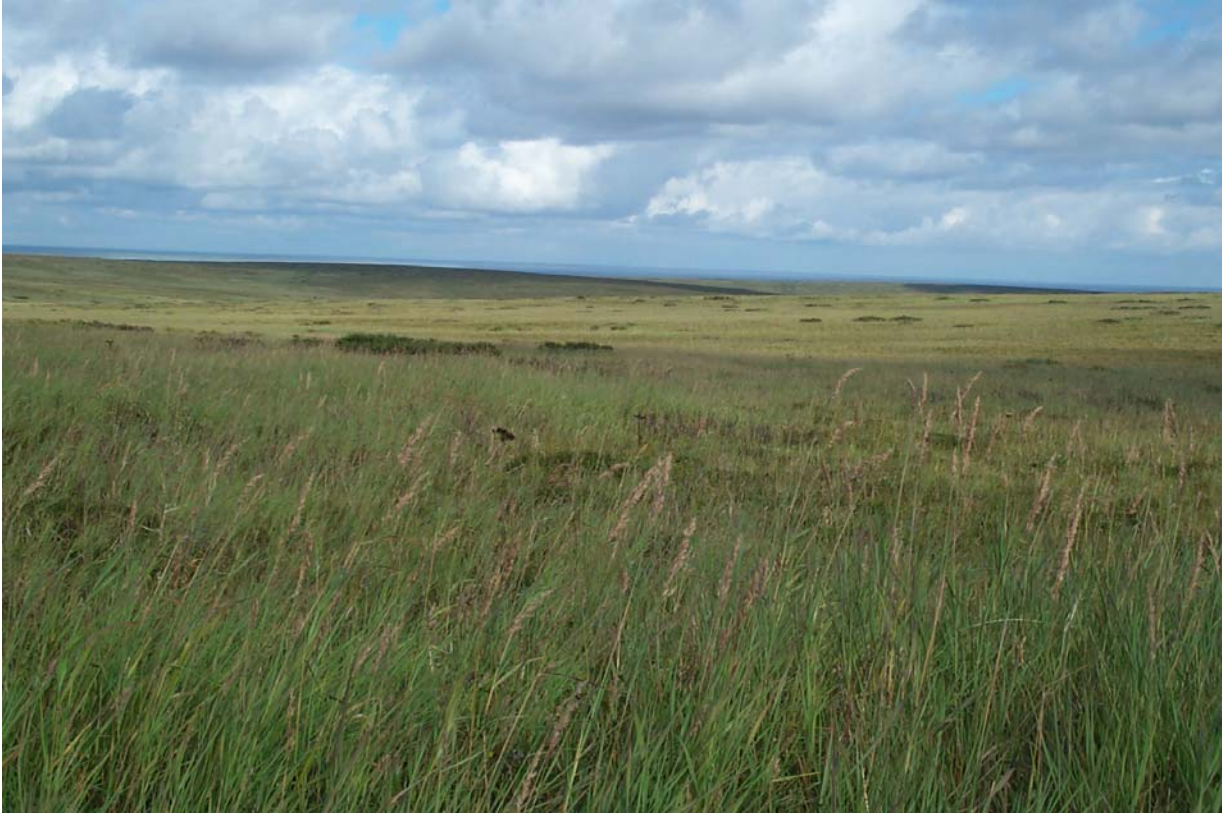
Photo 6: Runway 4 general view. Bluejoint and willows (*Salix pulchra*) are the dominant plant species at this sample site. Forming mats are crowberry, Labrador tea and dwarf birch.

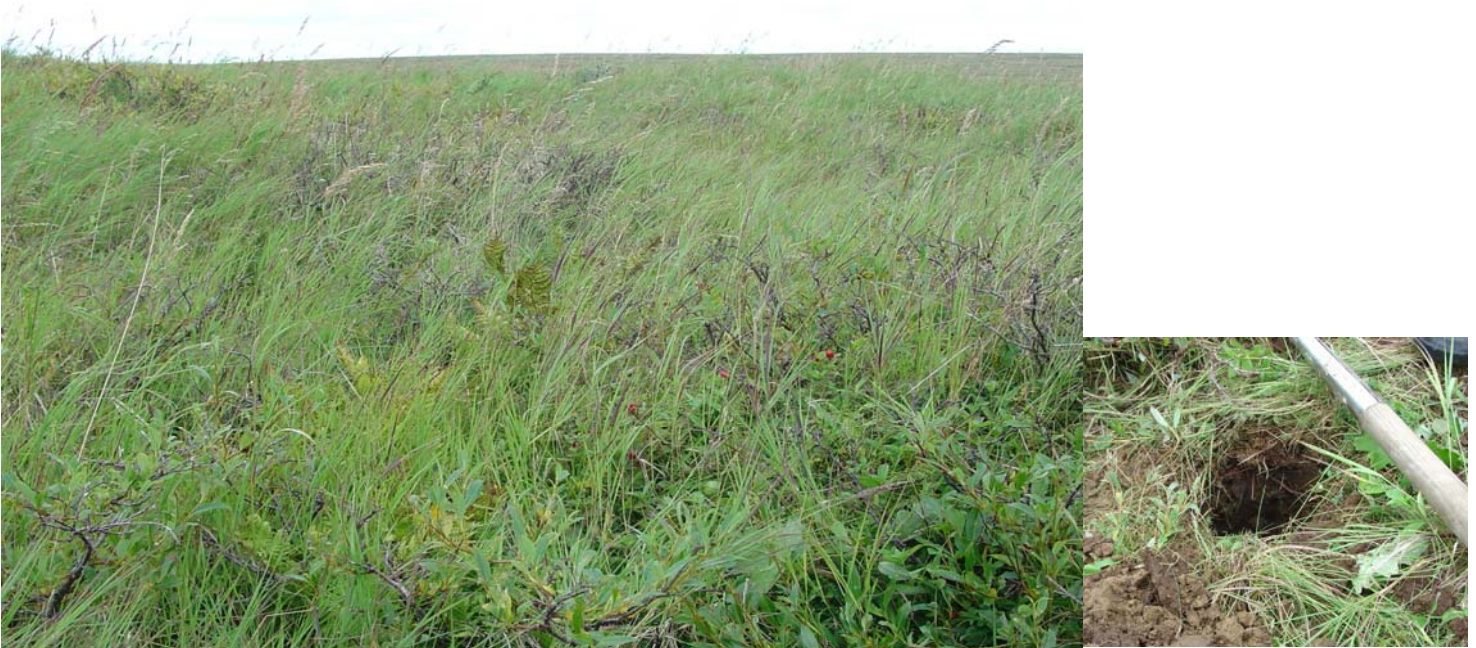
- Drainage slopes in the vicinity of runway 4 display moderate to well-drained soils. These stable slopes have undergone lateral erosion processes that have caused deepening of the active layer, rejuvenation of the weathered-derived nutrient supply into the soils, and improved its

Photo 7: Sample Site 1B - runway 4. Moderate drained soils found along drainage slopes with high plant species diversity. Soil rejuvenation caused by lateral erosion along drainage slopes might explain the improved soil hydrological conditions.

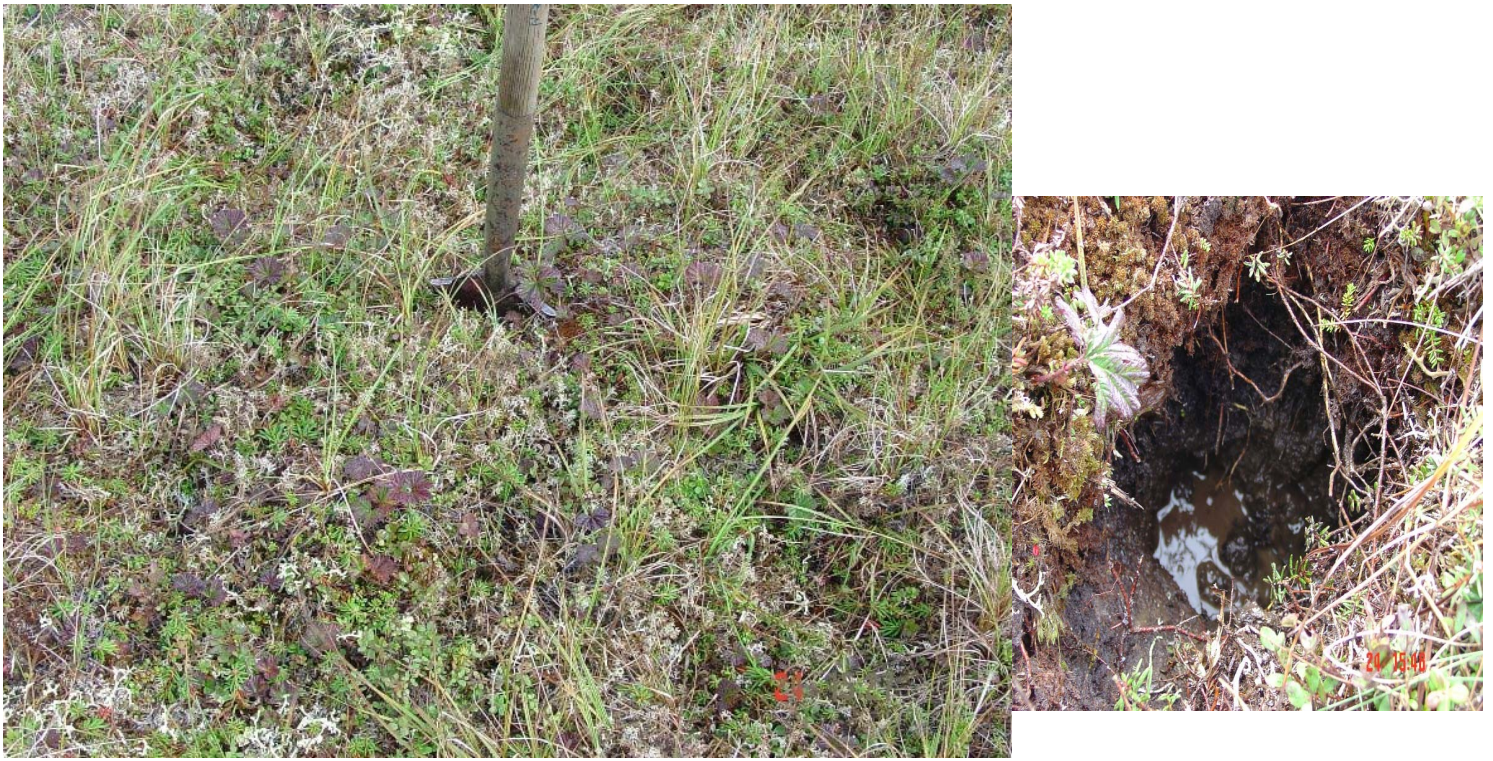
Photo 8: Palustrine scrub-shrub wetlands. Sample Site 1A- runway 4.

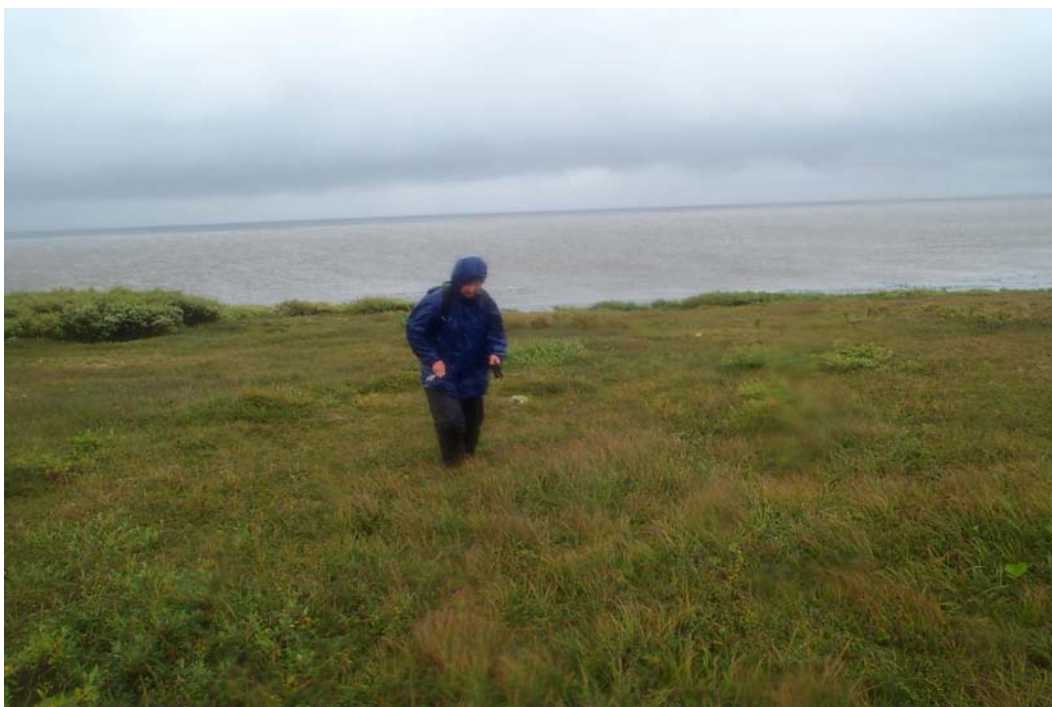
- In the slope (relocation site), palustrine scrub-shrub wetlands are established in more mesic¹ conditions, although hydric soil indicators are still observed. Sphagnum is not as abundant, and low growing ericaceous shrub tundra is dominant (Viereck et. al 1992) (photos 10a, 14, 15 & 16).

Photo 10a: Barge site vicinity. Vegetation is mainly dominated by scrub willow (*Salix pulchra*), Bigelowii sedge and low growing plants growing in patches (crowberry, dwarf birch, and Labrador tea).

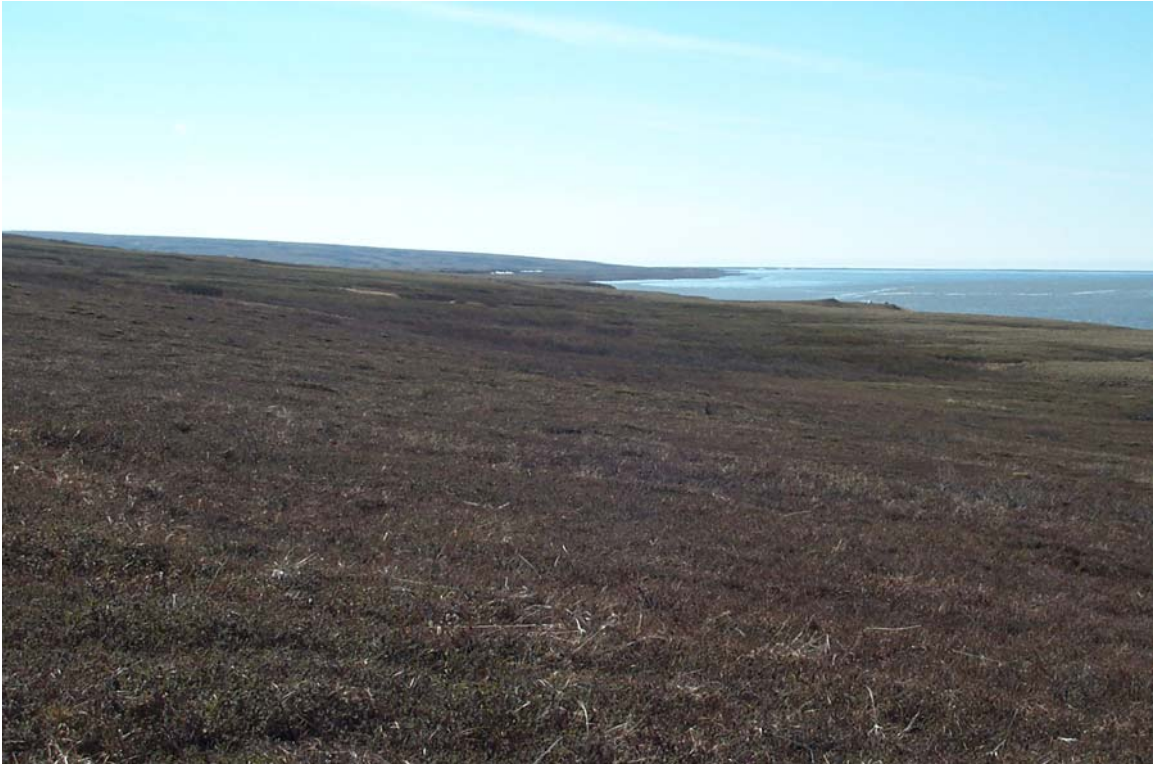
Photo 16: Other view of palustrine scrub-shrub wetlands on gentle slopes at the Newtok relocation site.

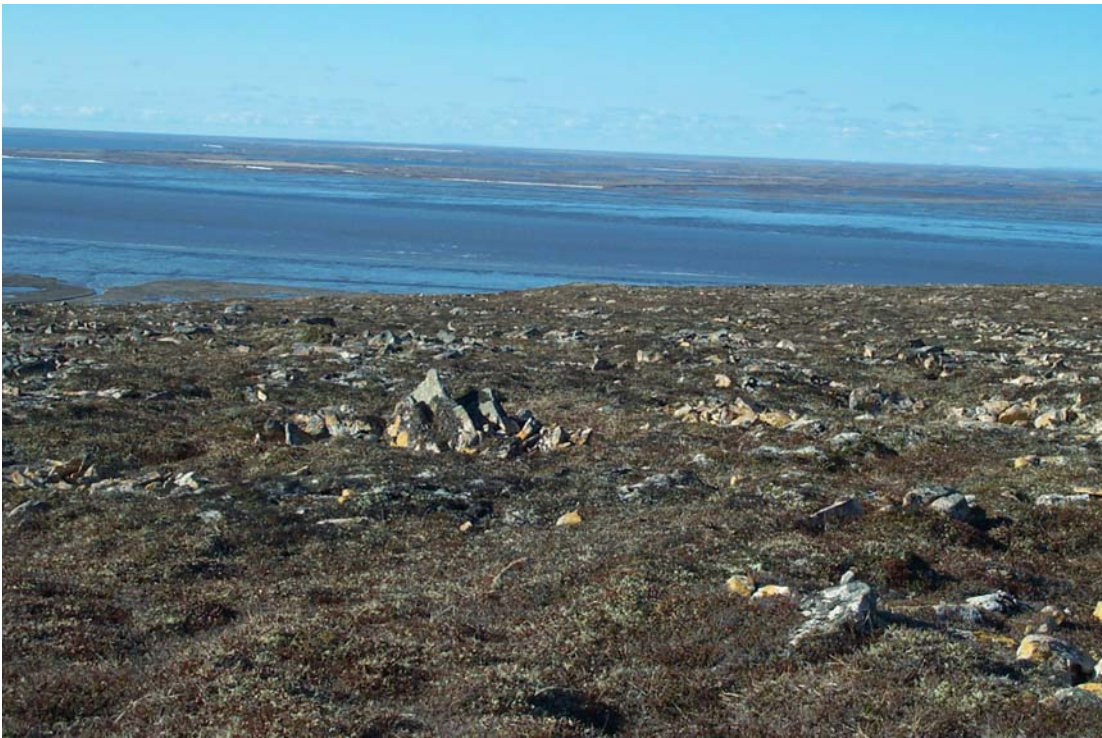
- Areas of uplands are found at the north facing slopes of the proposed borrow material site. Vegetation in these areas is typical of windswept alpine slopes with a predominance of crust mosses, lichens, and alpine plant species. Soils are rocky and shallow with an abundance of boulders (photos 17 & 18). Vegetation has formed root mats that cover the rock bed in many areas.

Photo 17: Potential borrow site view (uplands).

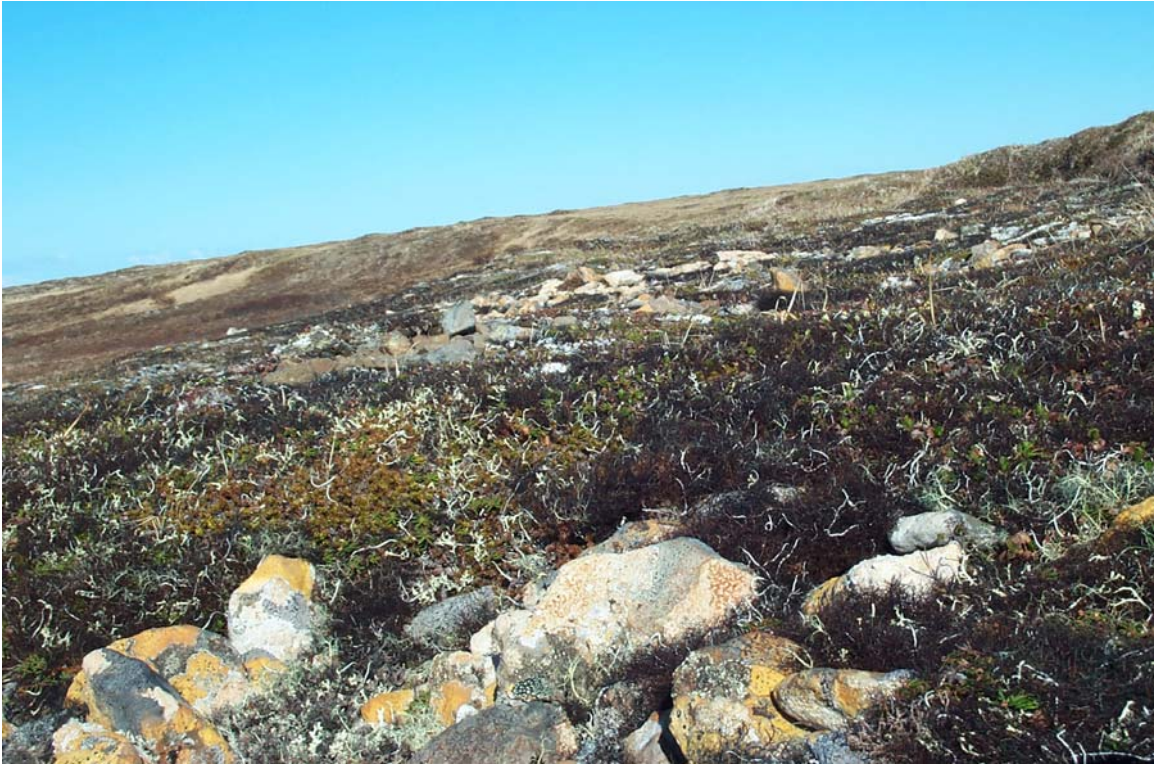
Photo 18: View of borrow site looking up the slope.

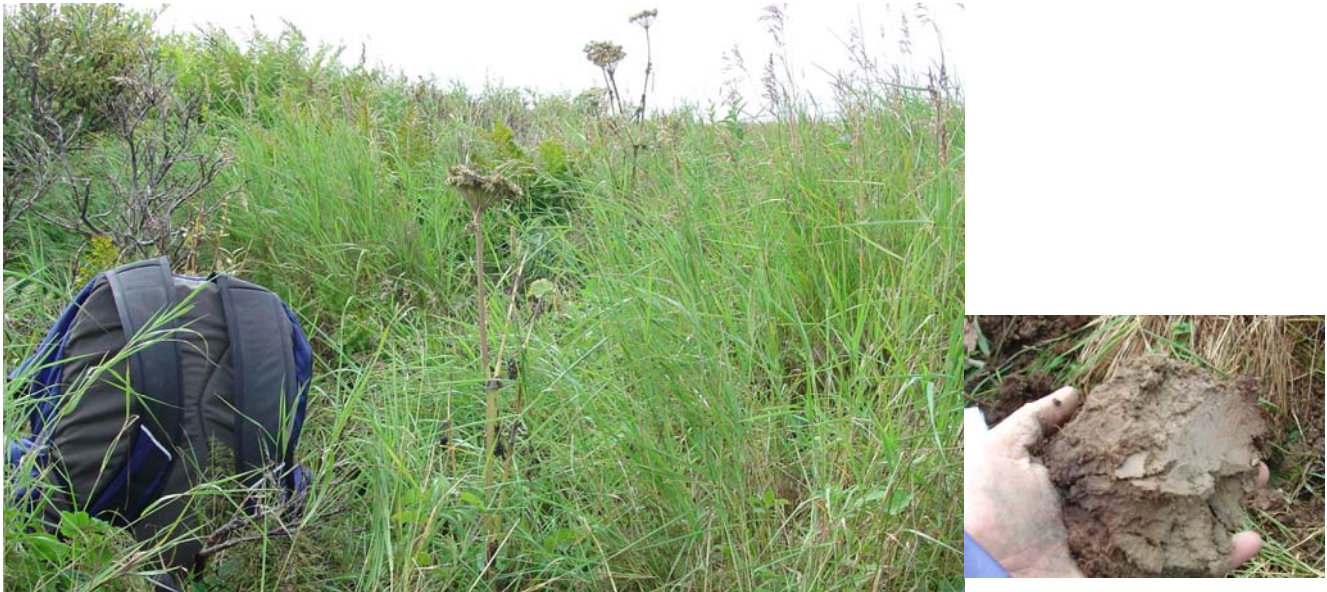
Photo 19 Palustrine Emergent/scrub-shrub wetland - Sample Site 2C at runway 1.
