## Mertarvik Waterfront Development Project Number 80861

**STATE OF ALASKA**  
**DEPARTMENT OF TRANSPORTATION &**  
**PUBLIC FACILITIES**  
**STATEWIDE DESIGN & ENGINEERING SERVICES**  
**COASTAL ENGINEERING SECTION**  
5800 East Tudor Road, Anchorage, AK 99507  
907-269-6239; Fax 907-269-6478  
8/15/2012

PROJECT NAME: Mertarvik Waterfront Development  
PRESENTED TO: Newtok Traditional Council  
(Acting for the Village of Newtok)  
PREPARED BY: Ruth Carter, P.E., Coastal Engineer  
Harvey Smith, P.E., State Coastal Engineer

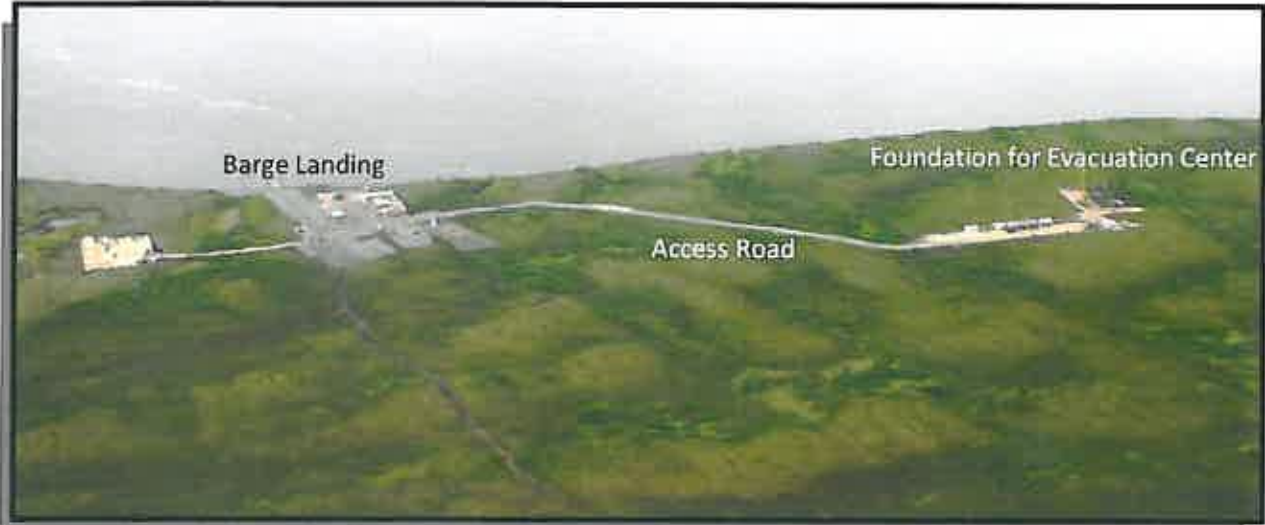
Mertarvik Barge Landing, Access Road & Evacuation Center Foundation. (Harvey Smith, ADOT&PF, 6-2011)

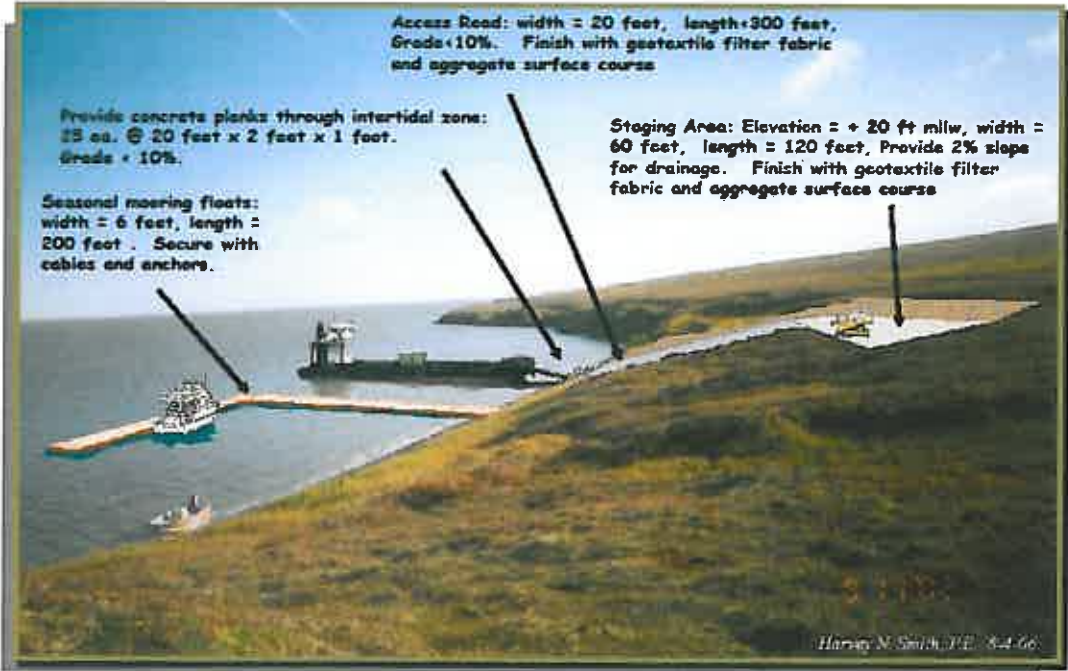
At the outset, waterfront development was recognized as a key element in the overall move from Newtok to Mertarvik. Harvey Smith, PE, State Coastal Engineer, proposed a barge landing site and seasonal boat moorage (2006).

This concept was used by the NPG, U.S. Army Corps of Engineers (USACE), and others in the development of the original community layout. Unfortunately the concrete plank landing was constructed without a thorough bathymetric survey and so an additional barge landing was constructed to better accommodate construction activity.

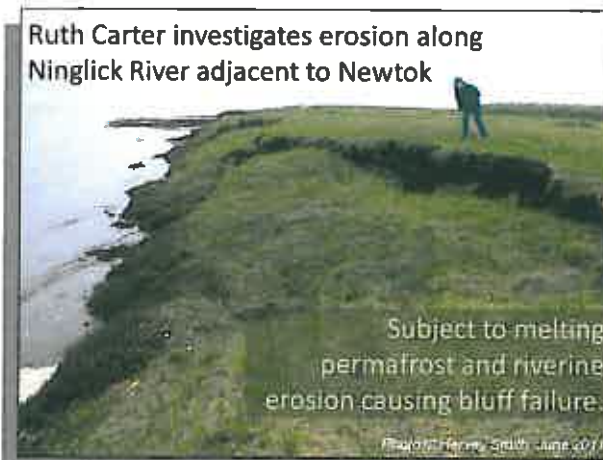
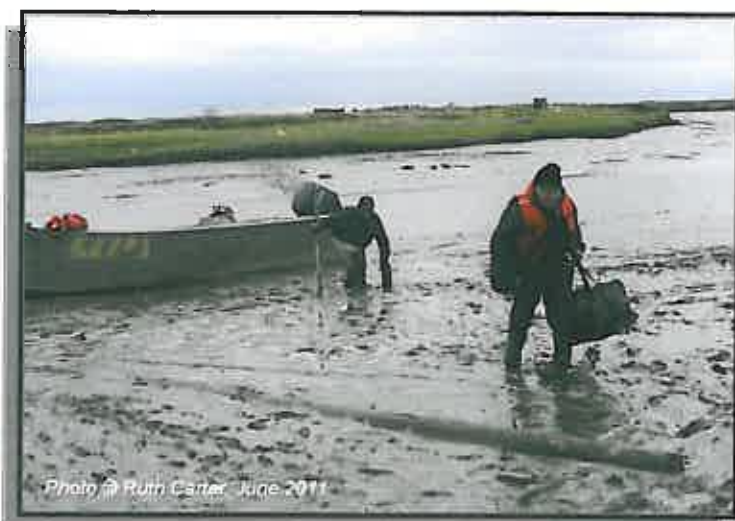
Ruth Carter investigates erosion along Ninglick River adjacent to Newtok

Late arrival of field gear and tides limited access to Mertarvik; however the team talked to Newtok residents and explored their fleet and harbor needs. They also looked at erosion issues along the Ninglick River. Local residents noted that Kealavik River has been silting in and traditional boat access is greatly reduced. Larger scale progressive erosion associated with melting permafrost is evident along the Ninglick River.

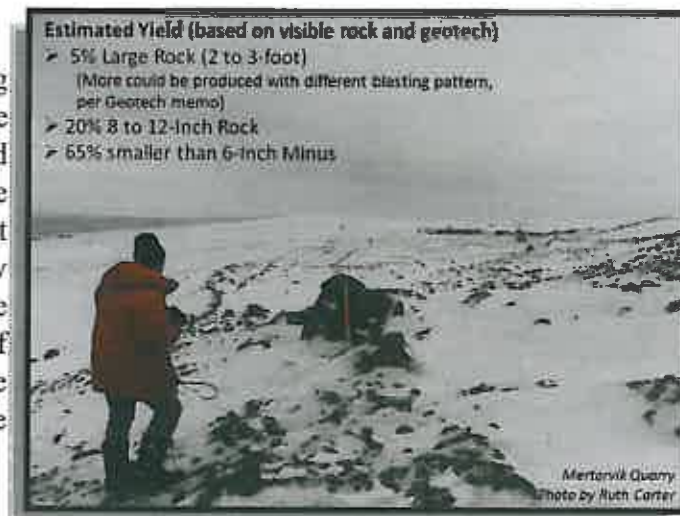
We landed at the quarry and despite being frozen, we were able to see the face of the quarry and how it had been developed. Based on visible rock and the geotechnical report, we were able to estimate the yield. The report described 4-foot of overburden and shallow permafrost. There is basalt and mudstone present; they are not uniformly distributed. If properly developed the quarry, should produce core and filter material. It might also produce armor stone if correctly blasted and mined.

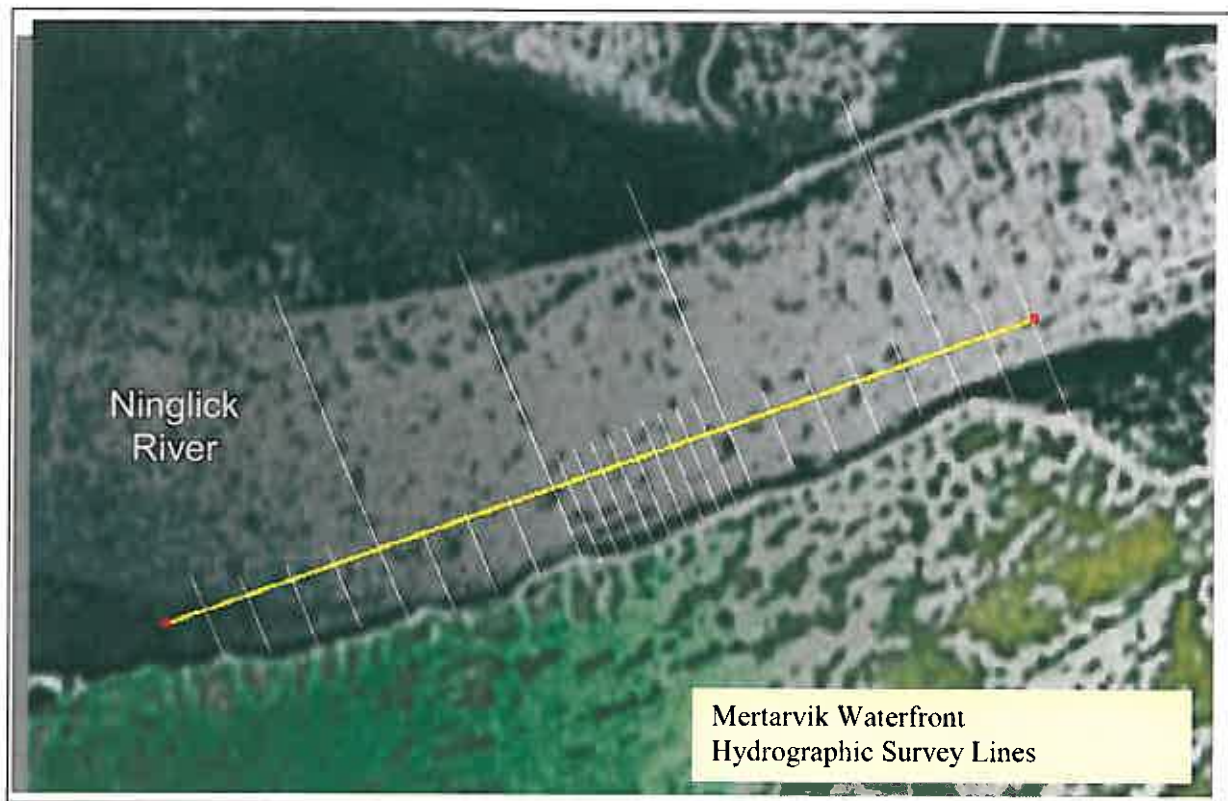
The survey shows a small anomaly almost directly offshore from the concrete ramp; this is most likely bedrock due to the proximity of the point on which the barge landing was constructed. It is also consistent with the coastal geomorphology of this area. Further west, near the spring is another point, but that is alluvial in nature. The smooth contours offshore reflect a movable sediment bed in the Ninglick River and Baird Inlet.

The upper beach along the Mertarvik waterfront is a mud flat with exposed boulders at low tides and was included in the survey. There is a shelf on a relatively flat slope (1:25) to the -10 foot MLLW contour, which then drops off to -36 feet in the main channel of the Ninglick River and Baird Inlet. There is about a four foot tidal range.

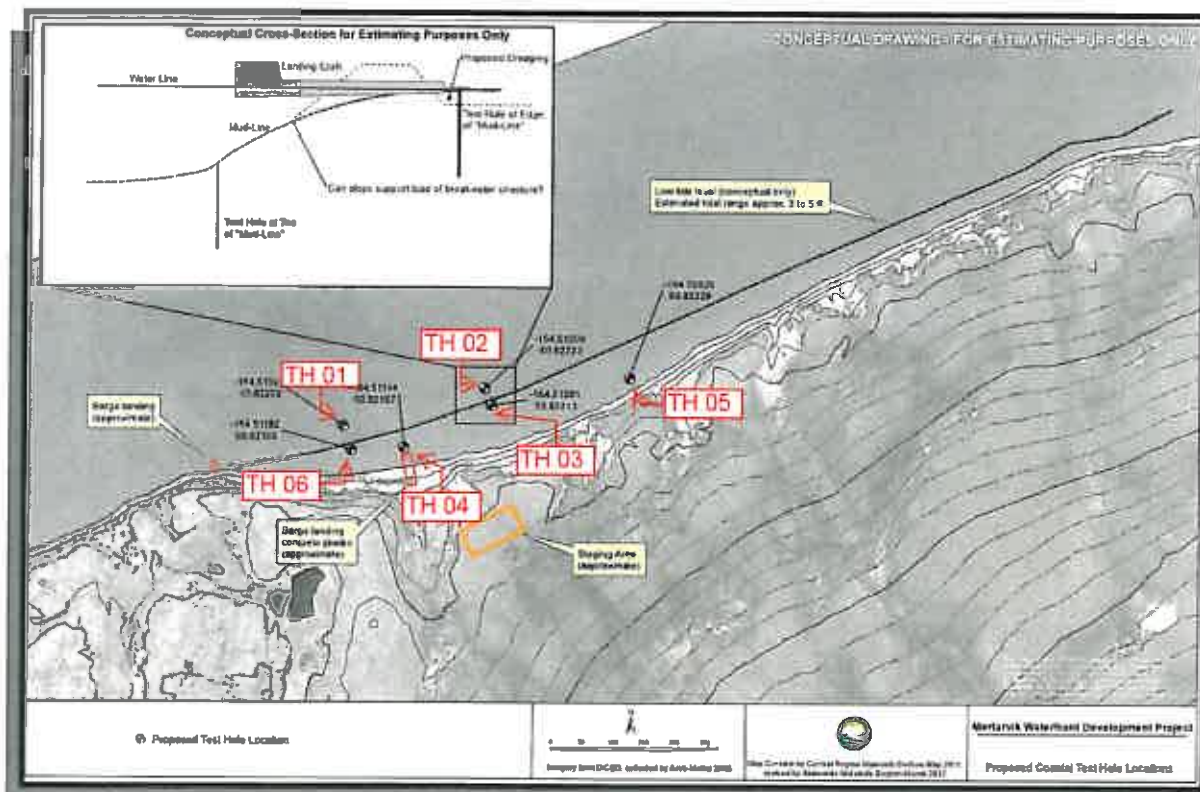
Generally they found dark gray silt with fine sand and sandy silt overlying weathered volcanic bedrock. The silt and sand generally ranged from 5 to 15 feet in depth in the western three borings, i.e. those nearest the barge landing and concrete planks, and from 20 to 25 feet in the eastern 3 borings. The silt and sand ranged from loose to medium with occasional dense layers containing gravel.

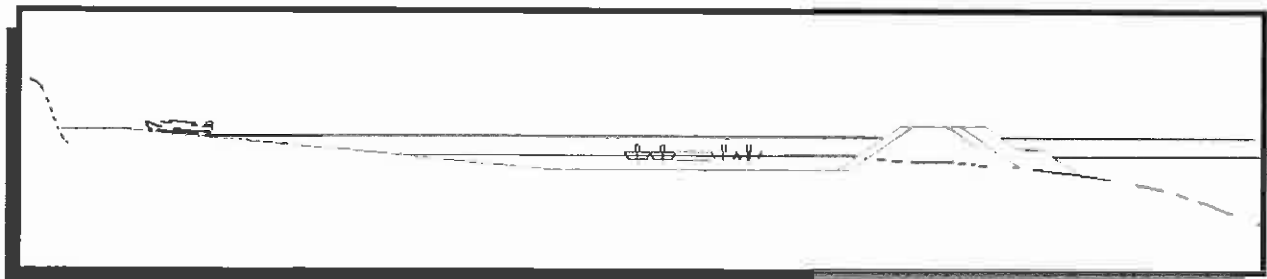
Cross-section showing breakwater and mooring basin; it is anticipated that the fleet will remain unchanged. The vessels are shallow draft requiring about 4-feet. Rock for the breakwater would be designed to withstand waves, currents and ice-picking. A road on top of the structure would allow access potential for a future dock structure and reduce construction costs.

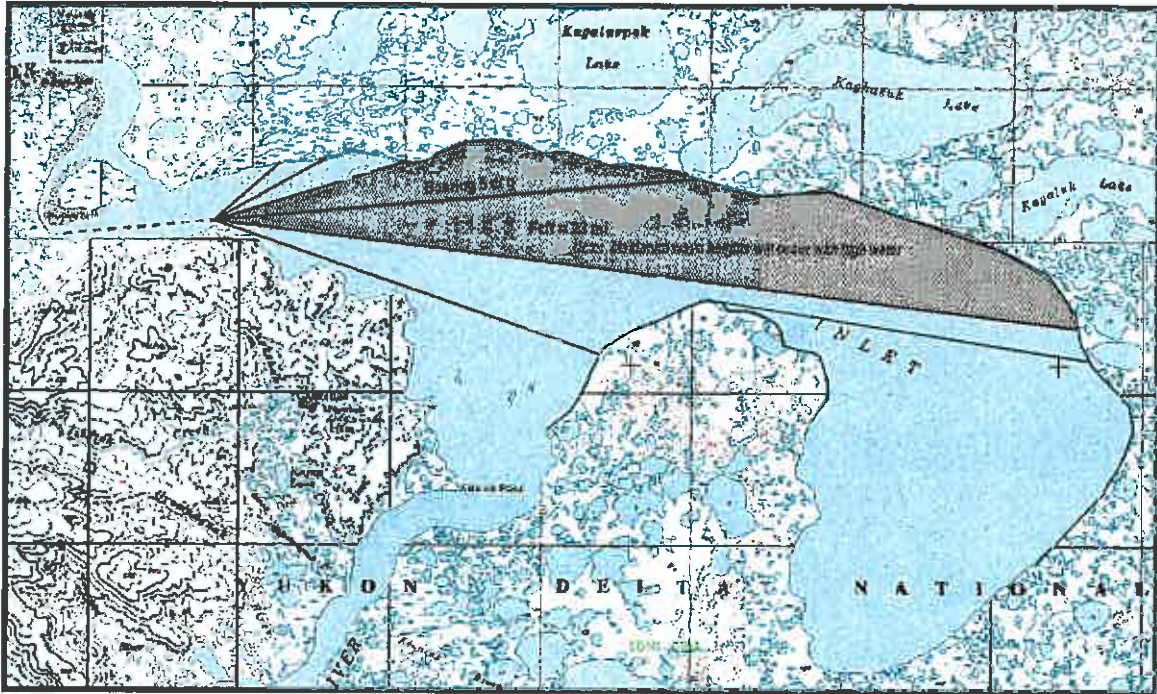
Wave exposure is determined by looking at local fetches; a fetch is the distance over which the wind can blow unobstructed by land before reaching the observer along a given compass heading. Nine, radials at 3 degree increments are the standard used to calculate the effective fetches, as shown nautical charts below.

There is a twenty-three (23) mile, open-water fetch in Baird Inlet, which may create long period waves that may diffract into the area of the Mertarvik Waterfront. All breakwaters considered

were therefore designed to include an east arm to protect the harbor from this wave exposure and associated sediment transport.

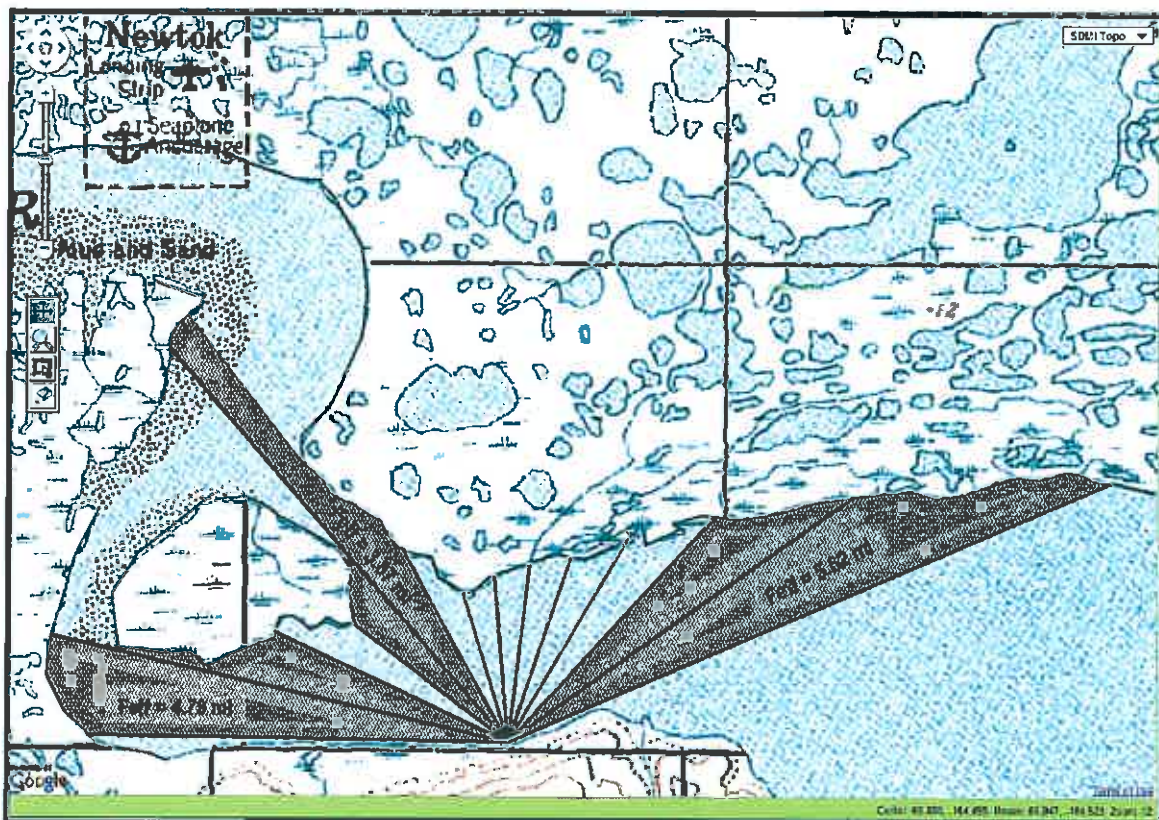
The proposed Mertarvik harbor is also exposed to direct fetches of 4.79, 3.87 and 5.62 miles from the west, northwest and northeast, respectively.

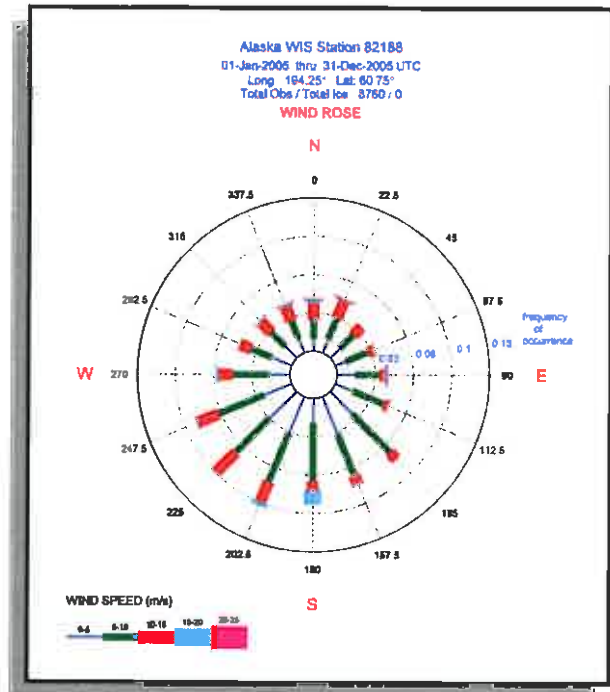
Wind data is not available at the site, but there was a Newtok Airport Relocation Reconnaissance Study that summarized anecdotal information for surrounding facilities. Local area winds vary widely, so local wind data will be collected at Mertarvik for the airport project. There is also data available through the Wave Information Studies (WIS), USACE (<http://wis.usace.army.mil/wis.shtml>); a typical wind rose from this site is shown here.

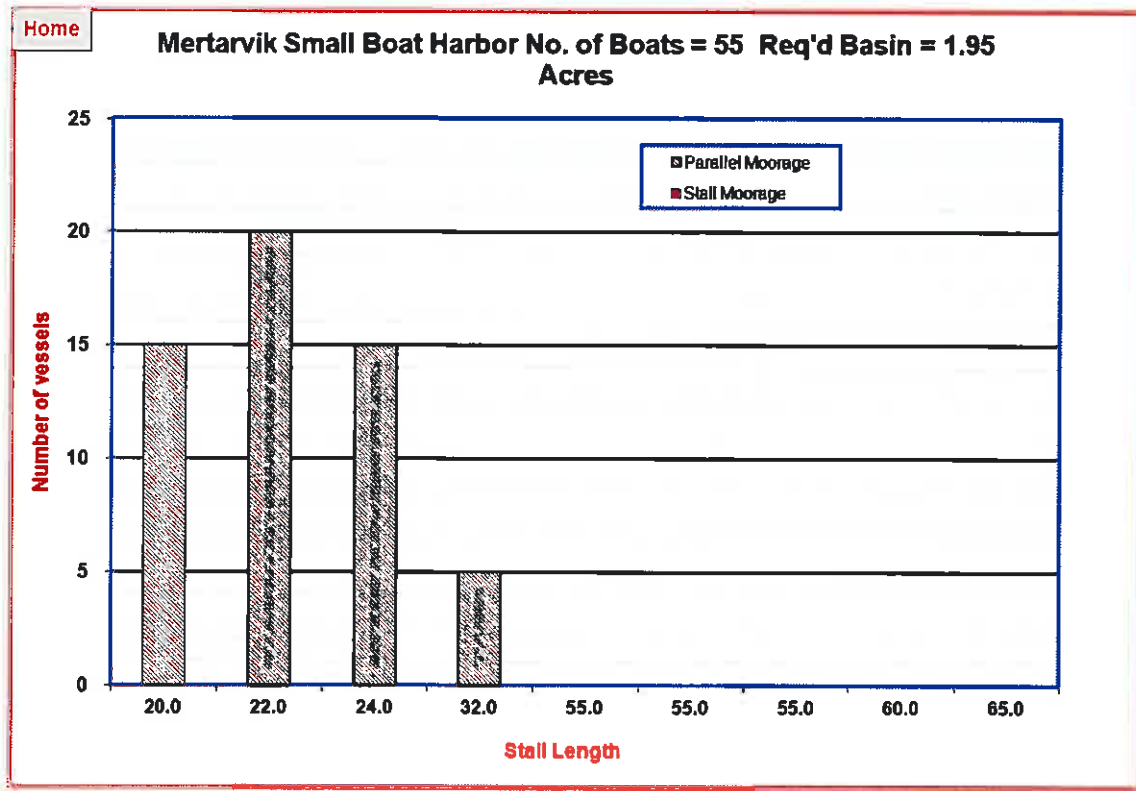
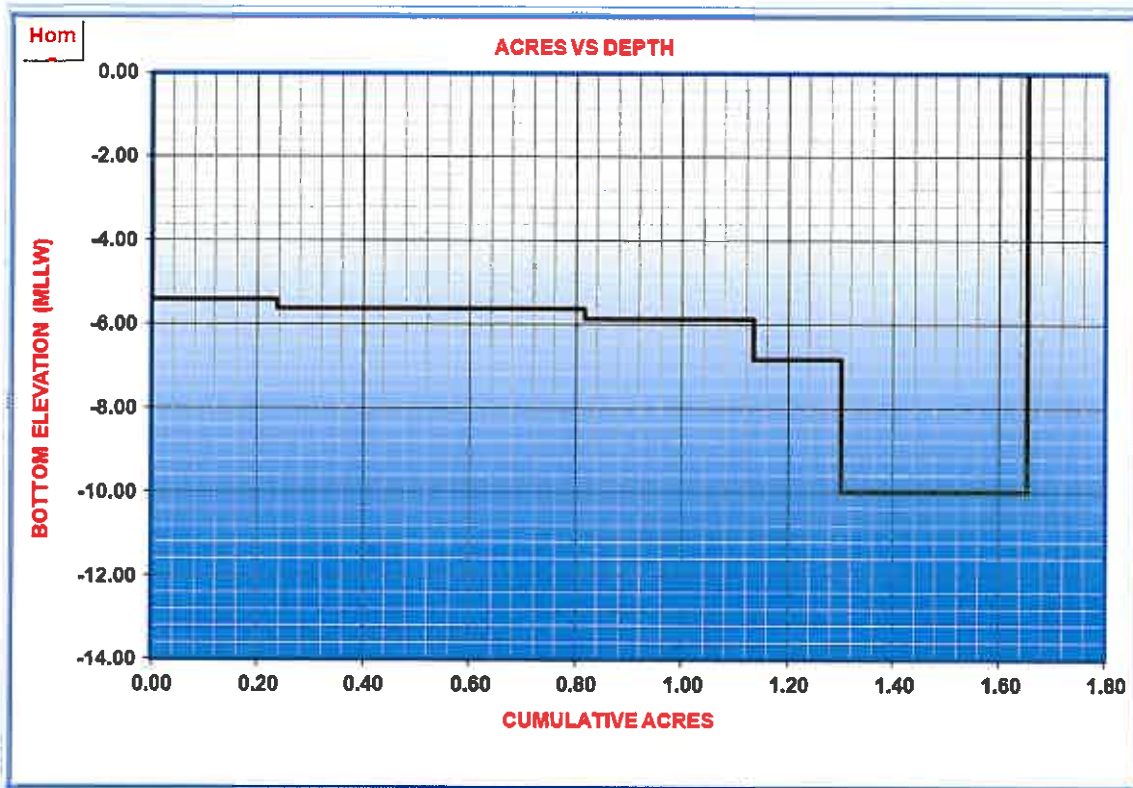
We used a 55 vessel fleet ranging from 16 to 32 feet, based on length overall (LOA). Design vessels ranging from less than 20 to 32 feet LOA were used to estimate the required basin size. Basin depths would be stepped from -7.5 to -9 feet; the navigation channel would be slightly deeper (shown as -10 feet in the graphic on the following page). Only parallel moorage would be provided to facilitate removal of the inner harbor float system each winter.

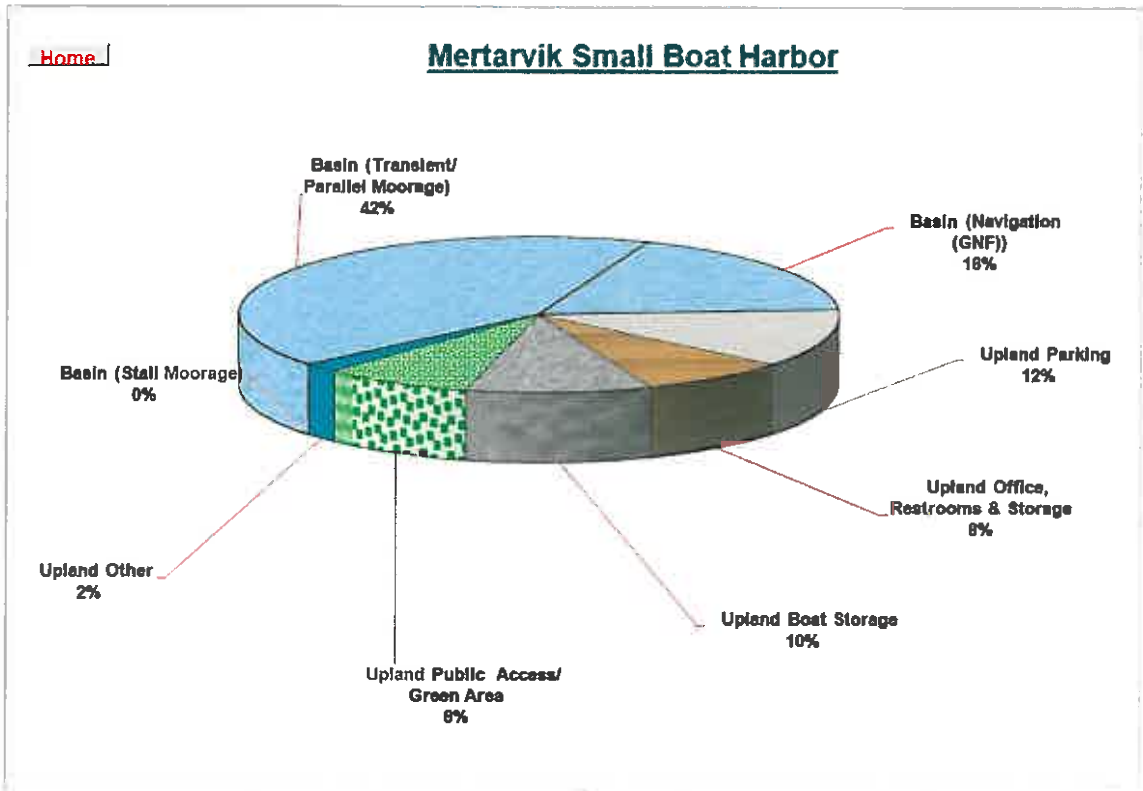
- Based on fleet, need 1.95 acre basin for moorage and navigation
- Floats need to be removable in winter due to icing conditions
- Safe access to shore
- Upland support areas for boat storage and staging areas
- Project may be phased (for example)
  - Phase I – construct breakwaters
  - Phase II – float construction
  - Phase III – dock
  - Phase IV – separate landing for commercial activities
- Relocate existing concrete plank ramp
- Separate barge landing and quarry access for commercial activities

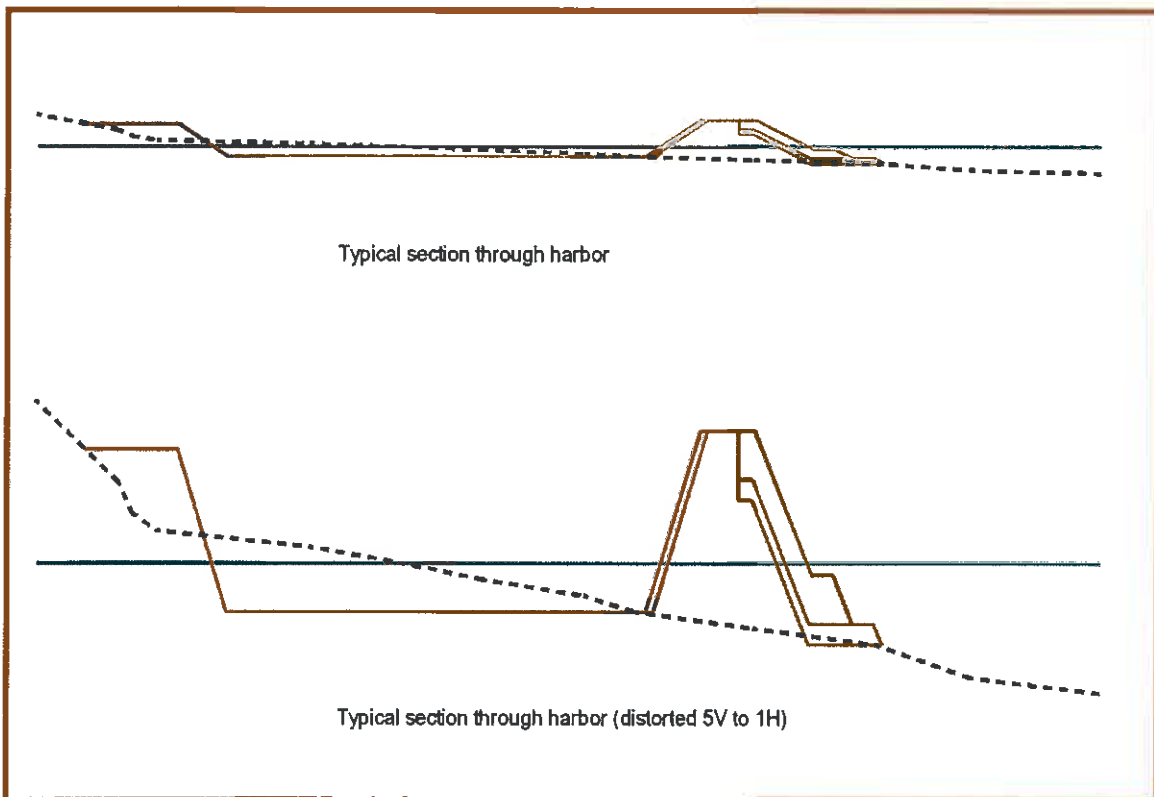
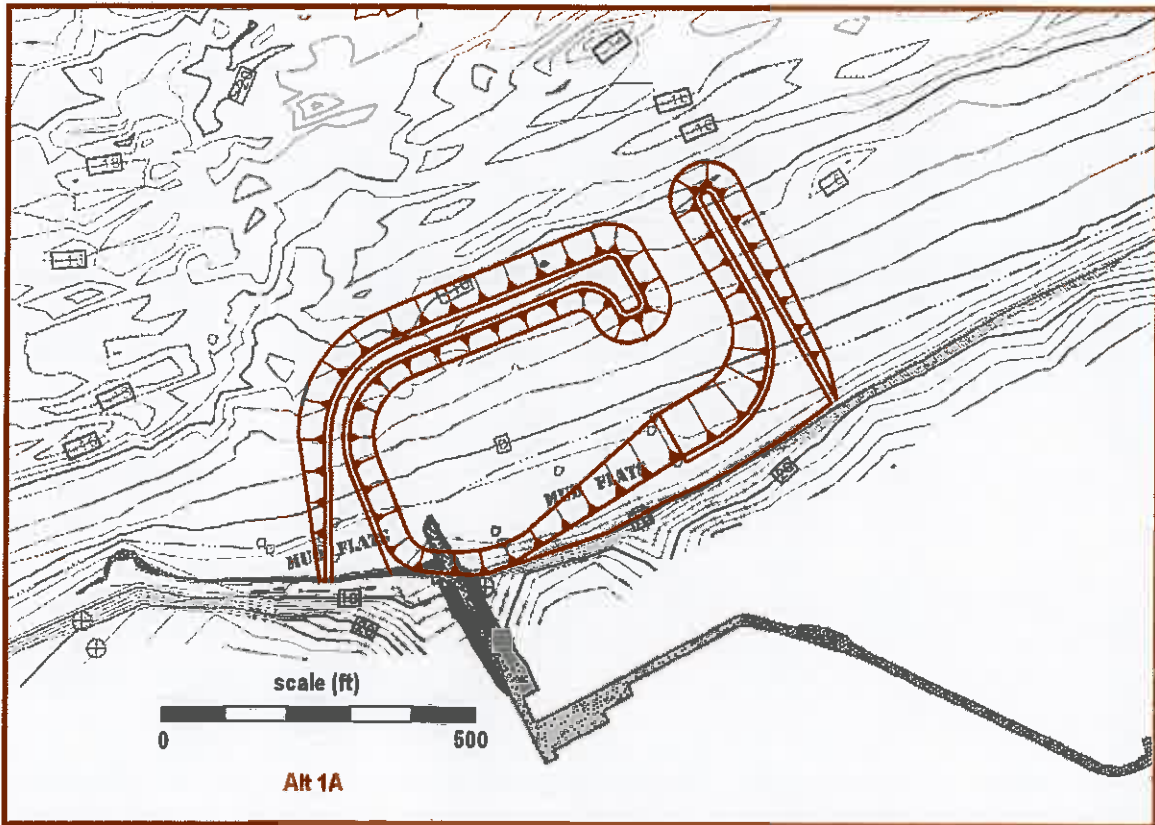
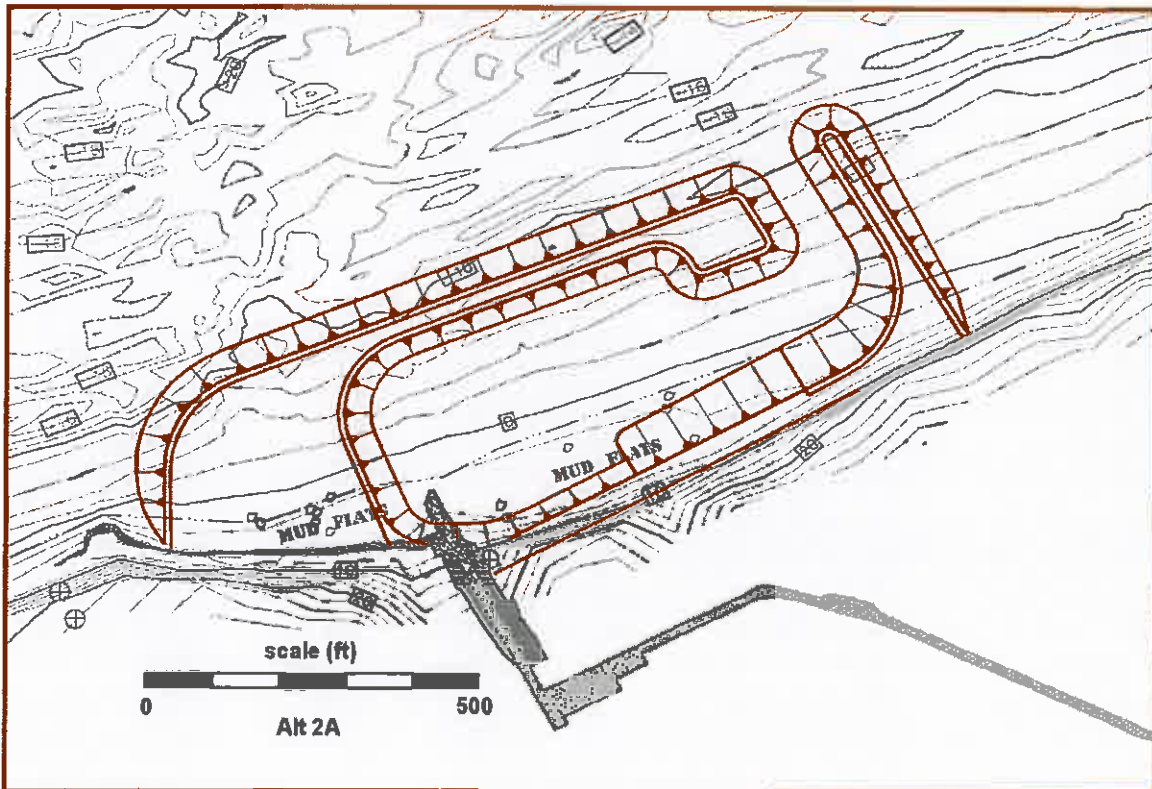
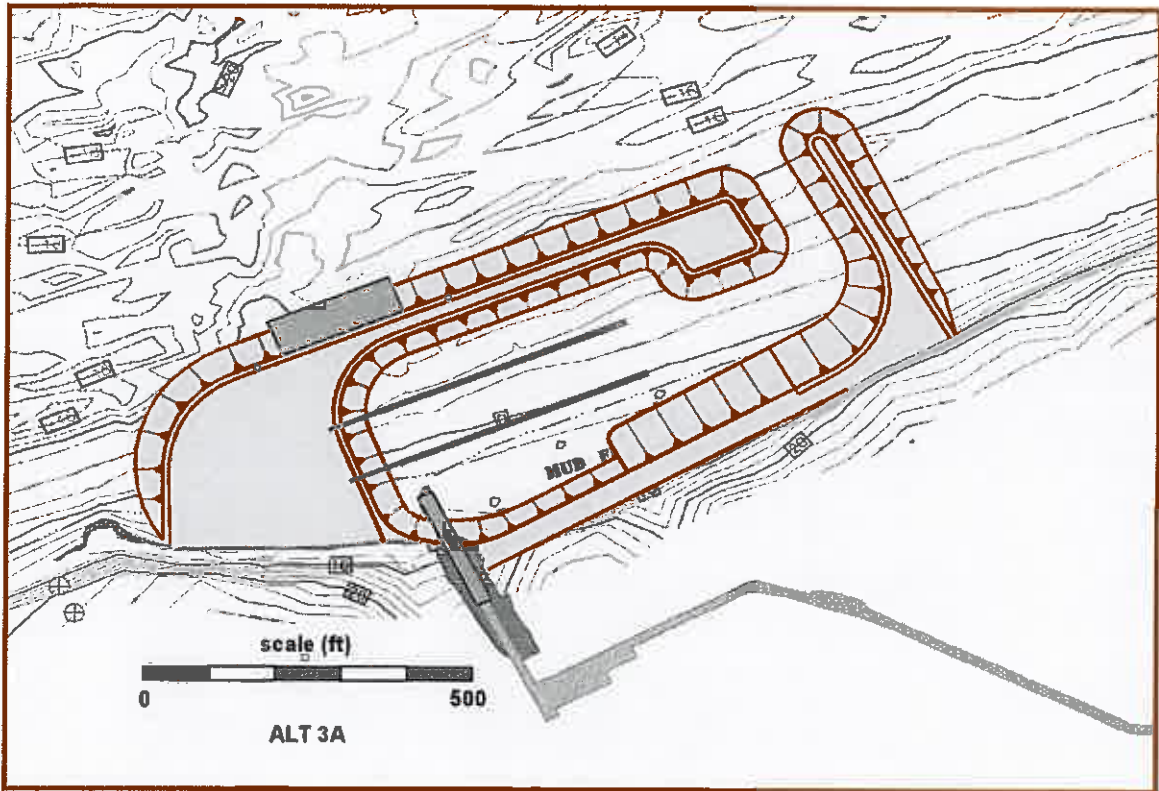
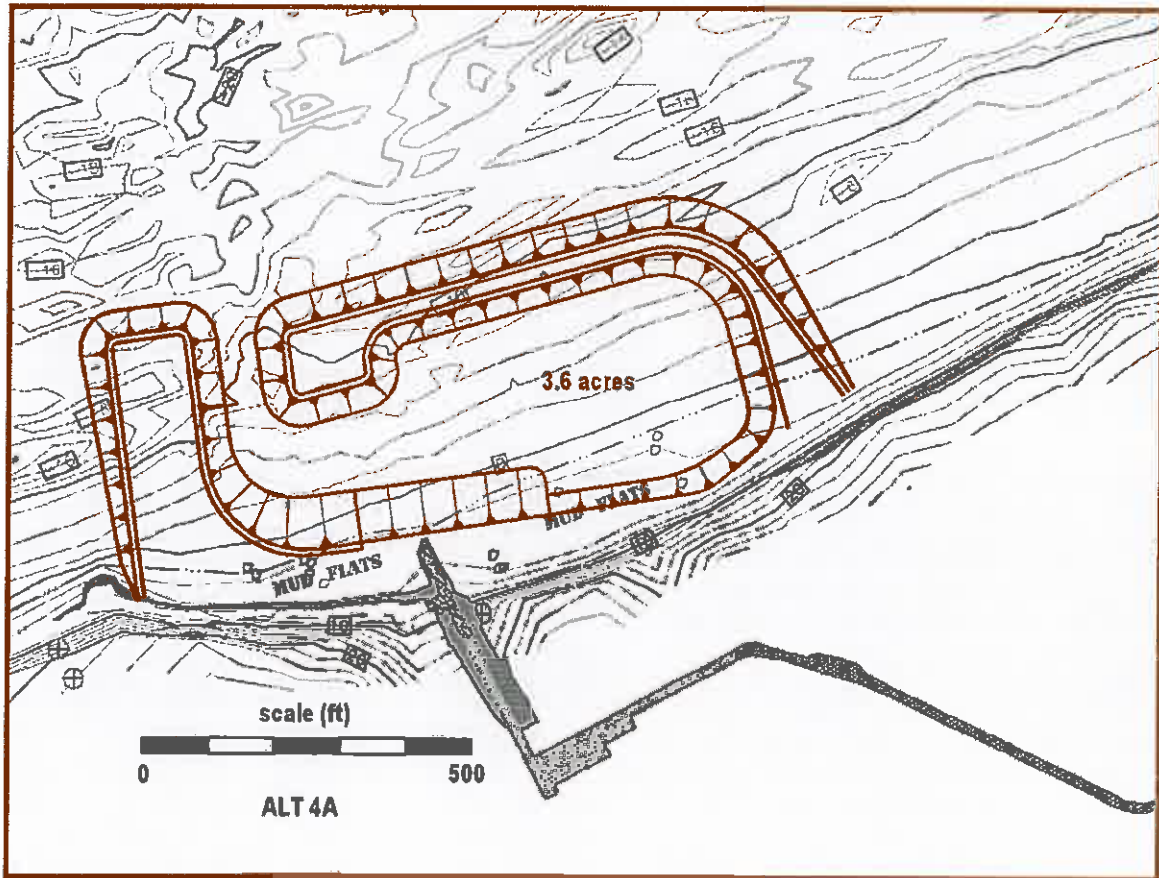
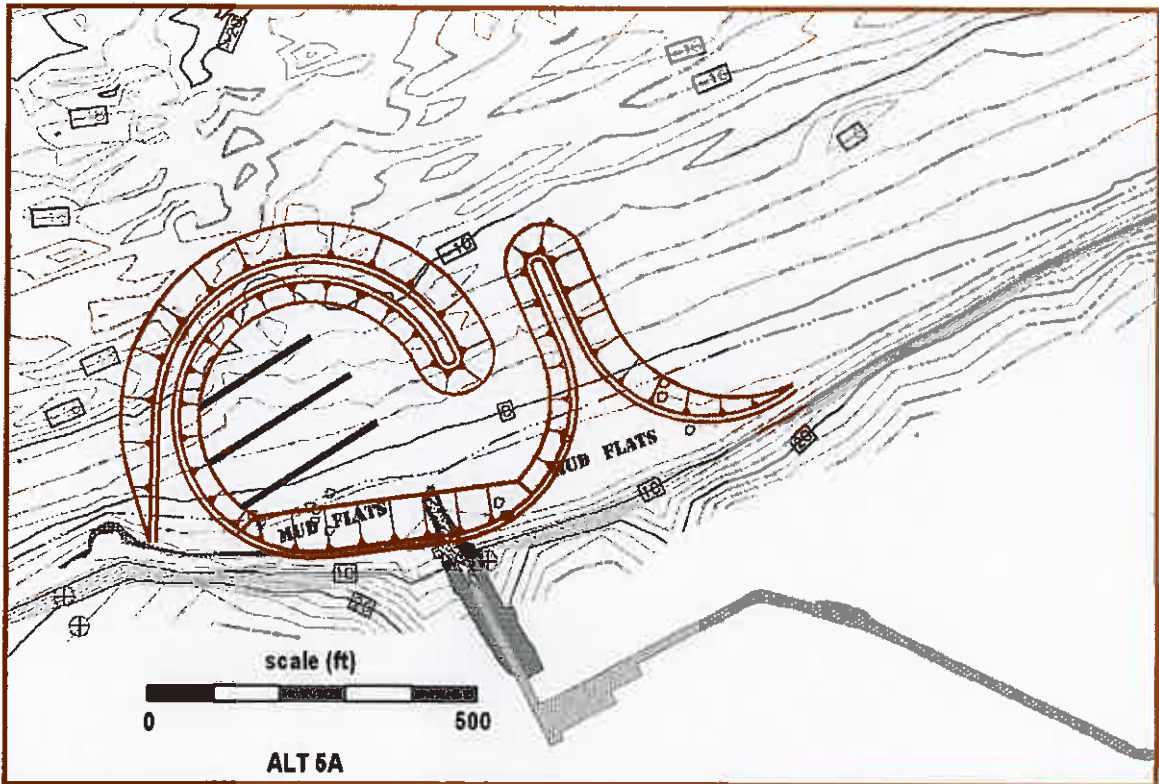
Among the alternatives developed for this study, six are shown here for consideration by the community. The alternatives provide a range of sizes and configurations to accommodate the local needs. A cross-section of the proposed harbor basin and breakwaters are shown below. The dashed line depicts the original ground as measured by the hydrographic survey.

The alternatives are shown on bathymetric contours.

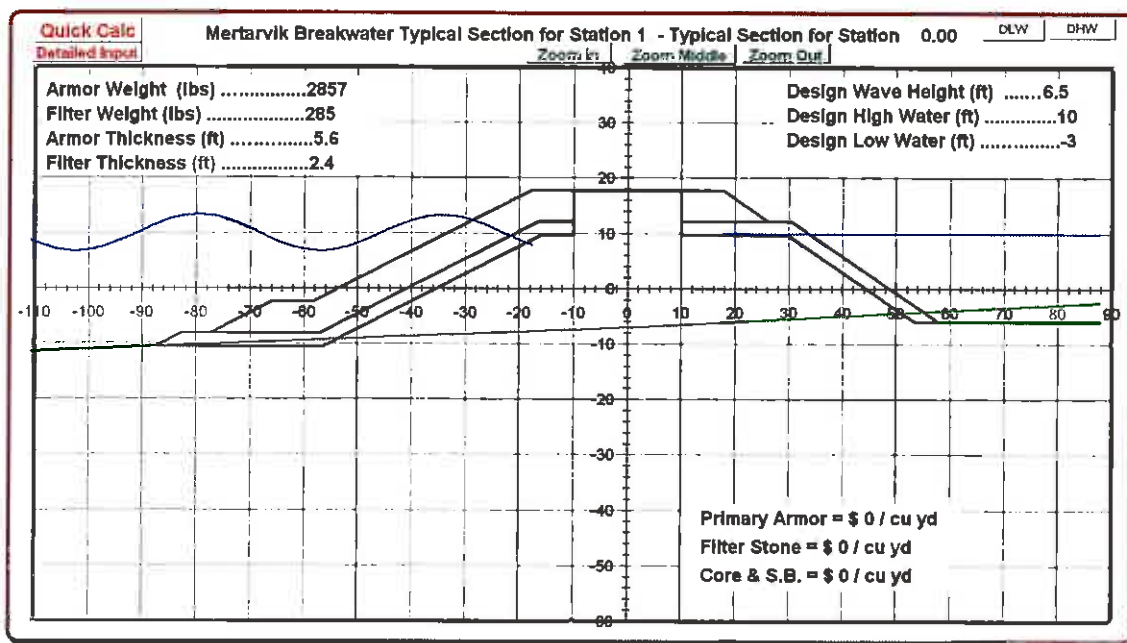
Based on field observations and preliminary analyses, the following breakwater cross-section is proposed.

Using a 2:1 slope on the outside and 1:5:1 on the inside, 3000-pound armor stone is recommended.

Primary Armor Weights (lbs)		Primary Armor Diameters (in)
Minimum	1000	25
Average	3000	36
Maximum	5000	43
Filter Stone Weights		Filter Stone Diameters (in)
Minimum	14	6
Average	150	13
Maximum	286	17
Core Stone Weights		Core Stone Diameters (in)
Minimum	0.3	1.7
Average	30	8
Maximum	60	10

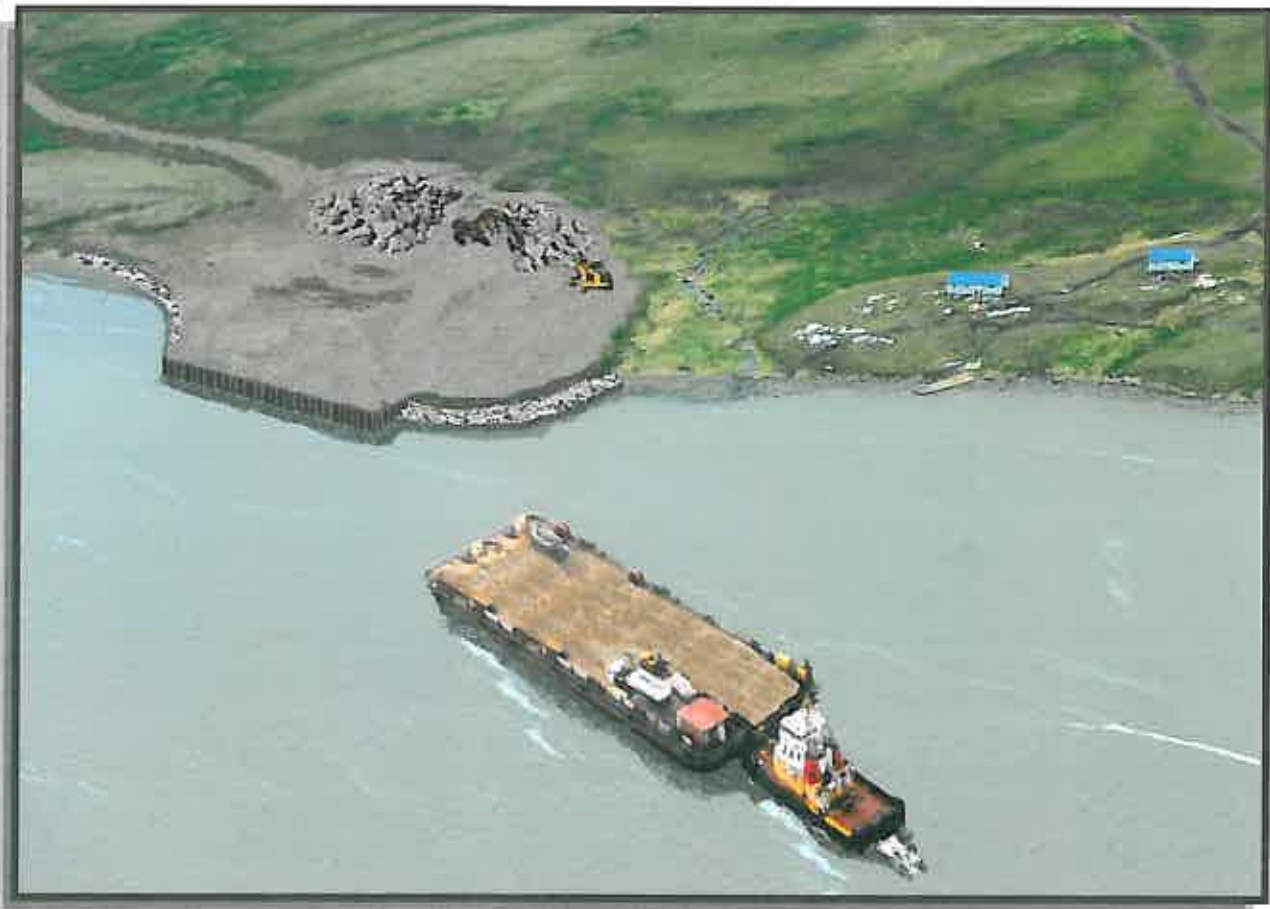
This shows the relative locations of the proposed commercial dock with the small boat harbor.

Once the community is relocated, additional infrastructure may be desirable along the Mertarvik Waterfront. This may include a commercial dock for exporting material from the local quarry. It would be undesirable to have rock or gravel hauled through the community, so a road would be needed to access a commercial dock and barge landing directly from the quarry site. We looked at a site near the first homes constructed at Mertarvik. The development would need to be laid out to minimize impact to the spring.
