# Atmautluak Hazard Impact Assessment

June 2010

Prepared for  
The Atmautluak Traditional Council

Prepared by  
WHPacific  
with  
Shannon & Wilson

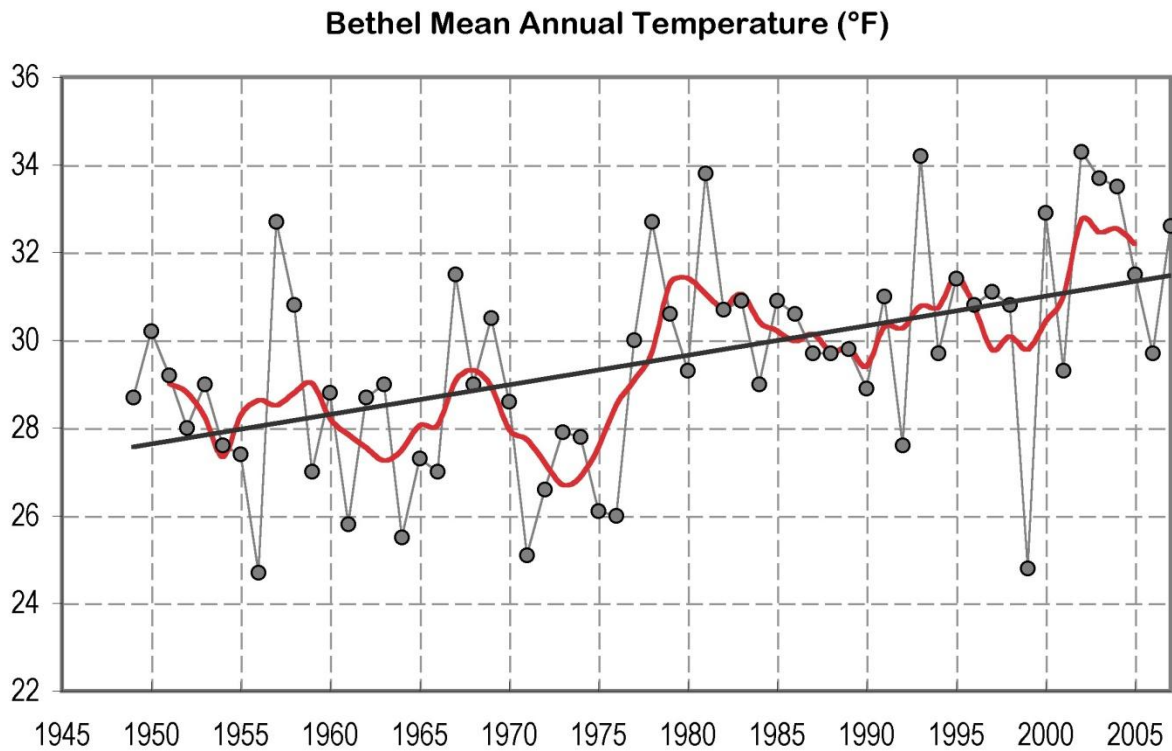
Figure 1 Change in Bethel's Mean Annual Temperature (degrees F), 1949-2009

Figure 1 shows the mean annual temperature fluctuation over the same period of time.

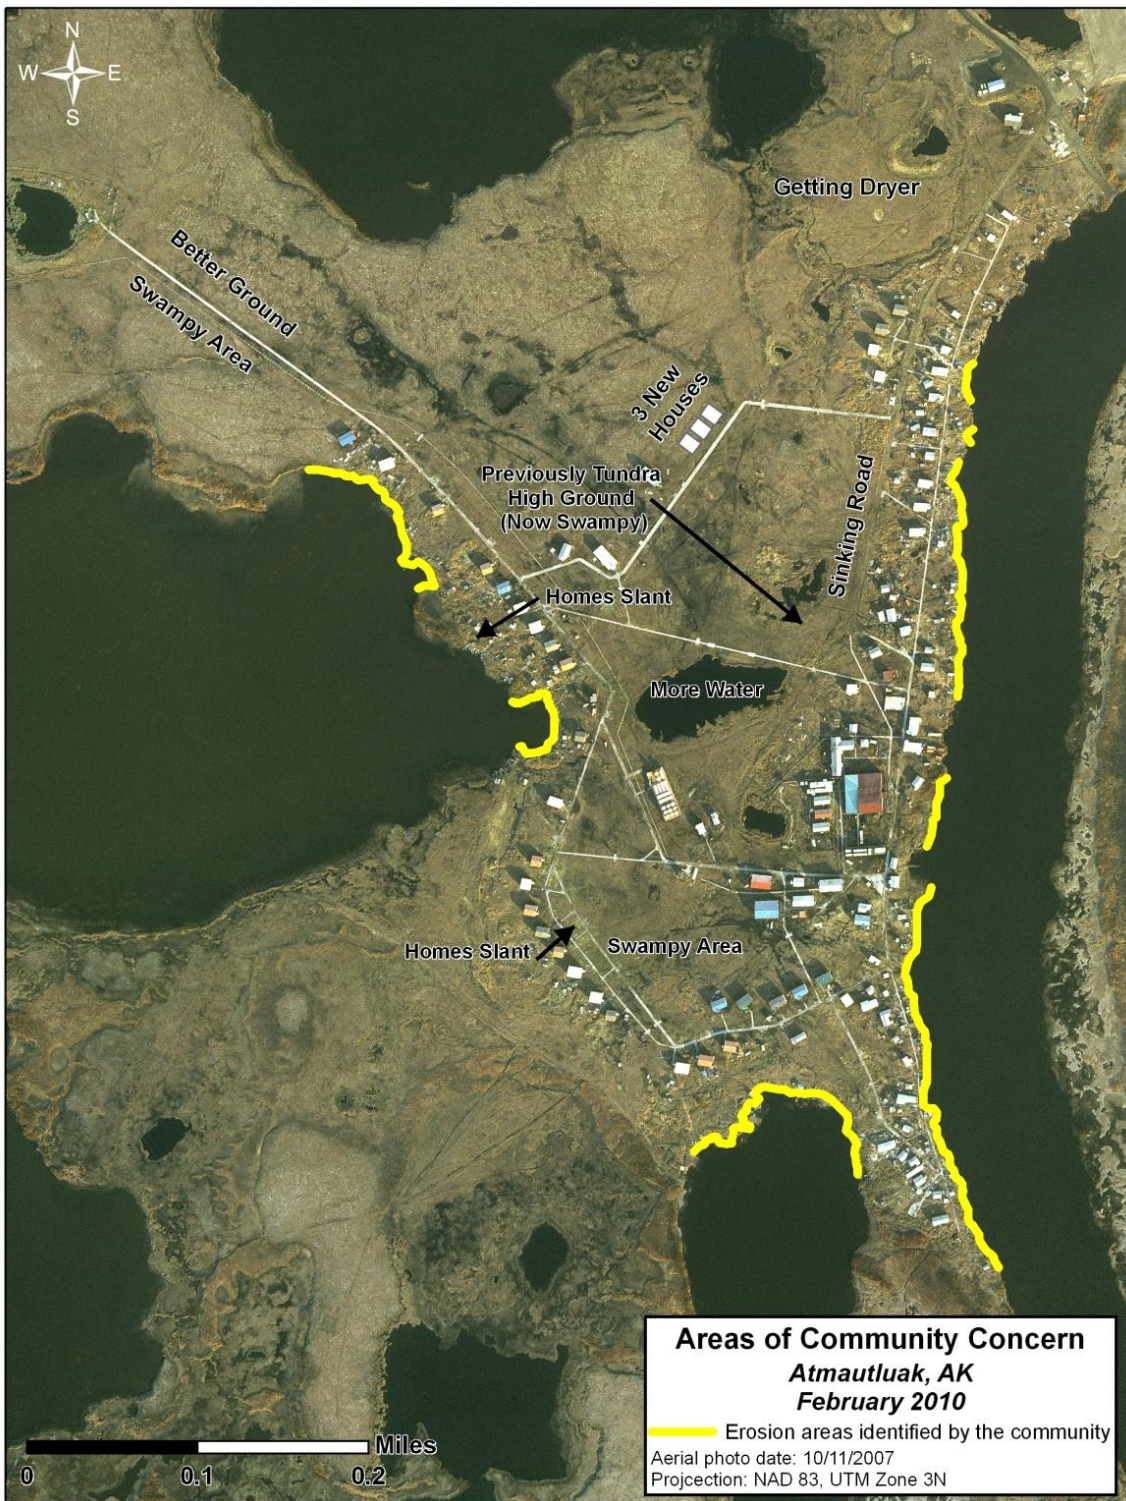
Figure 2 Community-identified Areas of Concern

All these concerns are shown on Figure 2 Community-identified Areas of Concern. Areas of major erosion concern are marked in yellow.

shoreline. Areas of particular concern are shown in yellow on Figure 2 Community-identified Areas of Concern.

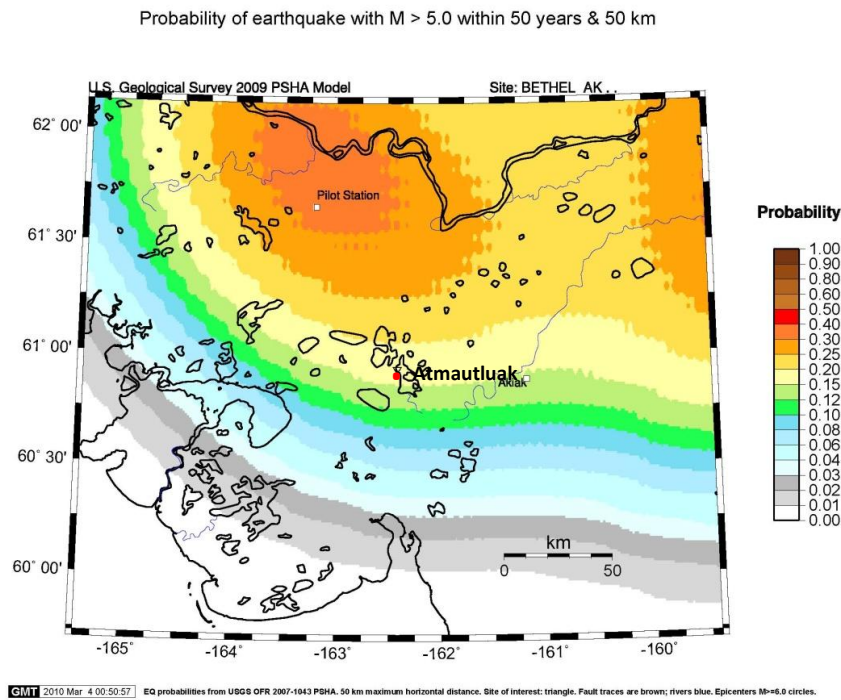
**Figure 3 50-year Earthquake Probability near Atmautluak**

While it is not possible to predict an earthquake, the US Geological Survey (USGS) has developed earthquake probability maps that use the most recent earthquake rate and probability modes using historic earthquake rate, location, and magnitude data from the USGS national Seismic hazard Mapping Project. Figure 3 shows that according to the USGS earthquake probability model, there is a 20 percent probability of an earthquake with a magnitude of 5 or greater occurring within the next 50 years in a 50 kilometer radius of Atmautluak. That probability increases to 25-30 percent over a 100-year timeframe (Figure 4).

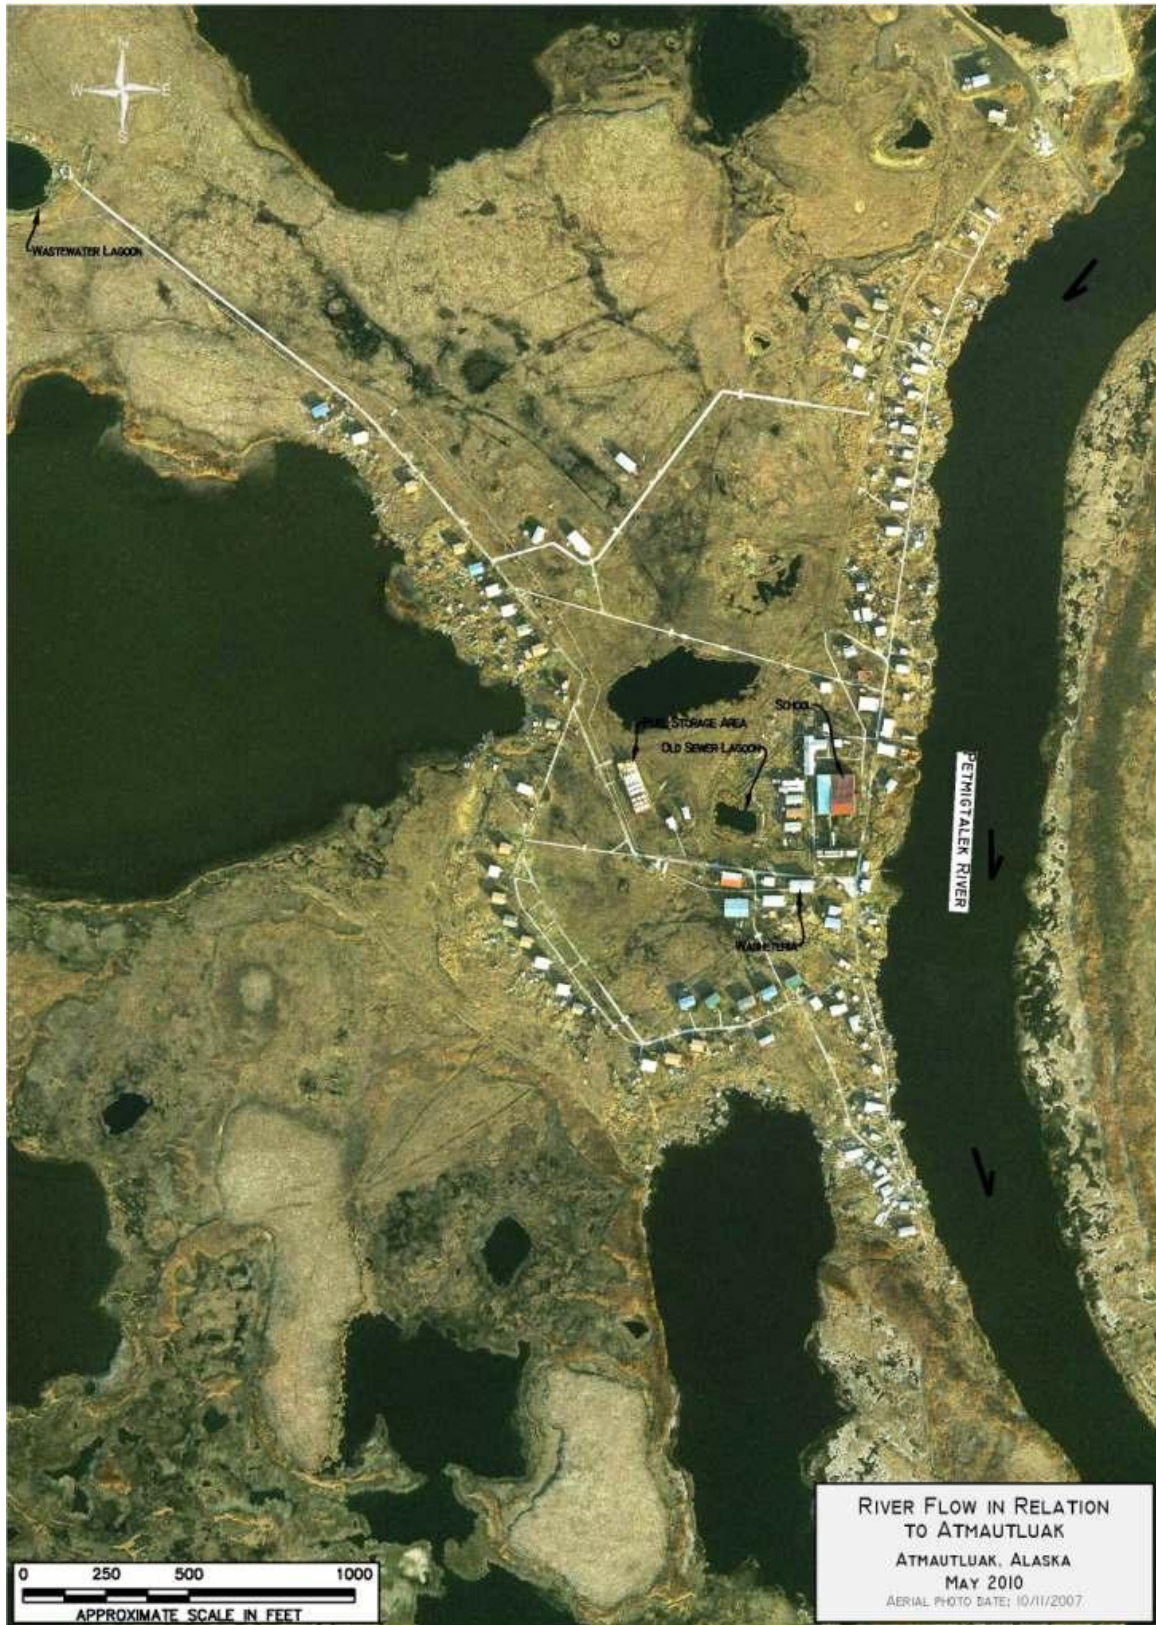
Figure 5 River Flow in Relation to Atmautluak

Erosion can be classified as coastal, riverine, or aeolian (wind-caused). With its location on the Pitmiktakik River, riverine erosion is the type most likely to affect the community (Figure 5). However, additional erosion is reported on the northern banks of the larger lakes at the south and east of town, where residents report that south winds blow across the lakes and cause wave action to erode the

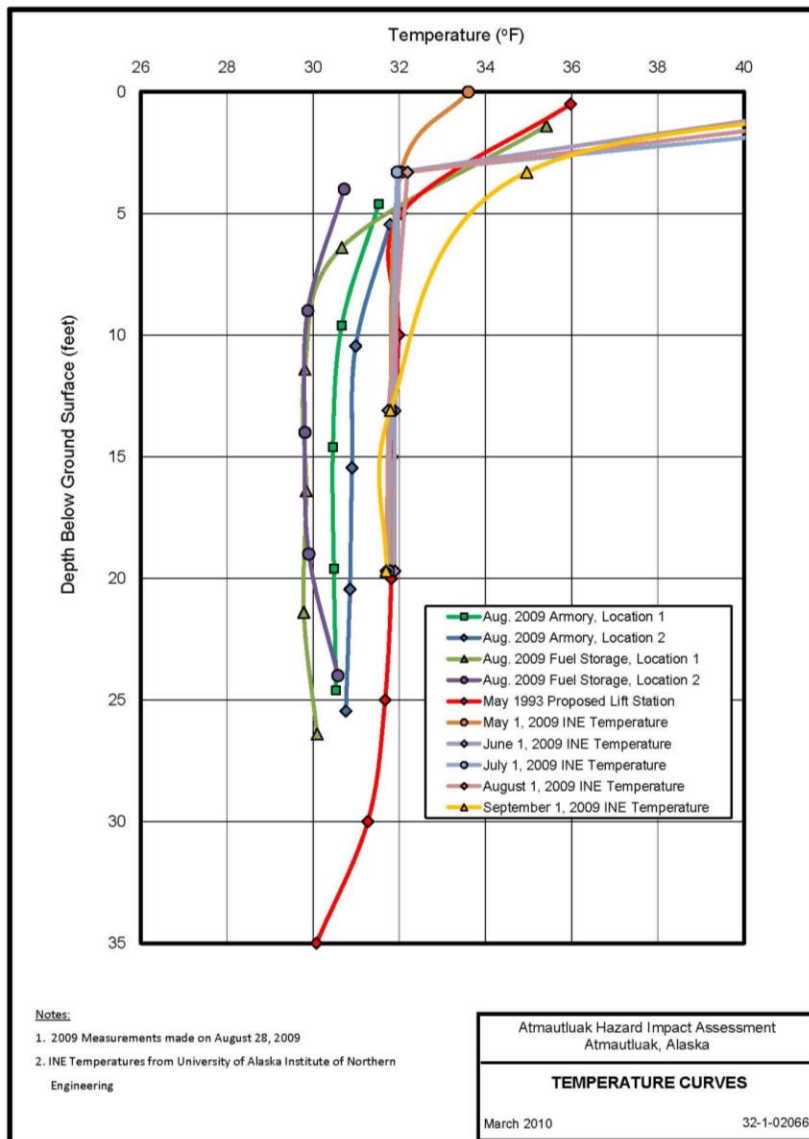
Figure 7 Temperature Curves

As part of their ongoing study, the Institute of Northern Engineering at the University of Alaska Fairbanks is working with the Atmautluak community to measure soil temperatures near the river bank. As reported on the temperature curves on Figure 7, the temperatures being reported are very close to 32°F to a depth of at least 20 feet. At the location of the thermistor string, depth to permafrost is probably about 5 to 10 feet, which is deeper than anticipated for most locations within the village. The location of this thermistor string (given as 60.857158°N, 162.2757°W on the Institute of Northern Engineering website) about 50 feet from the edge of the Pitmiktakik River and is likely close to the lateral boundary of the thaw bulb. This is consistent with Shannon & Wilson's observations at the site where

bank collapse has occurred 10 or more feet away from the edge of the water.

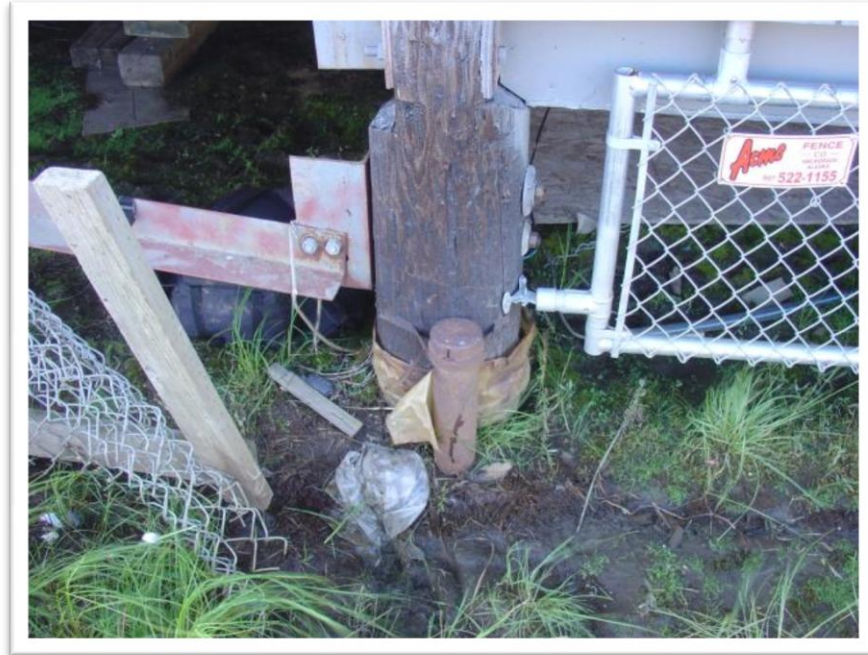
Photo 6: Blocking under school.
