City of Chefornak Head Start Building Replacement

Project No. 181012

PND Engineers, Inc.
1506 West 36th Avenue
Anchorage, AK 99503

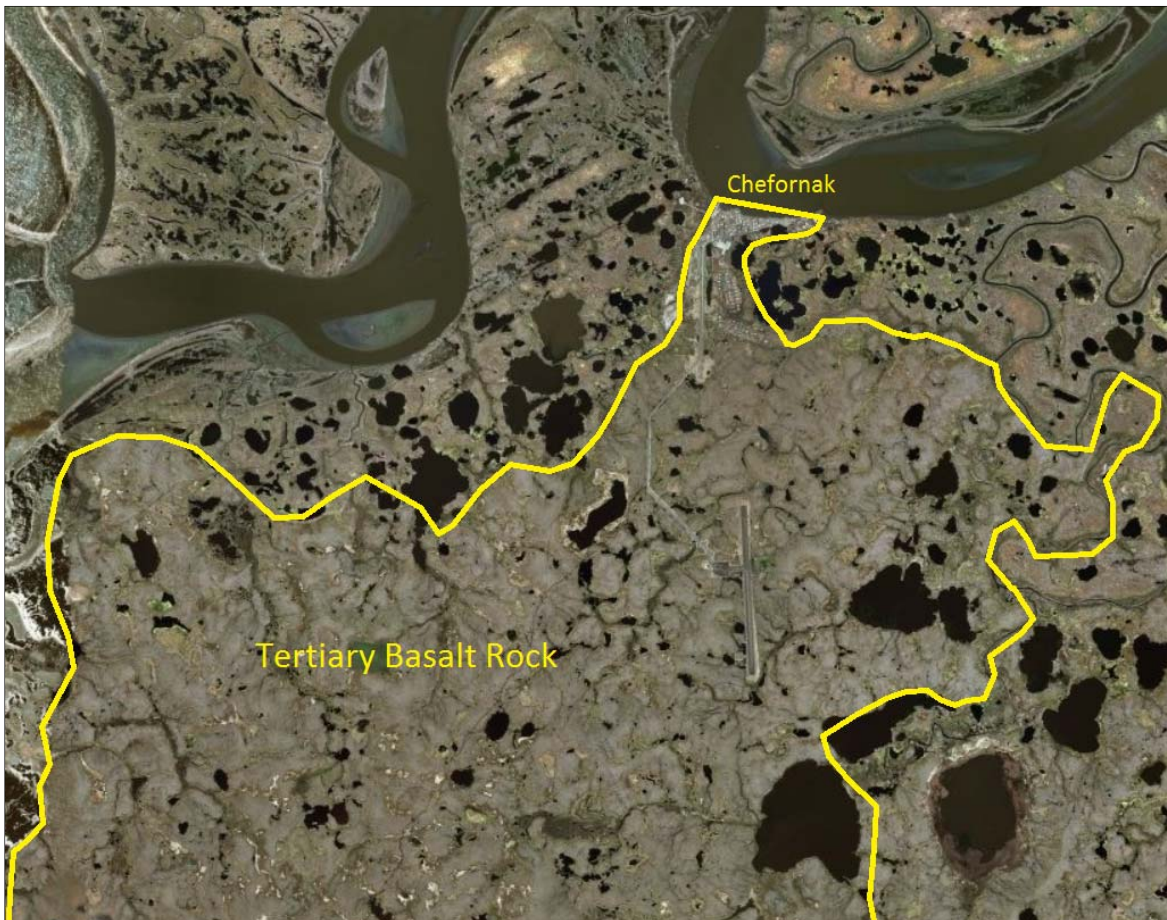
Figure 2. Tertiary Volcanic Basalt Rock (Image Courtesy of Microsoft Bing Maps)

Chefnak is founded on the northern extension of a Tertiary Basalt Formation (Figure 2) tied to the extinct volcano, Tern Mountain approximately 3 miles south of the city.

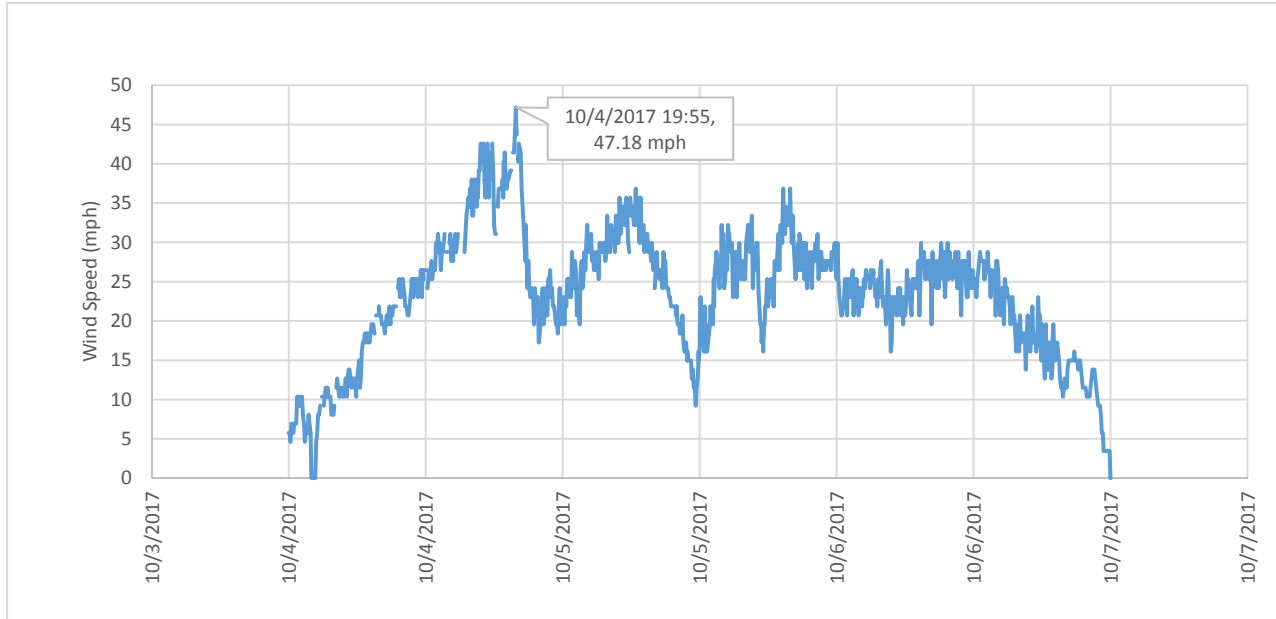
Figure 5. Wind speed record for Toksook Bay Airport, October 2017 (NWS data)

October 4-6, 2017- In early October of last year, a strong gale force wind event struck the eastern Bering Sea. Sustained winds of approximately 40 to 50 mph out of the West and Southwest were recorded at the airports in Toksook Bay (Figure 5, 44 miles NW) and Quinhagak (Figure 6, 86 miles SE).

The storm peaked at Toksook Bay at approximately 8:00 PM on October 4th and 11:30 AM on October 5th in Quinhagak. The approximate storm peak in Chefnak would have occurred during the late night hours of October 4th. The flooding extended over a 3 day period during and immediately following the storm.

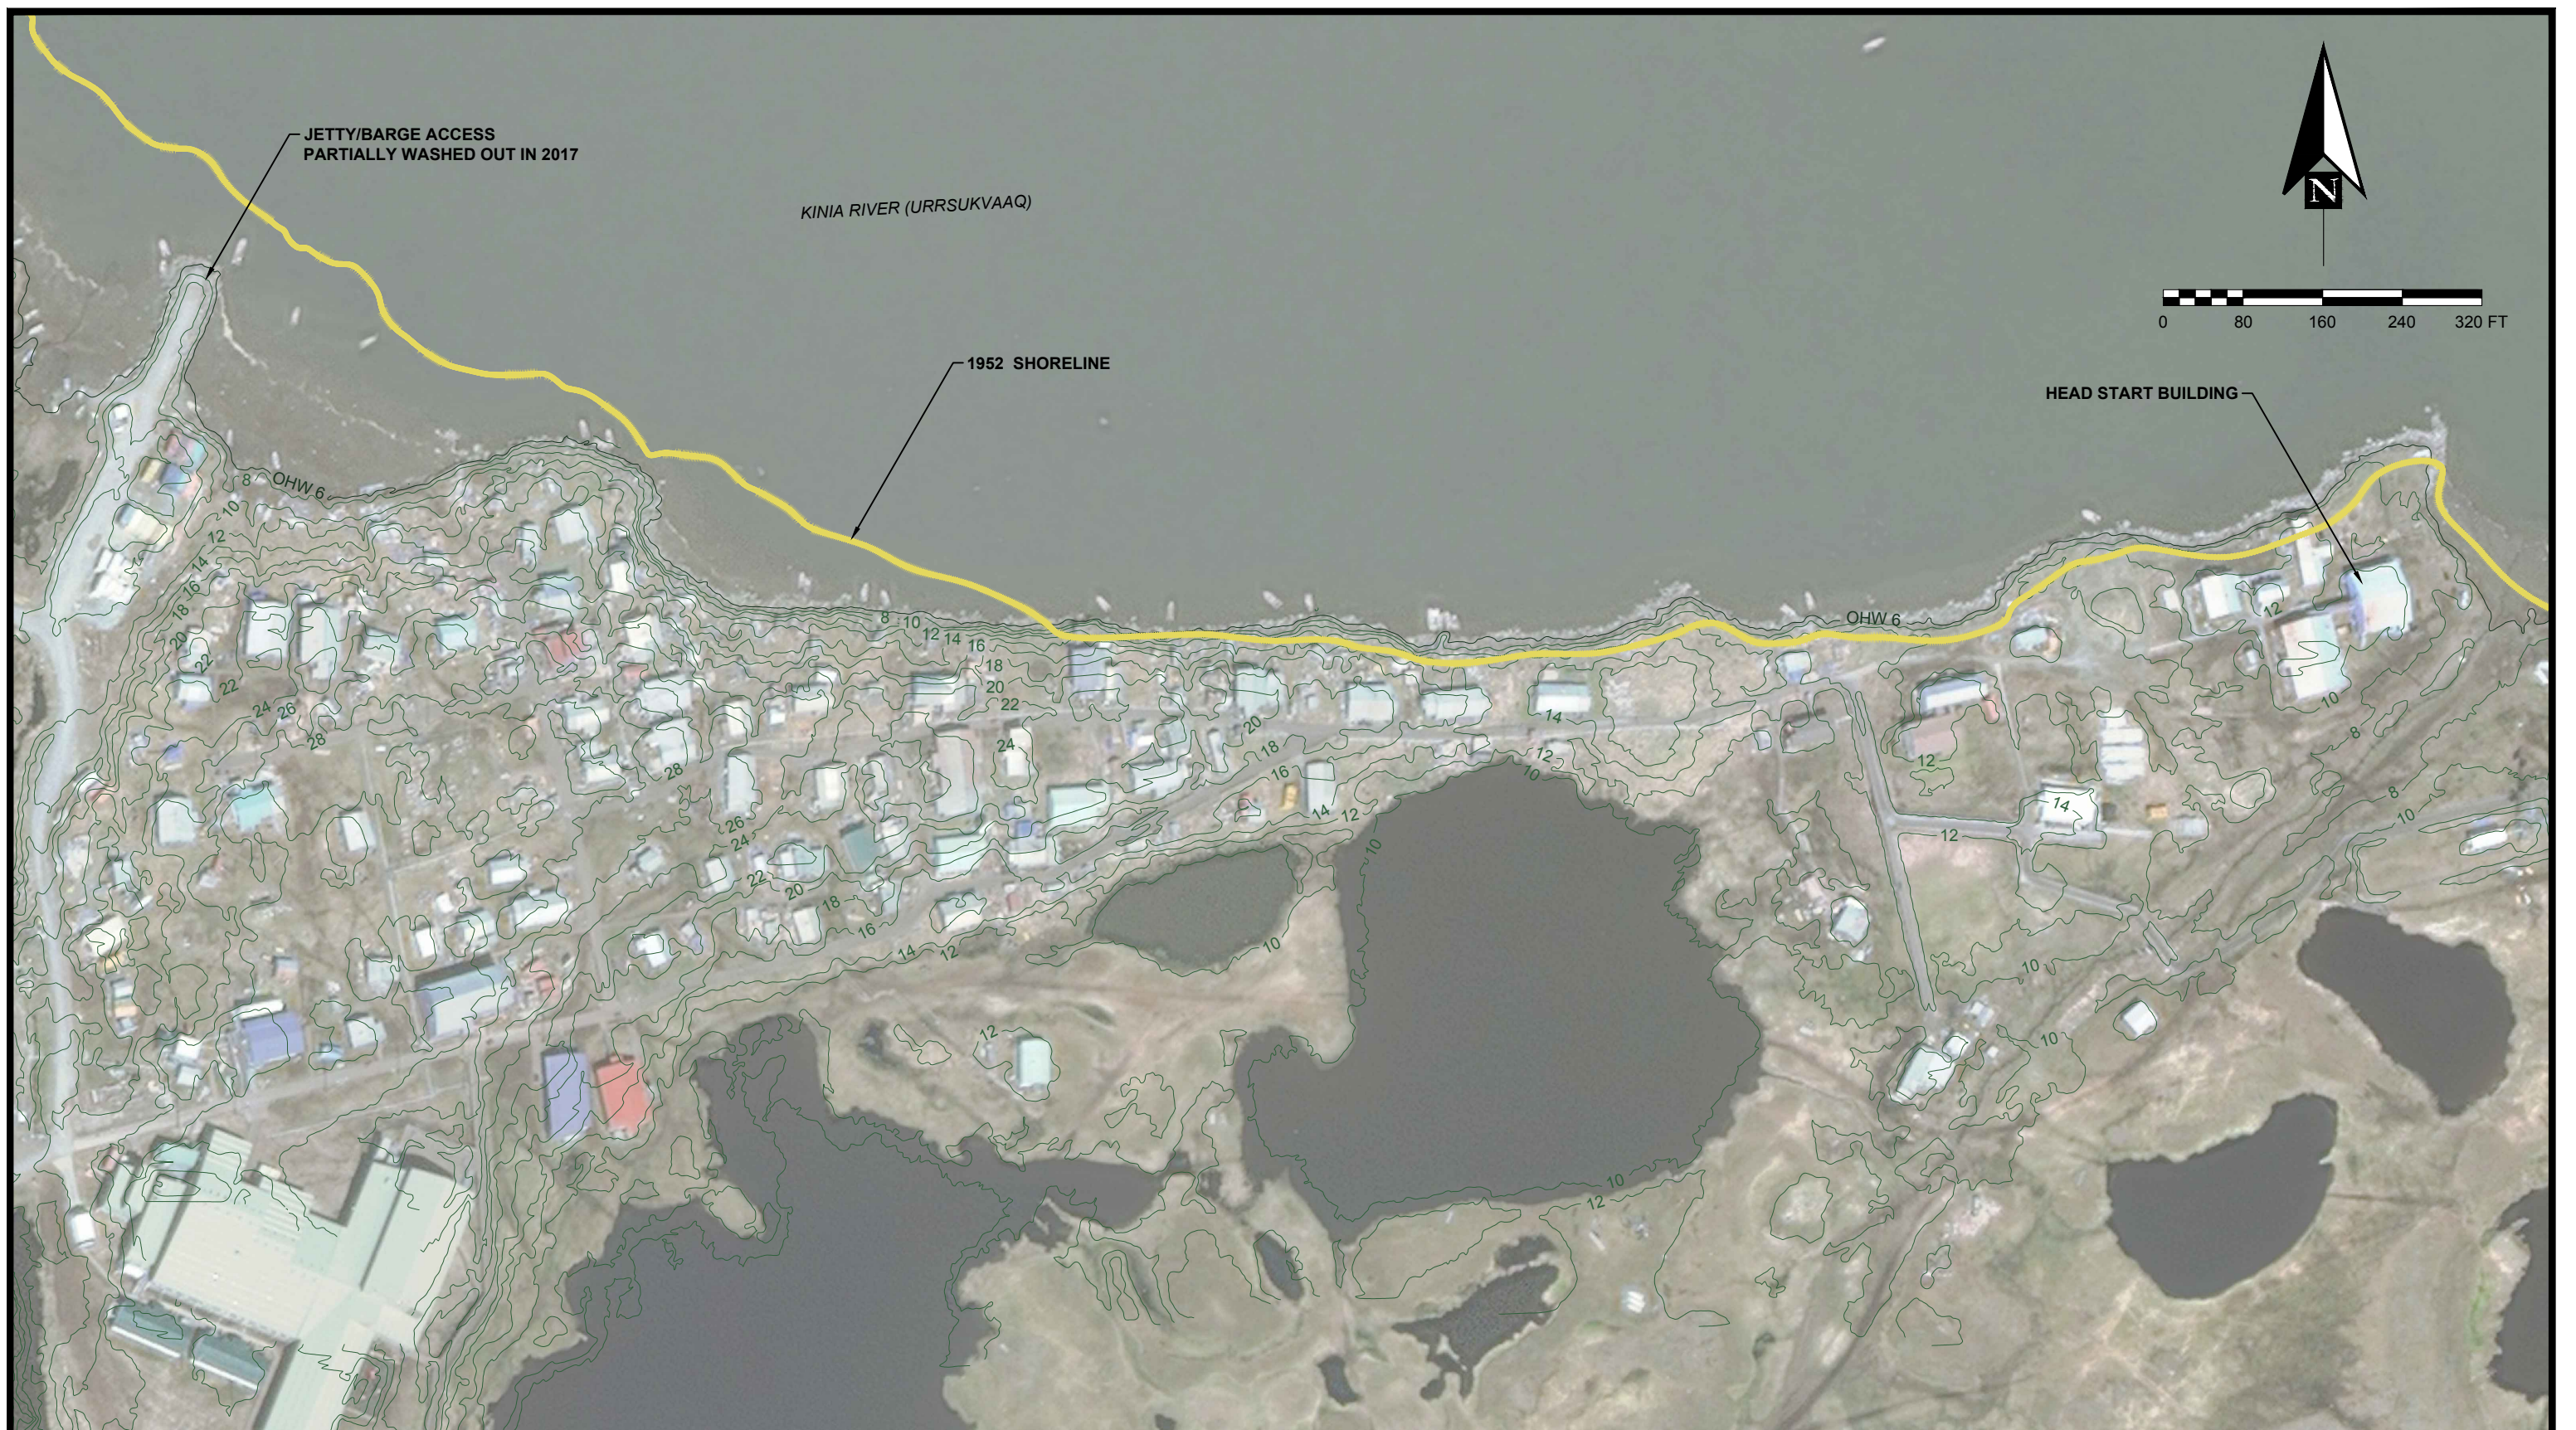
FIG 1

HEAD START BUILDING FLOODING OCTOBER 4-6, 2017
 APPROXIMATE STORM SURGE = +9 FT
