City of Chefornak Site Observation Report

Project No. 181012

PND Engineers, Inc.
1506 West 36th Avenue
Anchorage, AK 99503

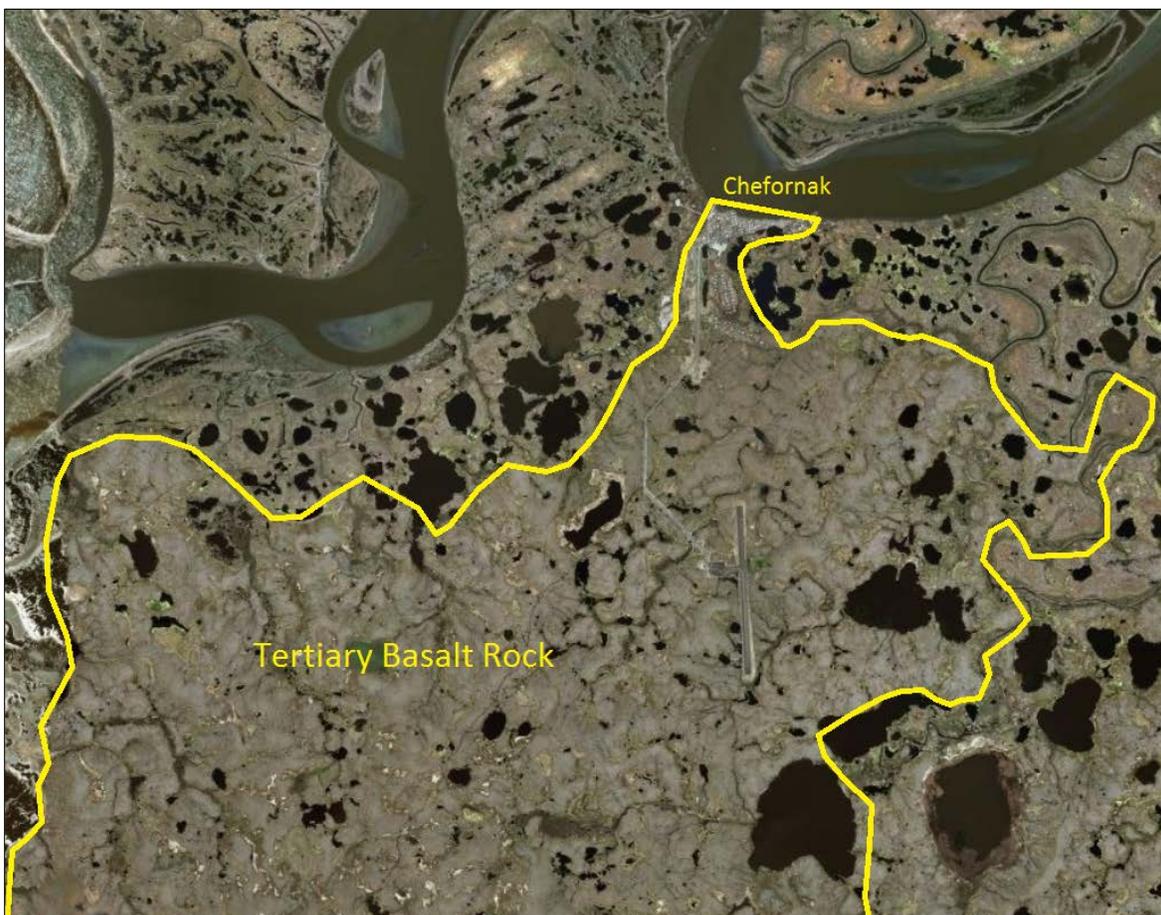
Figure 2. Tertiary Volcanic Basalt Rock (Image Courtesy of Microsoft Bing Maps)

The shoreline conditions of the Kinia River along the riverfront of Chefnak were observed during a walk on the river ice. The observation began at the Tank Farm on the west end of the city and extended to the Head Start Building on the east end of the city. Assisted by village representatives with knowledge of the areas-of-concern and historical photography (1954 and 2004), PND was able to identify those areas most at risk for accelerated erosion. One area extends along the riverbank from a point approximately 1600 feet downstream to approximately 350 upstream of the Barge Landing (Figure 2, Figure 3). Approximately 400 feet upstream of the barge landing is a rocky outcrop that does not appear to be eroding as fast as the surrounding areas. A portion of the shoreline approximately 400 feet in length upstream of this outcrop is actively eroding. As shown in Figure 2, Chefnak is located at the northern extreme of a sizeable formation of Basalt rock formed from the nearby extinct volcano at Tern Mountain approximately 3 miles south of the city.

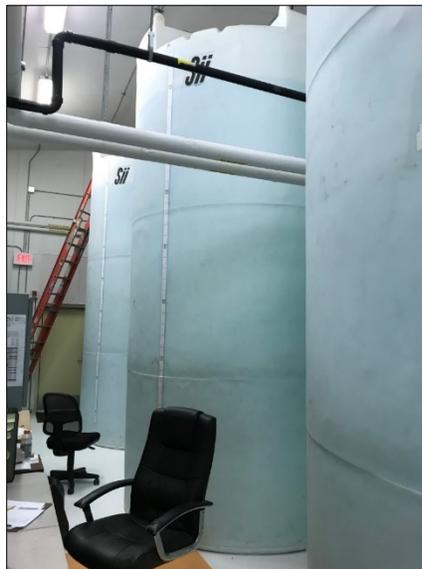
Figure 15. School Water Supply (Desalinated)

Drinking water for Chefnak is limited and difficult to obtain. While the school has a Reverse Osmosis (RO) System (Figure 15) sufficient to supply the students with drinking water, the equipment does not have the capacity to supply drinking water to the entire community. Currently, drinking water is obtained by collecting ice in 5 to 25 gallon containers from a nearby lake, hauling it by ATV or snow machine to their home and allowing it to thaw. More accessible water sources are not suitable for drinking due to the high salinity caused by tidal influence in most of the nearby water sources.

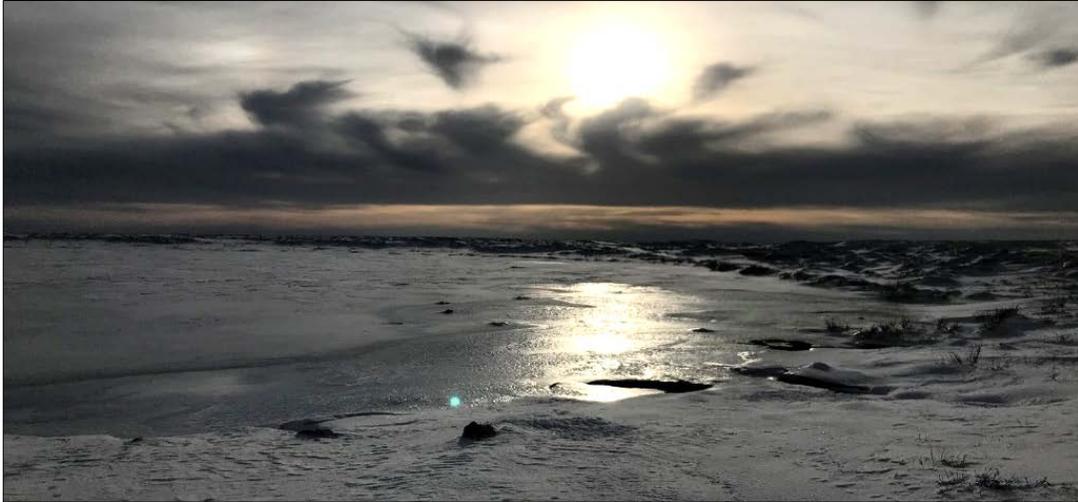
Figure 16. Possible Spring-Fed Water Supply

An artesian spring (Figure 16) that is believed to be a clean source with sufficient flow rates is located approximately 3 miles south of the city. Piping or hauling could be utilized to access this source and provide much needed, clean drinking water for the community.

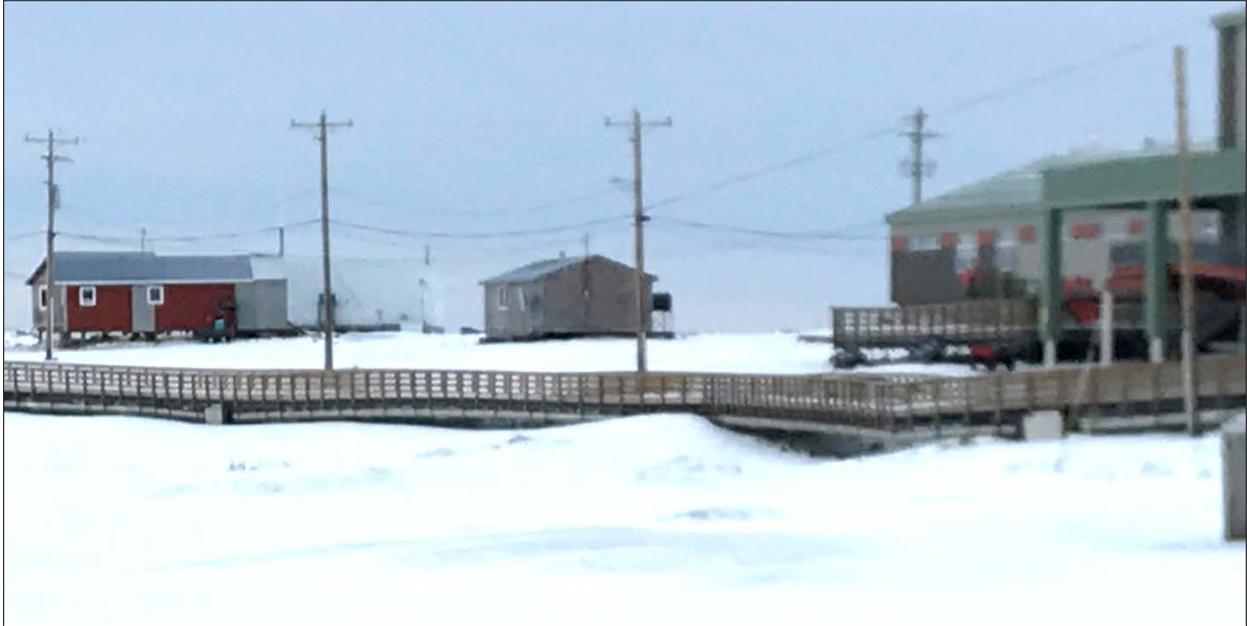
Figure 17. Boardwalk

The boardwalks (Figure 17) in Chefnak appeared to be in good condition, solidly constructed and they provide an effective means for pedestrians and ATV/Snow Machine operators to move throughout the town. Beyond the extents of the boardwalk system however, aerial photography of the area shows signs of significant degradation of the tundra. Extension of the boardwalks and/or linking them with roads or

hardened trails for the highest traffic areas is highly recommended to limit environmental damage to the surrounding landscape.
