# Point Lay Housing Survey 2023

**Cold Climate Housing Research Center & National Renewable Energy  
Laboratory**  
955 Draanjik Drive,  
Fairbanks, AK 99775

# Point Lay Housing Survey

April 2023

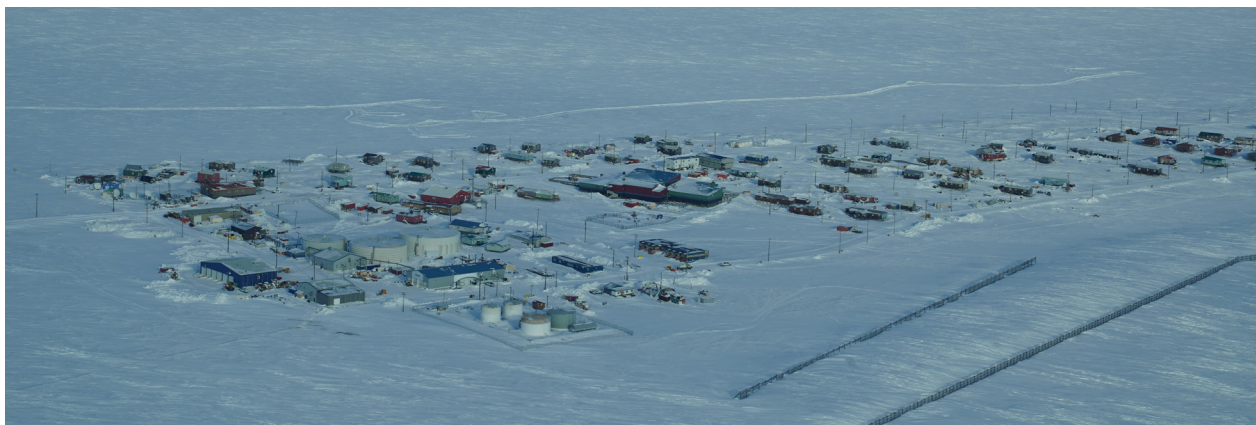
**Figure 2. Aerial View of Point Lay. (NREL, 2022)**

The location of Point Lay has affected how the community lives in many ways. The community began as a trading post because of the convenient location for hunters and whalers. Today, Point Lay’s economy is primarily based on subsistence hunting, fishing, and whaling, and its location has changed several times (Official Website Of The North Slope Borough, 2022). Figure 2 shows an aerial view of the community in 2022.

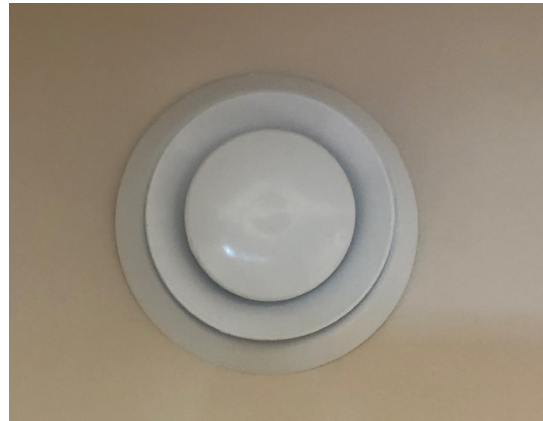
**Figure 15. Example of a Fresh 80 System Installed on a Wall. (NREL, 2022)**

**Fresh 80** refers to a passive ventilation product that creates an opening in the wall of a home. Outside, a vent is usually covered with a screen and a small hood, protecting it from weather events and animals. Inside is a mechanism that allows the opening size to vary from small to large, enabling different amounts of air to enter the home. The exact configuration is dependent on the brand. Fresh 80s require occupants to change the size of the opening by hand and do not require electricity.

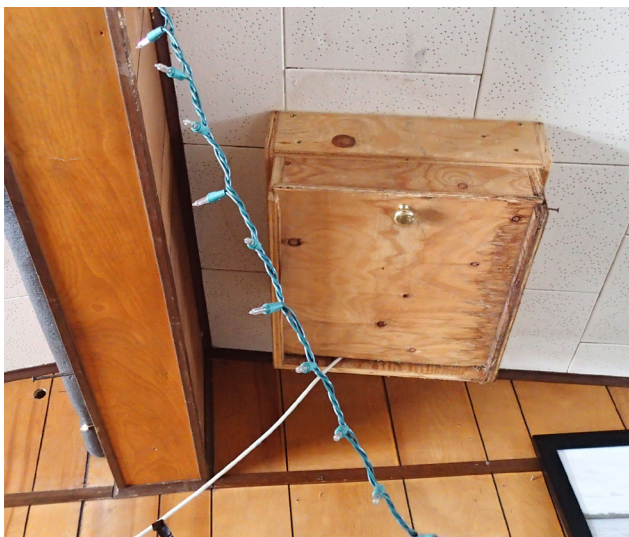
**Figure 16. Example of a Kingaq Installed on a Ceiling. (NREL, 2022)**

**Kingaqs** are a traditional, passive ventilation strategy used in many houses in the North. It consists of a hole in the roof of a house that can be opened and closed. This ventilation strategy relies on the principle that warm air rises, and thus an opened kingaq allows air to flow up and out of the house, while cooler, fresh air is drawn in through openings or cracks in the walls or around windows and doors.

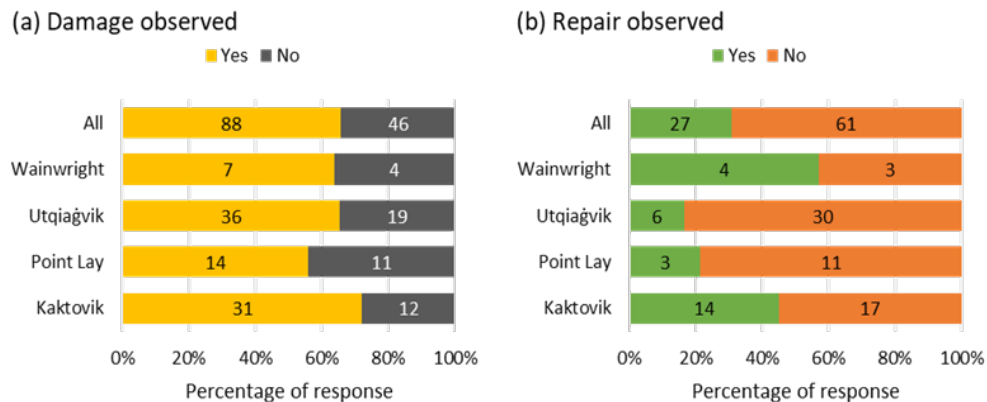
At the time of the survey, Point Lay had a population of 227 (119 adults, 108 minors). Twenty-six people (22%) started the survey, and 23 (19%) completed it. Survey respondents reported permafrost-thaw-induced ground surface changes, including surface water ponding (33% of respondents) and sinkholes (24%). These surface changes ranged from less than six months prior to taking the survey to as much as 10 years prior. There were reports of permafrost-thaw-induced ground surface changes affecting residences. Twenty-one percent of the homes that reported damage also reported repairs.

**Liew et al., Used with permission. Observations of damages and repairs to residential houses caused by permafrost thawing, 2022.**
