# HAZARD IMPACT ASSESSMENT

Kipnuk, Alaska

Submitted By: Golder Associates Inc. 2121 Abbott Road, Suite 100 Anchorage, AK 99507 USA

October 31, 2011

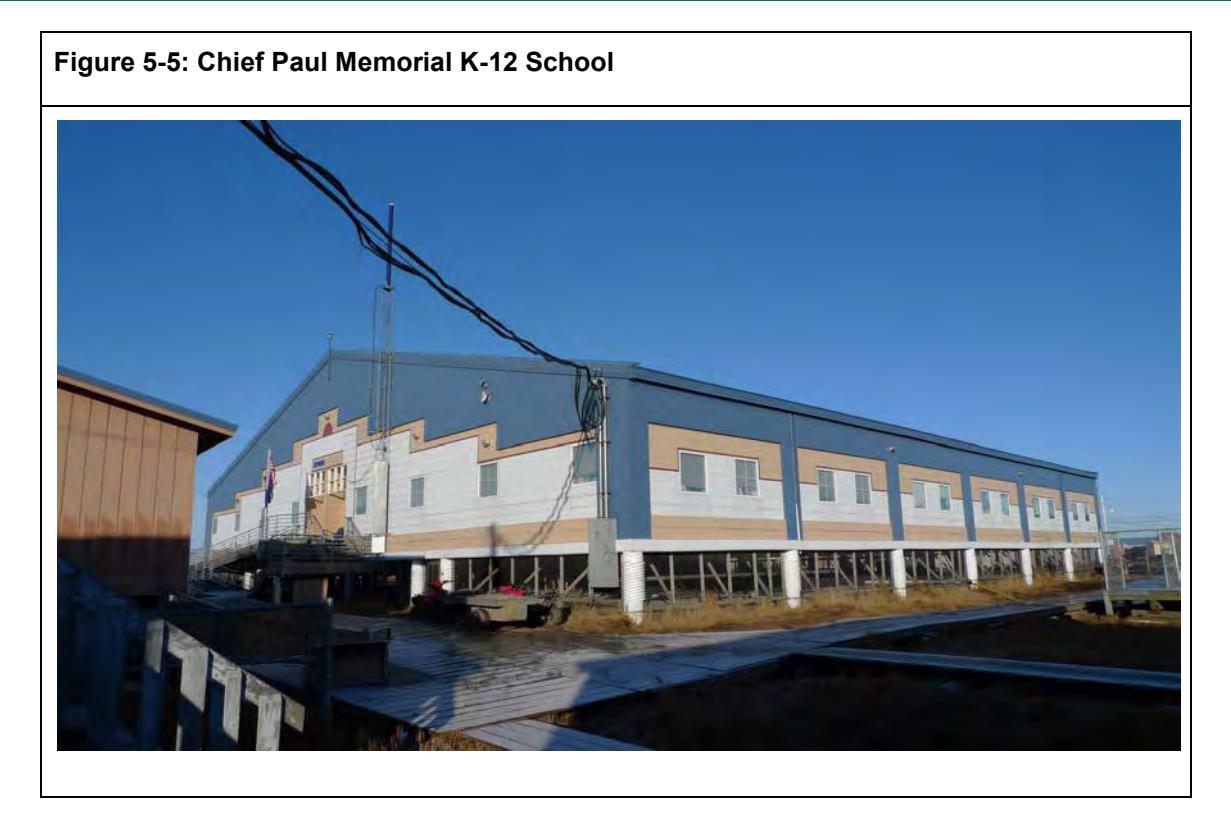
Shannon and Wilson's 1988 test borings at the Chief Paul Memorial K-12 School site encountered surface peat underlain by organic silt and silt with fine grained sand. All borings encountered frozen soil with ground temperatures measured from 29°F to 30°F. Unbonded permafrost was encountered and pore water salinity contents ranged from 1 to 8 ppt. The school is founded on passive refrigeration piling (thermal piles) and some differential movement has been observed since construction.

In the mid 1990's, movement of the school was reported. Pile cap surveys and analysis of ground temperatures were completed by Arctic Foundations Inc. Arctic Foundations Inc. determined that the movement was likely pile tip heave caused from over cooling the soils below the thermal pile foundation. Arctic Foundations Inc. determined that previously unfrozen, saline-rich pore water within the soils was most likely frozen due to cooling created by the thermal piles. To address the situation, some of the thermal piles were decommissioned to prevent further cooling and better control the heave. Recent movement of the school has been reported. Damage was visually observed to include cracks in walls and doorways and un-level floors, Figure 5-6.

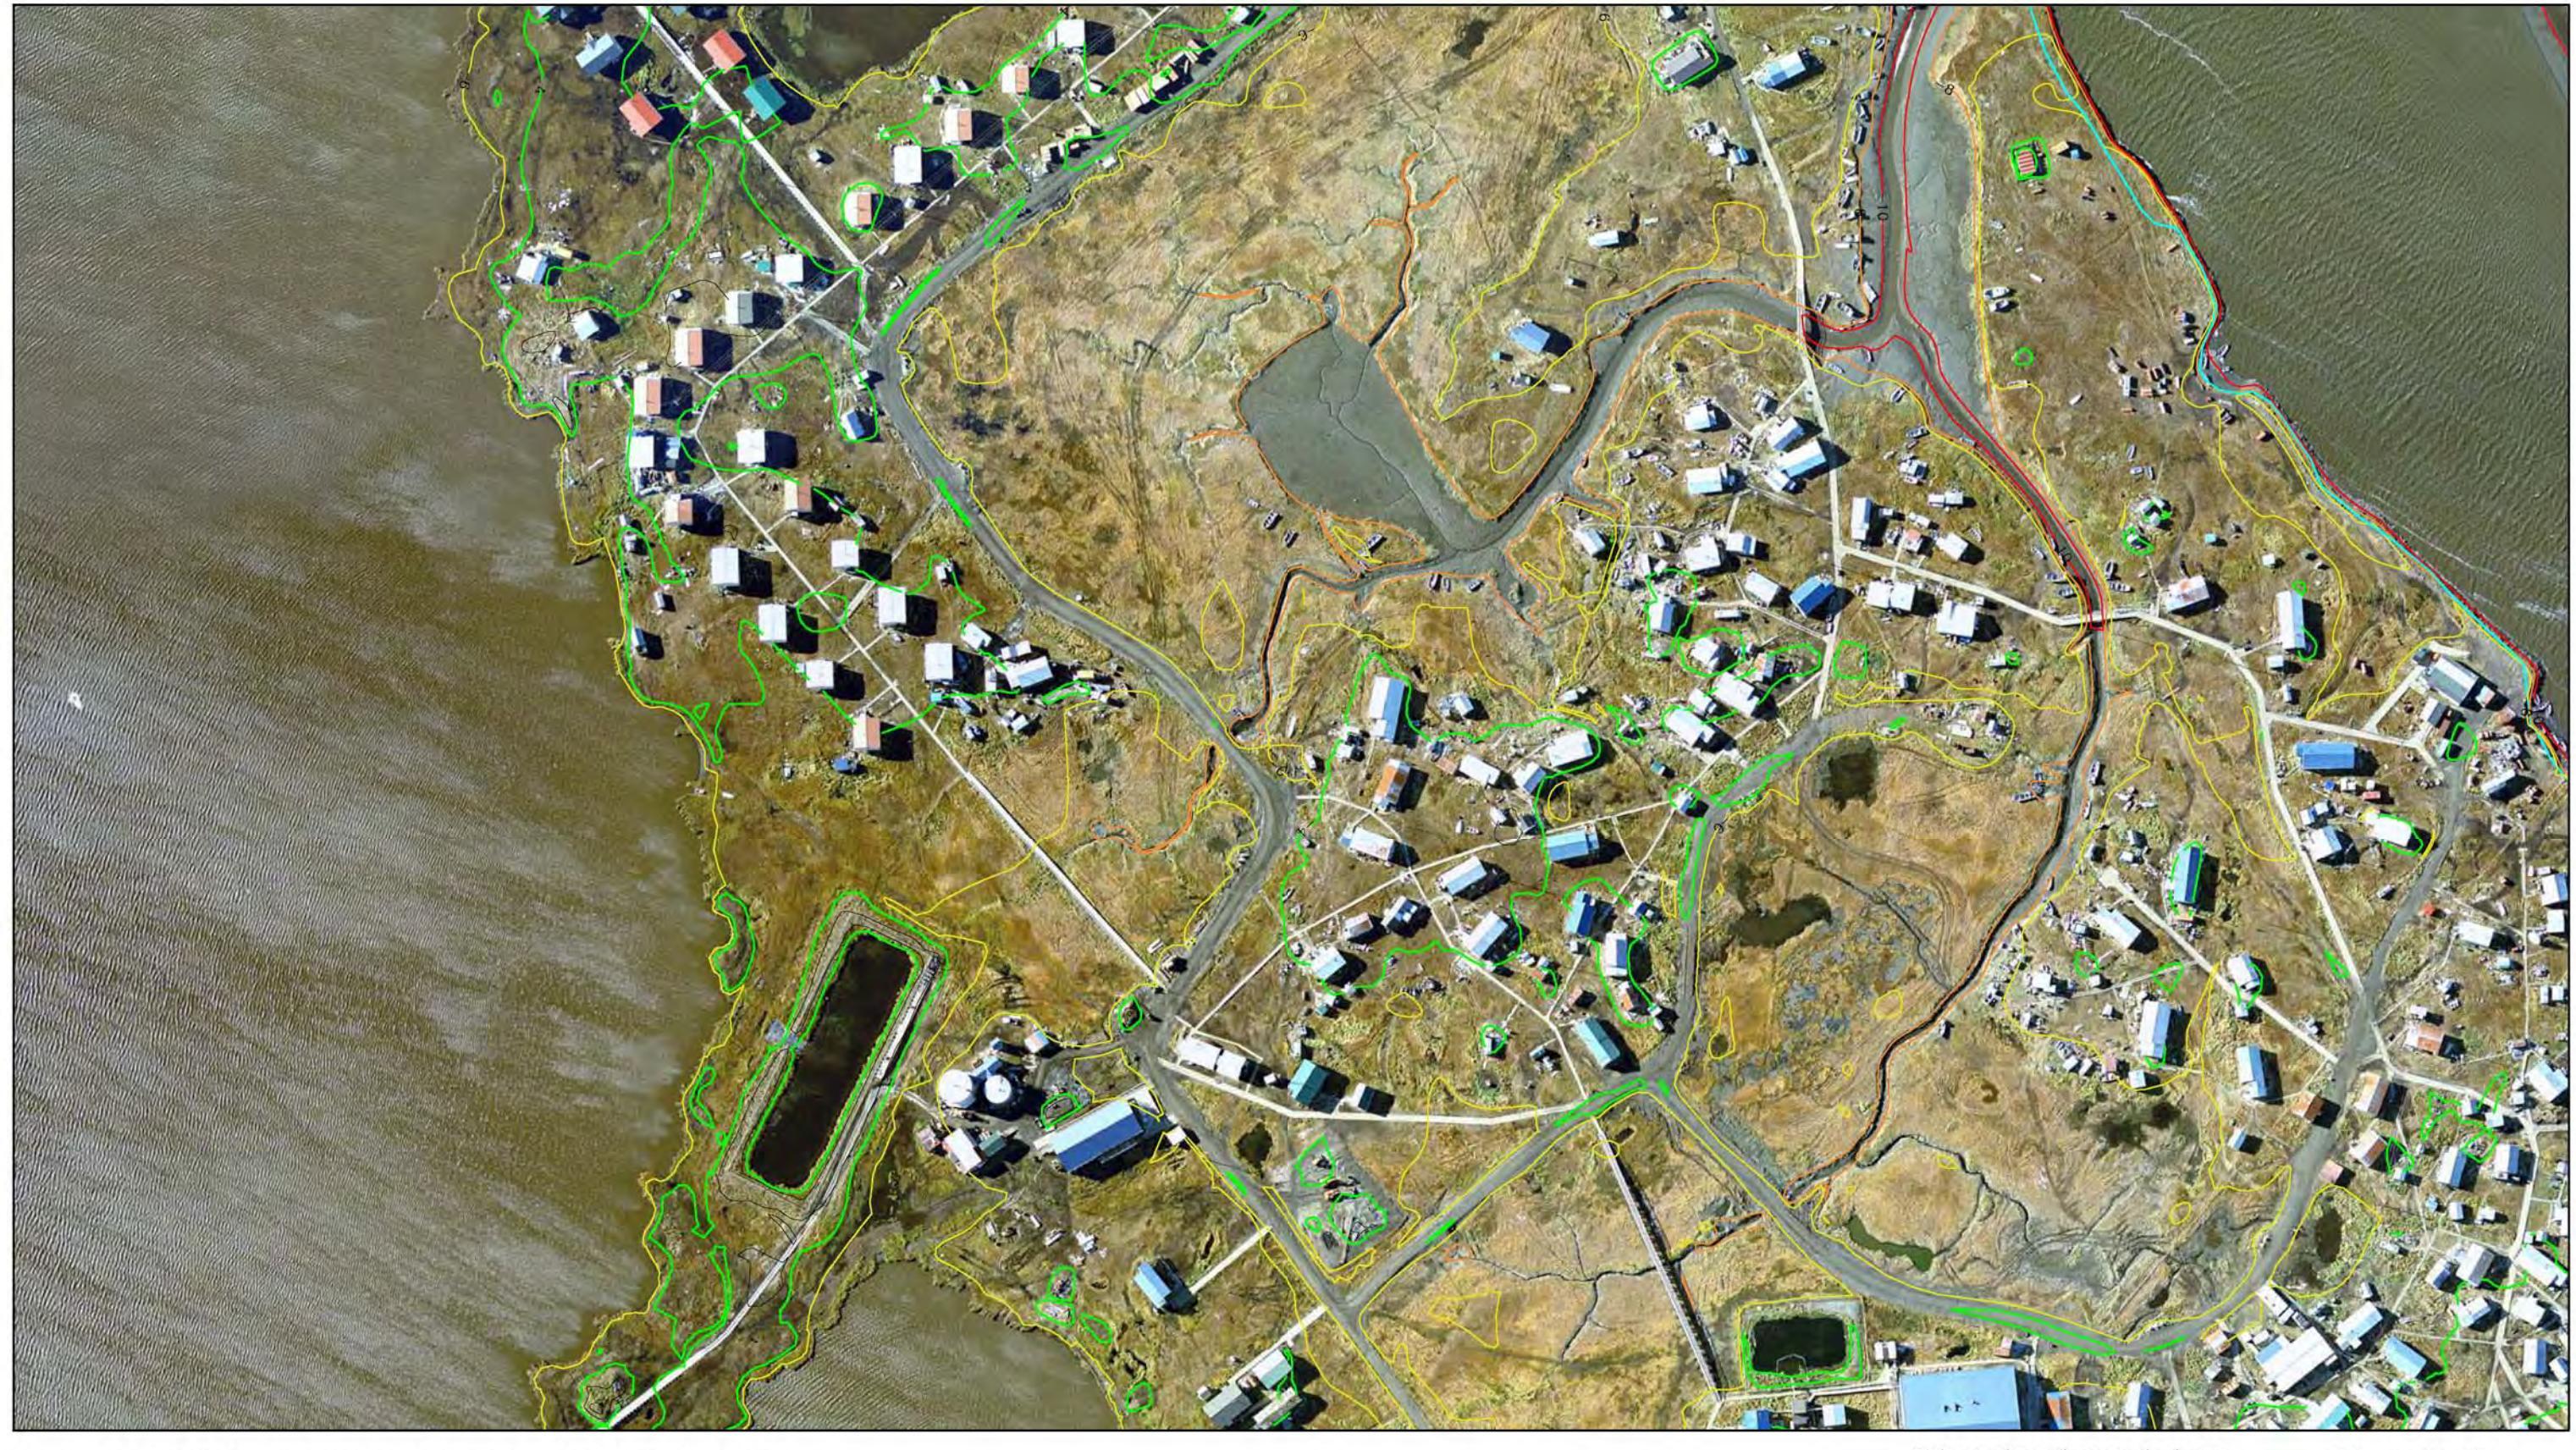
Plate 3.2

FLOOD MAP Hazard Impact Assessment Kipnuk, Alaska

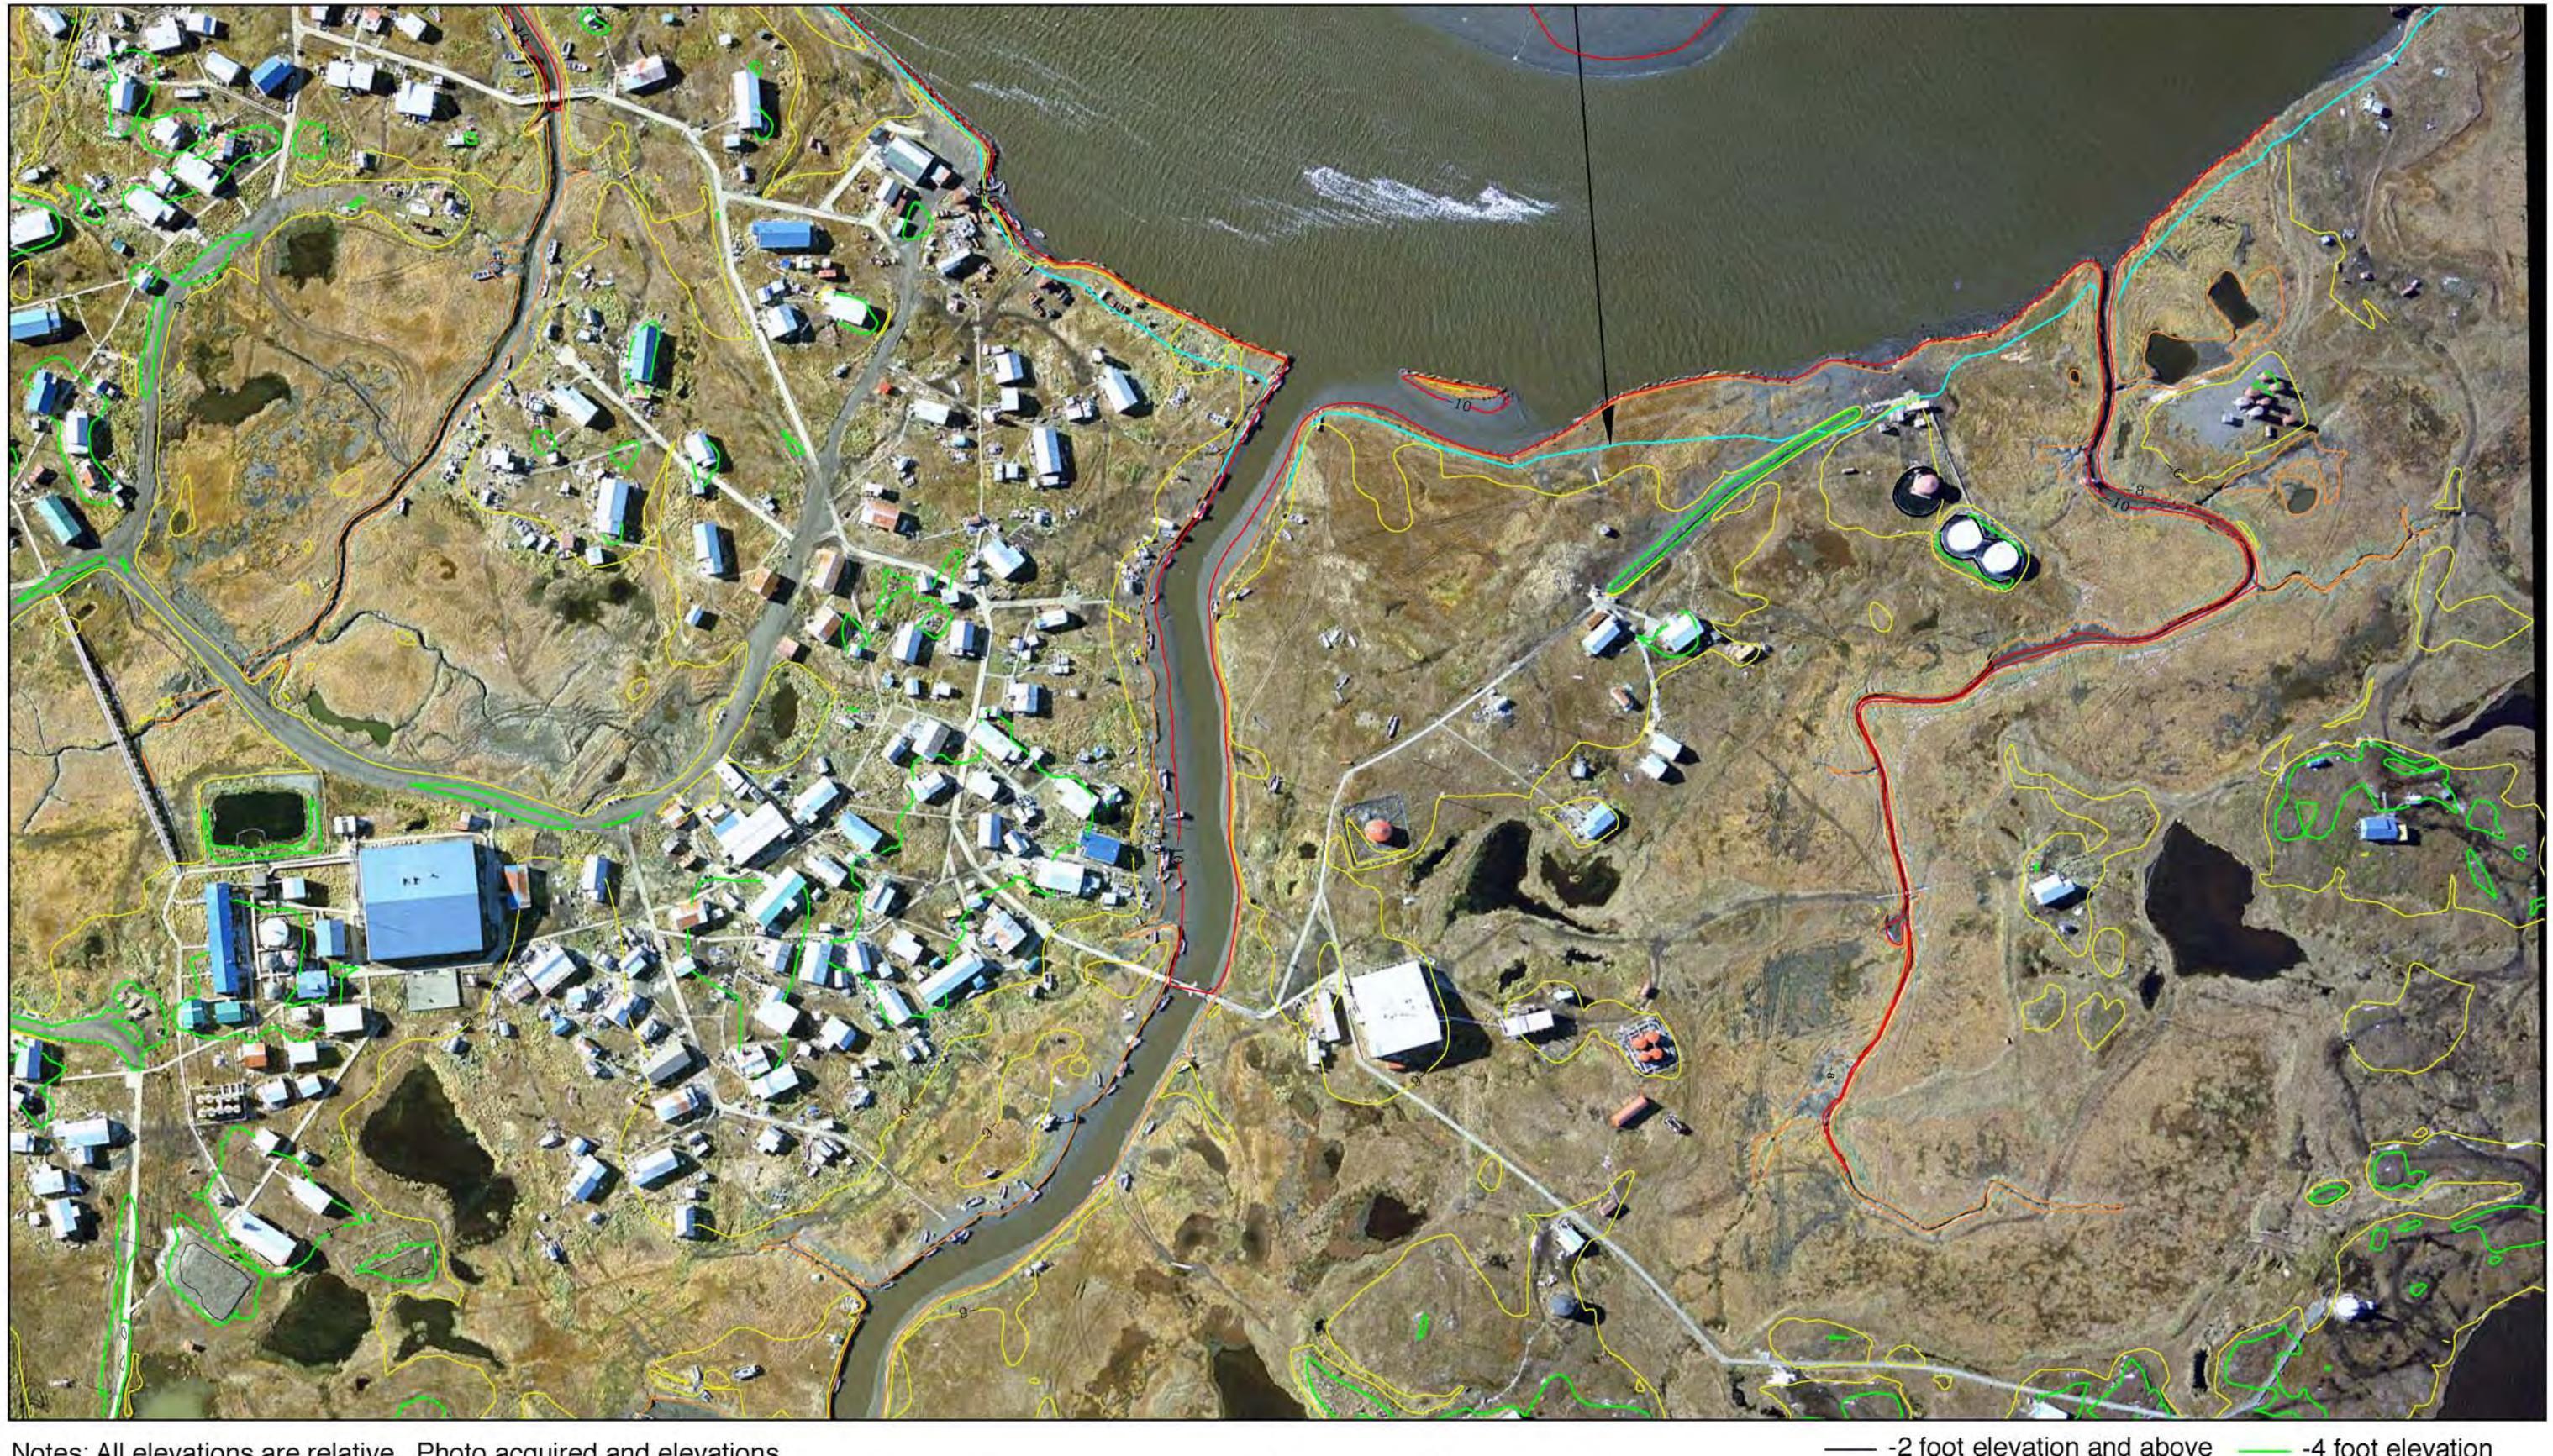
Plate 3.3

FLOOD MAP Hazard Impact Assessment Kipnuk, Alaska

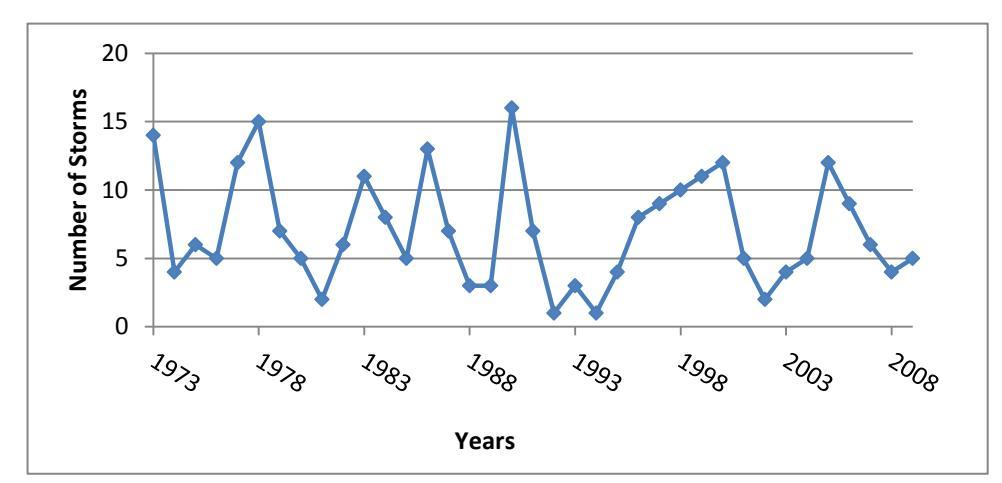
Figure 1. Number of storms per year at Nome between 1973 and 2009 and from June through October.

Figure 1 is a plot of the number of storms at Nome since 1973. A storm is defined as an event where the wind speed exceeds 25 knots. The plot is for storms from June through October. These are the months when the extent of open water makes it most likely that a storm surge can develop at Kipnuk. The figure clearly shows no obvious increase in the number of storms over the 37 year period (1973 to 2009).

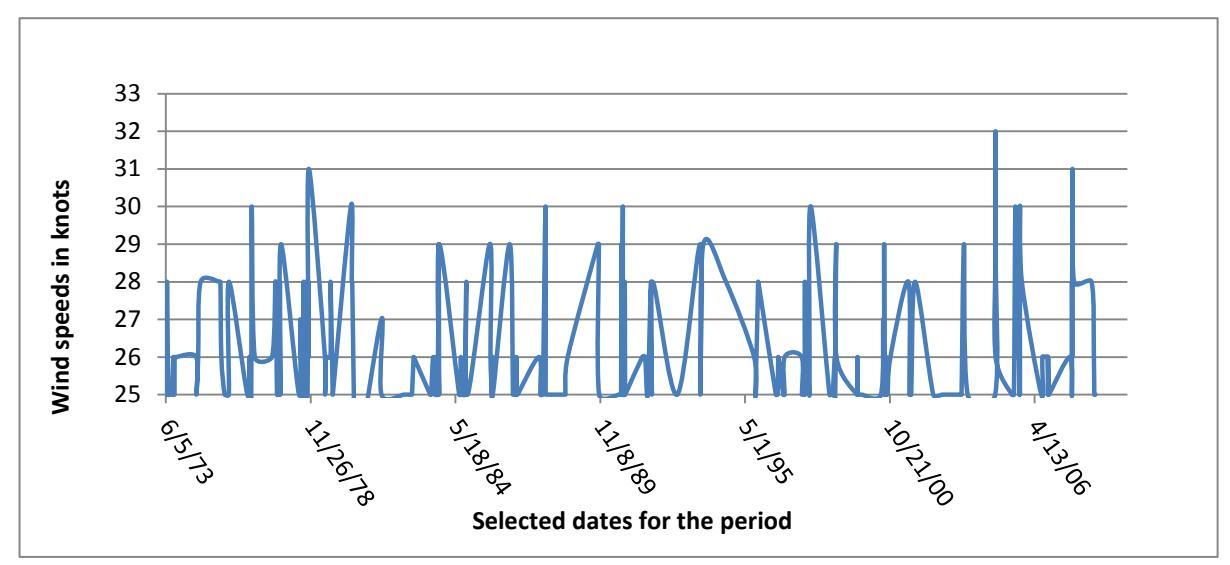
Figure 2. Storm magnitude as expressed through the wind speed for the same period and conditions as Figure 1.

Figure 2 is for the same period and for the same months (June through October). It again shows the intensity of the storms, expressed as maximum wind speeds, do not increase over the recent few years. In both cases only the winds from the south were considered. The importance of the wind direction can be area specific and will depend also on the offshore depth of the marine water near the mouth of the river and on the shoreline orientation there, neither of which has changed over the period or record. North winds are more likely to cause a negative storm surge or a set-down at Kipnuk. Set-downs are usually much less than set-ups for a given wind speed.
