VILLAGE HOUSING ASSESSMENT FOR THE VILLAGE OF MERTARVIK

FOR DOWL ENGINEERS AND NEWTOK VILLAGE

JUNE 14, 2017

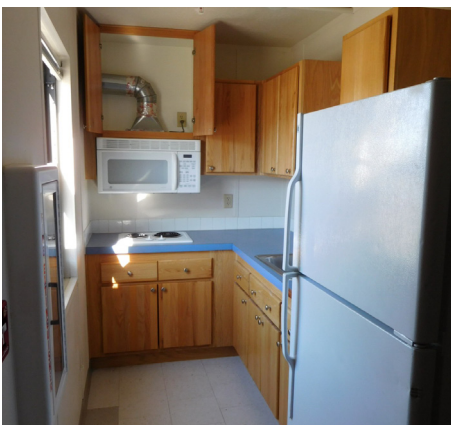
Kitchen in unit

Casework in these units is generally of low-quality, with lightweight drawer slides and standard weight hinges. The drawer and door fronts are three-quarter inch thick solid oak. Countertops are plastic laminate with plastic laminate edges, and are damaged in several areas. If these units were converted to support the village-based family, it is likely the entire kitchen would need to be renovated to a more durable solution, with proper storage and amenities.

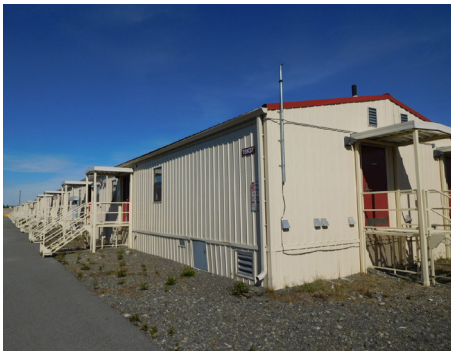
Exterior view of unit

There is a steel entrance stair and canopy over each unit entrance. The stairs are not constructed to meet current code and are starting to rust. The canopies over these entries have been damaged in many units by snow and ice.

Counters and downspouts are installed at each unit. Many of the downspouts are damaged or missing elements.

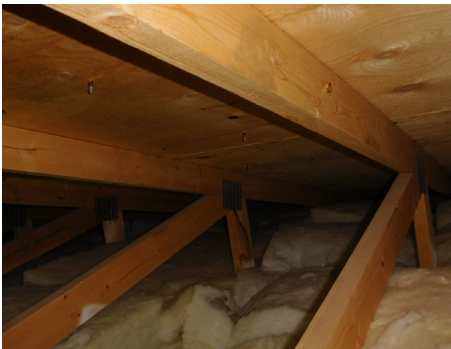
View into attic

The attics appear to be properly vented as cold roofs, with gable endvents, ridge vents, and eave vents. In Arctic conditions, these types of venting result in snowdrifts in the attic, which leads to water penetration, and eventually mold. If the modules are moved, baffled gable end vents would need to be added at the very least, and the ridge vents possibly removed. It appears additional venting was needed in the attics based on the observation of attic vents poking out of the metal roofing. Any alteration of the venting system could possibly lead to ice damming and other issues. It may be more prudent to apply rigid insulation on the top of the plywood roof deck and then have a new metal roof added, making these a warm roof solution. This would alleviate the need for a vented roof attic, and may give additional space to retrofit water and heating piping overhead if needed.

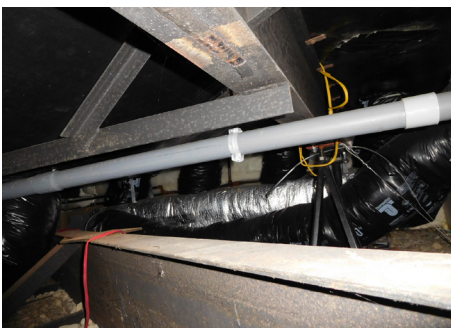
View into crawlspace

Currently, the modules are set on gravel pads on temporary foundation cribbing with insulated skirting from the bottom of the floor to the top of the gravel surface. The skirting is rigid insulation with a rating of R-19 attached to metal siding. If the modules are moved, a new R-38 soffit would need to be constructed under the units to protect the underfloor utilities from freezing. It is likely that the modules would be placed on an elevated foundation system, so the soffit would need to be protected on the bottom side with a steel liner panel, or painted wood sheathing.

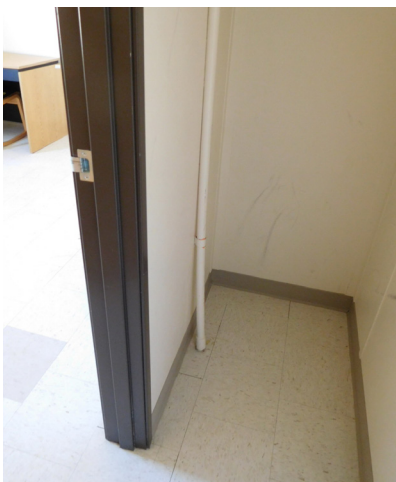
Interior view of piping

- + The modules are provided with sprinklers throughout, but to satisfy the code for an R-2 apartment style occupancy, sprinklers are not required. The sprinkler system would need to be removed entirely if these units are re-purposed, and cannot be abandoned in place. The sprinkler piping is routed in the crawl space and surface mounted in each unit.
- + The thermal envelope upgrade is not a code requirement, but strongly recommended to keep utility costs within a manageable limit for the tenants.
