## Newtok Environmental Site Inventory and Assessment Project

### Part I: Hazardous Materials Inventory

October 29, 2015

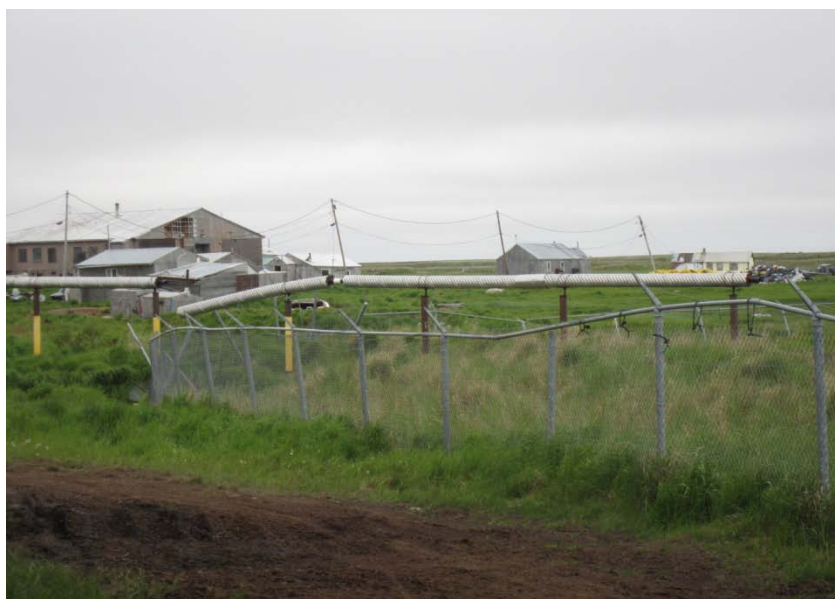
### **Washeteria (#3 on Figure 1)**

The washeteria was built in the 1980s. It housed the water treatment equipment for the village (except the Newtok School) and laundry facilities. Water was pumped to the water treatment system from ponds near the airstrip, filtered, treated with chlorine, and made available for village use by an outside fill spout. Chlorine and propylene glycol were stored onsite. A 211,000 gallon storage tank located outside the washeteria was

used for water storage. Five new, 20,000 gallon foam insulated horizontal tanks were housed next to the washeteria but were not currently in use.

The laundry facility comprised six washers and four dryers, none of which were in use. The break in the discharge pipeline to the sewage lagoon and incompatibility between the dryers and the transformer precluded their use.
