U.S. Army Corps
of Engineers
Alaska District

ALASKA BASELINE EROSION ASSESSMENT

Erosion Information Paper - Kotlik, Alaska

Current as of March 7, 2008

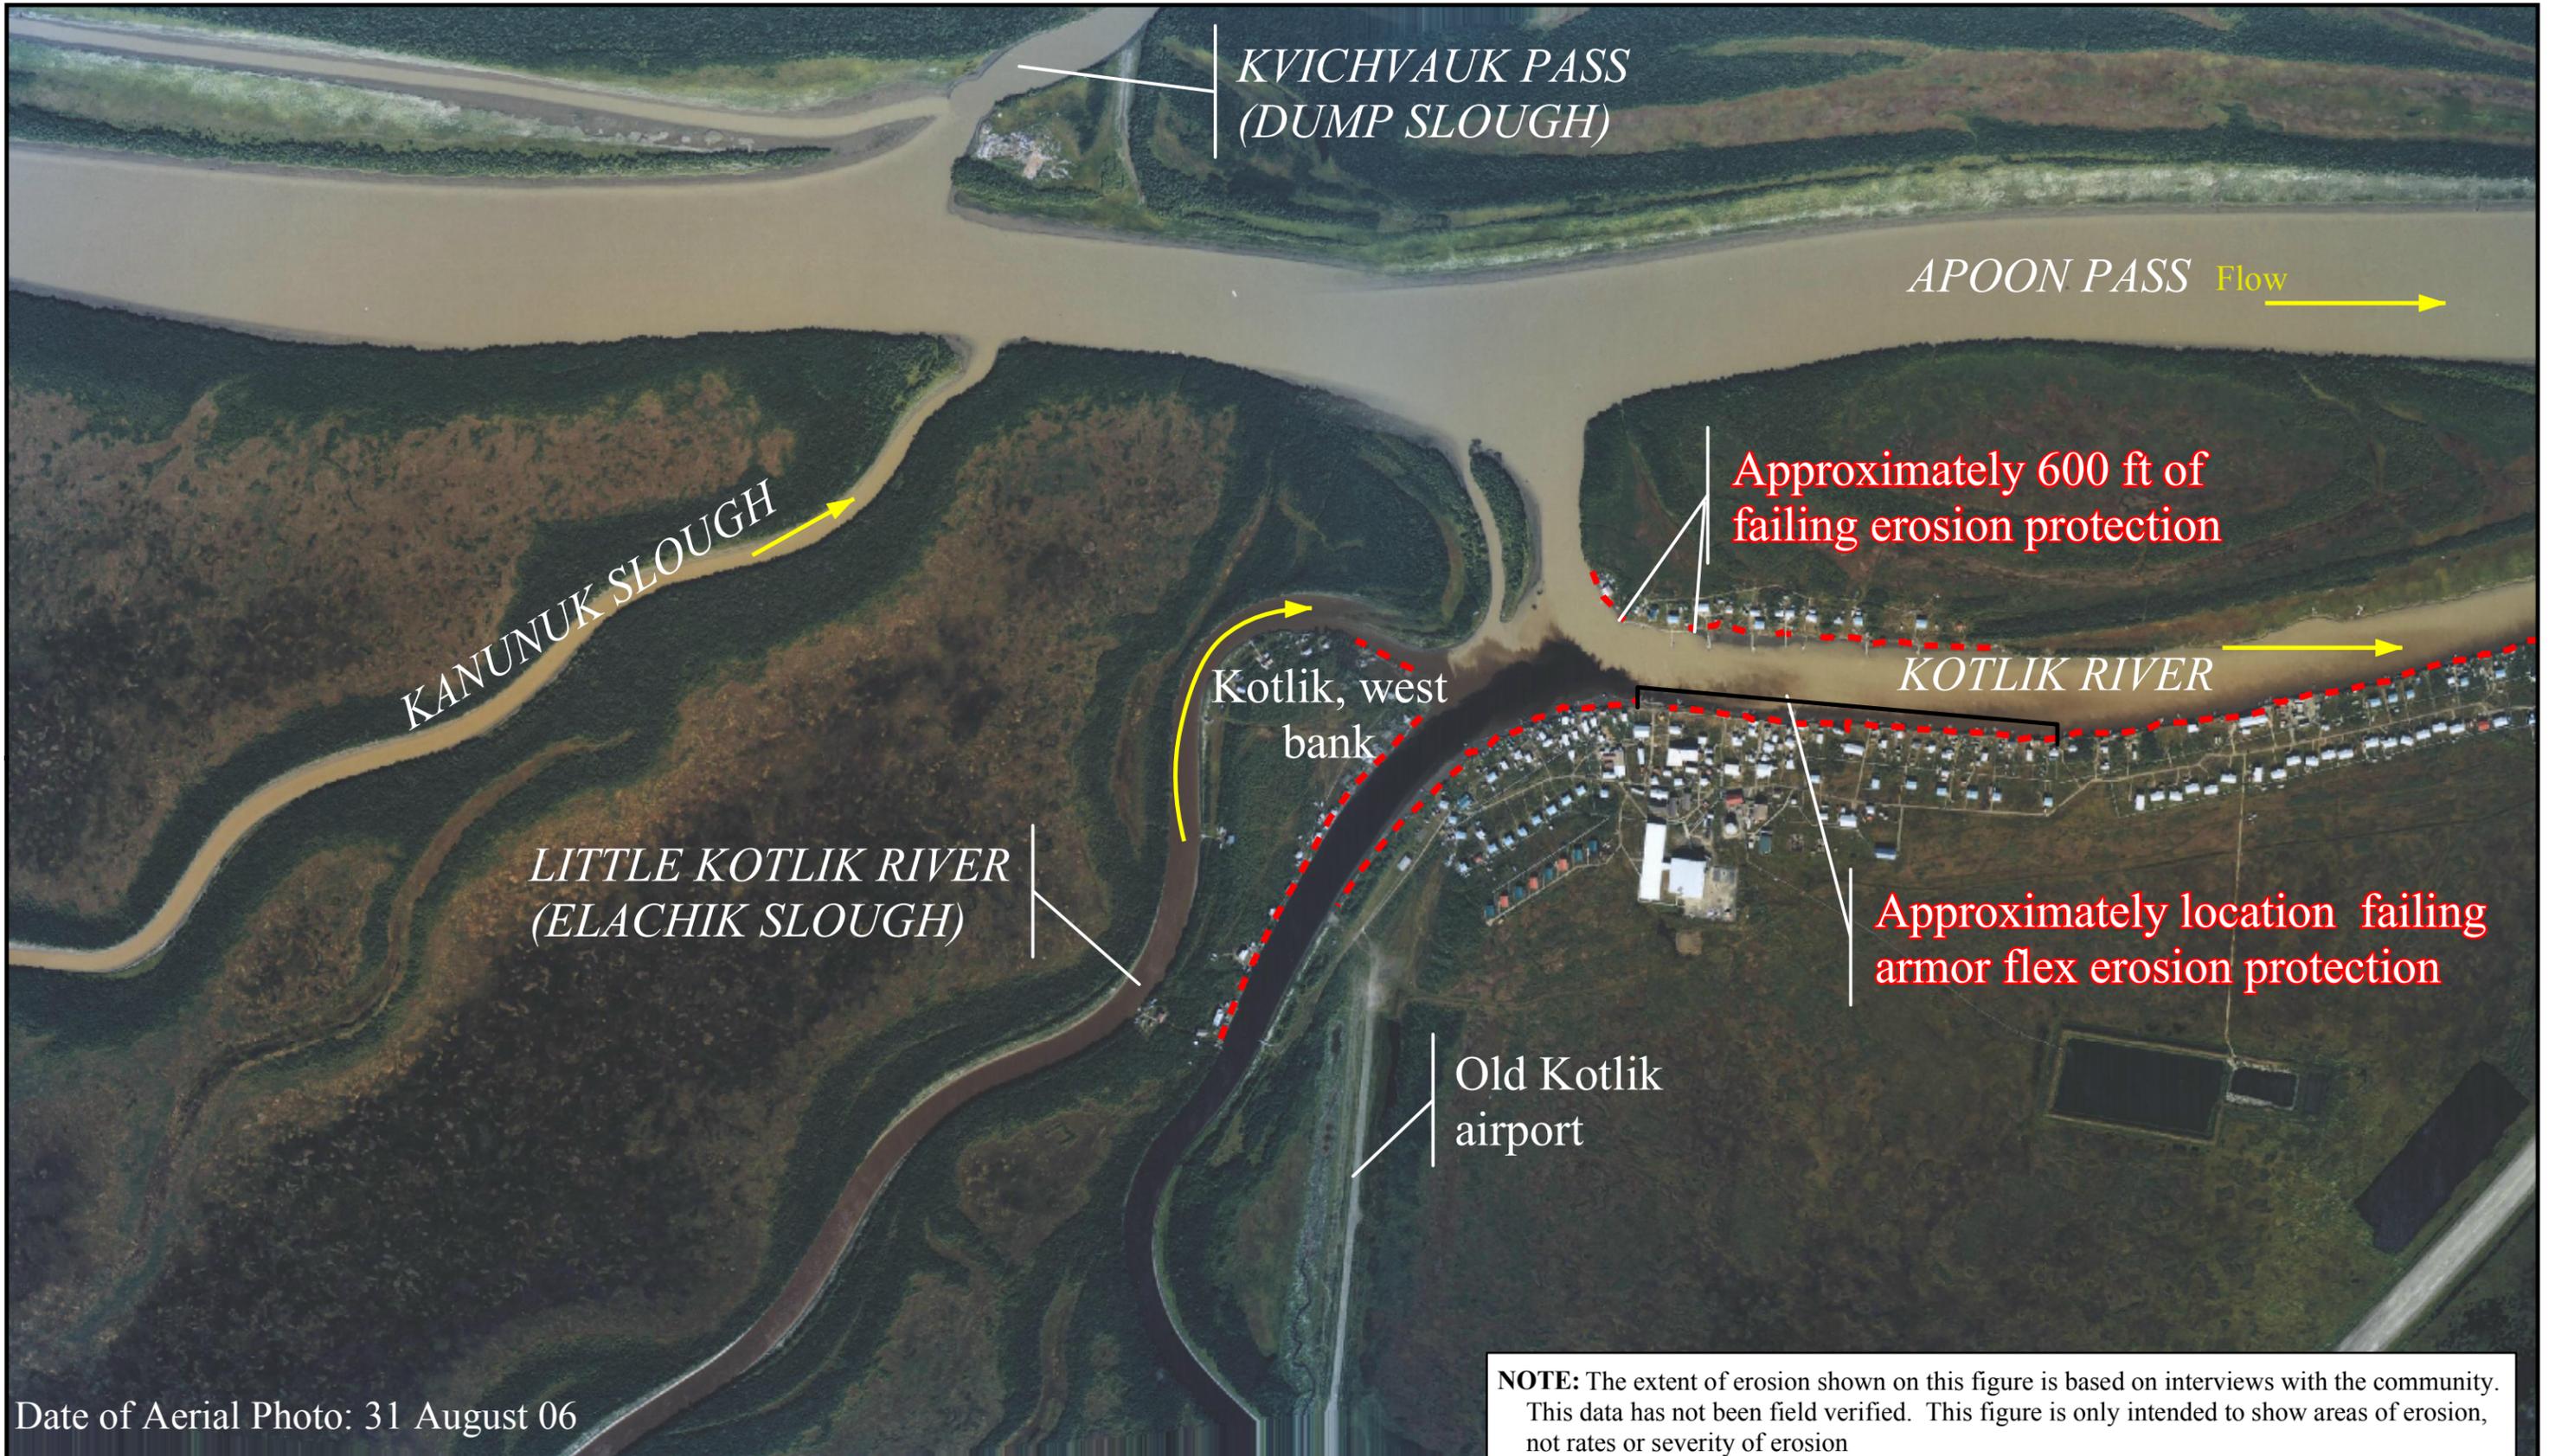
Date of Aerial Photo: 31 August 06

NOTE: The extent of erosion shown on this figure is based on interviews with the community. This data has not been field verified. This figure is only intended to show areas of erosion, not rates or severity of erosion

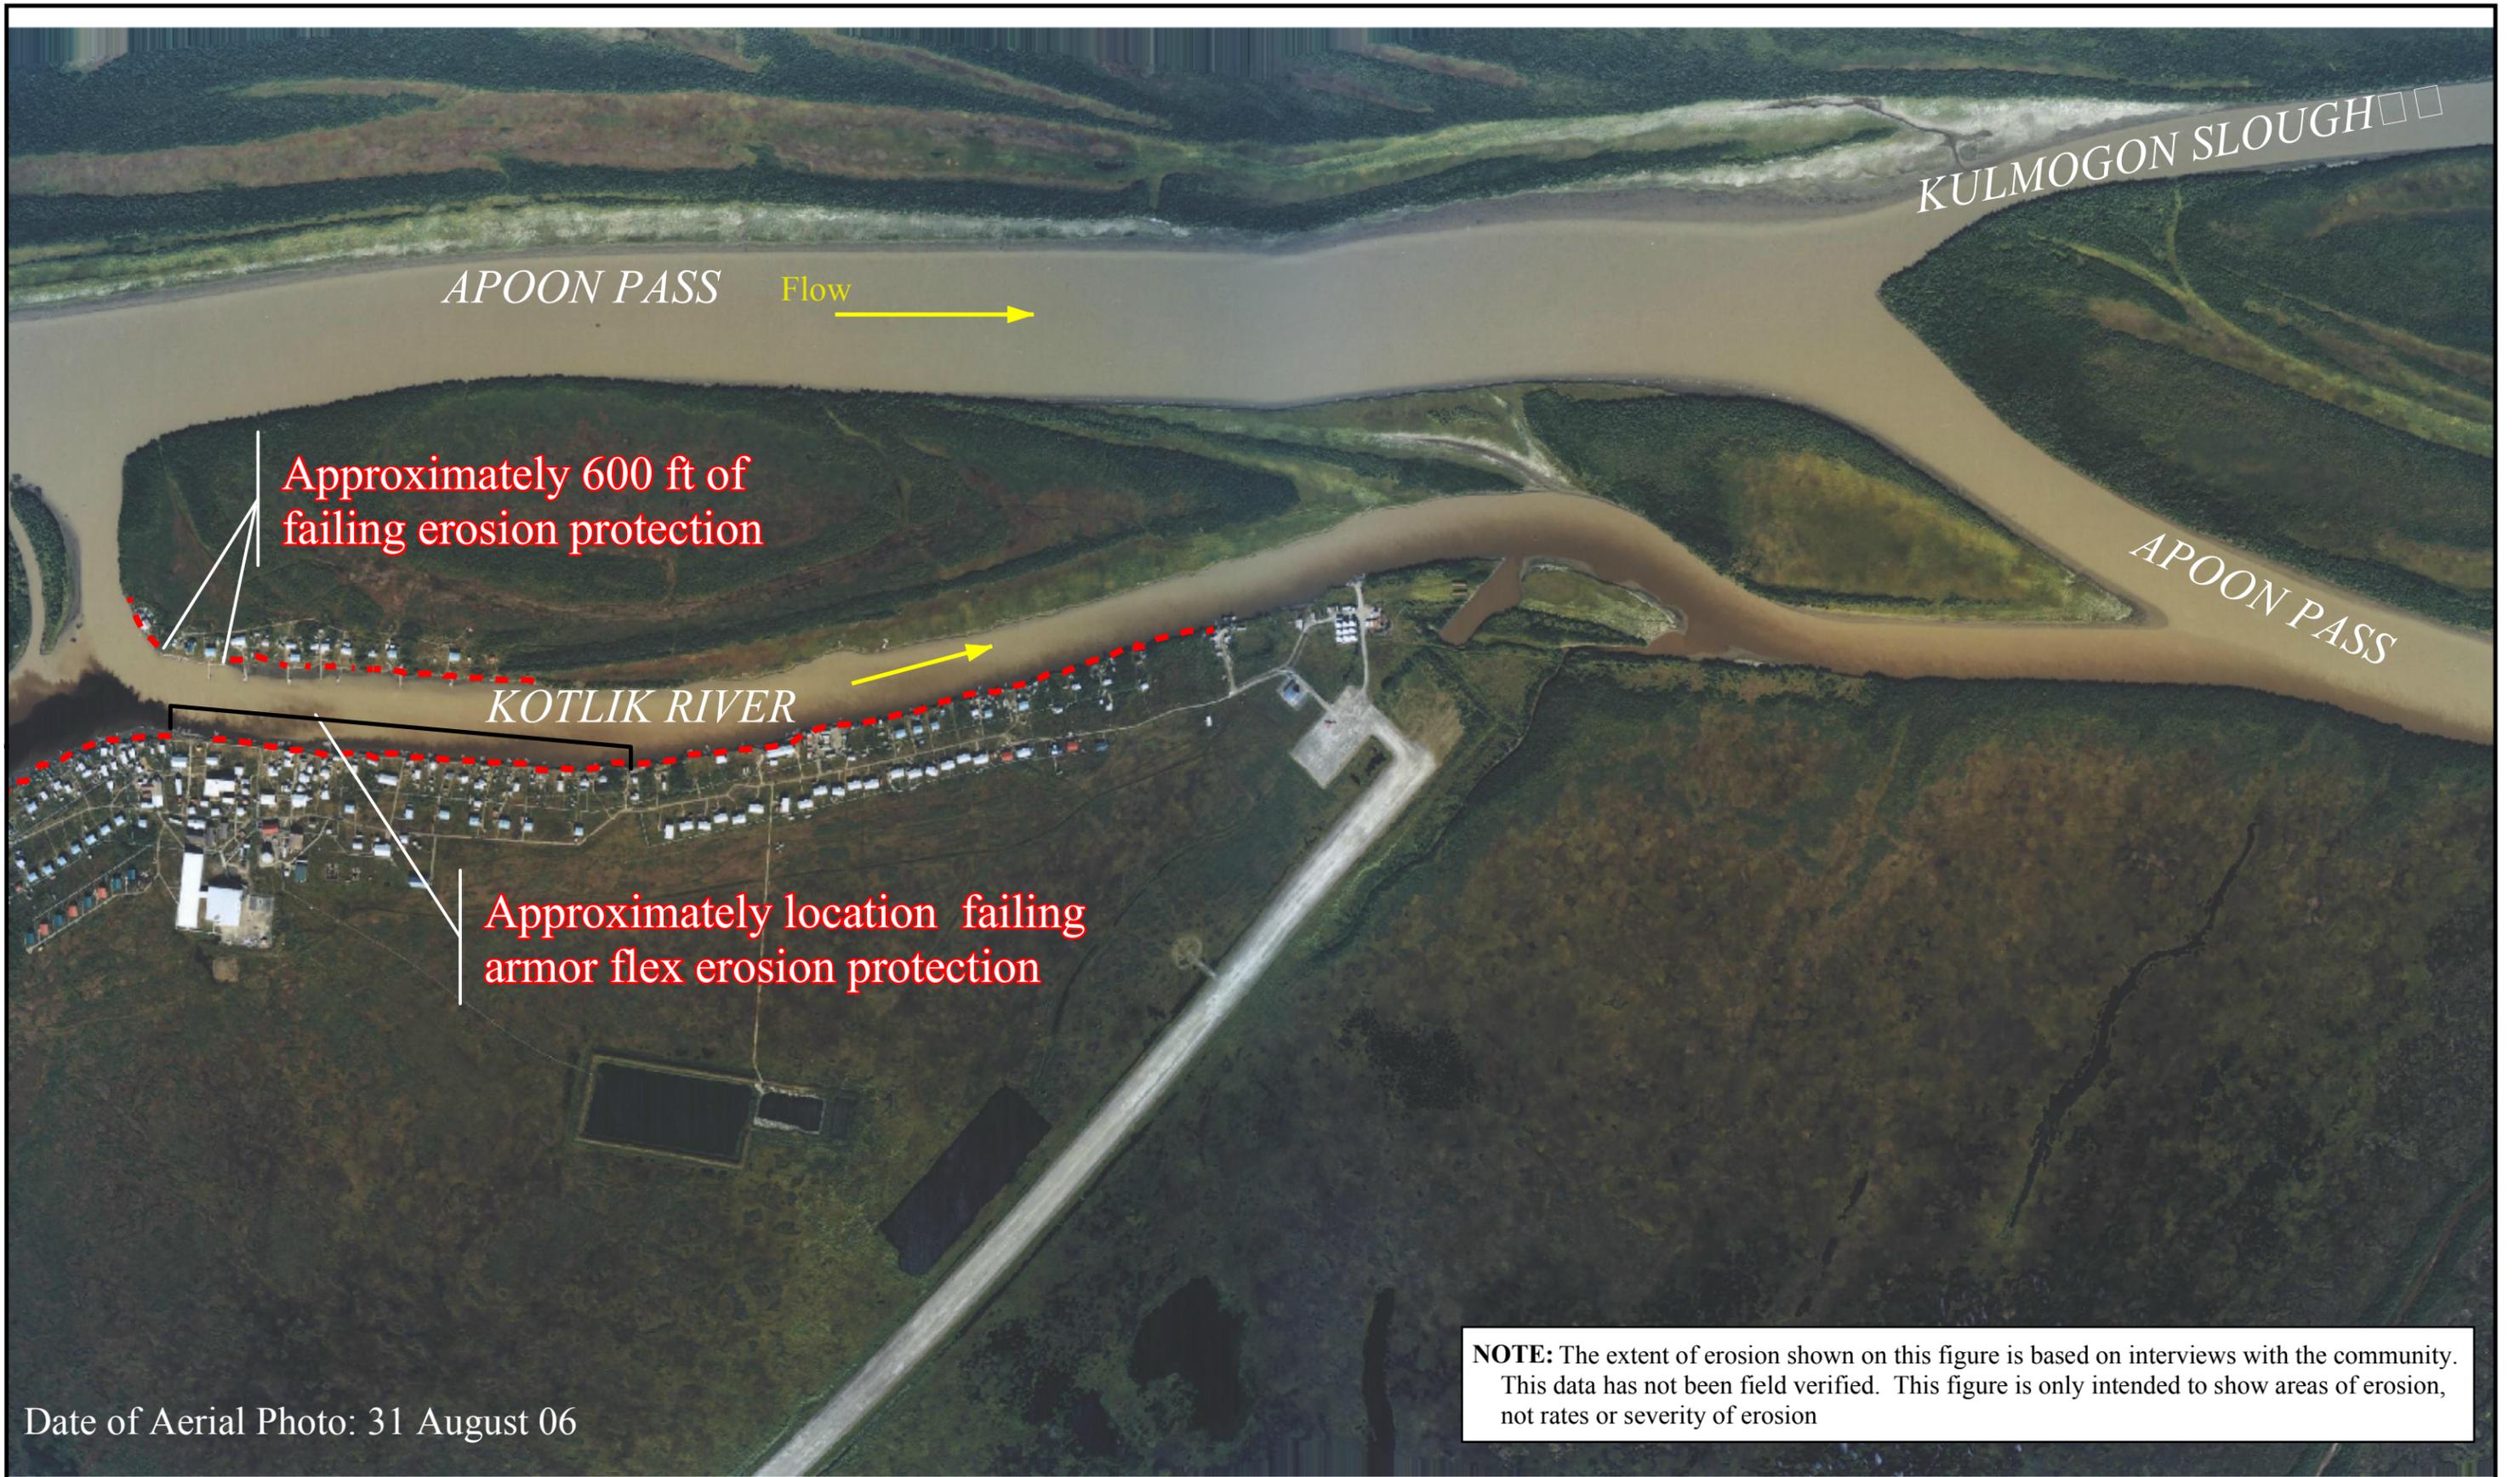
Date of Aerial Photo: 31 August 06

NOTE: The extent of erosion shown on this figure is based on interviews with the community. This data has not been field verified. This figure is only intended to show areas of erosion, not rates or severity of erosion
