DETAILED ACTION PLAN KOTLIK LANDFILL

WASTE EROSION ASSESSMENT & REVIEW (WEAR) MAY 2015

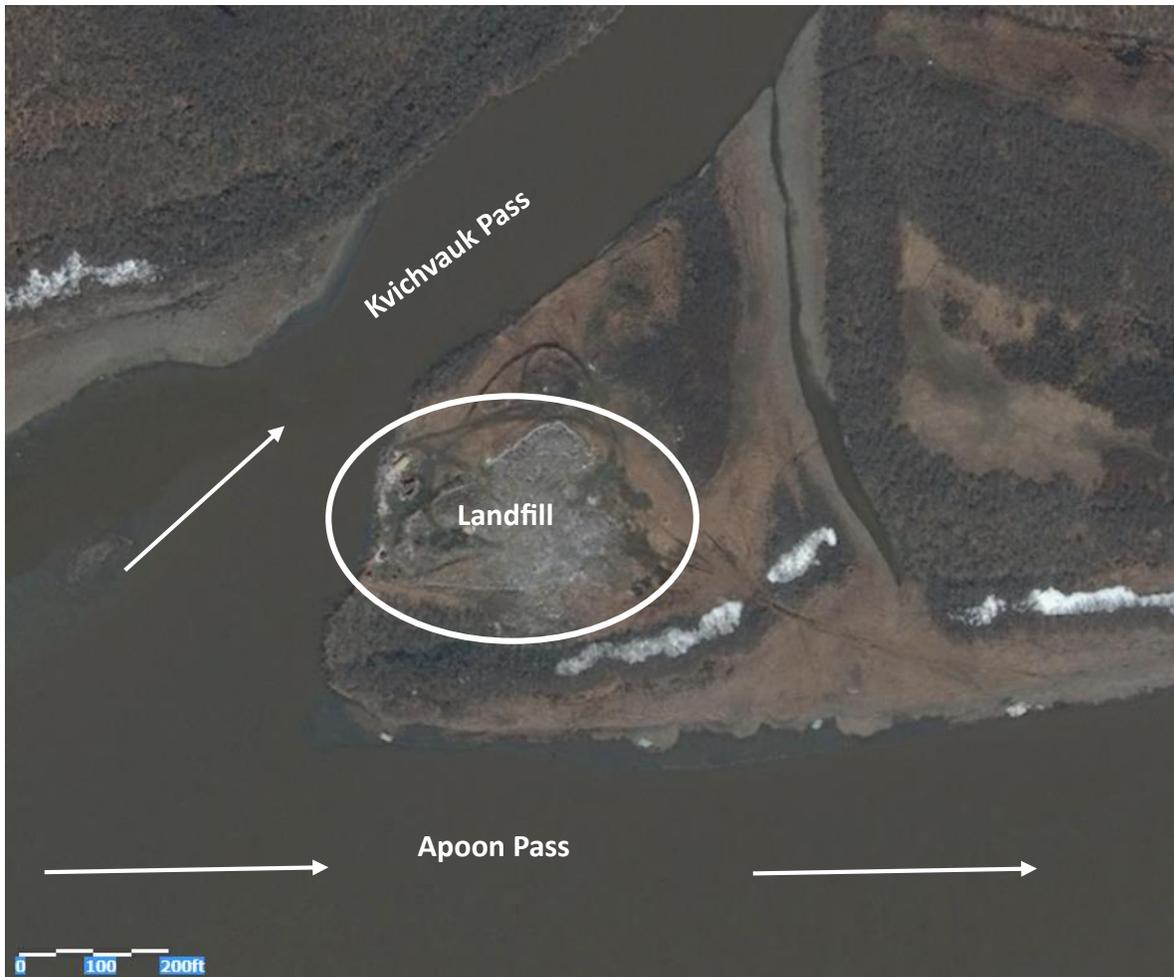
The US Army Corps of Engineers 2009 study, *Alaska Baseline Erosion Assessment (BEA)*, lists an estimated erosion rate of 3 feet per year along the banks of the landfill. During the 2012 WEAR site inspection, the landfill was only 15 feet from the eroding riverbank. According to the BEA, natural fluctuations in flows and water levels, flooding, ice jams, spring break up, and wave action from boat wakes and wind reportedly contribute to bank erosion. The soil structure of silt and clay is more likely to erode than other soil types and is weakened with the semi-annual thaw-freeze cycle.

Erosion is estimated to impact the landfill by 2016.

Imagery Dated 2011. WEAR Map at <http://dec.alaska.gov/eh/sw/wear.html>

The ADEC Solid Waste Program recommends the community construct a new permitted landfill, ideally located on the same side of the river as the community to provide year-round access to the site. Removal of the existing landfill, with disposal of waste into the new landfill is then necessary to address contaminant risk.

Until a new landfill can be constructed, the community should continue to use the current landfill, and move the waste away from the encroaching riverbank several times a year using heavy equipment. Signs should be posted along the river bank informing residents to take waste to the interior of the site.
