GEOTECHNICAL REPORT

MERTARVIK TOWNSITE

Newtok, Alaska

February 2008

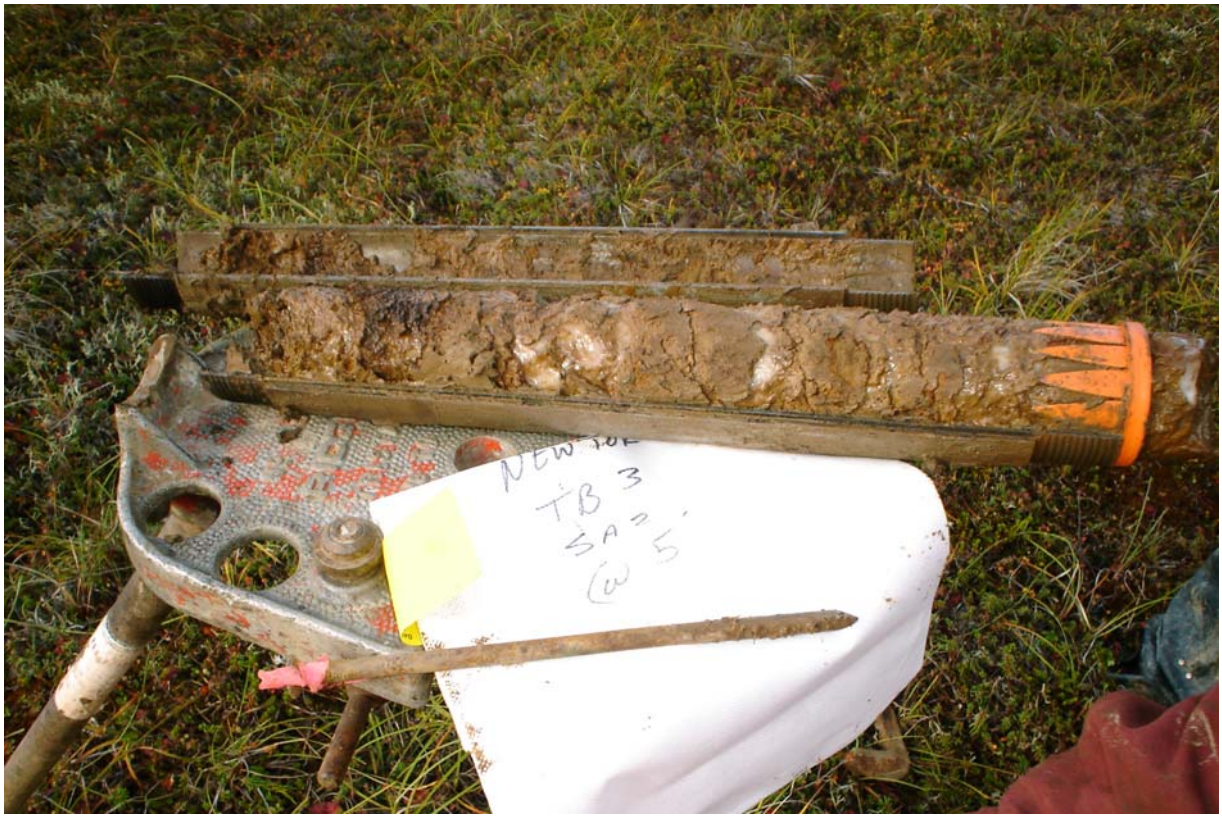
Photograph 3. Typical sample showing the ice content present in many of the frozen soils.

Photograph 4. Ice typical of many areas in the permafrost.

The permafrost conditions on the site vary greatly between boring locations. It appears that the permafrost has degraded at locations near drainage paths and in areas where water may pond. In general, the permafrost is either present within two to three feet of the ground surface or it is degraded to below the bedrock surface. One observation that was made at the site was that in some areas where permafrost degradation has occurred the subsidence of the ground surface was on the order of a couple of feet or more as shown in Photograph 5. For a detailed description of the subsurface conditions encountered at each boring location, see the exploration logs contained in Appendix A.
