CIAP WEAR Trip Report Chefornak (population 434) September 18, 2012

Alaska Department of Environmental Conservation (ADEC) Solid Waste Program and Contaminated Sites Program (Doug Huntman and Grant Lidren) conducted a Coastal Impact Assessment Program (CIAP), Waste Erosion Assessment and Review (WEAR) site visit for the Village of Chefornak, September 18th, 2012. Tom Tom, Waste Technician and Richard Matthew, trash hauler working with the Native Village of Chefornak participated on the site visits. The following narrative is a brief description of our findings during the September inspection.

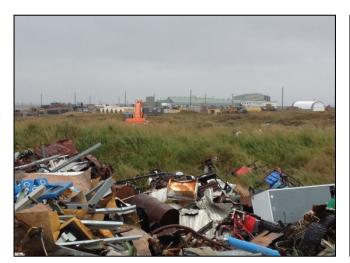
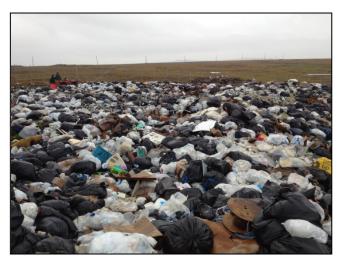
➤ Landfill, 60.153534/-164.288125 (Active) – This permitted, landfill has been in operation since the mid 1990's and has waste spread though the 5 acre site. It is located southwest of the village and is managed by the City of Chefornak. It contains municipal waste and construction and demolition debris. The top concerns at the site include: uncovered waste spread thought the site, uncontrolled burning of waste on the ground, disposal of prohibited and hazardous waste, and uncontrolled access to the landfill. It is 2,400 feet from the Kinia River.

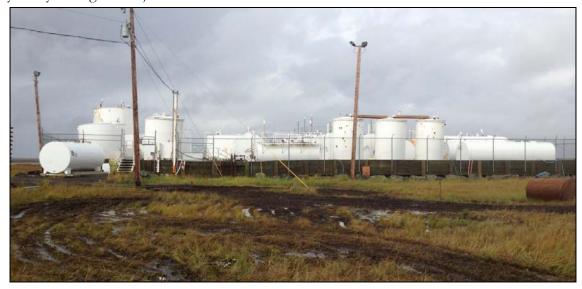
➤ Consolidated Tank Farm, 60.160121/-164.286799 (Active) – This tank farm stores fuel for the City of Chefornak, Lower Kuskokwim School District, Naterkaq Light Plant, and Chefarnmute Corporation. It was completed around 2002. There are approximately 20 tanks that range in size from 15,000 gallons to 40,000 gallon tanks. The tanks appeared to be in good condition with secondary containment in place. It is approximately 400 feet from the Kinia River. Locals reported the bank is eroding at 2 to 6 feet per year. It was reported that site stayed dry during the major flood event of October 2012.

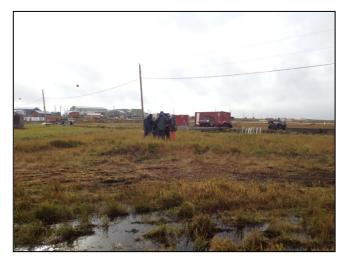
➤ Chefarnmute Corp. Former Tank Farm, 60.160115/-164.286085 (Active) – This former tank farm is an active Contaminated Site (File ID 2408.38.005). It was owned and operated by Chefarnmute Corporation. It consisted of gasoline and diesel, vertical and horizontal, aboveground tanks with a total fuel capacity of approximately 84,300 gallons. There were no documented spills at this site; however active leaks were noted during an Alaska Division of Community and Regional Affairs (DCRA) bulk fuel inventory conducted in 1998. During a site evaluation in 2001, dead and stressed vegetation was noted at the area of the site. As of the 2012 site visit, the tanks were removed, but stressed vegetation remained. There were also several piles of used sorbent pads left from a previous clean-up. Soil samples collected by a DEC contractor in 2012 contained DRO above ADEC maximum allowable concentrations. The site is currently being evaluated by the Contaminated Sites Program. The site is located approximately 140 feet from the consolidated tank farm and 370 feet from the Kinia River.

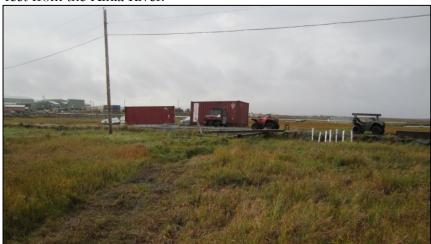
➤ Light Plant Former Tank Farm, 60.1598/-164.285853 (Active) – This former light plant tank farm is an active Contaminated Site (File ID 2408.38.002). It consisted of four tanks, three vertical and one horizontal, with a total fuel storage capacity of approximately 44,900 gallons. In 2001, it was noted that the old piping and tanks had been removed and the area exhibited stressed vegetation. Soil samples collected by a DEC contractor in 2012 contained DRO above ADEC migration to groundwater cleanup levels. The site is currently being evaluated by the Contaminated Sites Program. It is located approximately 190 feet from the consolidated tank farm and 405 feet from the Kinia River.

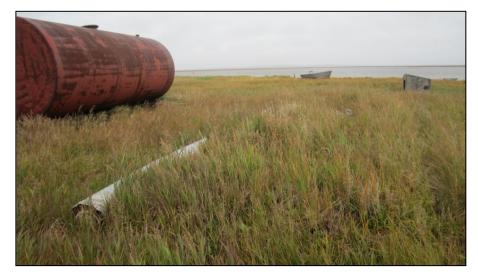
➤ Avugiak Store, 60.160980/-164.285135 (Active) – This active Contaminated Site (File ID 2408.28.006) is the site of a store's old fuel tank that leaked approximately 100 gallons of heating oil (diesel #1) in 2000. Initial cleanup work consisted of excavating approximately 240 square feet of soil to depths ranging from 1 to 2 feet. The excavated soil was stockpiled on the site on plastic sheeting. During the 2012 inspection, the tank, piping, and stockpile remain on site. The stockpile is overgrown with vegetation with used absorbents and liner in the pile. The site is located around 20 feet from the Kinia River. Area is an active boat launching area and there are approximately 20 or more abandoned fuel storage tanks in the immediate area. It was reported that two large bulk fuel tanks were eroded away and washed upstream during a storm event in 2011. One tank had been located several miles from the village, the other was presumed sunk. This site is in marshy wetlands with silty soil and grass. Boats located several hundred feet inland indicate that the site floods regularly with the tides. It was reported the area is eroding at 2-6 feet per year.

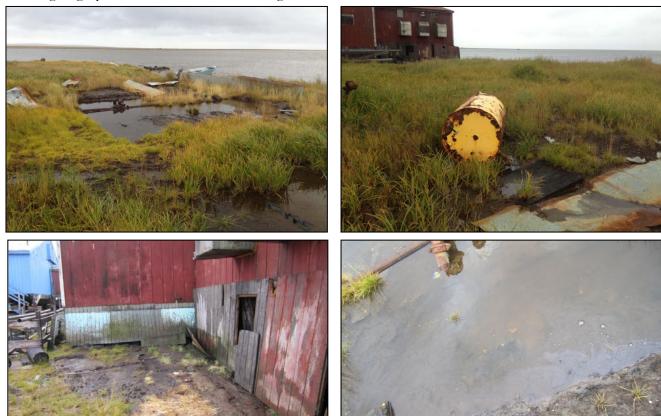
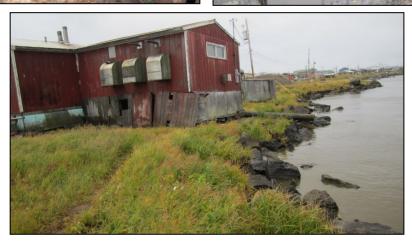
Former BIA School Tanks, 60.159392/-164.270584 (Active) – This active Contaminated Site (File ID 2408.38.008) is the site of a former tank farm used by the BIA school. It was reported in 2001 that the area surrounding the tank farm and the day tanks were heavily impacted with fuel contaminations. Neither tank areas had visible liners at that time. During the 2012 inspection, the tank farm and day tanks had been removed from the site, but the tank farm's piping remained. Heavily impacted soil and stressed vegetation was observed in both locations. The school associated with the site is used as the Head Start program for the village. The area was very silty with grass in the surrounding area. There was a lot of ponding observed at the site, indicating that the site floods regularly. Erosion was reported by local residents to be consuming the shoreline at 5 feet per year. There have been some attempts to mitigate erosion with large rocks placed along the shoreline, but it was reported that these too are washing away. Distances to the Kinia River bank are: 10 feet to the tank farm contamination, 20 feet to the school building, and 30 feet to the day tank contamination. Characterization of the site is ongoing by the Contaminated Sites Program.
